**Servicing and Stormwater
Management Report – 2829
Dumaurier Avenue**

Stantec Project No. 160401596

September 19, 2024

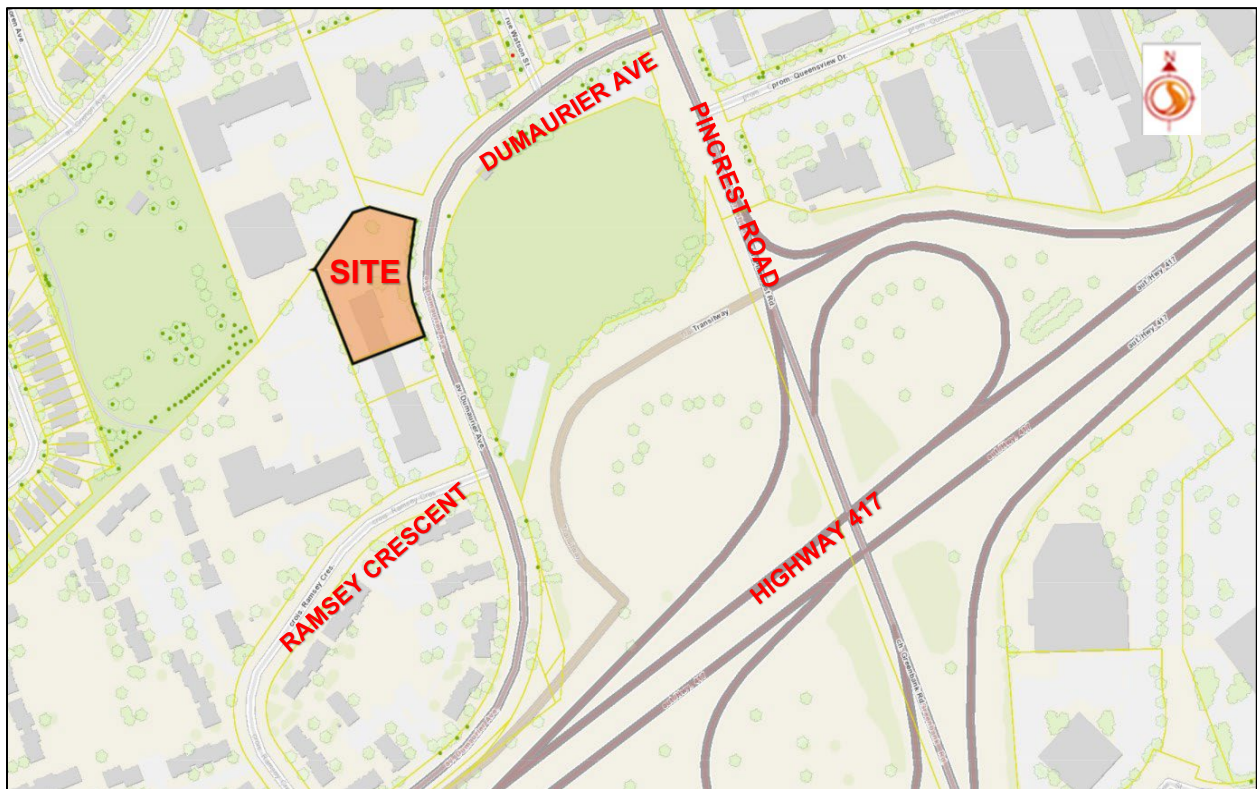
Figure 1: Key Plan (2829 Dumaური Ave. Site highlighted in Orange)

The proposed development area (0.42 ha) consists of a 40-storey residential high-rise building with commercial space on the first floor. The building is to contain 407 units in total consisting of 240 one-bedroom units (@1.4ppu), 161 two-bedroom units (@ 2.1ppu), 6 three-bedroom units (@ 3.1ppu), and 200m² of commercial area. Parking is to be provided via 6 surface parking spots and two underground parking levels (P1 and P2).

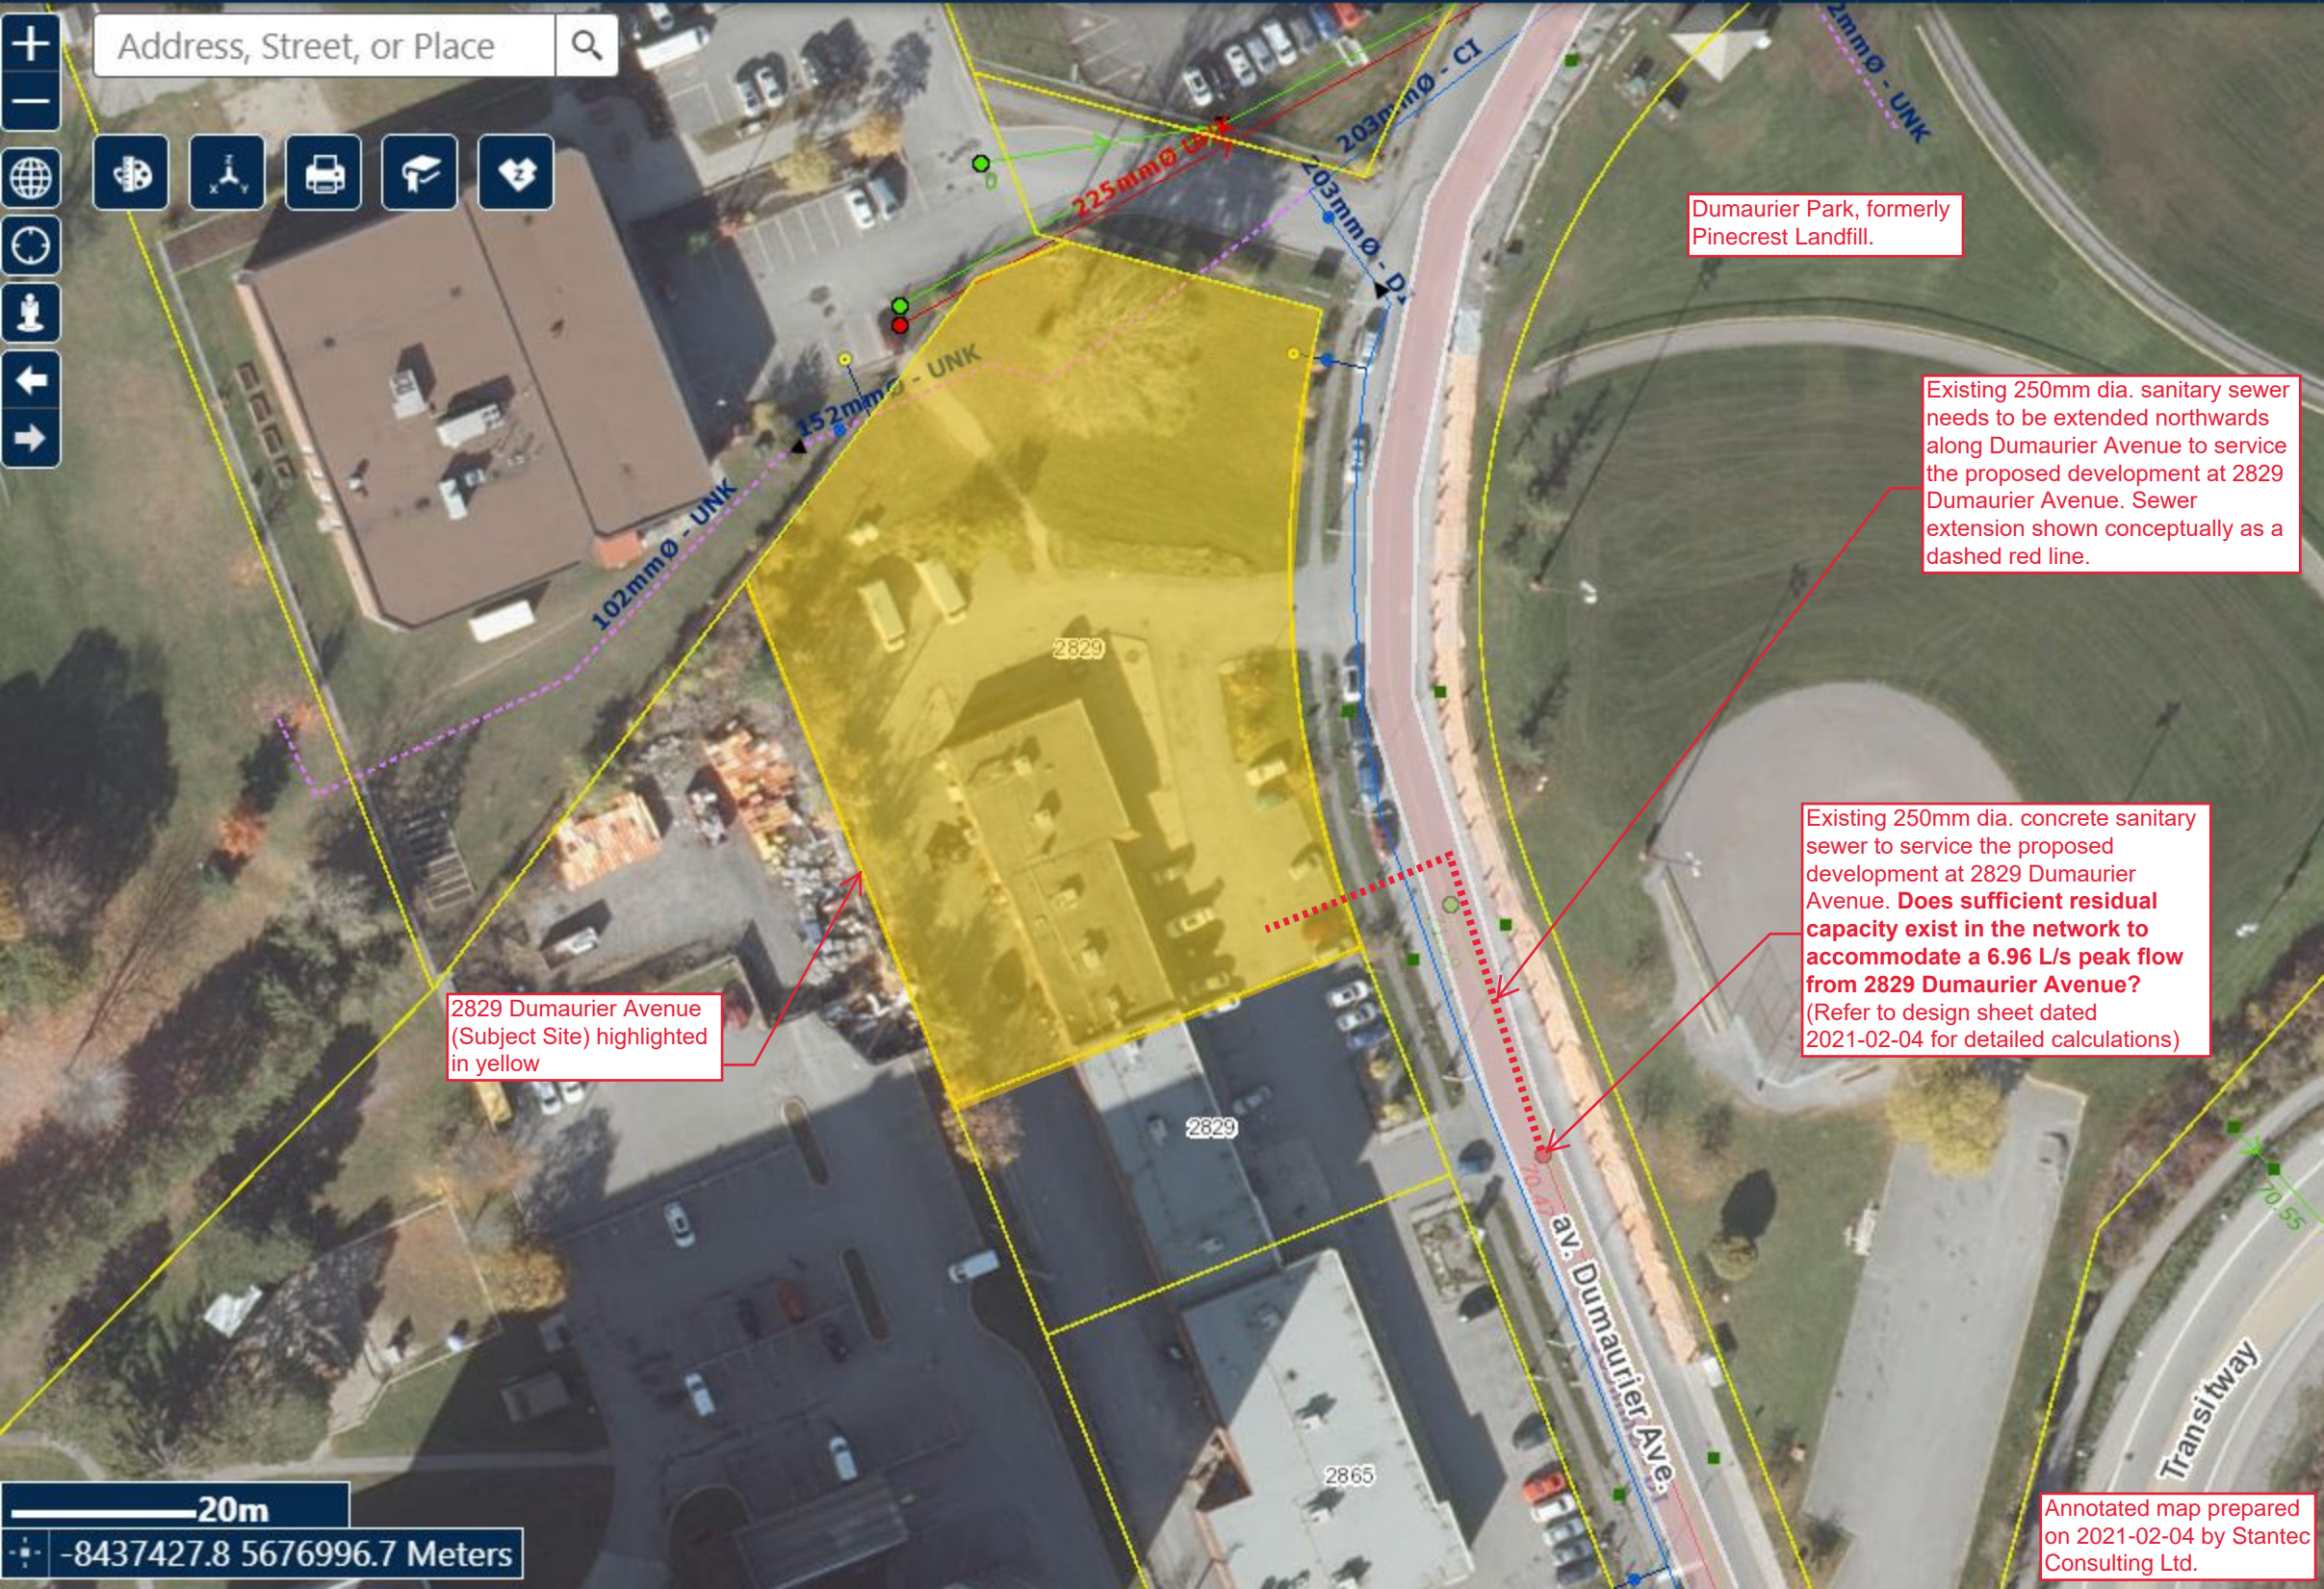
Dumaaurier Park, formerly Pinecrest Landfill.

Existing 250mm dia. sanitary sewer needs to be extended northwards along Dumaaurier Avenue to service the proposed development at 2829 Dumaaurier Avenue. Sewer extension shown conceptually as a dashed red line.

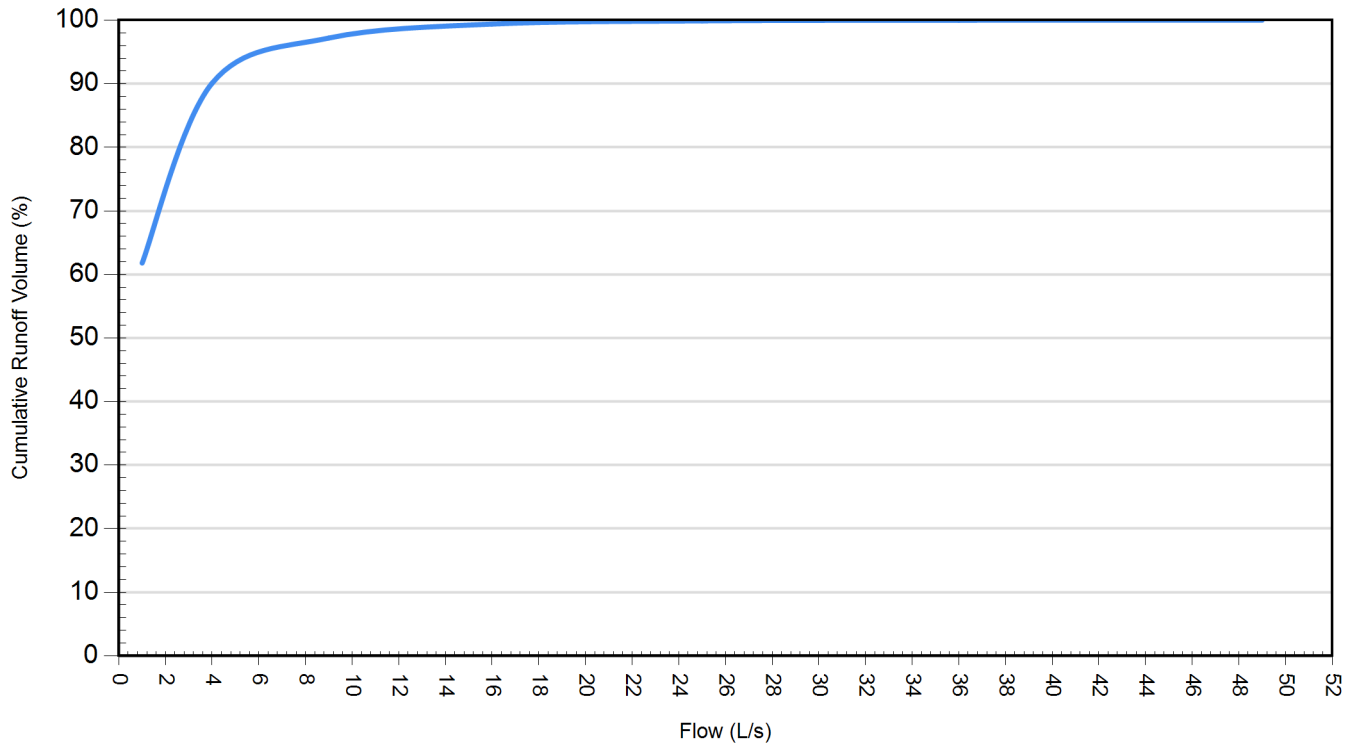
Cumulative Runoff Volume by Runoff Rate

For area: 0.17(ha), imperviousness: 99.90%, rainfall station: OTTAWA MACDONALD-CARTIER INT'L A
