Phase I-Environmental Site Assessment

257-277 King Edward Avenue and
260 Murray Street
Ottawa, Ontario

July 13, 2021
Report: PE5193-1

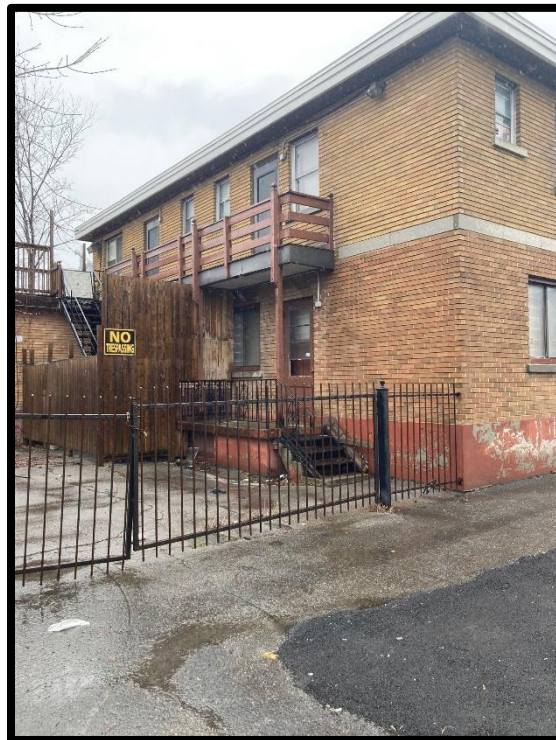
Photograph 2: View of the rear of the residential dwelling addressed 257-259 King Edward Avenue on the Phase I Property, facing east.

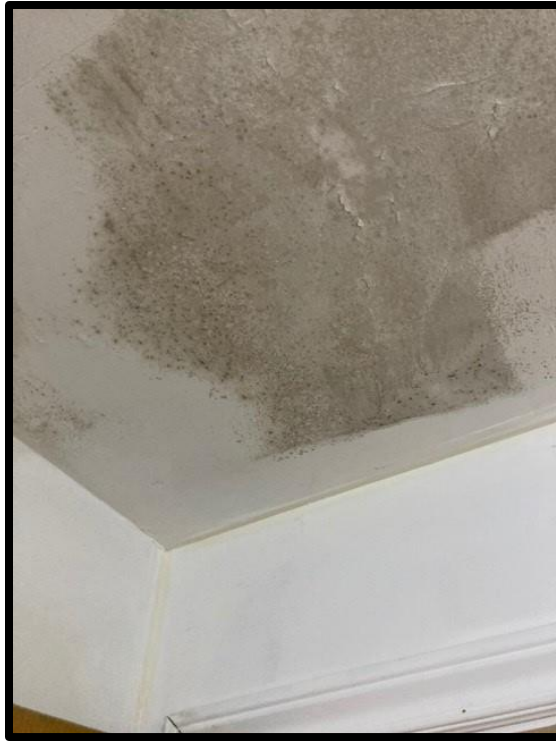
Photograph 3: Mold growth in the basement of 257-259 King Edward Avenue.

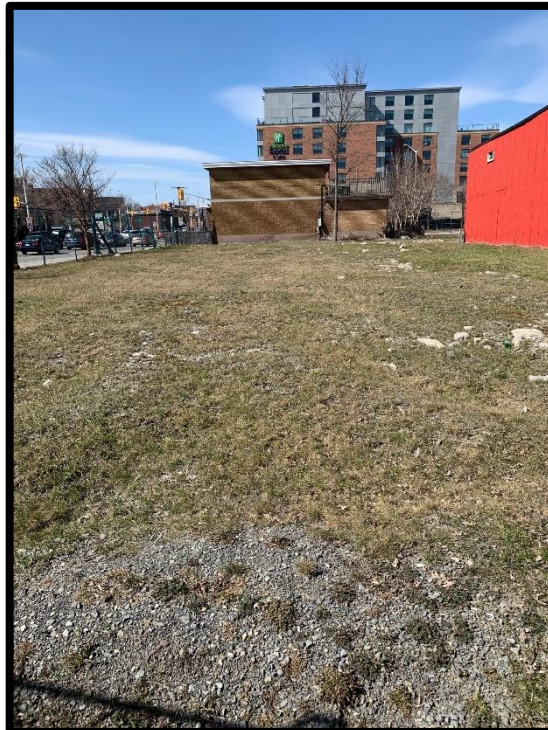
Photograph 4: View of the Phase I Property from the south property boundary, facing north.
