# CONSERVATION PLAN

## 359 KENT STREET, 436 & 444 MACLAREN STREET, OTTAWA

July 2023    Revision 3

Application File Number: D02-02-21-0095 [ZBLA] & D01-01- 21-0015 [OPA]

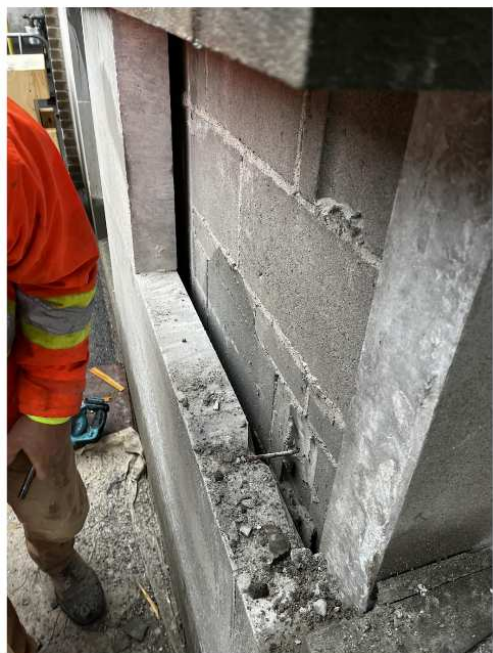
*Figure 12: View of a test removal panel from a building at 100 Argyle constructed circa 1955 using a similar limestone cladding material as 359 Kent. The limestone cladding units are secured to the concrete block back-up wall with a single metal anchor centred on the width of the panel. Source: Heritage Grade Test Removal Report, 100 Argyle.*

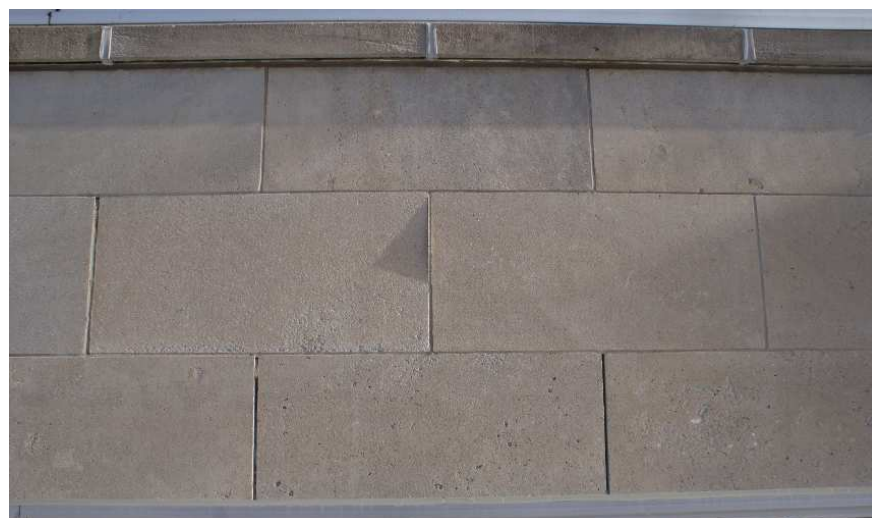
**Condition:** The limestone cladding is in good condition generally with a few stones at grade level that have been adversely affected by de-icing salts. A number of stones have surface defects or concretions that have not weathered well; however, they are limited in number. A detailed condition assessment of each stone panel will be completed as part of the dismantling process. There are a number of stone panels where the mortar is missing from the joints particularly in the area of the introduced Kent Street entrance providing a general sense of how difficult the removal of the mortar from the units may be during the salvage process.

*Figures 13: View of the Niagara limestone cladding above the Kent Street entrance. Note the variations in the material, coursing, and the windowsill course band the length of units corresponding with the cladding coursing. Mortar is missing from a number of joints. Source: Commonwealth 2023.*

**Risks:** The removal of any adhered Portland based pointing from the stones may be problematic, and a method should be developed to minimize damage that may result. Exposing the stones outdoors for a period of six-months including a winter is one option. (It will be important to follow up with Masonry Contractor, who carried out the test removal of a limestone panel from the façade of the building at 100 Argyle. This will give a sense of how the adhered Portland from the stone was removed. In the summary description it states that the Portland mortar was well adhered to the end grain of the stone.)

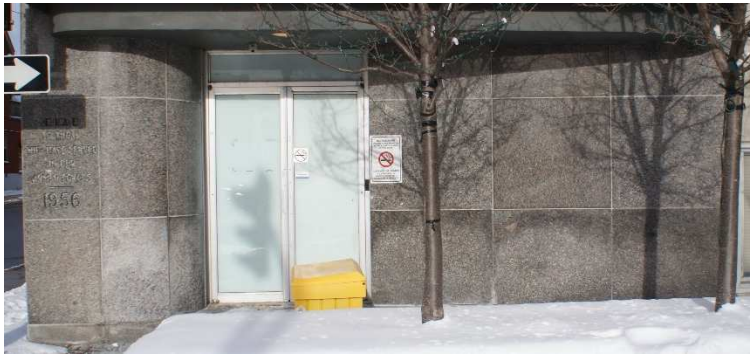
Figure 14: View of granite inset entrance with canopy

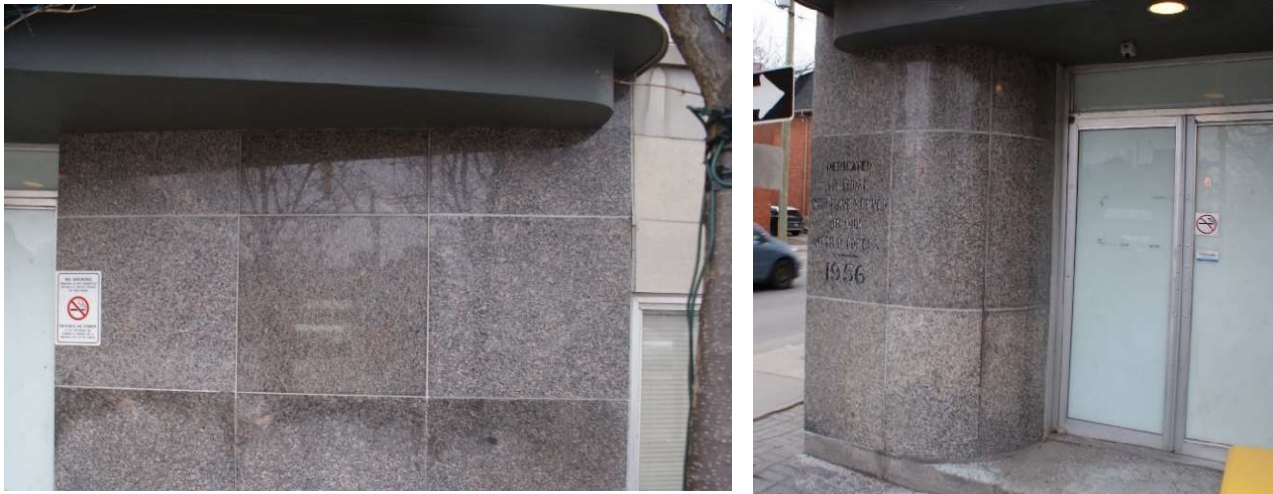
**Condition:** De-icing slats have had a major impact on the lower three stones set at floor level. The surfaces are disaggregated and crumble to the touch. The memorial stone with an incised date and inscription is in better condition although it is not clear when the inscription was incised.

Figures 16 & 17: (6 -left) View of the introduced polished granite panels to the right of the Gilmour Street entrance. (7-right) View of the original polished granite panels. Source: Commonwealth 2023

**Rehabilitation** – The original granite cladding panels to the east of the entrance door were removed in 2009 when the coat of arms was removed. The entrance door width will be increased to meet the OBC. Remove the existing granite panels and insert a glazed curtain wall to the east of the new entrance door maintaining the existing entrance plan configuration and canopy.

**Restoration:** Reinstall new polished granite cladding to match the original material and panel configuration modified in width to accommodate an increased exit width to the right of the door where the original material was removed in 2009.

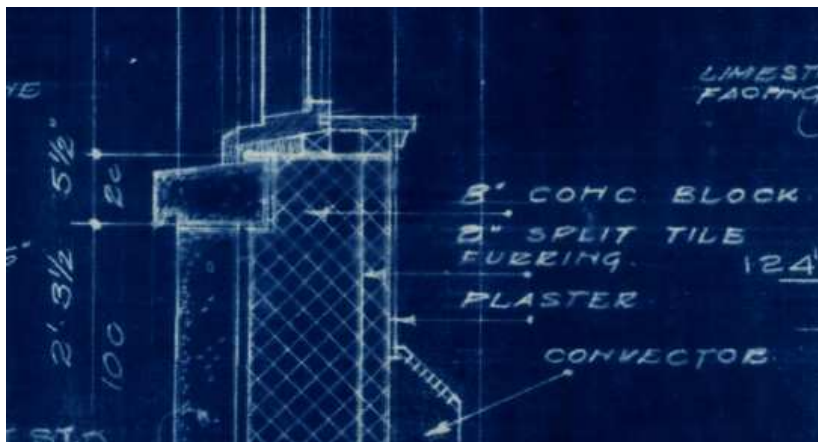
Figure 18; Detail section through the Kent and Gilmour facades illustrating the arrangement of the limestone sill course and limestone cladding. The sills are bonded to the limestone cladding and the concrete back-up wall making it difficult to salvage the windowsill course material. The drip edge only adds to the difficulty of successfully salvaging the material for reuse. Source: 1955 Drawing Set A4

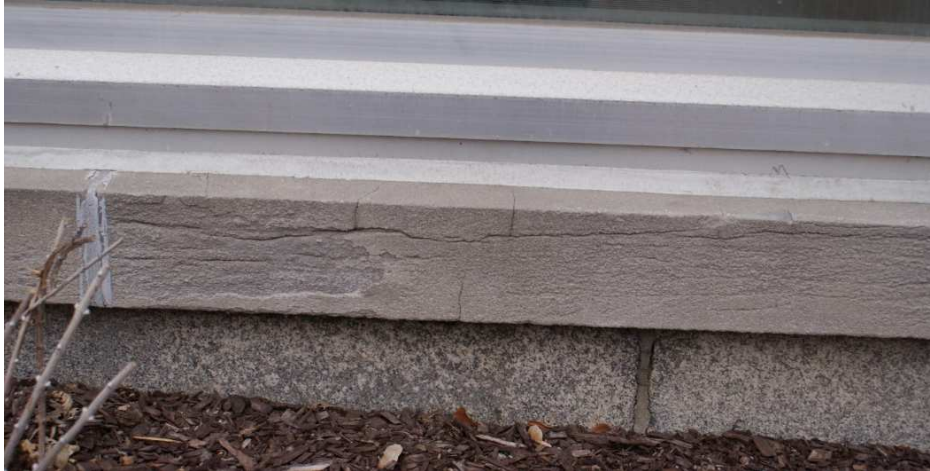
**Condition:** The limestone windowsills are relatively porous along cleavage planes, susceptible to de-icing salts, and freeze-thaw cycling to varying degrees dependent upon material defects within individual stones. Stones vary in quality as is evident on all elevations where sound stones are interspersed with poorer quality material that has failed. Typical failure patterns include delamination along cleavage planes after the surface has weathered and at the exposed surfaces where the material pops during freeze thaw cycling. Approximately 30% of the sill stones will need to be replaced, and further loss is expected during the dismantling, storage, and reinstallation processes; however, between the four façades there should be enough good quality sill stones to complete the Gilmour and Kent street windowsill courses.

*Figure 20: View of a deteriorated limestone windowsill and the granite plinth course below. The cleavage planes within the limestone sills are evident where the sawn surface has weathered. The cleavages planes follow the layers of deposition of the sedimentary rock. Source: Commonwealth 2022.*

**Rehabilitation** – The limestone sills will continue to weather and deteriorate over time. The limestone is not the highest quality material. Install new pre-cast concrete sills that are tinted to match the dimension, form, and colour of the existing material. Replacing them all is the client's preference.

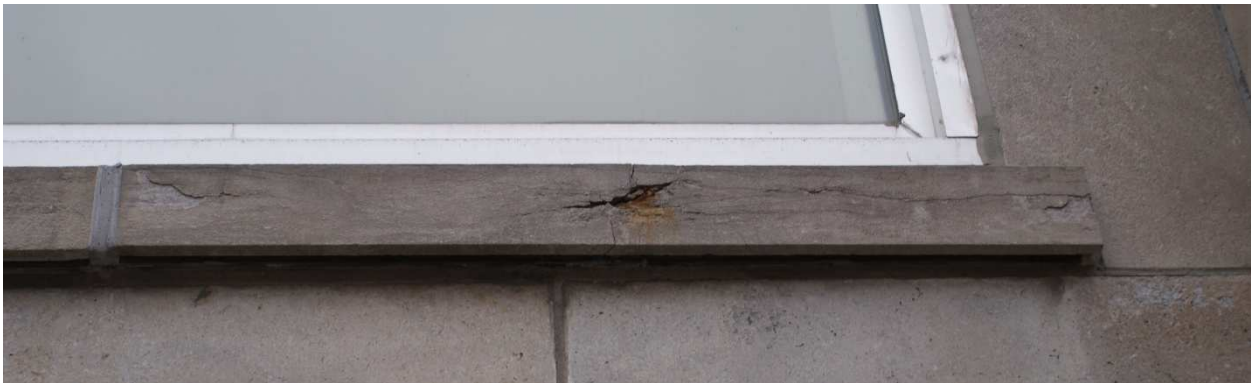
*Figure 21: View of a deteriorated limestone windowsill. The cleavage planes within the limestone sills are evident where the sawn surface. The cleavages planes follow the layers of deposition of the sedimentary rock. Source: Commonwealth 2022.*

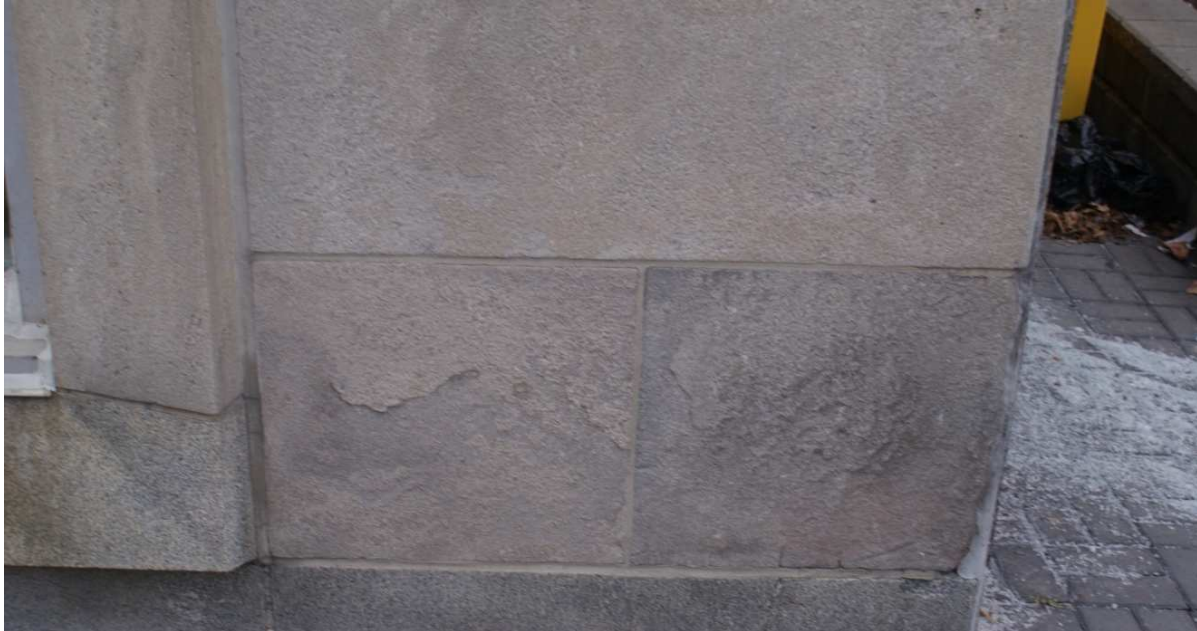
**Condition:** The limestone window surrounds on the multi-storey windows on Kent and Gilmour are generally in good condition. There is some deterioration of the surface due to de-icing salts where the units are in proximity to grade, some material defects, and rust staining of the material. The condition of the individual units will be assessed and noted during the dismantling phase.

*Figure 22: Detail view at the base of the wall at the south-west corner. The surface of the two Niagara limestone panels at the base of the wall are scaling due to de-icing salts. The granite plinth course is evident at the bottom of the photo. The Niagara limestone window surround is the vertical element to the left and a granite windowsill/surround below. Source: Commonwealth 2022.*

**Preservation** of the limestone window surrounds and reinstallation in the Kent and Gilmour Street façades.

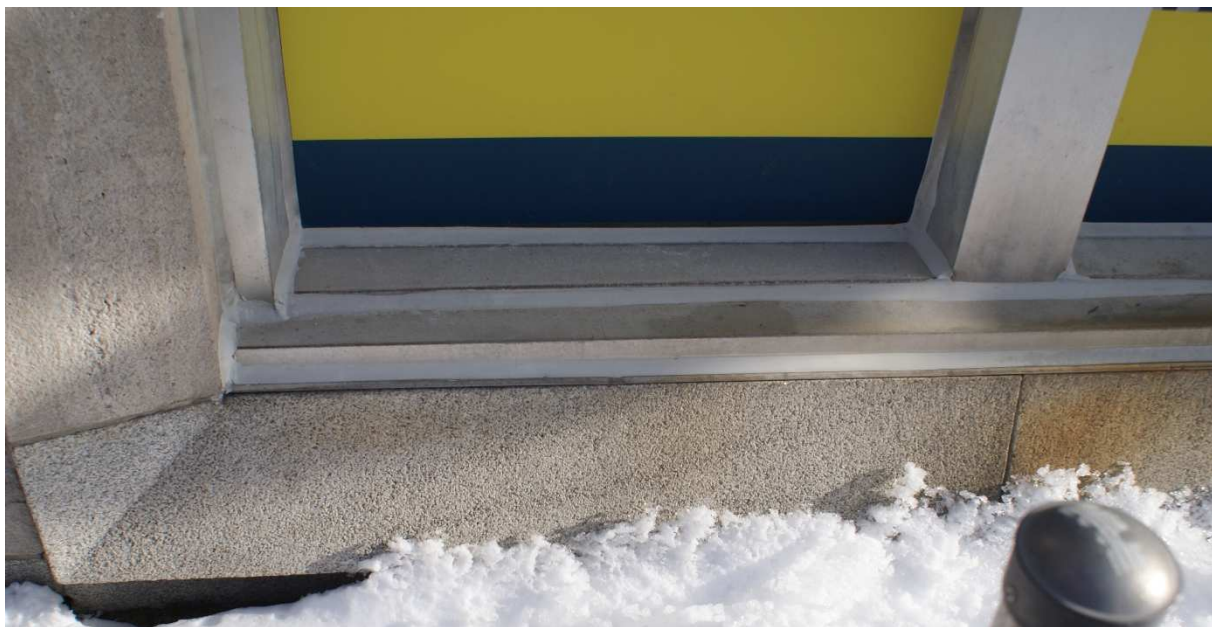
*Figure 23: Detail view of the base of the Kent Street window. The horizontal units at the base of the window are formed of the same material as the granite plinth course. The vertical stone to the left is a limestone unit. Note the close match in colour and surface texture. Source: Commonwealth 2023*

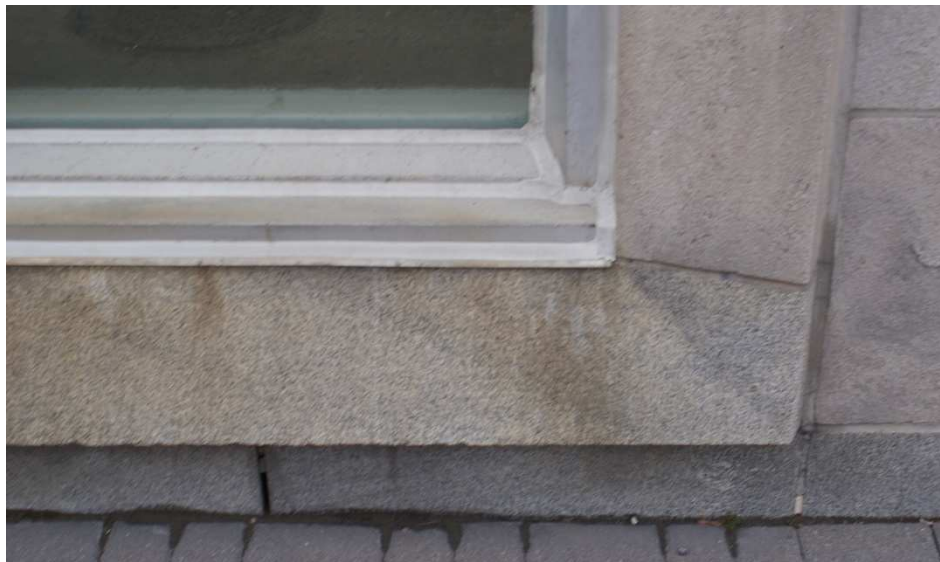
**Condition:** The granite sill on the Kent Street window is in good condition. The condition of the granite plinth course buried below grade has not been determined.

Figure 25: Detail of the granite plinth course and granite windowsill surround at the base of the three-storey Kent Street window. The colour of the granite sill is very close to the limestone cladding and window surrounds. Source: Commonwealth 2022.

**Preservation** of the intact granite sill and plinth course panels and reinstallation in the Kent and Gilmour Street façades forming an upstand wall supporting curtain wall glazing. The condition of the material buried below grade has not been determined.

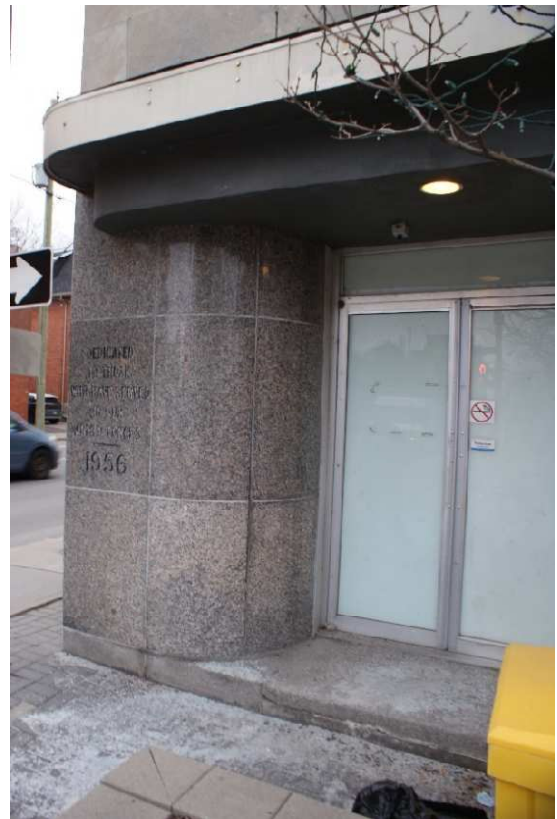
**Condition:** The canopy has been modified with a dropped modern enclosure with recessed lighting.

Figures 26 & 27: Detail section of the Gilmour Street Entrance illustrating the form and materials and the relationship to the entrance doors. Existing view of the canopy illustrating alterations to the canopy and entrance doors. Source: Original 1955 Drawing Set A5 & Commonwealth 2022.

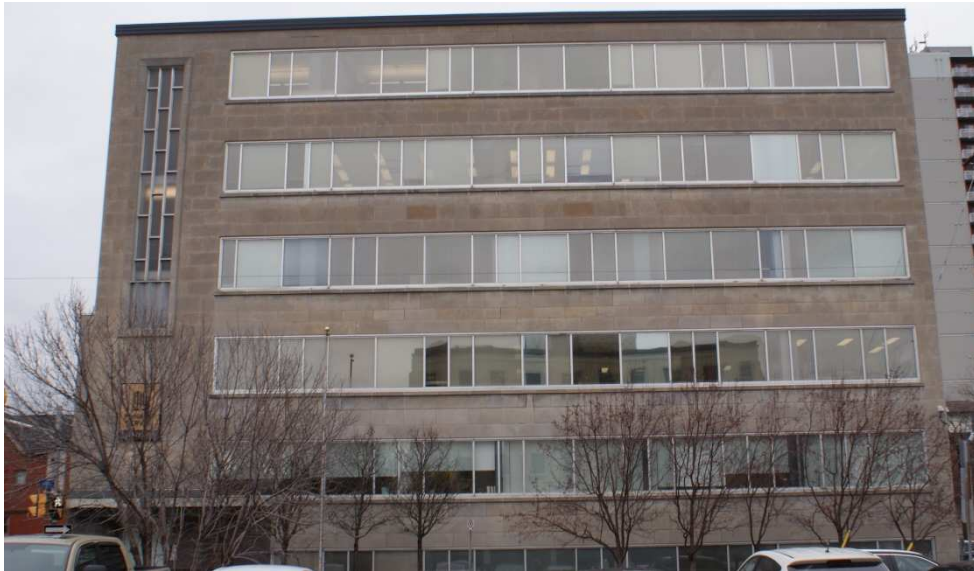
**Condition:** The existing windows are being replaced with new aluminium thermal units. The original vertical and horizontal division of the lights will be replicated in the three-storey windows on the Kent and Gilmour façades.

Figure 30: View of the windows on the Gilmour Street façade. All of the original windows have been replaced with the exception of the three-storey window above the Gilmour Street entrance. Source: Commonwealth 2022.

**Rehabilitation** – The windows are being replaced with a modern aluminum thermal unit. The horizontal and vertical arrangement of the original sash should be maintained in the new units. The horizontal division at the midpoint of the height of the units is an important feature adding to the horizontal sweep of the façades a character defining feature of the International Style.

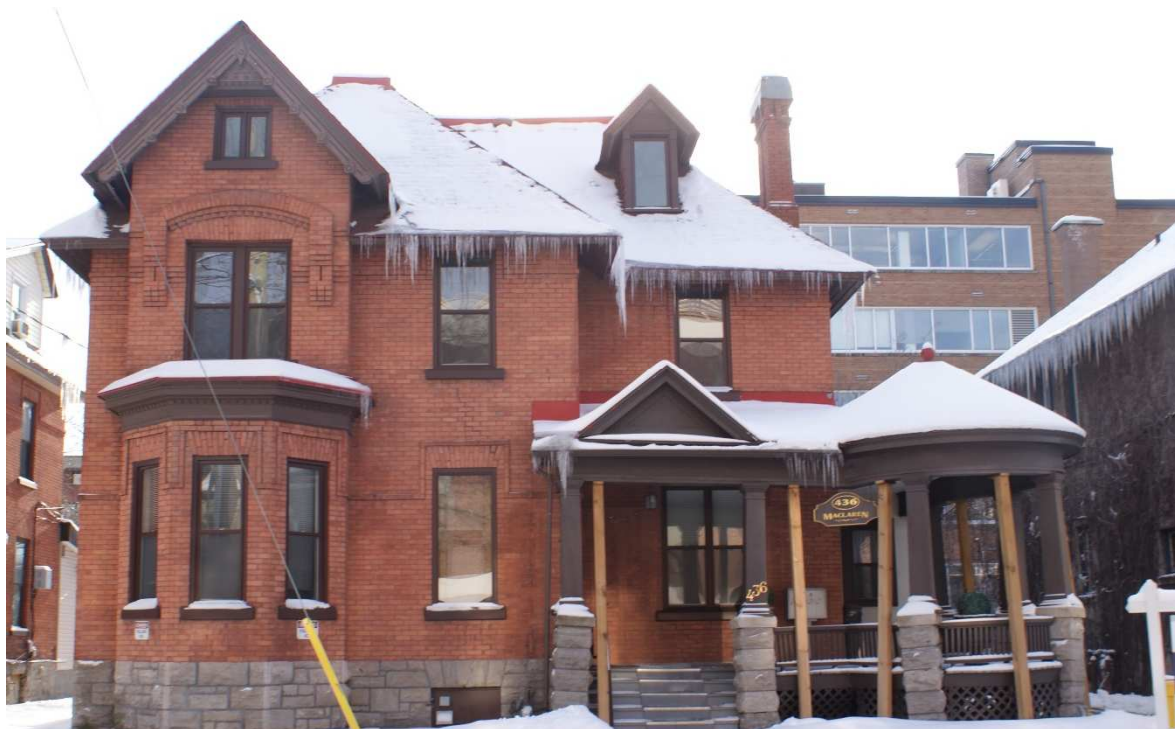
*Figure 35: View of 436 MaClaren Street. The masonry piers supporting the porch have settled due to inadequate foundation depth. A detailed assessment of the condition of the porch is required. Guidelines from the CHCDP provide guidance for the conservation approach to the materials and assemblies. Source: Commonwealth 2023.*

**Response:** Following the CMPHCP policies and guidelines for **front porches** a restoration plan is being prepared. The coursed limestone pillars supporting the deck structure will be dismantled and rebuilt with a new foundation as part of the 2024 work plan. The work will include the masonry piers, deck structure, railings, and columns.

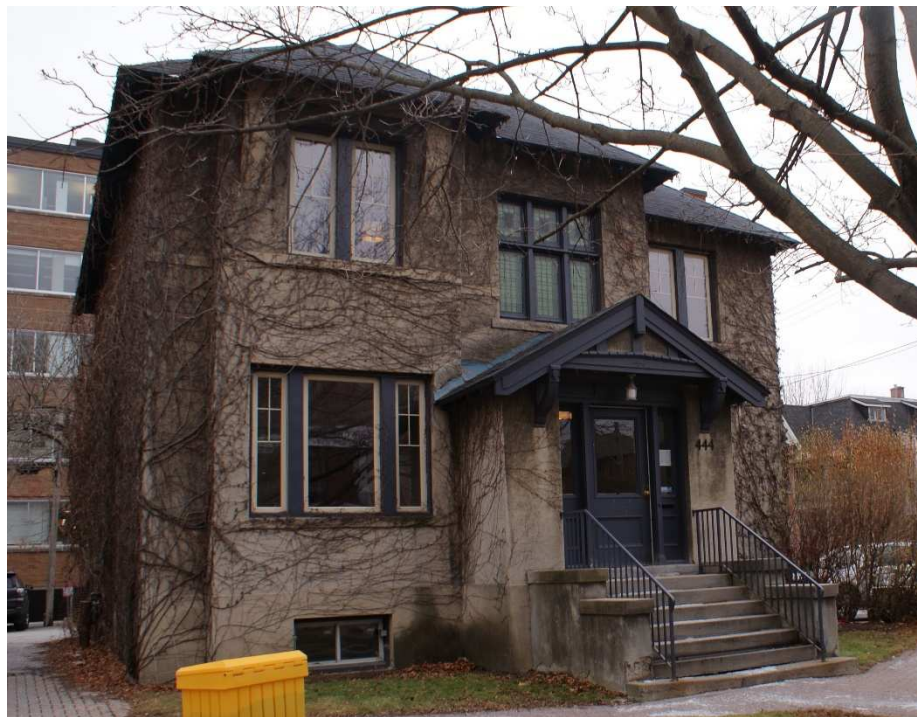
The building at 444 MacLaren is covered in vines that should be removed. The guidelines contained in the 2022 Centretown Heritage Conservation District Plan (CHCDP) are provided to guide the conservation work.

*Figure 36: View of 444 MacLaren Street. The stuccoed exterior wall is covered in vines that should be removed before they have an adverse impact on the stucco finishes. Source: Commonwealth 2022*
