Phase I - Environmental Site Assessment

359 Kent Street
436 and 444 MacLaren Street
Ottawa, Ontario

Taggart Realty Management

Report: PE5204-1

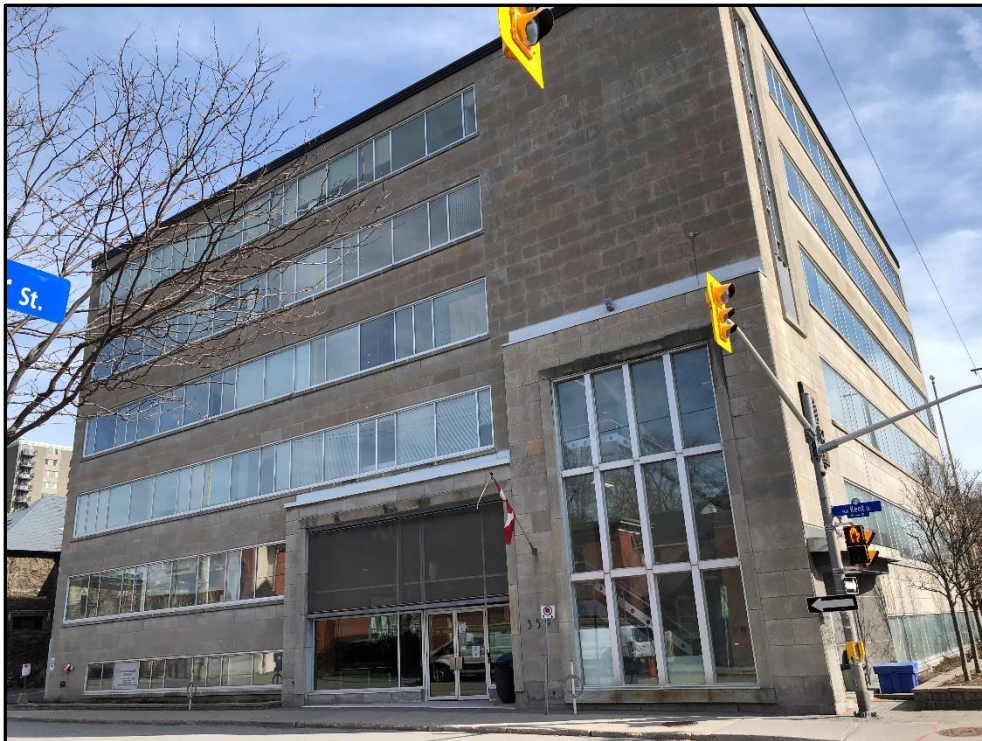
Photo 2: West of Kent Street, facing northeast towards 359 Kent Street.

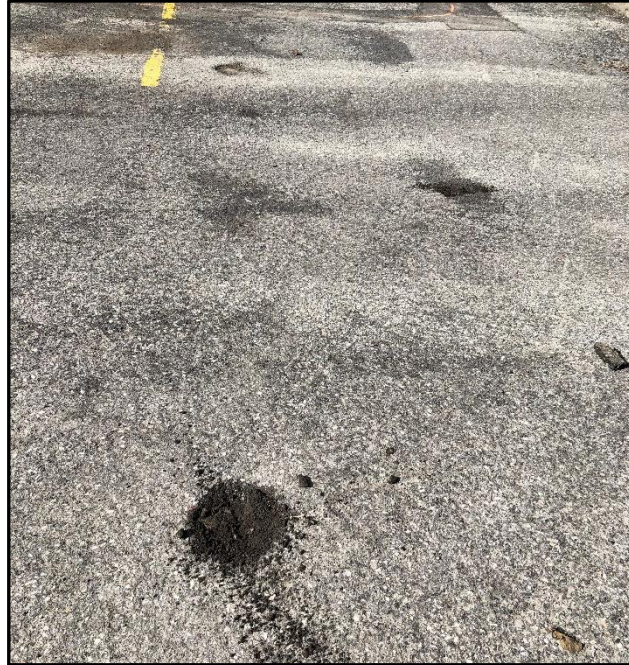
Based on previous environmental reports conducted by Jacques Whitford, a 19,000L underground storage tank (UST) containing heating oil was formerly located near the northeast corner of the 359 Kent Street building. Sealed boreholes and monitoring wells were observed in the asphalt in the vicinity of the former UST from the 2005 Phase II investigation. As previously mentioned, impacted soil was identified during the 2005 investigation directly below the former UST location. The presence of the former heating oil UST represents an APEC on the subject site.

Photo 3: Evidence of boreholes present from the 2005 Phase II investigation at the location of the former heating oil UST location (359 Kent Street).

As part of this investigation, it was recommended that groundwater in the vicinity of the former UST be resampled, however, the seven (7) monitoring wells were decommissioned. As such, the former presence of the UST represents an APEC on the Phase I property.

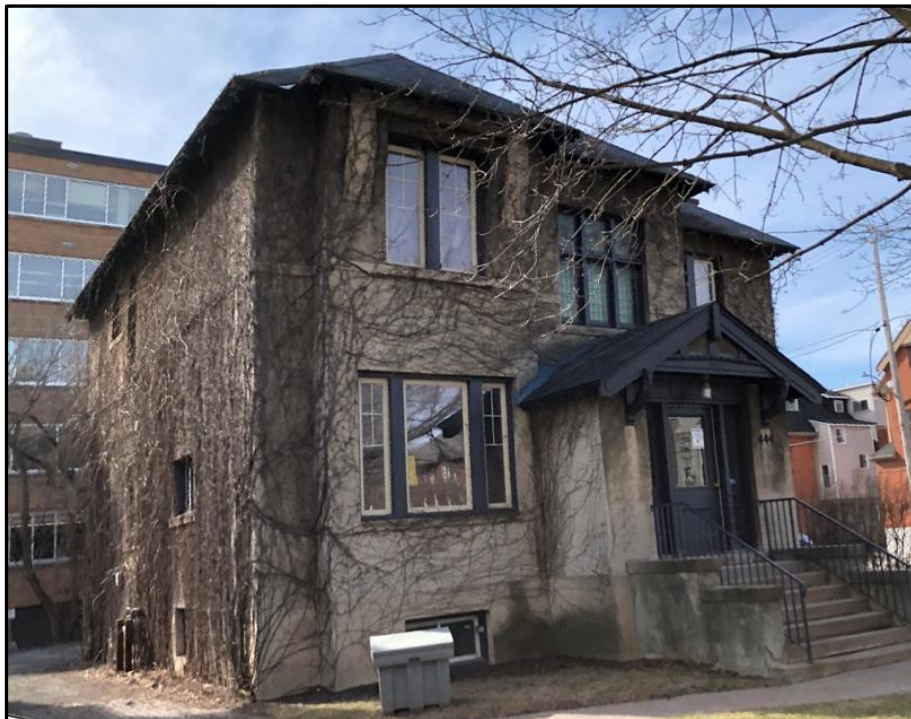
The property addressed 444 MacLaren Street is occupied by a two-storey cement parking clad office building. The building features a stone foundation, and a sloped and shingled roof. Based on the historical data, the building was built in the mid 1890s for residential purposes, and has since been repurposed for commercial office use. The building is heated with a natural gas fired boiler.

Photo 6: North of 444 MacLaren Street, facing south towards the 444 MacLaren Street commercial office building.

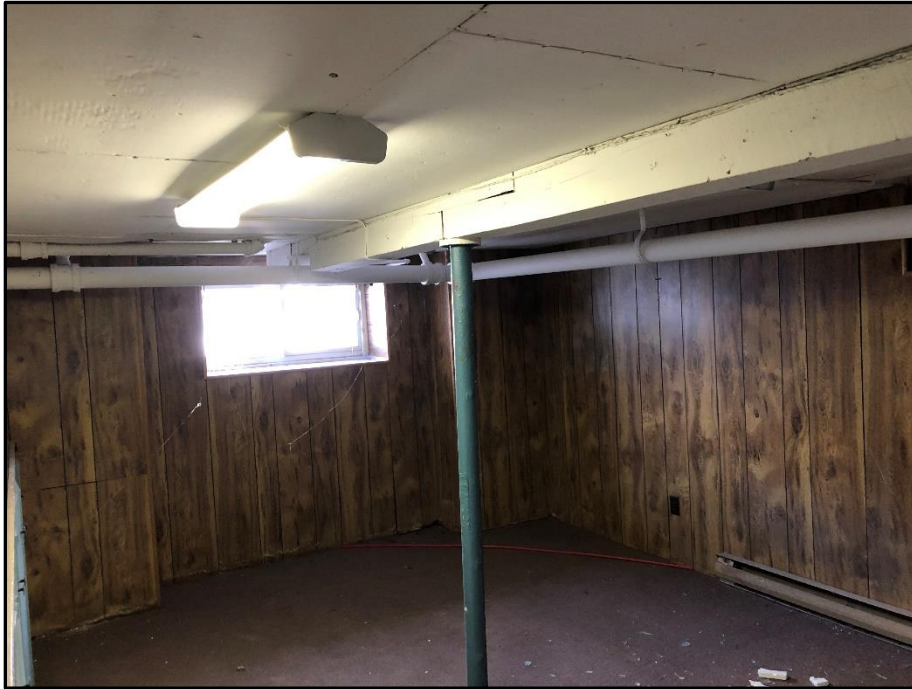
The building is heated with a natural gas fired boiler located in the basement. Floor drains were observed in the basement, and found to be dry and in good condition at the time of the site visit.

Photo 7: In the basement of the 444 MacLaren Street commercial office building, with finished walls and floors.
