## TREE CONSERVATION REPORT

PROJECT NAME:	359 Kent Street
PROJECT NO.	21819-1
LOCATION	359 Kent Street, Ottawa ON, K2P 0R6
DATE:	August 11, 2021

**359 KENT STREET  
OTTAWA, ONTARIO**

PRE-DEVELOPMENT VEGETATION

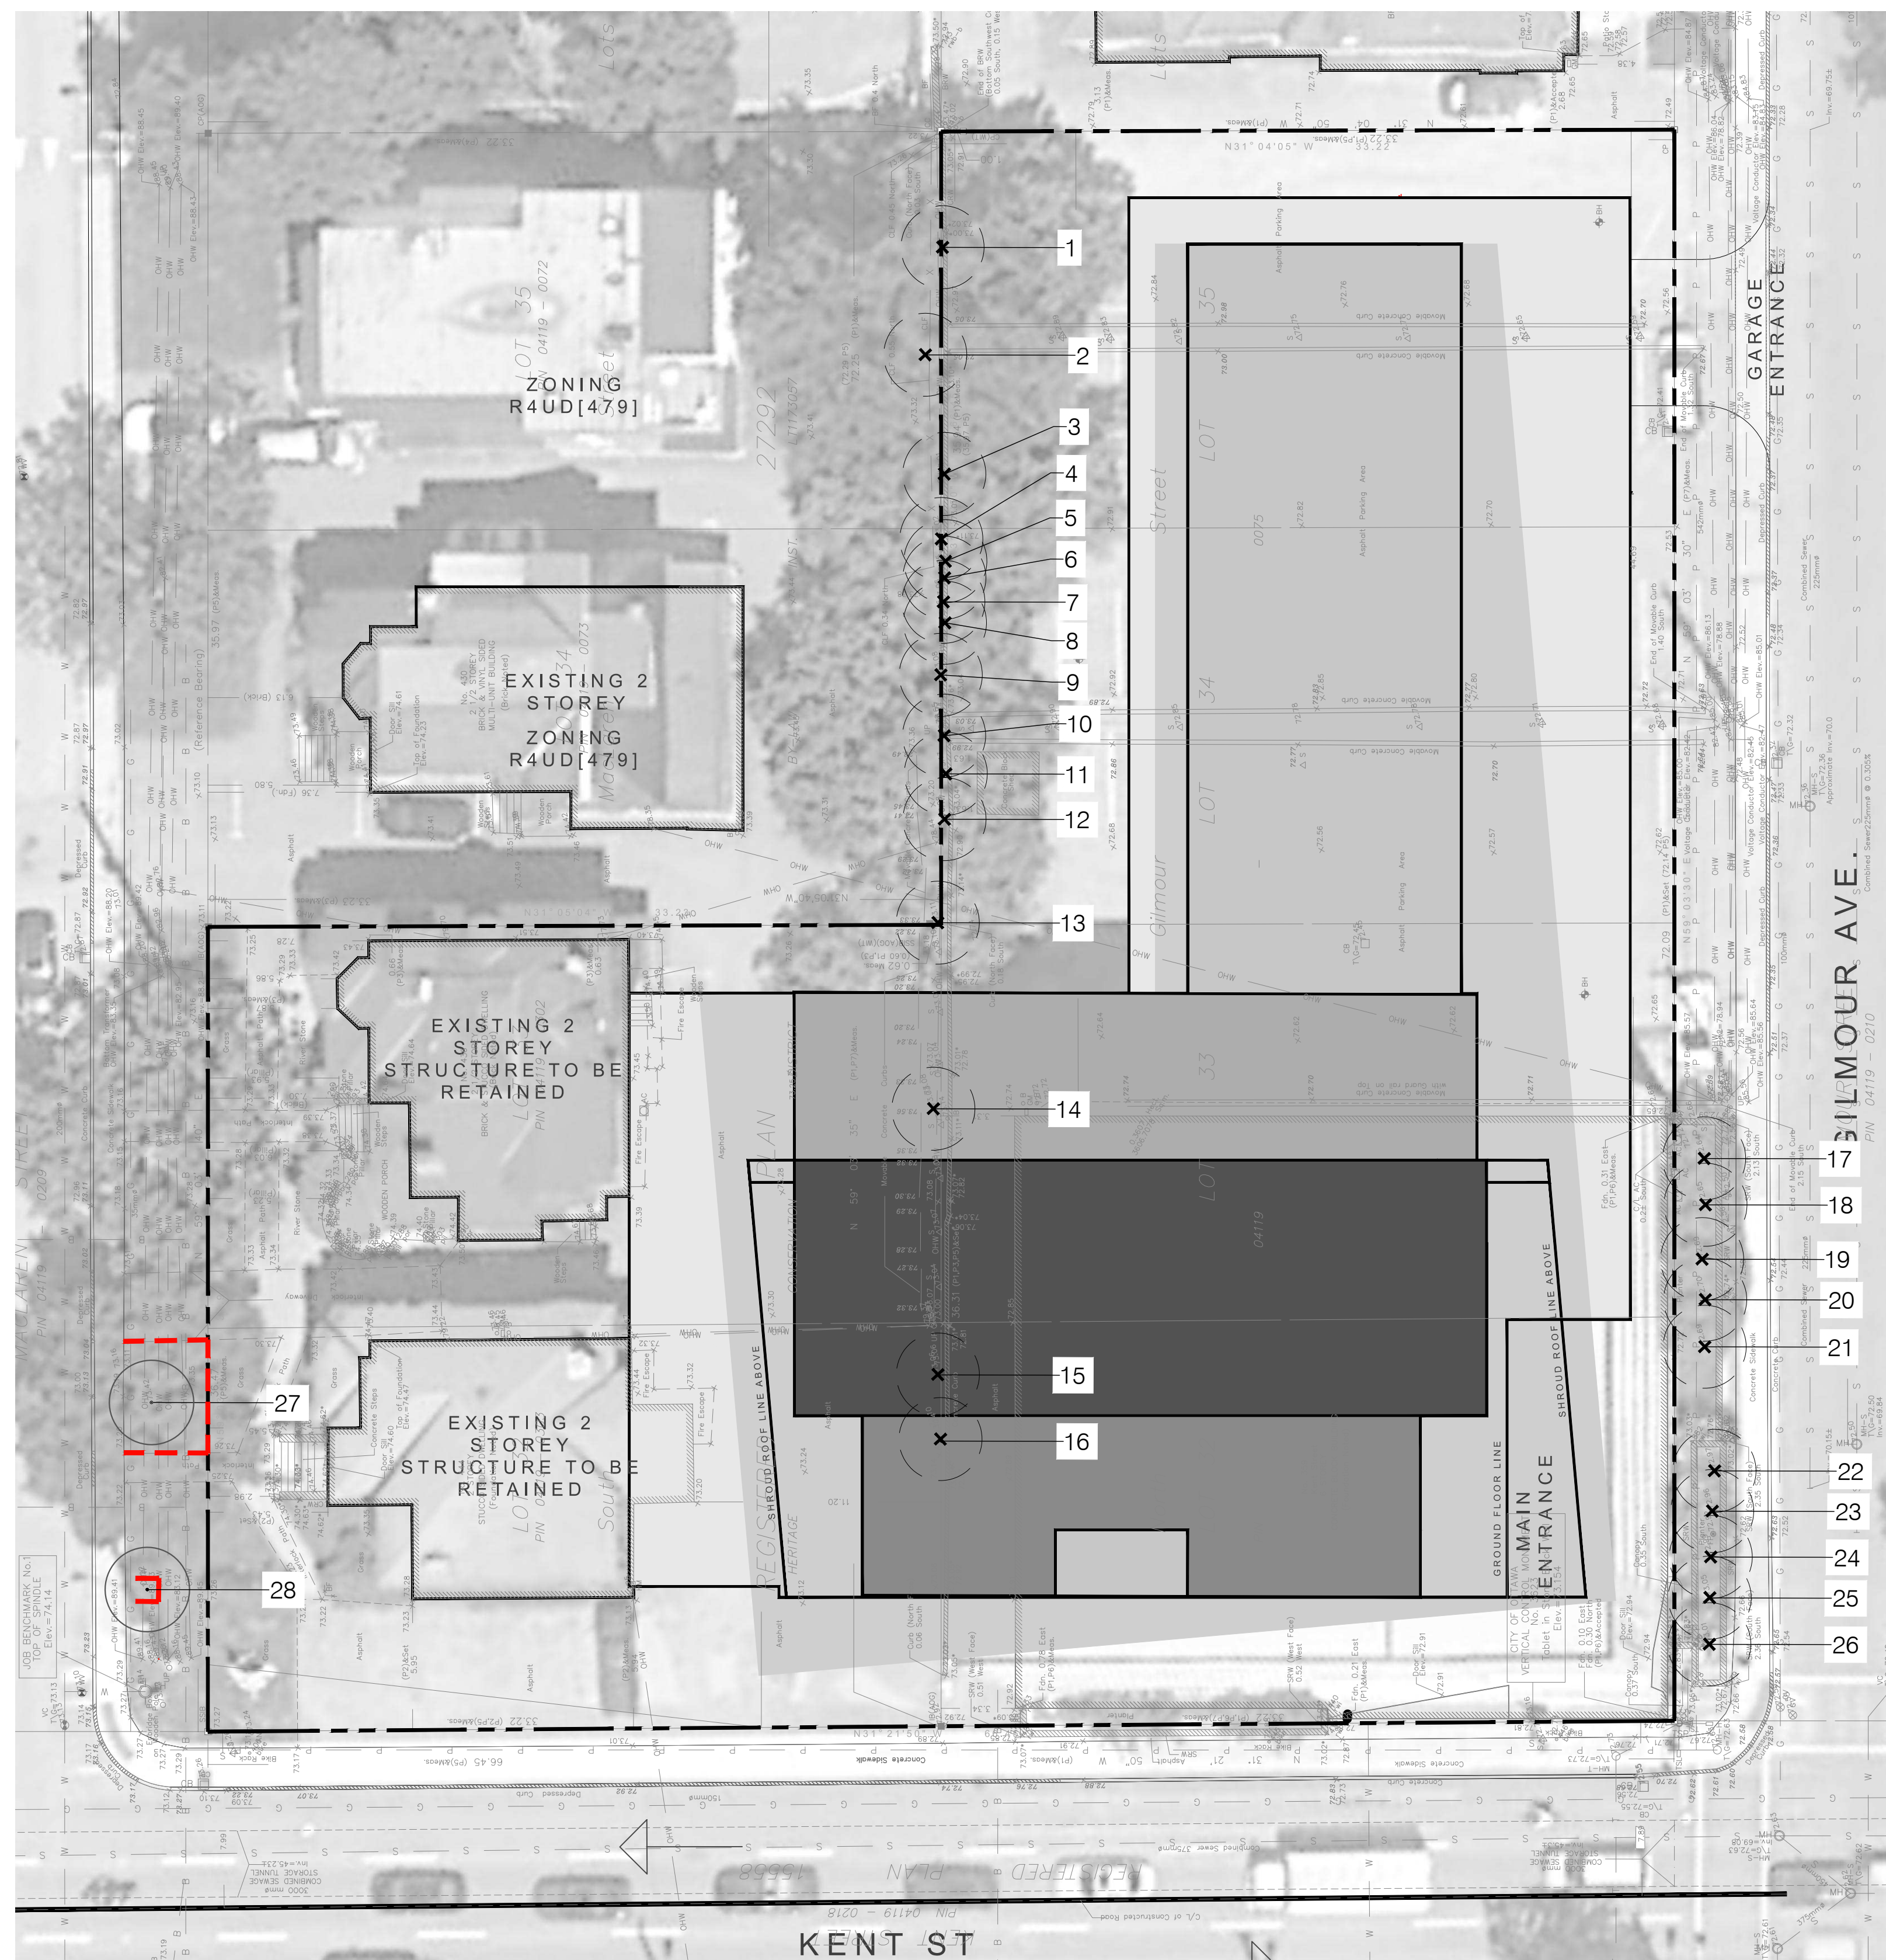
1 POST DEVELOPMENT VEGETATION

EXISTING TREES TO BE RETAINED				
NO.	SPECIES	DBH (CM)	HEALTH	COMMENTS
27	Norway Maple / Acer platanoides	38	Good	City Tree
28	Crabapple / Malus sp.	5	Good	City Tree

EXISTING TREES TO BE REMOVED				
NO.	SPECIES	DBH (CM)	HEALTH	COMMENTS
1	Manitoba Maple / Acer negundo	17, 35	Poor	Trunk damage, wire conflict, 2 stems joined at base
2	Silver Maple / Acer saccharinum	74	Fair	Branch dieback
3	Manitoba Maple / Acer negundo	20, 24	Poor	Included fence, trunk damage, 2 stems joined at base
4	Manitoba Maple / Acer negundo	15	Poor	Included fence, trunk damage
5	Manitoba Maple	19	Poor	Included fence, trunk damage
6	Manitoba Maple / Acer negundo	26	Poor	Included fence, trunk damage
7	Manitoba Maple / Acer negundo	29	Poor	Included fence, trunk damage, internal rot
8	Manitoba Maple / Acer negundo	23	Poor	Included fence, trunk damage
9	Manitoba Maple / Acer negundo	17, 17, 20	Poor	Included fence, trunk damage, 3 stems joined at base
10	Manitoba Maple / Acer negundo	25, 28	Poor	Included fence, trunk damage, 2 stems joined at base
11	Manitoba Maple / Acer negundo	17	Poor	Included fence, trunk damage

12	Manitoba Maple / Acer negundo	28	Poor	Included fence, trunk damage
13	Manitoba Maple / Acer negundo	25, 30	Poor	Included fence, trunk damage, 2 stems joined at 1m
14	Manitoba Maple / Acer negundo	41, 58	Poor	Included fence, trunk damage, 2 stems joined at base, fungal fruiting bodies
15	Manitoba Maple / Acer negundo	19, 27	Fair	2 stems joined at base
16	Manitoba Maple / Acer negundo	31, 39	Poor	2 stems joined at base, longitudinal cracking
17	Crabapple / Malus sp.	10	Good	City Tree
18	Crabapple / Malus sp.	14	Good	City Tree
19	Crabapple / Malus sp.	10	Good	City Tree
20	Crabapple / Malus sp.	14	Good	City Tree
21	Crabapple / Malus sp.	14	Good	City Tree
22	Tree Lilac / Syringa reticulata	10	Good	City Tree
23	Tree Lilac / Syringa reticulata	10	Good	City Tree
24	Tree Lilac / Syringa reticulata	14	Good	City Tree
25	Tree Lilac / Syringa reticulata	10	Good	City Tree
26	Tree Lilac / Syringa reticulata	10	Good	City Tree

- NOTES:
- THE FOLLOWING PROTECTION MEASURES MUST BE IMPLEMENTED FOR RETAINED TREES, BOTH WITHIN THE WORK AREA AND ON ADJACENT PARCELS.
- UNDER THE GUIDANCE OF AN ARBORIST, ERECT A MODULAR FENCE AT THE CRITICAL ROOT ZONE (CRZ) OF TREES WHERE THE CRZ IS ESTABLISHED AS BEING 10 CENTIMETERS FROM THE TRUNK FOR EVERY CENTIMETER OF TRUNK DIAMETER AT BREAST HEIGHT.

- TREE PROTECTION SHALL BE ERECTED TO PROVIDE A CONTINUOUS BARRICADE BETWEEN DESIGNATED TREES AND THE WORK AREA PRIOR TO CONSTRUCTION.
  - TUNNEL OR BORE WHEN DIGGING WITHIN THE CRZ OF A TREE.
