## **Phase Two Environmental Site Assessment**

322-326 Waverly Street  
Ottawa, Ontario

LRL File No.: 190523

July 30, 2021

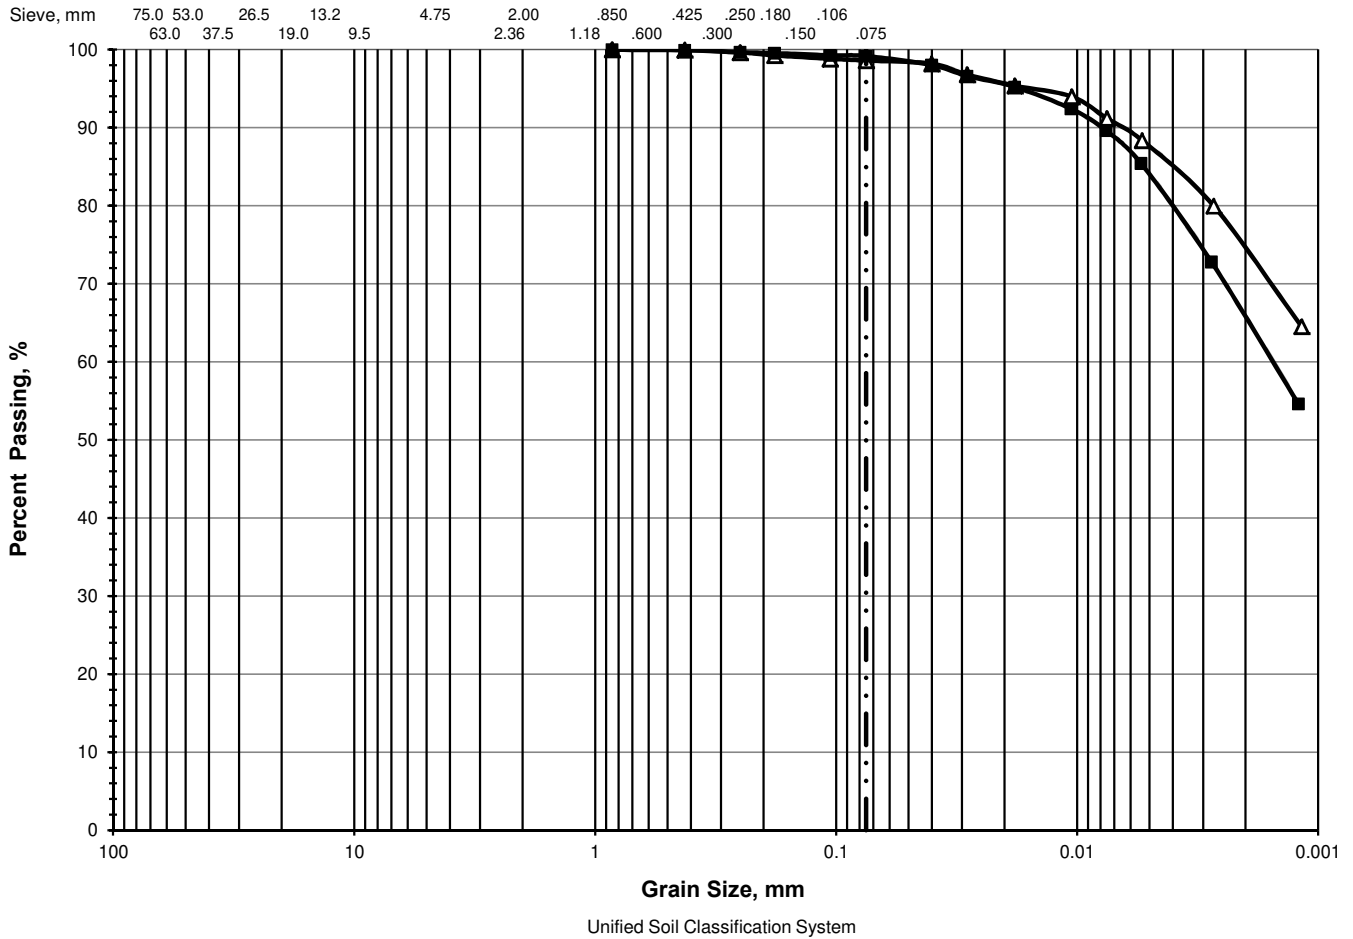
> 75 mm	% GRAVEL		% SAND			% FINES	
	Coarse	Fine	Coarse	Medium	Fine	Silt	Clay
△	0.0	0.0	0.0	0.1	1.4	25.7	72.8
■	0.0	0.0	0.0	0.1	0.7	35.3	63.9

Location	Sample	Depth, m	D <sub>60</sub>	D <sub>50</sub>	D <sub>30</sub>	D <sub>15</sub>	D <sub>10</sub>	C <sub>c</sub>	C <sub>u</sub>
△	BH 2	1.52 - 2.13							
■	BH 3	4.57 - 5.18	0.0017

Native subsurface soil was observed to consist of a silty clay. Two soil samples were submitted for a grain size distribution analysis as part of the Geotechnical Investigation completed in May 2021. The soil was reported as fine-grained. The laboratory certificate of analysis is included in **Appendix B**.

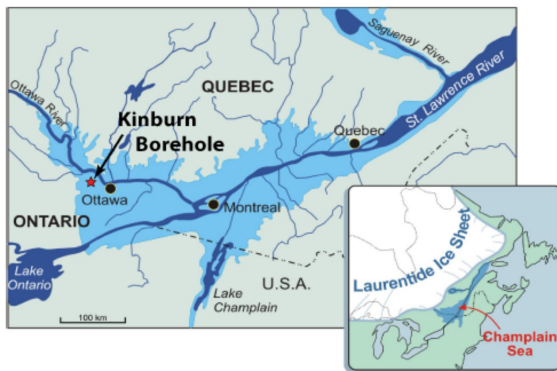
Figure 1. Interpreted extents of the Champlain Sea Basin and its relative position to the Laurentide Ice Sheet (Knight et al., 2012).

The Champlain Sea was a body of saline to brackish water forming a temporary inlet of the Atlantic Ocean, created by the retreating glaciers during the late glacial period 12 000 to 10 000 years ago. It spanned over 55,000 km<sup>2</sup> known as the St. Lawrence Lowland within both Canadian provinces of Quebec and Ontario, as well as parts of the American states of New York and Vermont (Chapman and Putnam, 1984). Within Canada, it extended from Québec City to Brockville, Ontario, and up the Ottawa River Valley to Pembroke (Figure 1).
