**Headwater Drainage Features Assessment Report
37 Wildpine Court, Stittsville, Ottawa, Ontario**

Draft Report

December 11, 2020

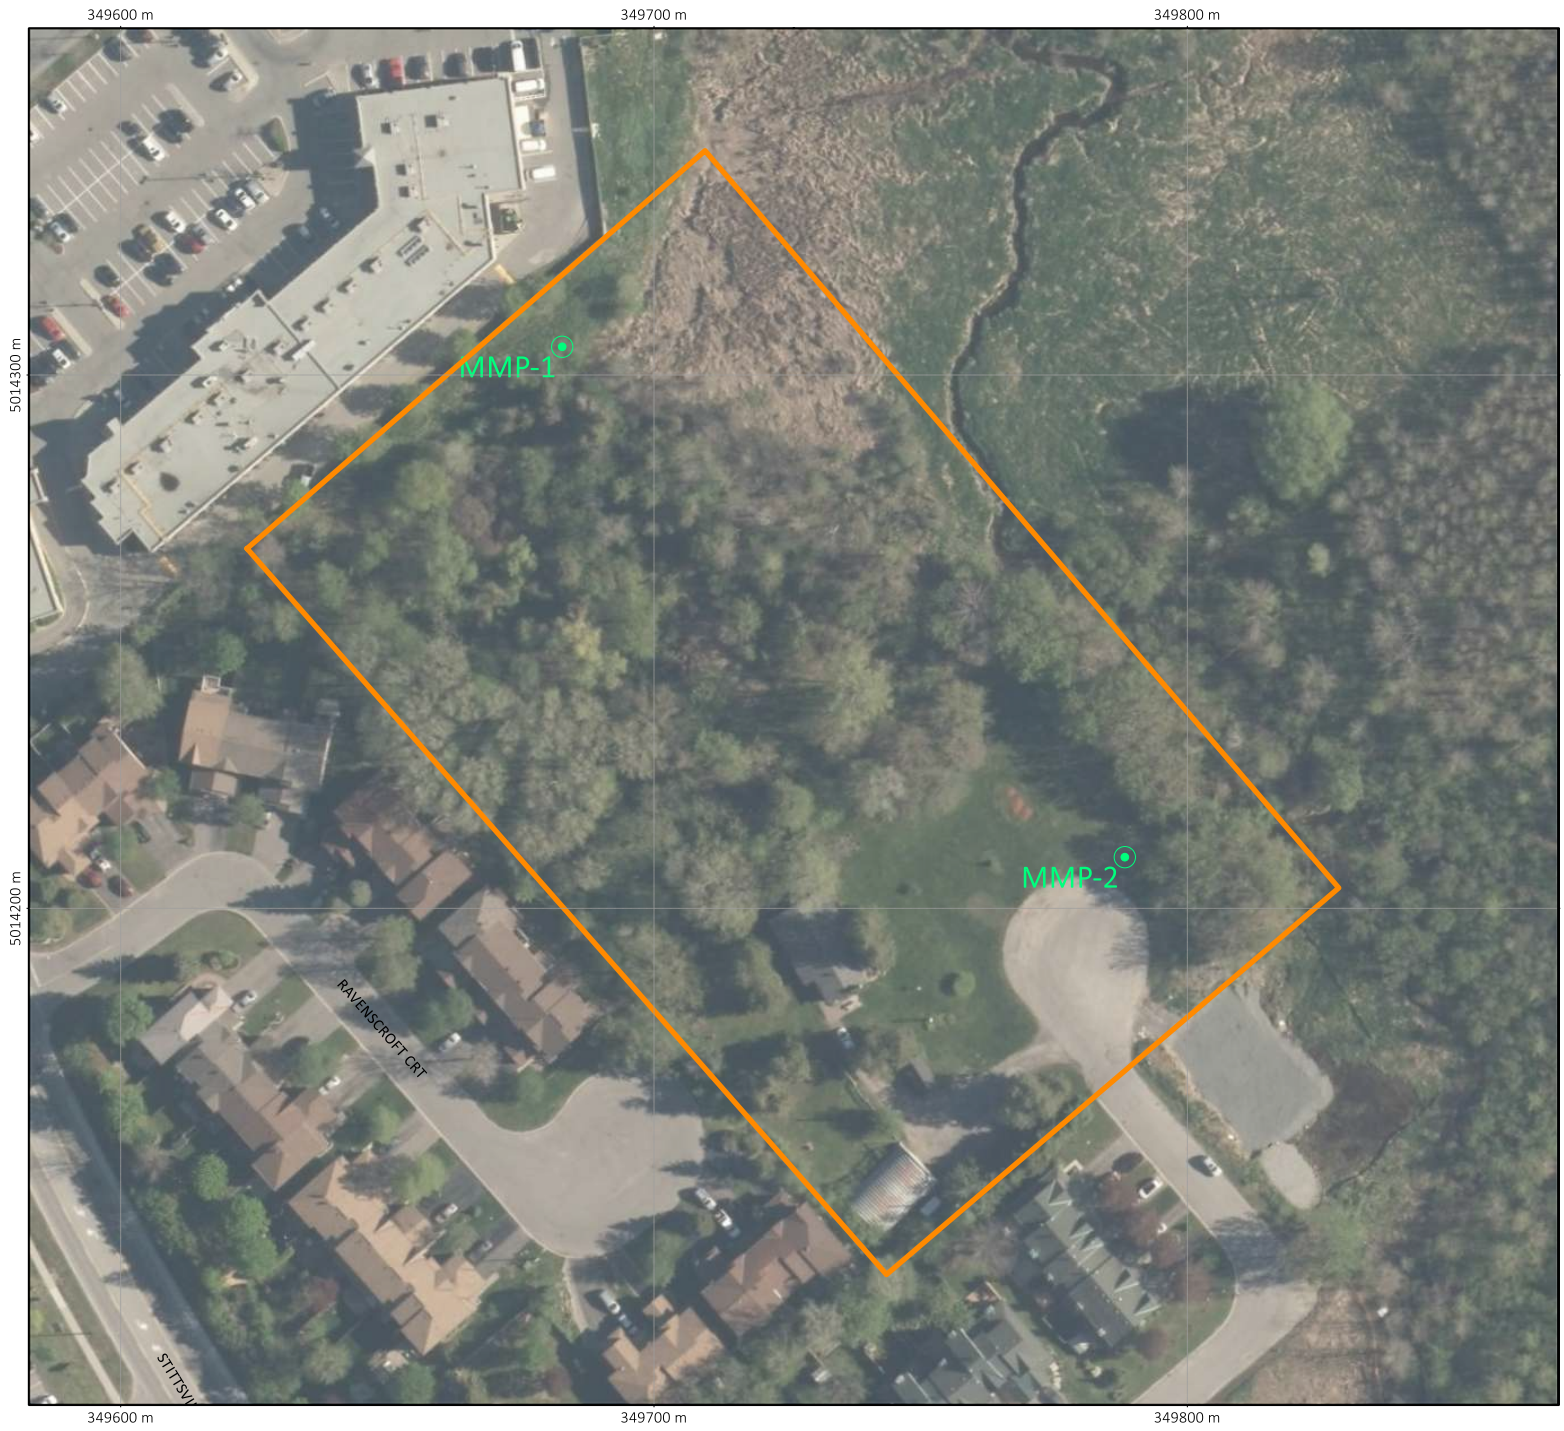
Figure 2 Map showing the locations of anuran survey stations for the Site

Aural anuran surveys were performed following the Marsh Monitoring Program (Bird Studies Canada et al., 2008). This protocol calls for multiple survey stations at a site to capture spatial and habitat variability. Accordingly, surveys were performed from two stations (“MMP-1” and “MMP-2” on Figure 2) adjacent to the wetland on the Site. The Marsh Monitoring Program advises that each station be visited a minimum of three times at night, no less than 15 days apart, during the spring and early summer.

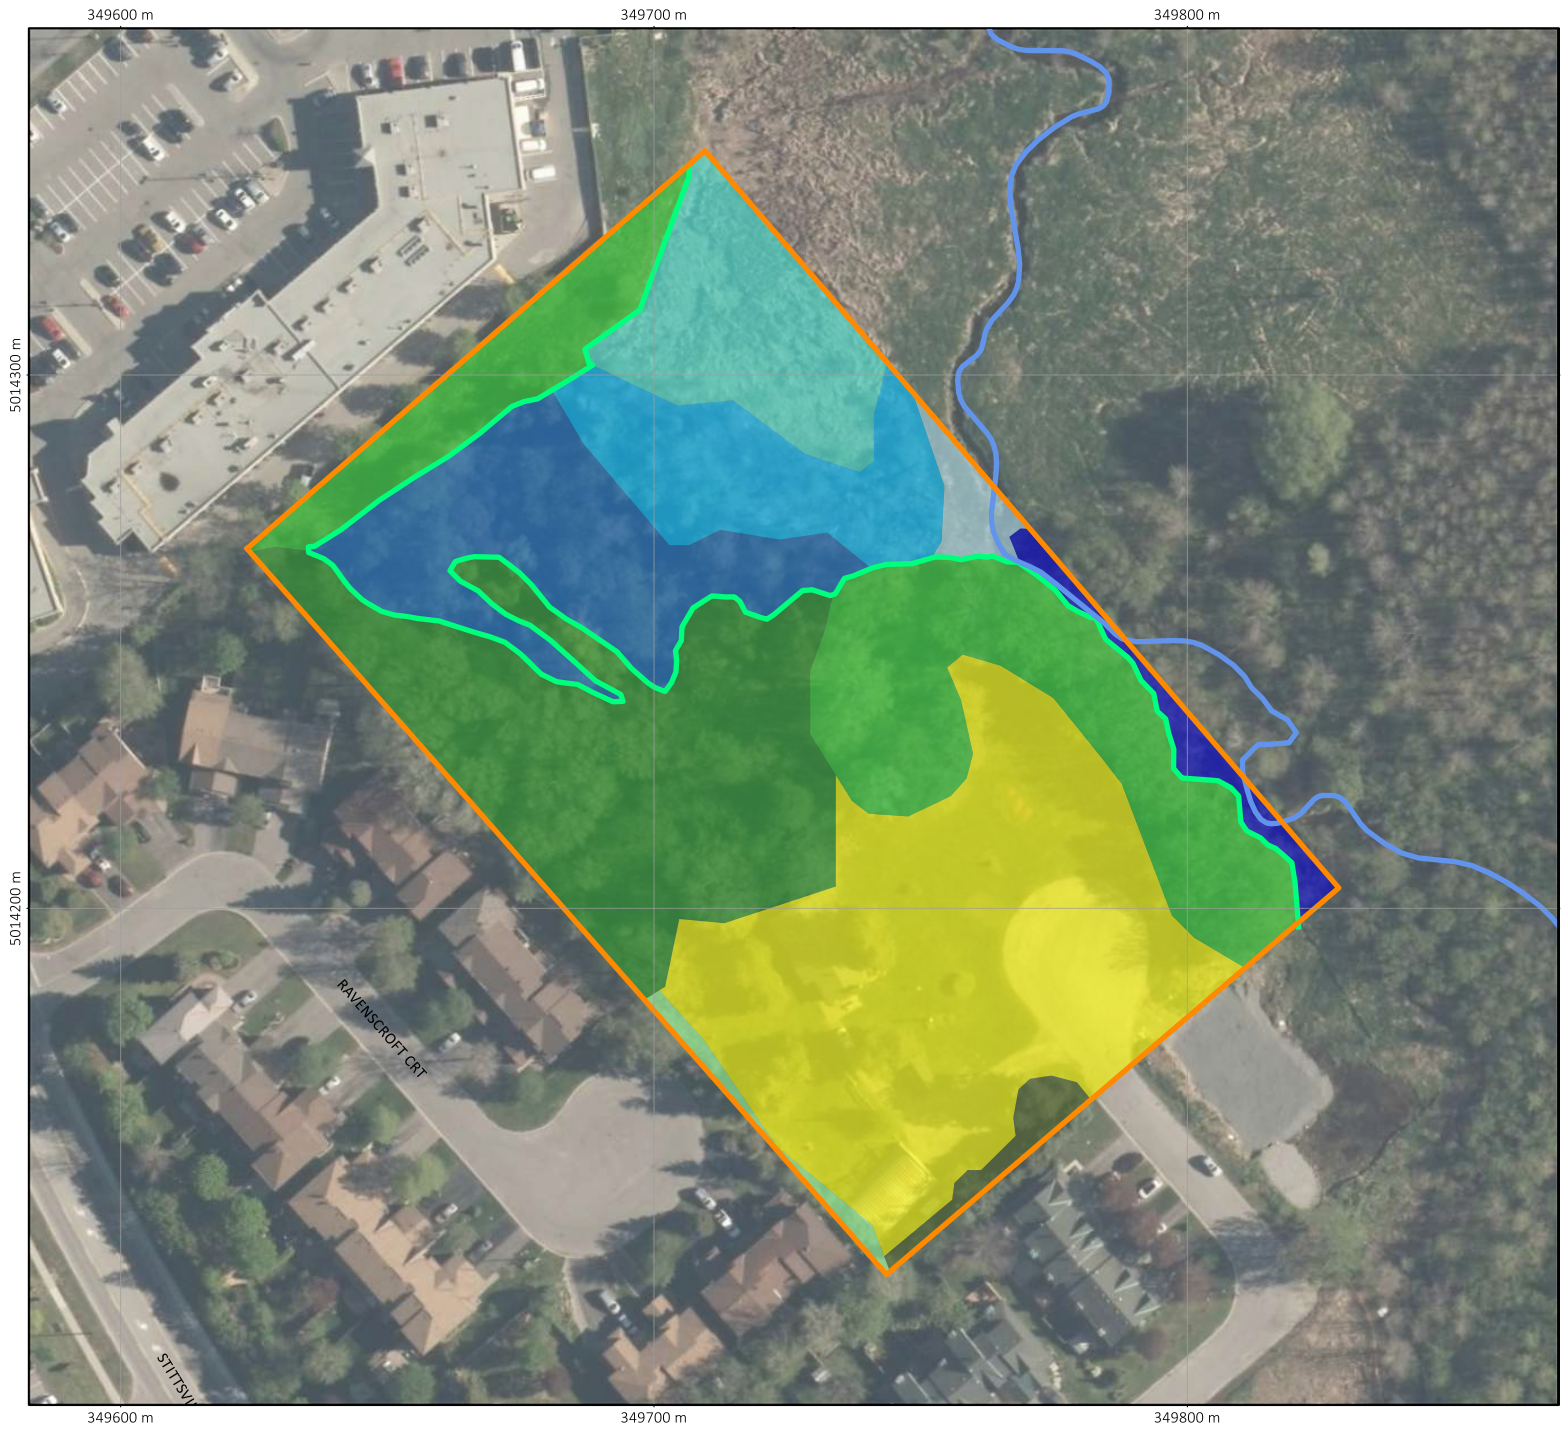
Figure 3 Map showing the boundaries and Ecological Land Classification for the portion of the headwater wetland that falls on the Site

The boundaries of the wetland on the Site, as determined through field and desktop methods and in consultation with MVCA, are shown in Figure 3. The boundaries of the wetland were clear in the field based on the transition between wetland and upland vegetation and elevational change. The upland edge at the wetland boundary is comprised of a considerable amount of fill material that has since naturalized with vegetation. The total wetland area on the Site is approximately 0.6 ha and consists of several types

of wetland: meadow marsh, cattail marsh, deciduous thicket (low shrub) swamp, mixed swamp, and deciduous swamp.

Five distinct vegetation communities were delineated within wetland on the Site using ELC (Figure 3). Each wetland community and the dominant vegetation therein are described below. On the Site, the wetland is fully bounded by terrestrial forest ecosites including Dry – Fresh Manitoba Maple Deciduous Forest (FODM4-5) and Fresh – Moist Bitternut Hickory Deciduous Forest (FODM9-5; Figure 3).

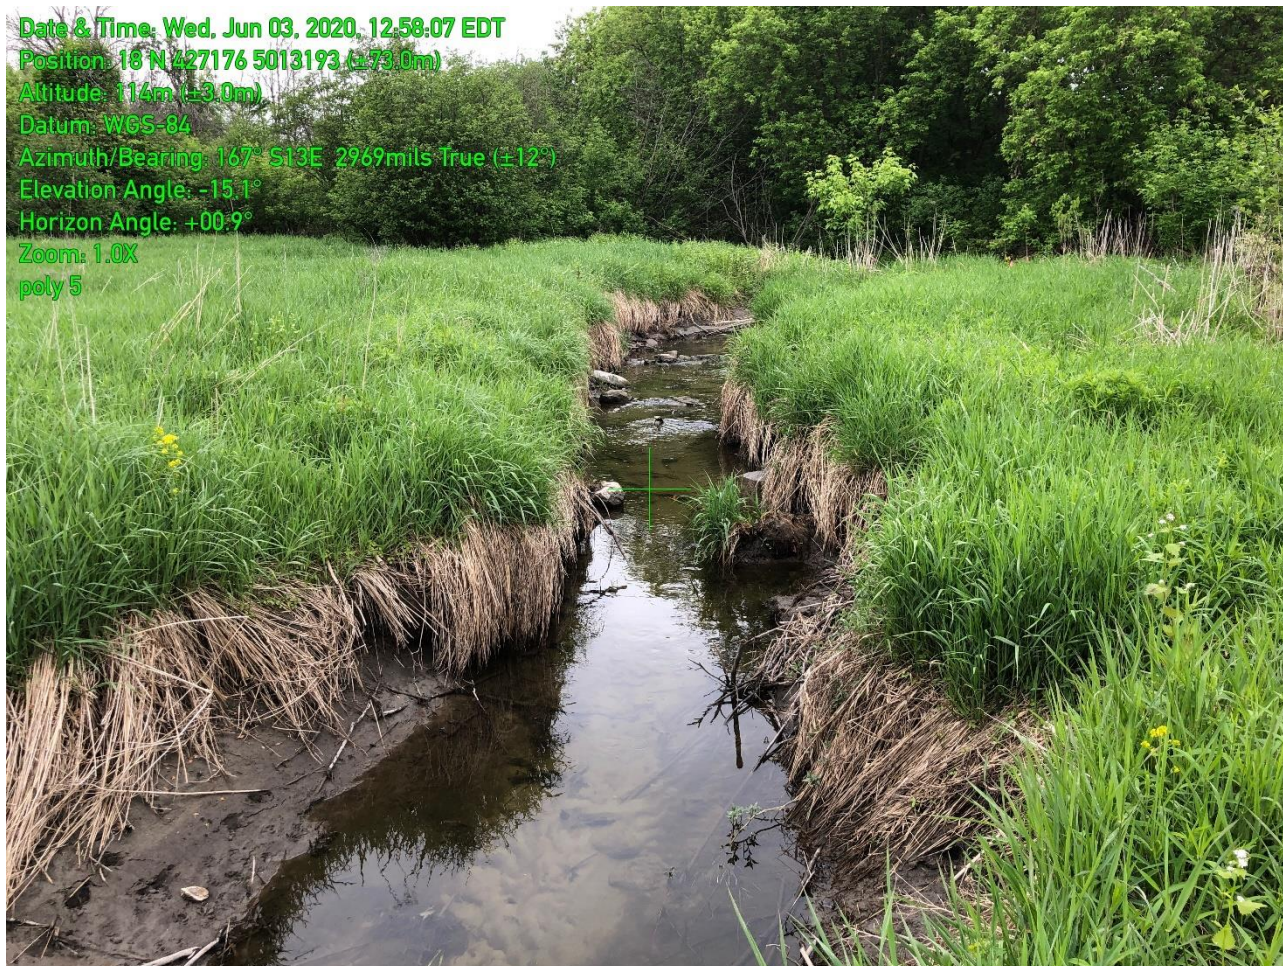
Figure 6 Photo of the Reed Canary Grass Organic Shallow Marsh Type (MASO1-4) within the headwater wetland on the Site

The riparian corridor of Poole Creek north of the SWD6 ecosite on the Site consists of meadow marsh dominated by Reed Canary Grass (*Phalaris arundinacea*; Figure 6).

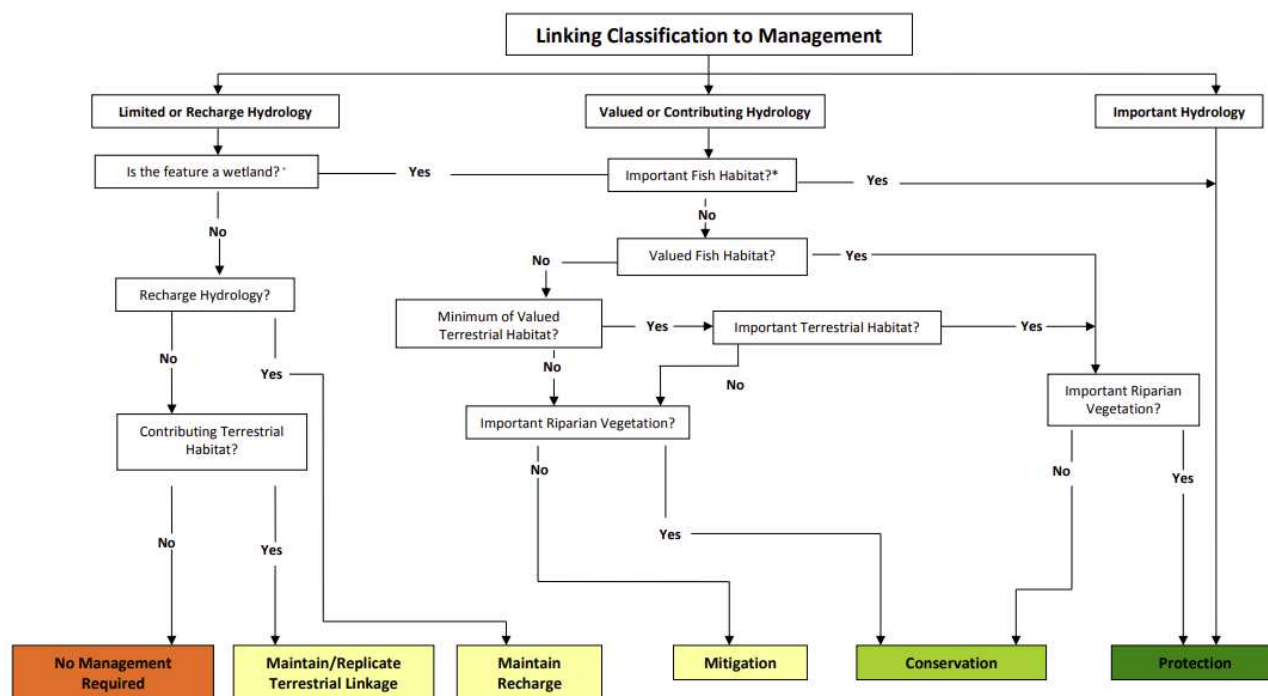
Figure 9 Flow chart providing direction on management options based on the wetland’s classifications adapted from TRCA and CVC (2014)

The functions rankings (classifications) identified for the hydrology, riparian conditions, fish habitat, and terrestrial habitat of the wetland form the basis of the management recommendation for the feature (Table 4; Figure 9; TRCA and CVC, 2014).

The management recommendation for the wetland on the Site is **Conservation**. Conserving the wetland includes (TRCA & CVC, 2014):

- Maintaining and/or enhancing the feature;
- Restoring hydrological and riparian and terrestrial habitat functions that may have been lost due to the historical placement of fill along the wetland’s edge, as feasible;
- Maintaining catchment flows (e.g., maintaining onsite flows through low impact development and/or natural design techniques and/or stormwater management design);
- Designing and locating the onsite stormwater management system such that impacts to the wetland (e.g., sediment loading, temperature changes) are avoided; and
- Maintaining a development setback from the wetland to prevent impacts to the feature.
