Phase II Environmental Site Assessment

3432 Greenbank Road
Ottawa, Ontario

Minto Communities

Report: PE4940-2

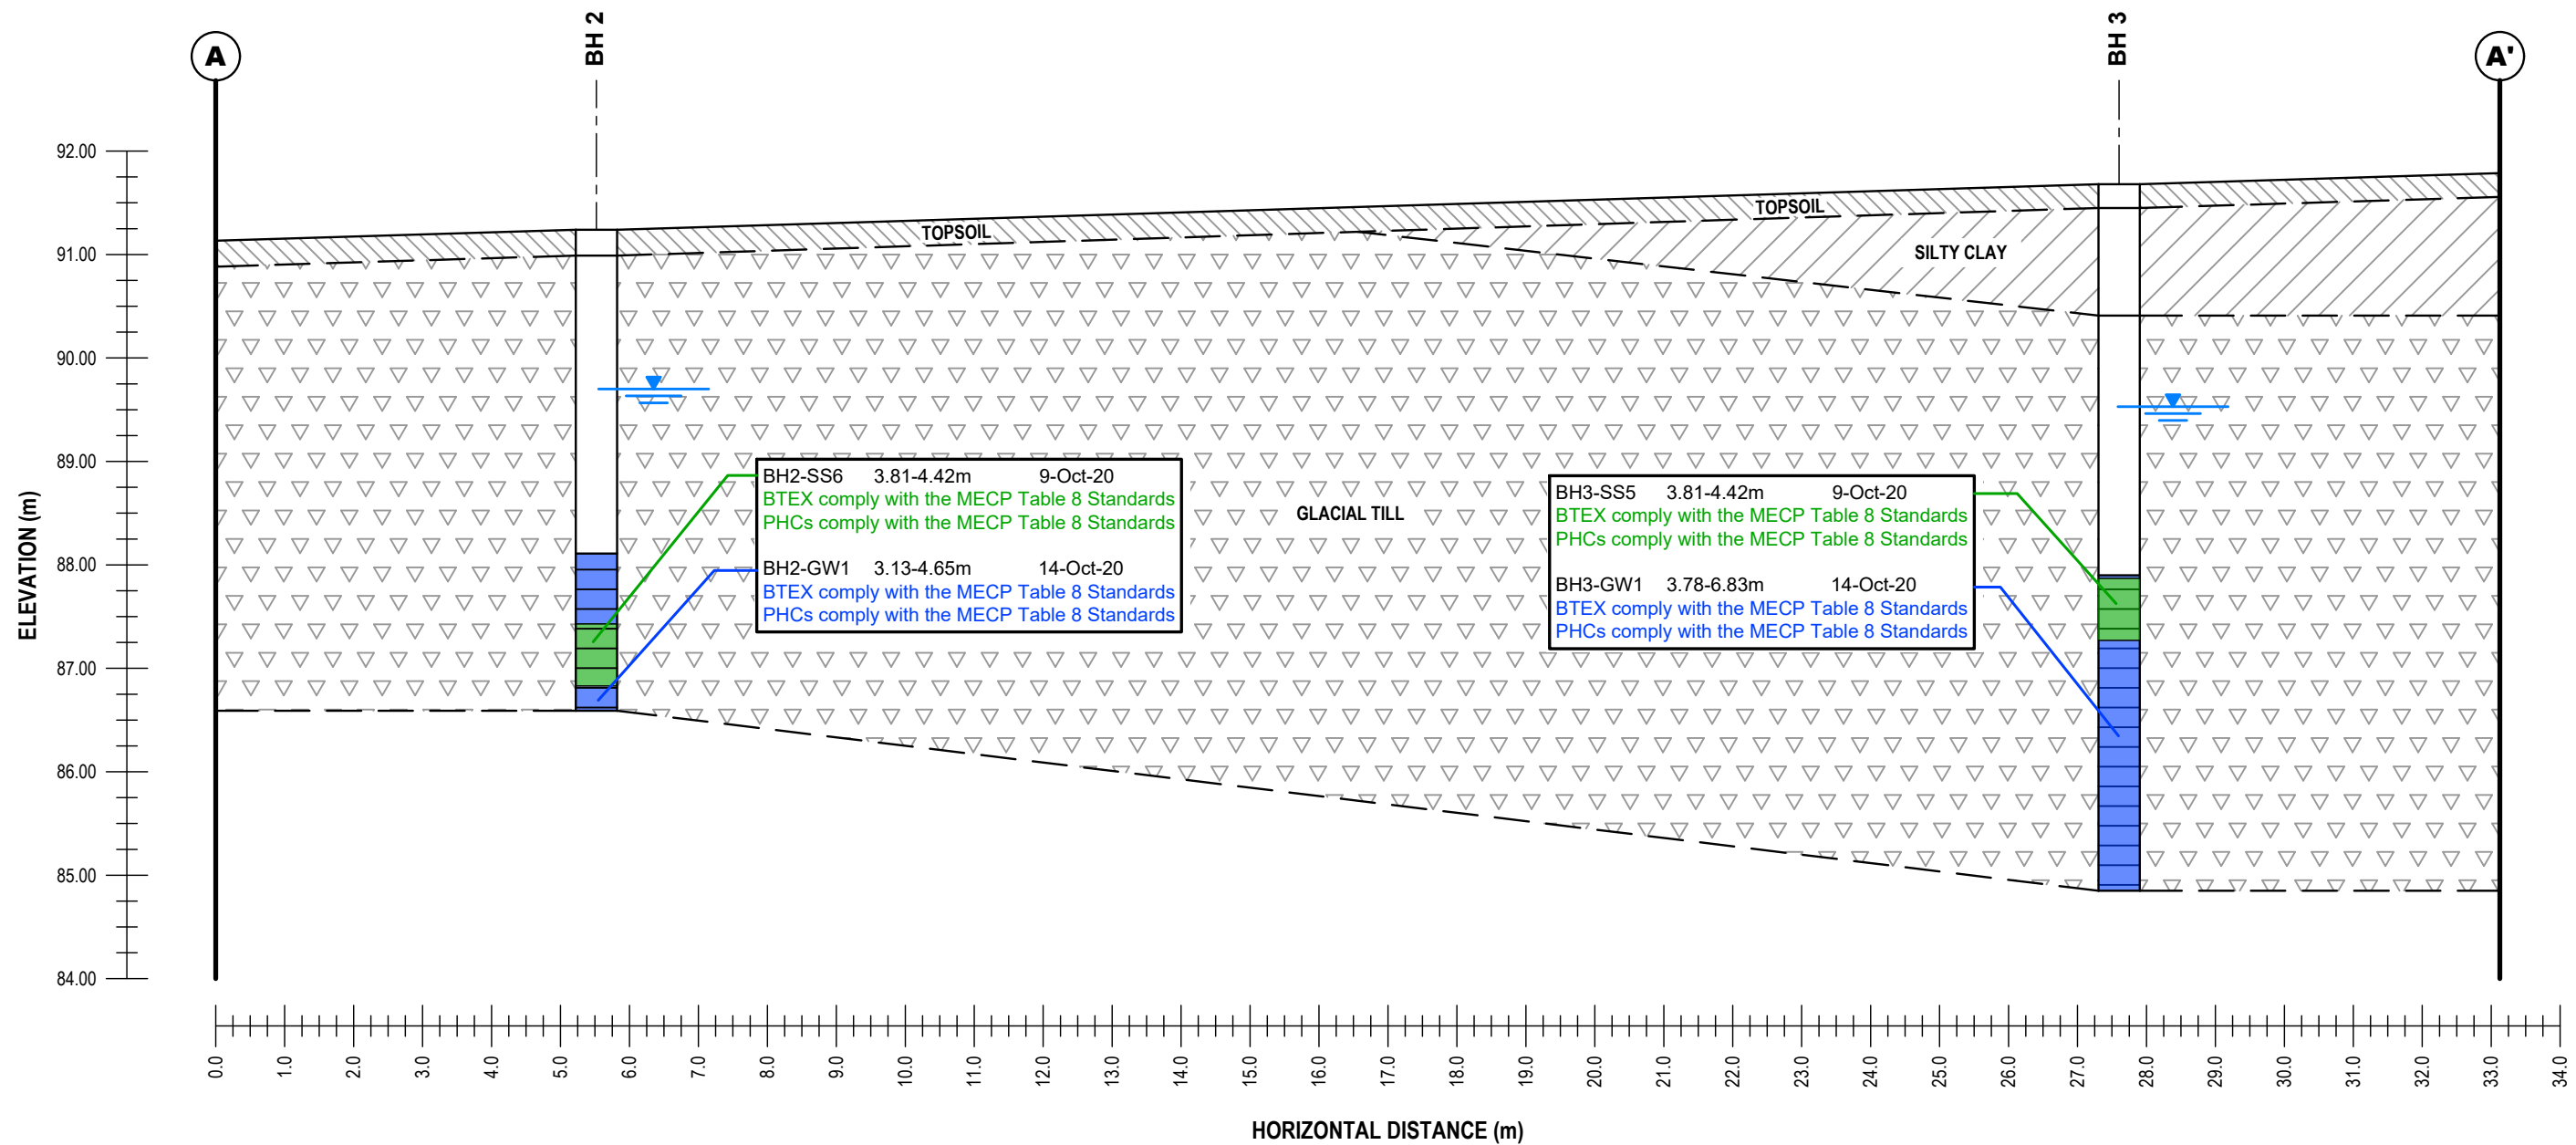
**DRAWING PE4940-6 – CROSS-SECTION A – A' – SOIL &
GROUNDWATER**

SOIL RESULTS COMPLY WITH MECP TABLE 8 STANDARDS

GROUNDWATER RESULTS COMPLY WITH MECP TABLE 8 STANDARDS

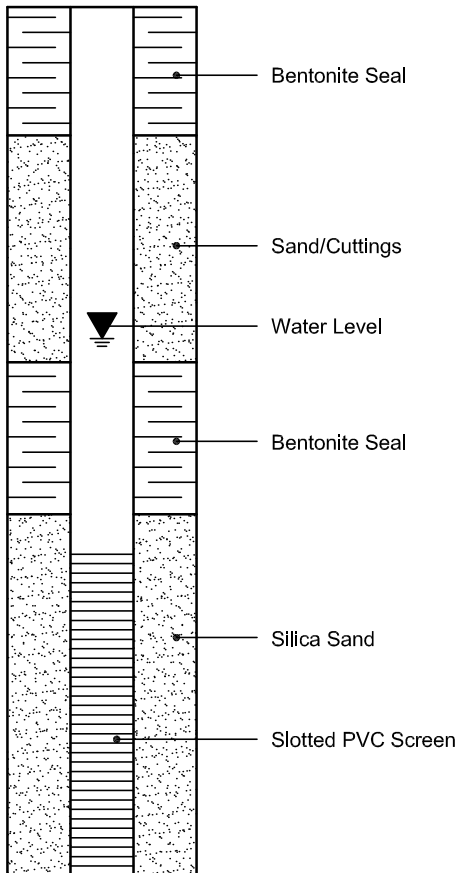
MONITORING WELL CONSTRUCTION

Three (3) groundwater monitoring wells were installed on the Phase II Property as part of the subsurface investigation. The monitoring wells consisted of 50 mm diameter, Schedule 40 threaded PVC risers and screens. Monitoring well construction details are listed below in Table 2 and are also presented on the Soil Profile and Test Data Sheets provided in Appendix 1.
