**Phase I Environmental Site Assessment**

3484, part of 3490 and 3592 Innes Road  
Ottawa, Ontario

July 10, 2018

Report: PE4288-1

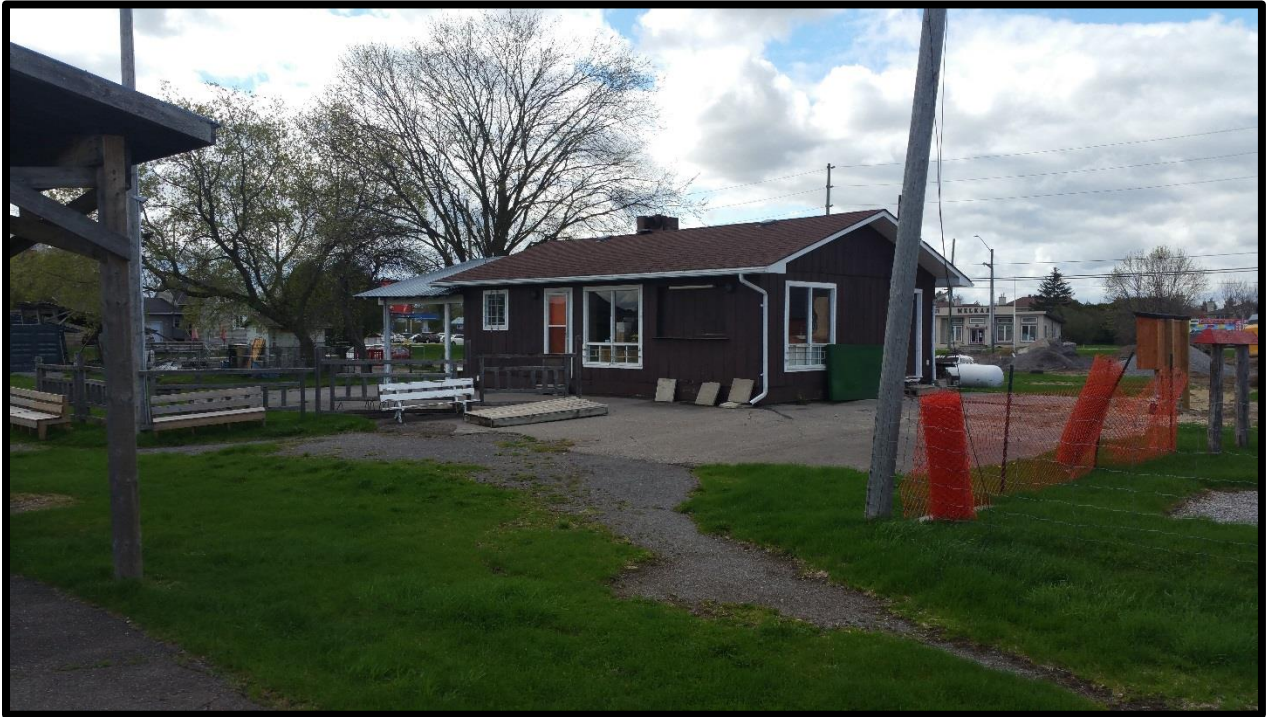
Photograph 1: View of the Golf Land rental shack on the northern portion of the site, facing northwest.

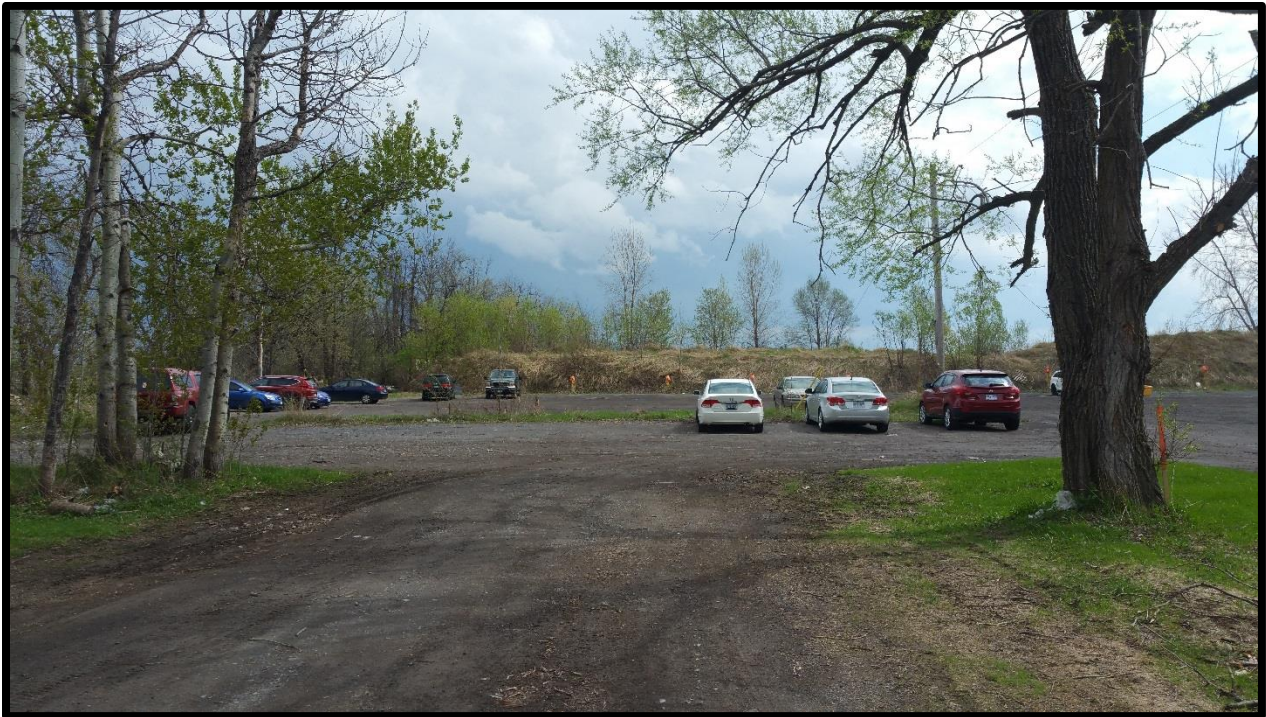
Photograph 2: View of the eastern side of the subject site, facing south. Photograph illustrates a gravel parking lot and a berm in the distance.

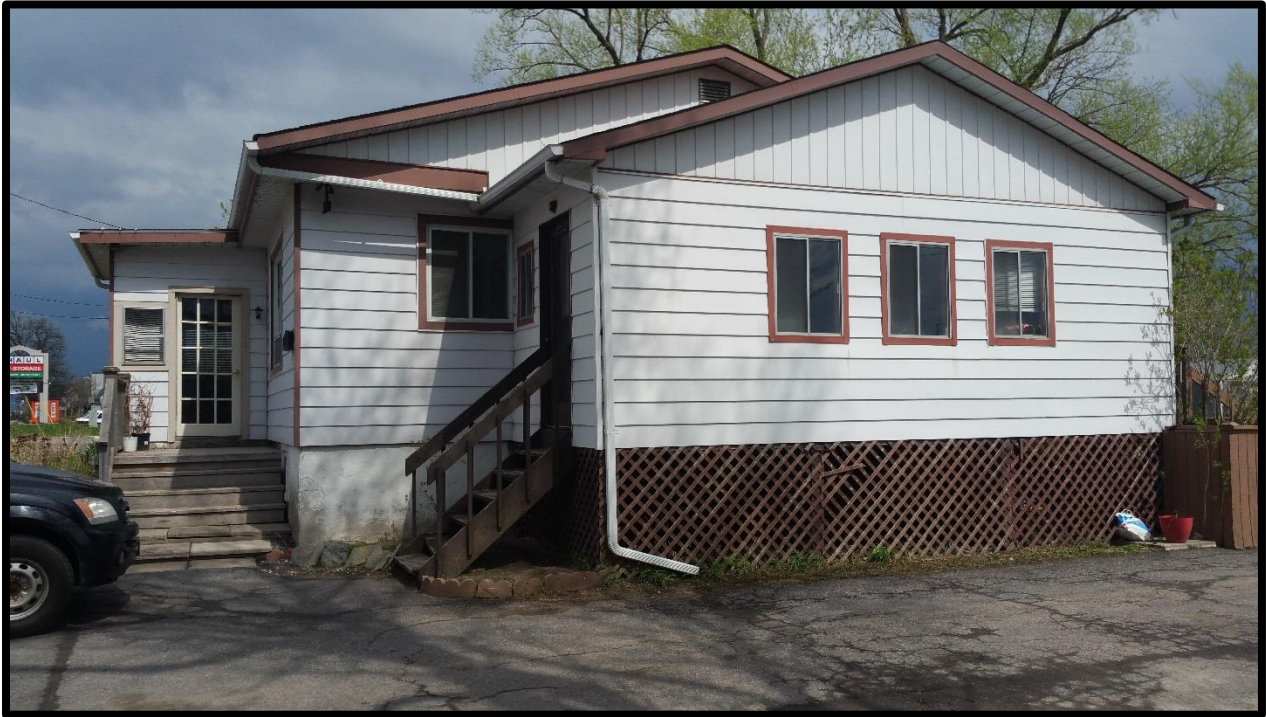
Photograph 3: View of the residential dwelling addressed 3592 Innes Road.

Based on the age of the commercial/residential building located at 3484 Innes Road (late 1960s) and the residential dwelling addressed 3592 Innes Road (mid-1970s), potential asbestos containing materials (ACMs) may be present. Potential ACMs include ceiling stipple, linoleum and dry-wall joint compound, which were all observed to be in good condition at the time of the assessment. An asbestos survey of the subject structures should be completed in accordance with Ontario Regulation 278/05, if one has not been completed, prior to demolition or any major renovation activities.

Based on the age of the subject buildings constructed between the 1960s and late 1970s, lead-based paints may be present on original painted surfaces. Painted surfaces were observed to be in good condition at the time of the assessment. Lead testing should be conducted in the buildings prior to major renovations or demolition activities. Major works involving lead based painted surfaces must be done in accordance with Ontario Regulation 843, under the Occupational Health and Safety Act.

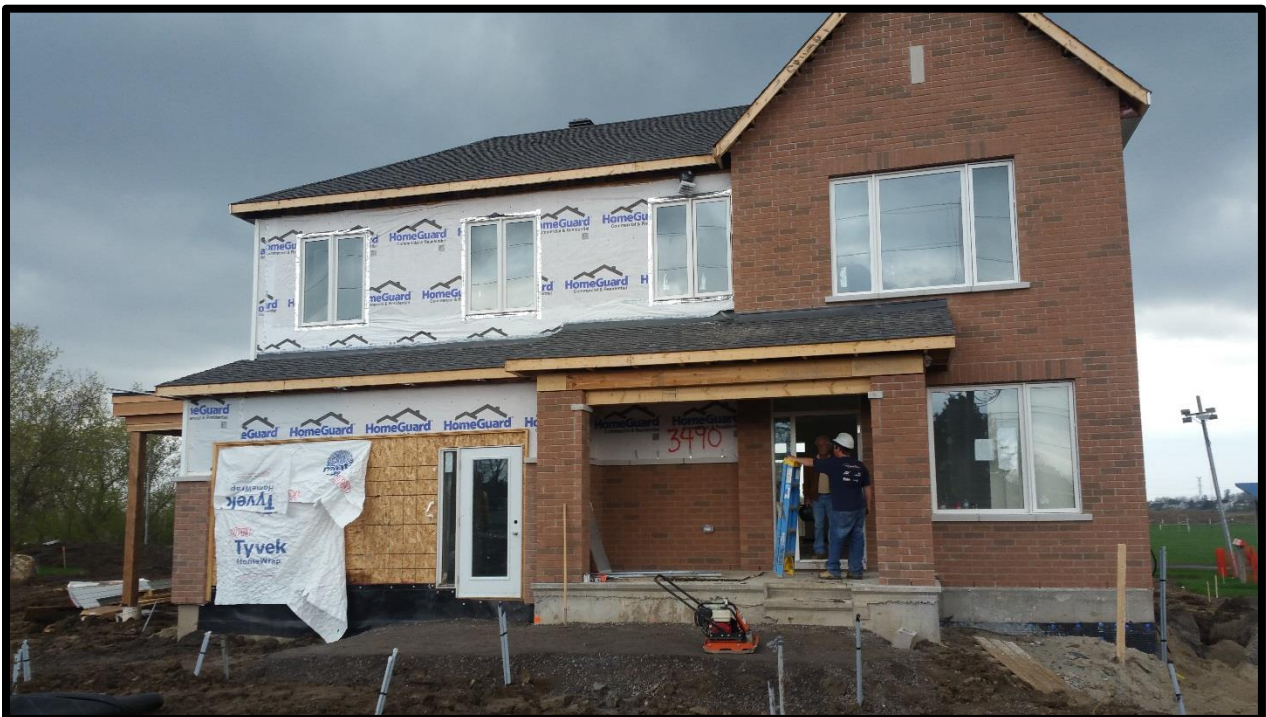
Photograph 4: View of the model home on the northern portion of the subject site, facing southeast.

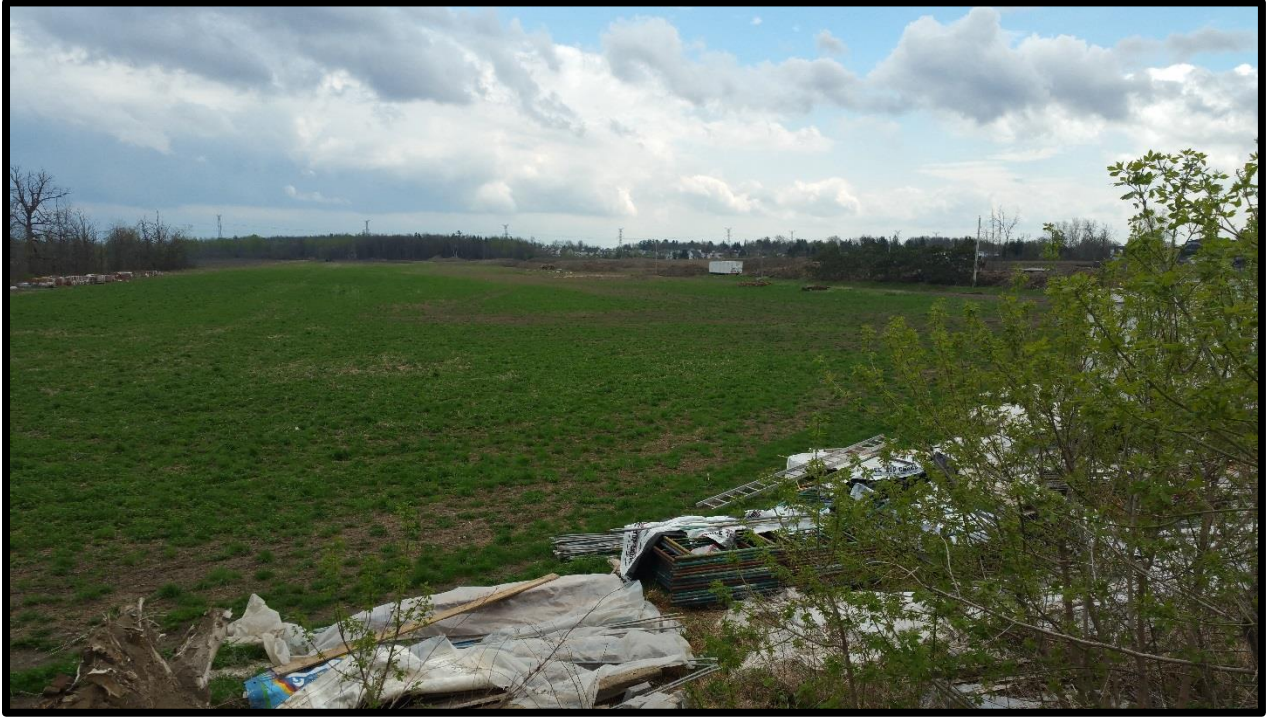
Photograph 5: View of the southern portion of the subject site, facing southwest. Photograph illustrates an undeveloped grass field.
