Phase One Environmental Site Assessment 1927 Maple Grove Road, Stittsville, Ontario

Final

OTT-00262363-A0

EXP Services Inc.

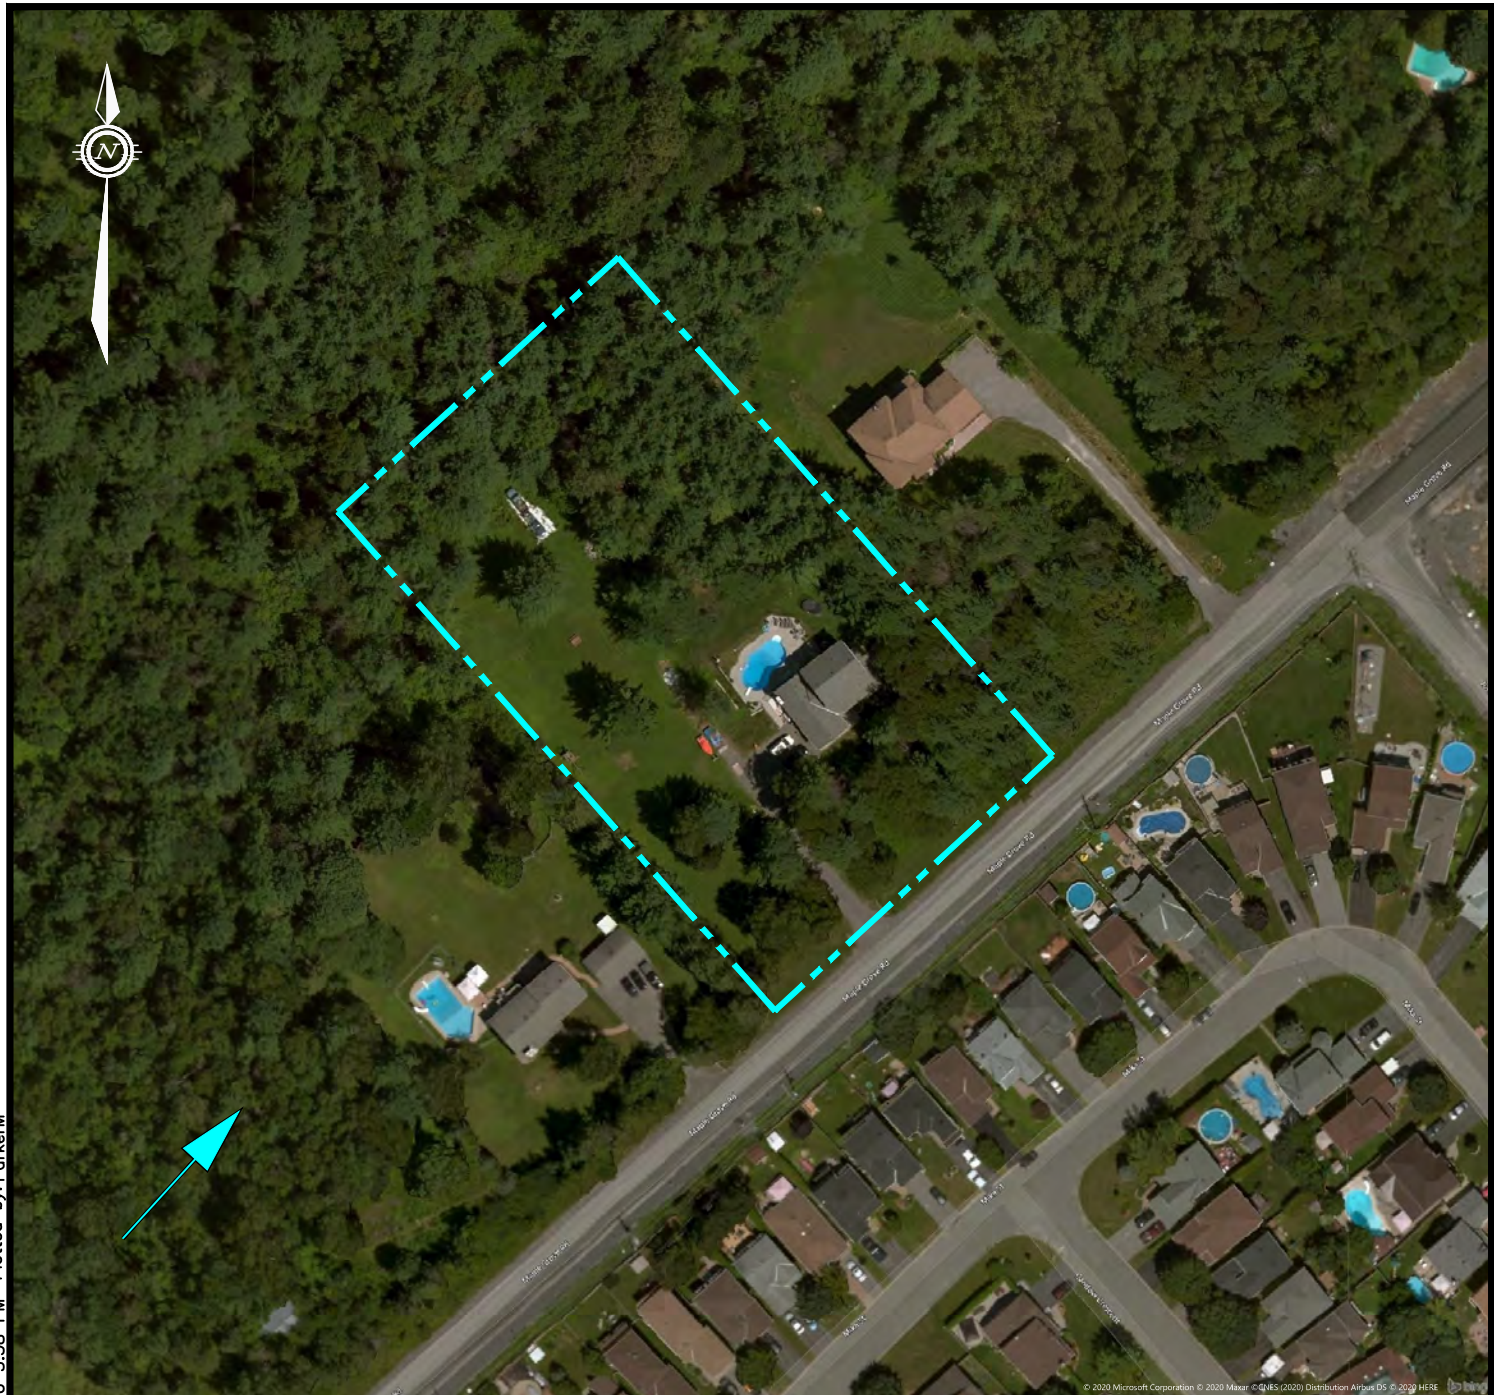
DATE OCT 2020	CLIENT: LATITUDE HOMES INC.	project no. OTT-00262363-A0
DESIGN O.V.	CHECKED P.S.	scale 1:1,500
DRAWN BY M.P.		FIG 2
TITLE: CONCEPTUAL SITE MODEL - PHASE ONE PROPERTY 1927 MAPLE GROVE ROAD, STITTSVILLE, ON

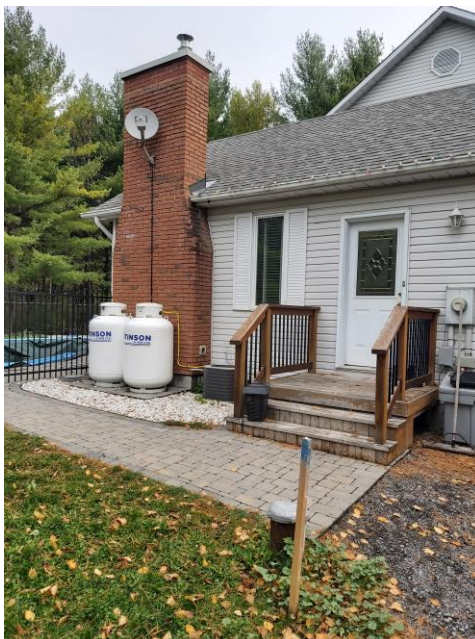
Photograph No. 1

Front Face of Residential House with Water Well in Foreground, Looking North

- The borehole database identified grey limestone bedrock in the vicinity of the Phase One property.
- There were records for four domestic water wells and one set of monitoring wells listed in the Water Well Information System (WWIS) database for the Phase One study area. It is likely that the record for well ID 1513368 pertains to the water well observed on the Phase One property.

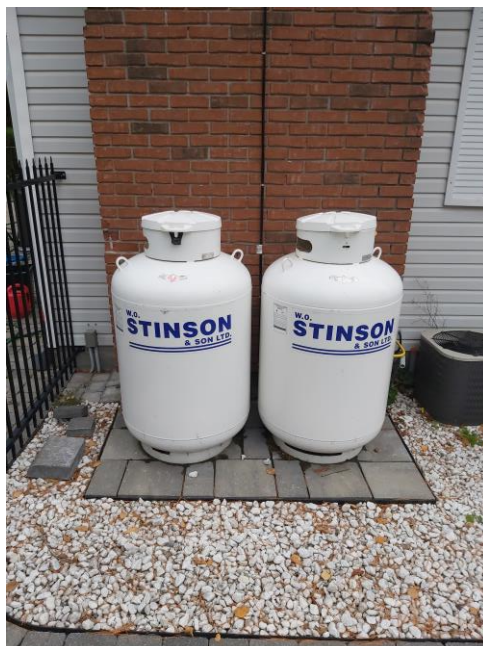
Photograph No. 2

Two Propane Tank AST at the Front of the House, Looking Northeast

Two propane tank AST were observed on the Phase One property and were used for heating the property building. The AST appeared to be in good condition. No staining was observed in the vicinity of the AST.

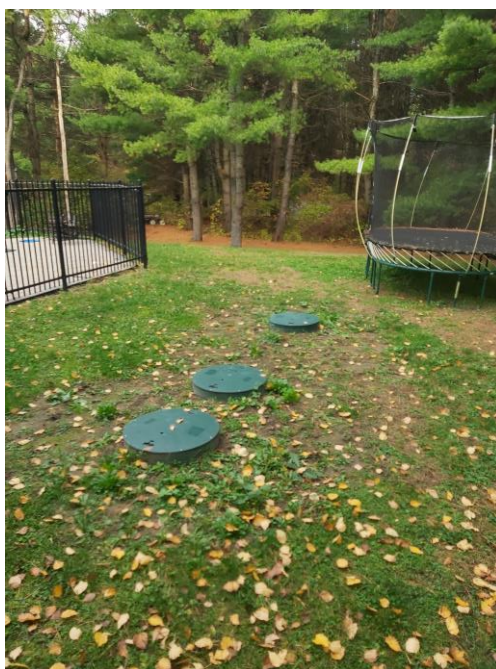
Photograph No. 3

Septic System located adjacent to the Swimming Pool, Looking Northwest

No UST were observed on the Phase One property and there was no evidence of historical UST. An on-site septic system was observed.

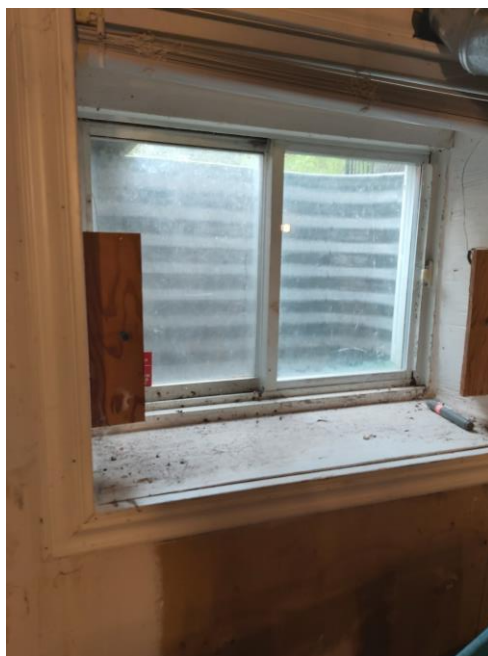
Photograph No. 5

Mr. Cybulski reported that flooding had occurred previously through the windows in the basement. During the site visit, evidence of water damage was observed in the vicinity of the basement window. However, mould growth was not observed.

Water Damage Around Basement Window

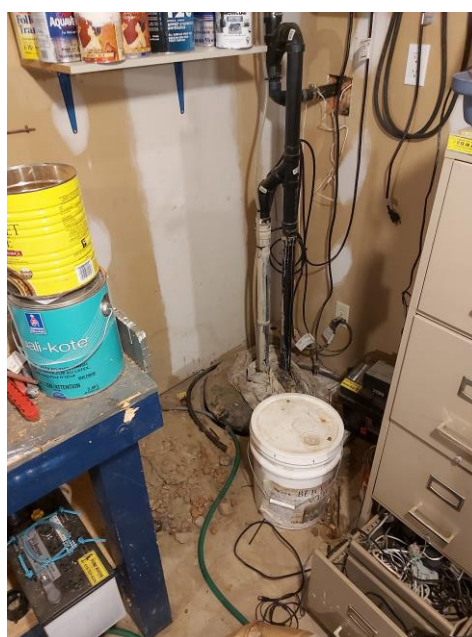
Photograph No. 6

Sump Pump in the Basement

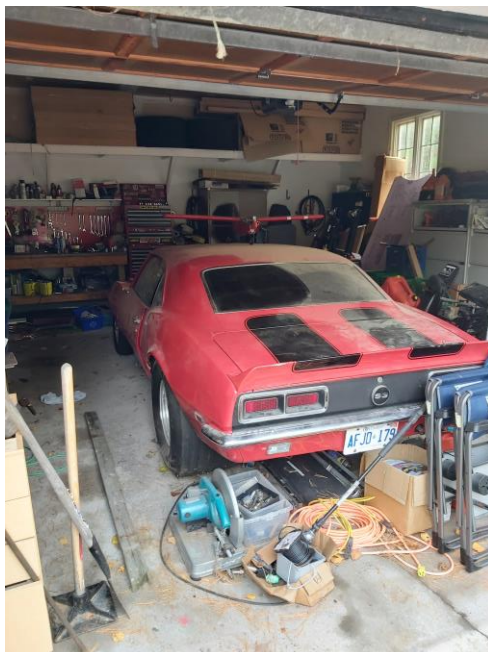
Photograph No. 7

Vehicle and equipment maintenance activities were observed in the car garage. However, no obvious spills or staining from their chemical use was observed in the vicinity.

Garage with Vintage Vehicle
