# Stillwater Station Ltd.

## Environmental Impact Statement

Proposed Site Redevelopment – Stillwater Station,  
1987 Robertson Road, Ottawa, Ontario

CIMA+ file number: A001177- 080  
February 28, 2024 – Revision 004

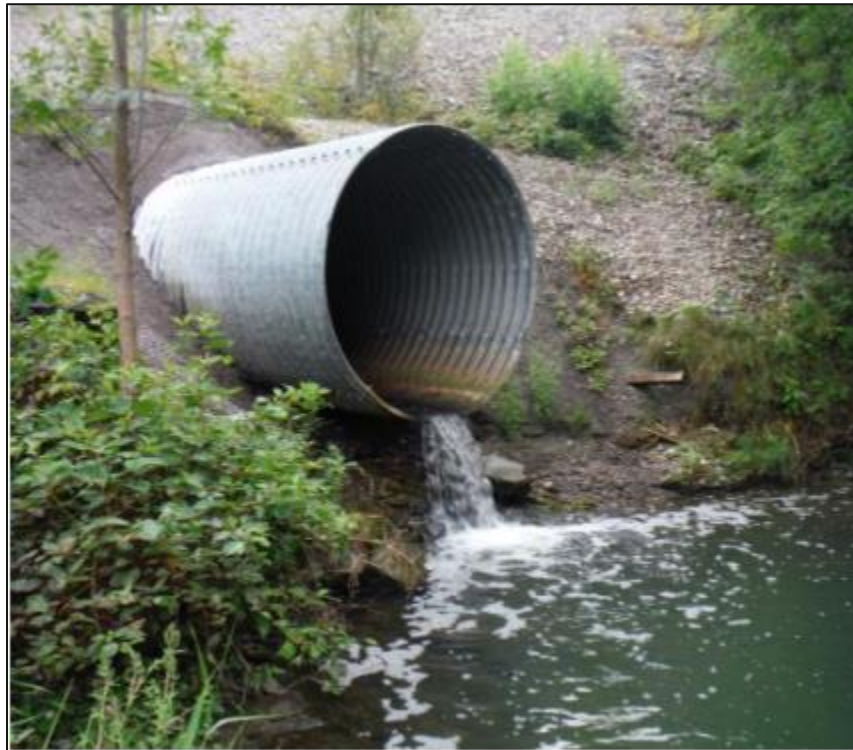
The RVCA's City Steam Watch Stillwater Creek 2015 Summary Report notes the known locations of migratory obstructions within the watershed because these features can prevent fish from accessing important spawning and rearing habitat. Fish migration is currently being impacted by the perched culvert identified on the main channel of the creek at the tributary east of Moodie Drive at the Beachburg railway. Refer to **Photo** below to view the perched culvert directly north of the Study Area.

**Photo 1: Perched culvert that conveys flow of Stillwater Creek under the Beachburg railway (RVCA, 2015)**

Stillwater Creek flows north through a narrow channel within the Study Area. Surface drainage is managed by a large CSP culvert that extends under the abandoned railway. The water was slow moving and clear at the time of the Site visit, and no aquatic vegetation was observed within the channel. There were no visible signs of bank erosion along the Stillwater Creek both north and south of the railway however erosion was observed at points along the western side of the valley associated with stormwater runoff channels from parking lots, etc. Passage through the culvert running under the abandoned rail line was unobstructed; however, the culvert running under the active Beachburg Rail line to the north of the Site was observed to be perched on its north side by approximately 1 meter which presents a major barrier to upstream passage (Refer to **Photo 1** above).

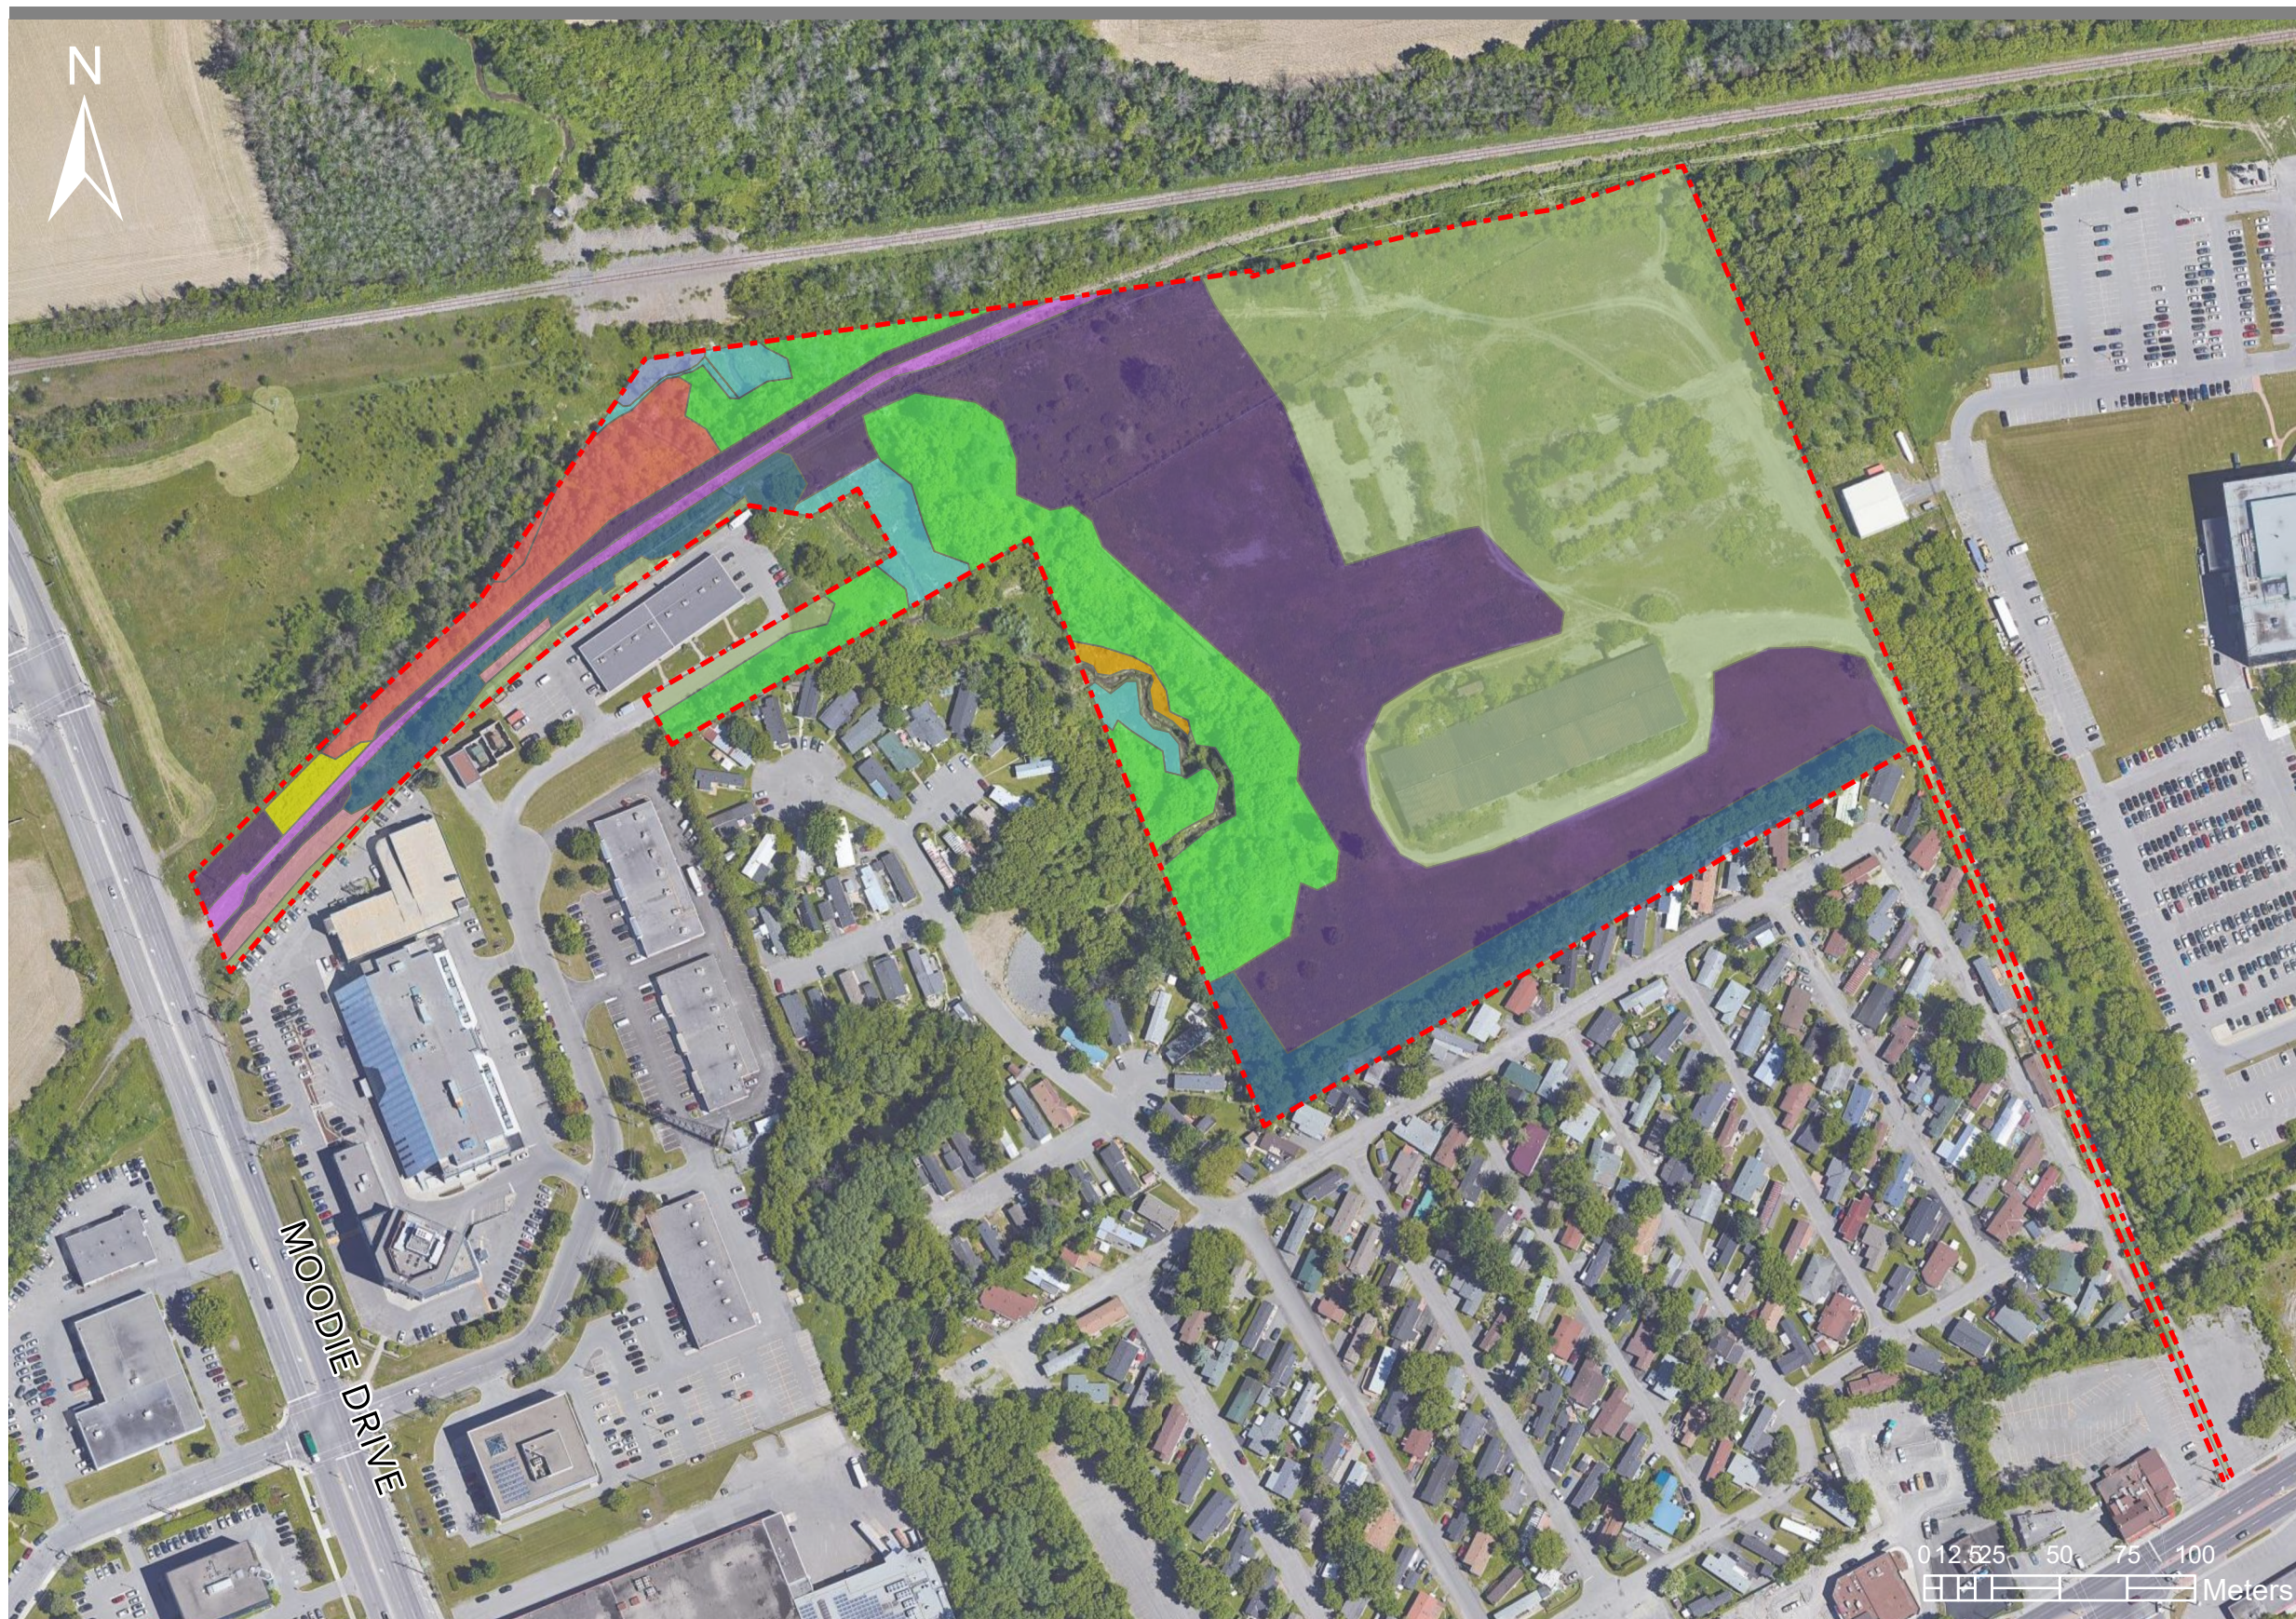
- Site boundary
- ELC Communities**
- ELC Code
- CVC\_1 - Business Sector
  - CVL\_1 - Transportation
  - FOCM6-3 - Dry-Fresh Scots Pine Naturalized Coniferous Plantation
  - FODM11 - Naturalized Deciduous Hedge-Row
  - FODM4-5 - Dry-Fresh Manitoba Maple Deciduous Forest
  - MAMM1-2 - Cattail Graminoid Mineral Meadow Marsh
  - MAMM3 - Mixed Mineral Meadow Marsh
  - MEMM3 - Dry-Fresh Mixed Meadow
  - SWTM2-1 - Red-osier Dogwood Mineral Deciduous Thicket Swamp
  - SWTM3-6 Mixed Willow Mineral Deciduous Thicket Swamp
  - THDM2 - Dry-Fresh Deciduous Shrub Thicket

Eleven (11) ELC community classes were identified within the Site. A summary of community class findings is outlined in **Table 5**, and the locations of the various vegetation communities present within the Site are outlined in Appendix A – Figure 5. No rare vegetation species or SAR plants were observed within the Study Area. Refer to Appendix E for the full vascular plant inventory and Appendix F for a photographic log of the ELC communities on Site.

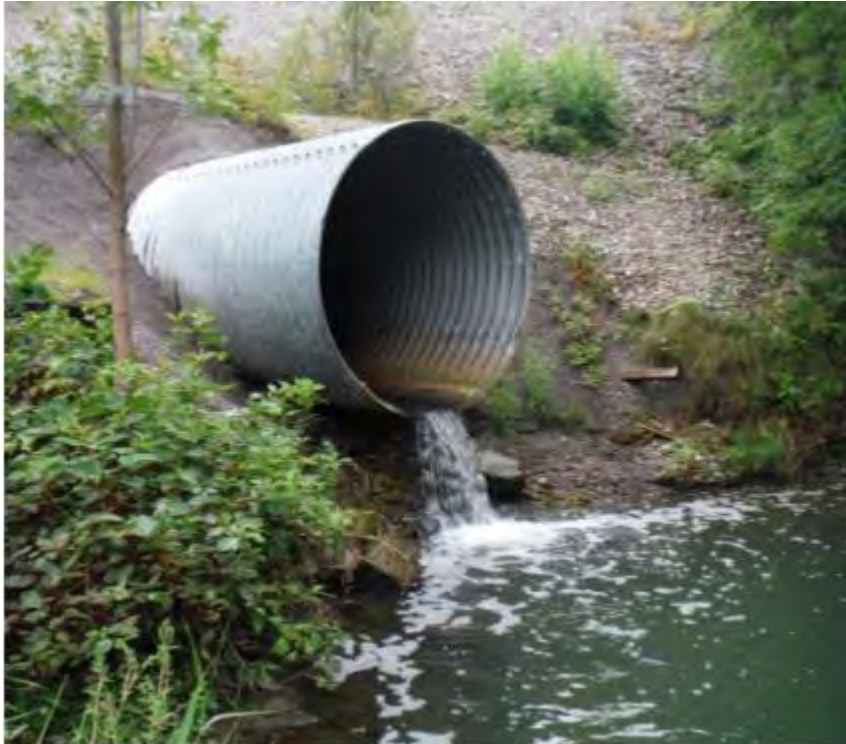
Figure 1: Photo of perched culvert that conveys flow of Stillwater Creek under the Beachburg Rail line (RVCA, 2015)

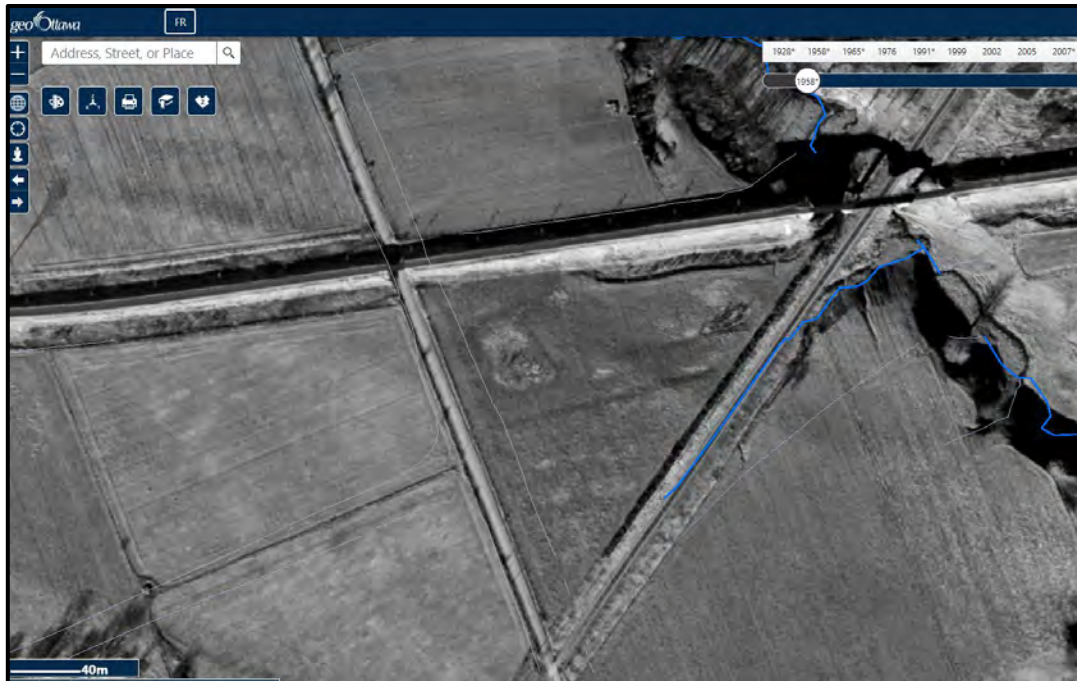
Figure 3: GeoOttawa 1958 image of the project area with conifers planted along the northwest side of the rail.

A review of historic aerial imagery (geoOttawa, 1958 – 2019) was completed to understand the evolution of the site in relation to the wetland feature currently mapped as 'swamp'. The earliest imagery of the site was recorded in 1958 which displays the active Beachburg rail spur lined with planted conifers on the northwest side (i.e. Scots Pine, Figure 3). By 1976, the conifers have matured and appear to have established on the southeast side of the now abandoned rail spur (Figure 4). The image generated in 2007 exhibits a mature Scots Pine plantation both northwest and southeast of the abandoned rail spur (Figure 5).

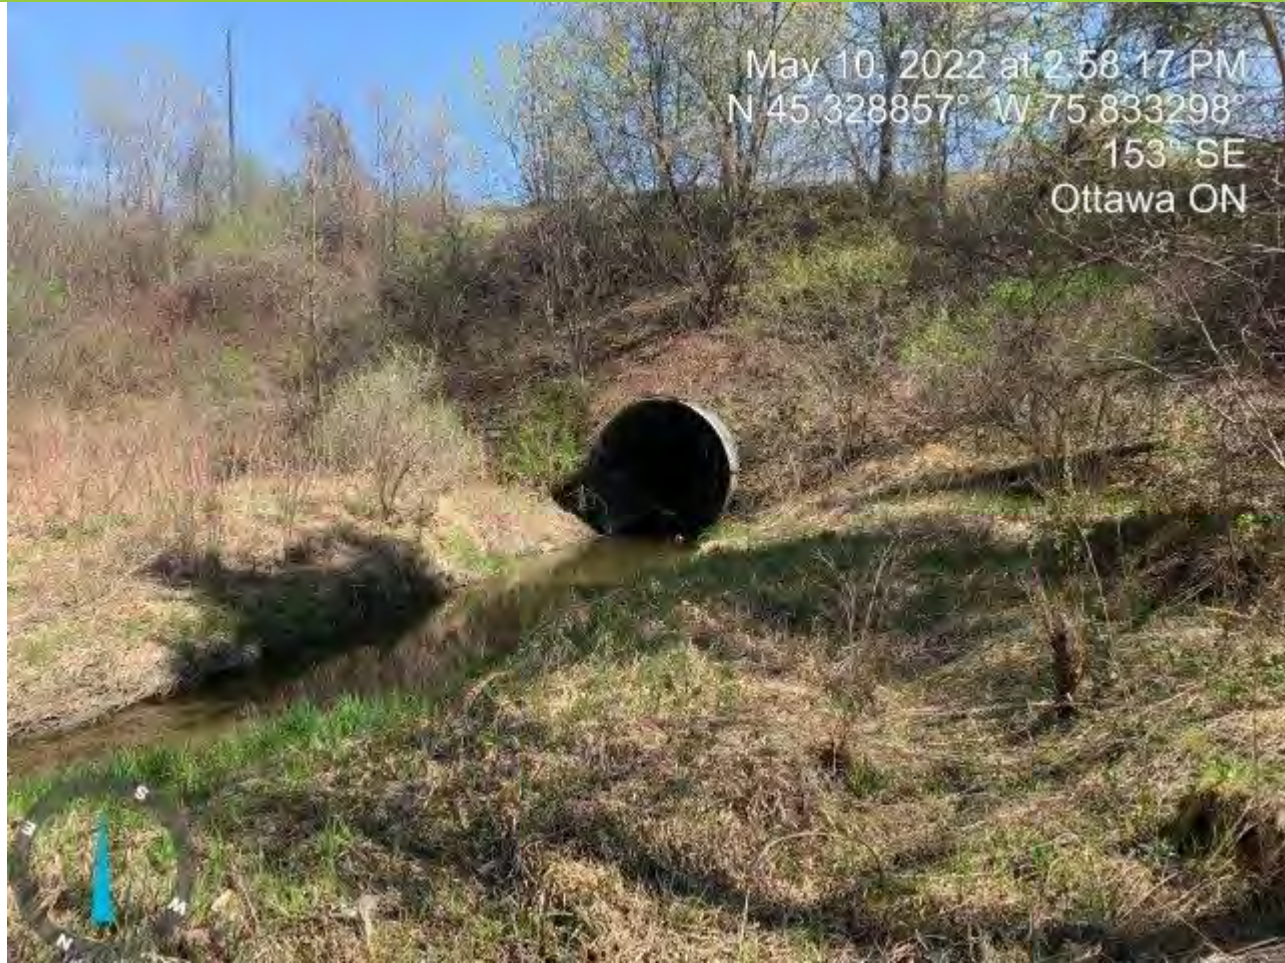
Site Location		
Stillwater Station Ltd – 1987 Robertson Road, Nepean, Ontario		
Photo #	Date	Cardinal Direction
23	2022/05/10	South
Description		
View of the culvert outlet along the eastern extent of the wetland boundary during the 2022 assessment.

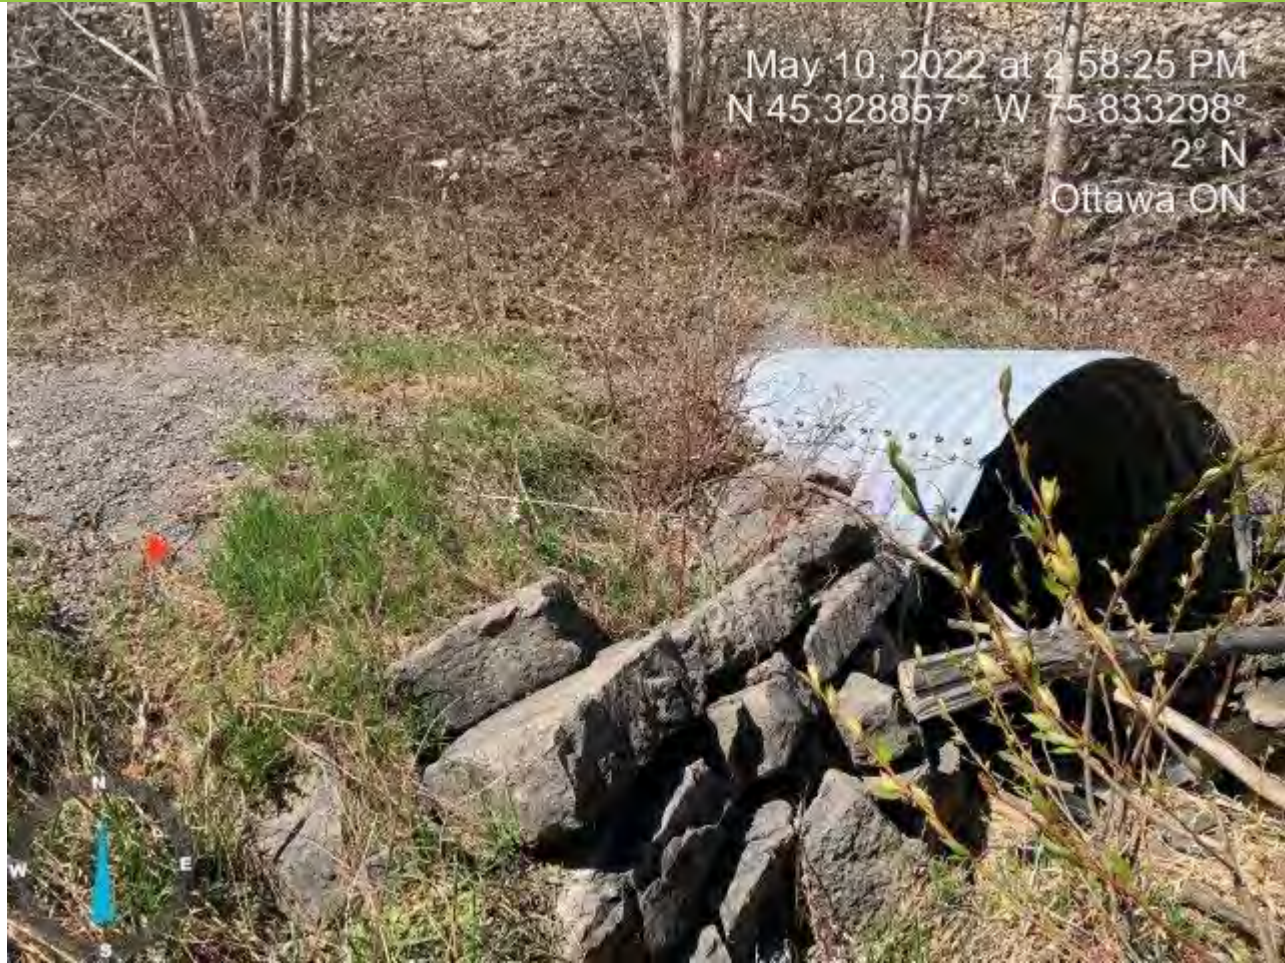
Site Location		
Stillwater Station Ltd – 1987 Robertson Road, Nepean, Ontario		
Photo #	Date	Cardinal Direction
24	2022/05/10	North
Description		
View of the culvert inlet along the eastern extent of the wetland boundary during the 2022 assessment.

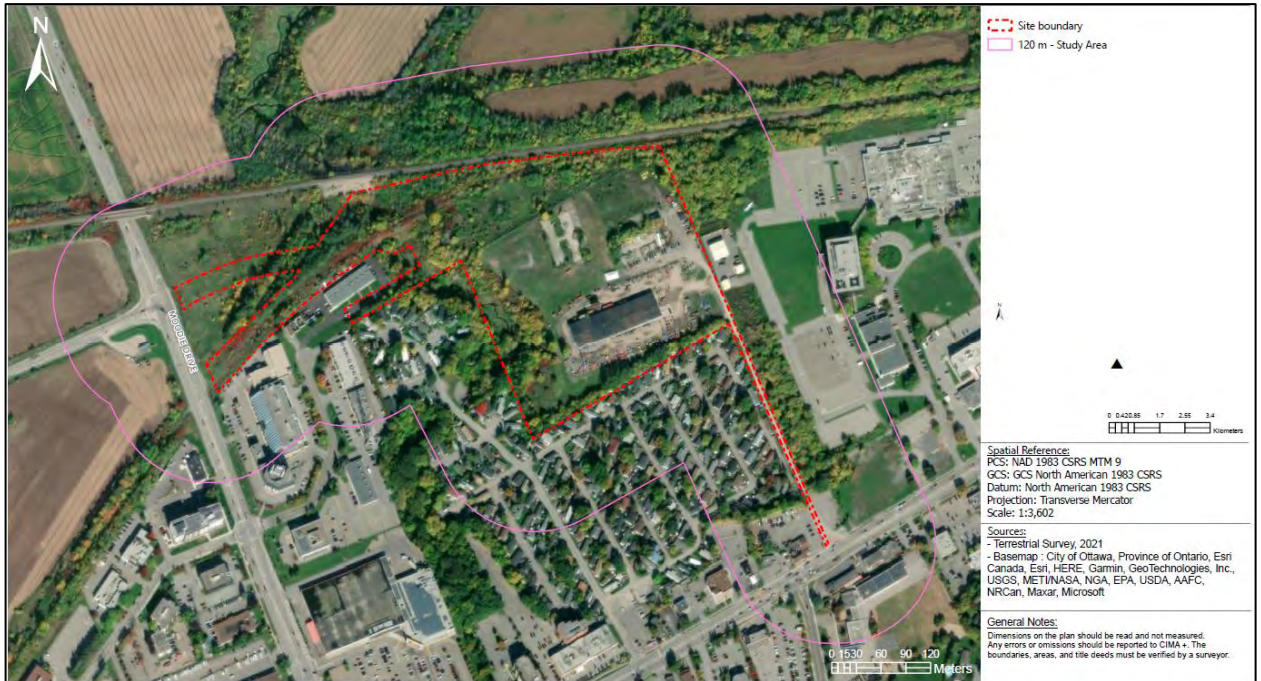
**Figure 1: Site Location Map**

The 1987 Robertson Road property is currently occupied by an equipment rental service. At present, there is a one-storey warehouse building, paved and gravelled surfaces for parking and access, and grass covered areas.

The northern portion of the site also encompasses an old rail spur which has been decommissioned.

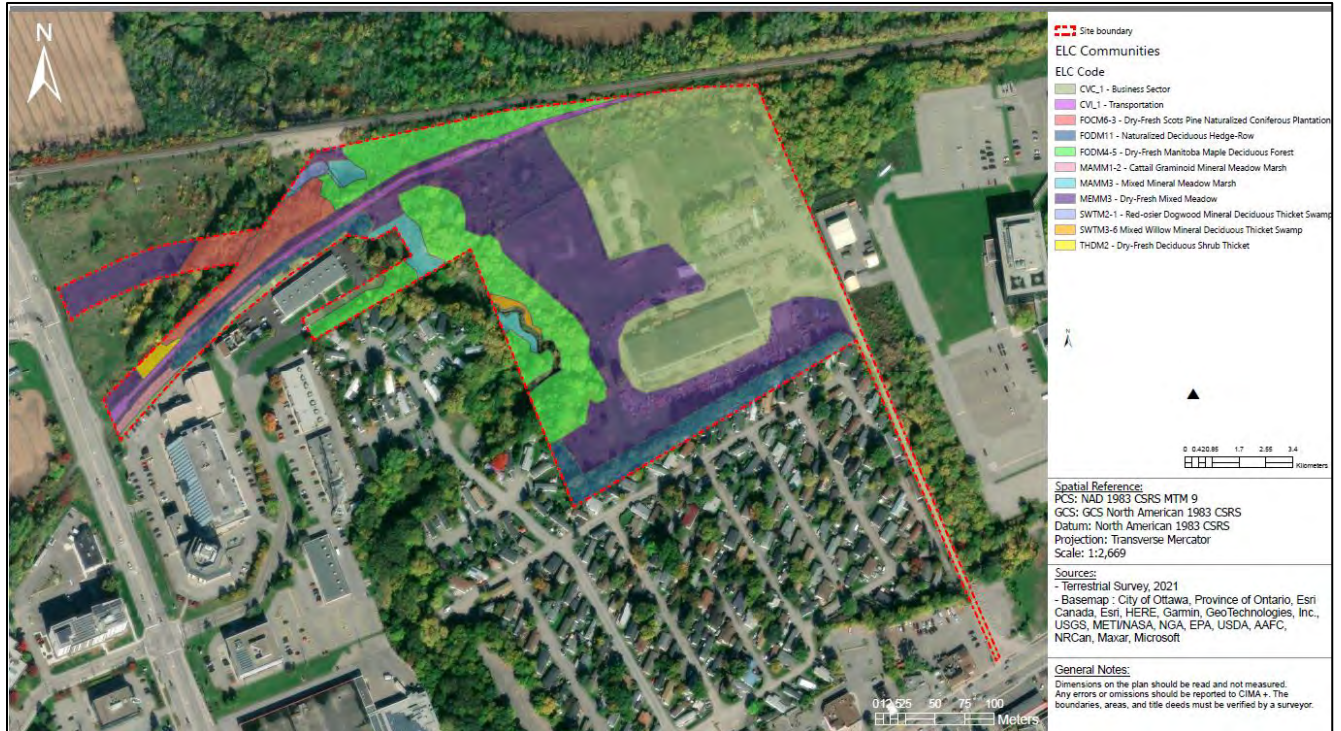
**Figure 2: Ecological Land Classification of the Stillwater Station Site**

Eleven (11) ELC community classes were identified within the Site. A summary of community class findings is outlined below in **Table 4**, and the locations of the various vegetation communities present within the Site are displayed in **Figure 2**. No rare vegetation species or SAR plants were observed within the Study Area.

ELC Community	Dominant Vegetation Species	Approximate Area Onsite (m <sup>2</sup> )
<b>MAMM3 – Mixed Mineral Meadow Marsh</b>	The Mixed Meadow Marsh communities within the Site are dominated by Joe Pye weed, Narrow-leaved Cattail, and Reed Canary Grass. This community is situated along Stillwater Creek, both north and south of the railway, as well as north of the naturalized Scots Pine plantation where the entrance to the Site is planned.	2,124
<b>MEMM3 – Dry-Fresh Mixed Meadow</b>	The Mixed Meadow communities within the Site are comprised of a mix of common grass-like and broadleaf species dominated by Smooth Brome, Wild Carrot, Bird's-foot trefoil, Common Mugwort, Goldenrod, vetch, dandelion, and bedstraws.	32,836
<b>SWTM2-1 – Red-Osier Dogwood Mineral Deciduous Thicket Swamp</b>	A Thicket Swamp dominated by Red-osier Dogwood is present east of the meadow marsh and adjacent to Stillwater Creek north of the railway.	311

<b>SWTM3-6 – Mixed Willow Mineral Deciduous Thicket Swamp</b>	The Mixed Meadow Marsh community located south of the railway and adjacent to Stillwater Creek transitions into a Mixed Willow Thicket Swamp along the eastern banks of the creek.	315
<b>THDM2 – Dry-Fresh Deciduous Shrub Thicket</b>	This Deciduous Shrub Thicket is located east of Moodie Drive, along the north side of the rail line. It is dominated by Red-osier Dogwood ( <i>Cornus sericea</i> ) and Staghorn Sumac.	422

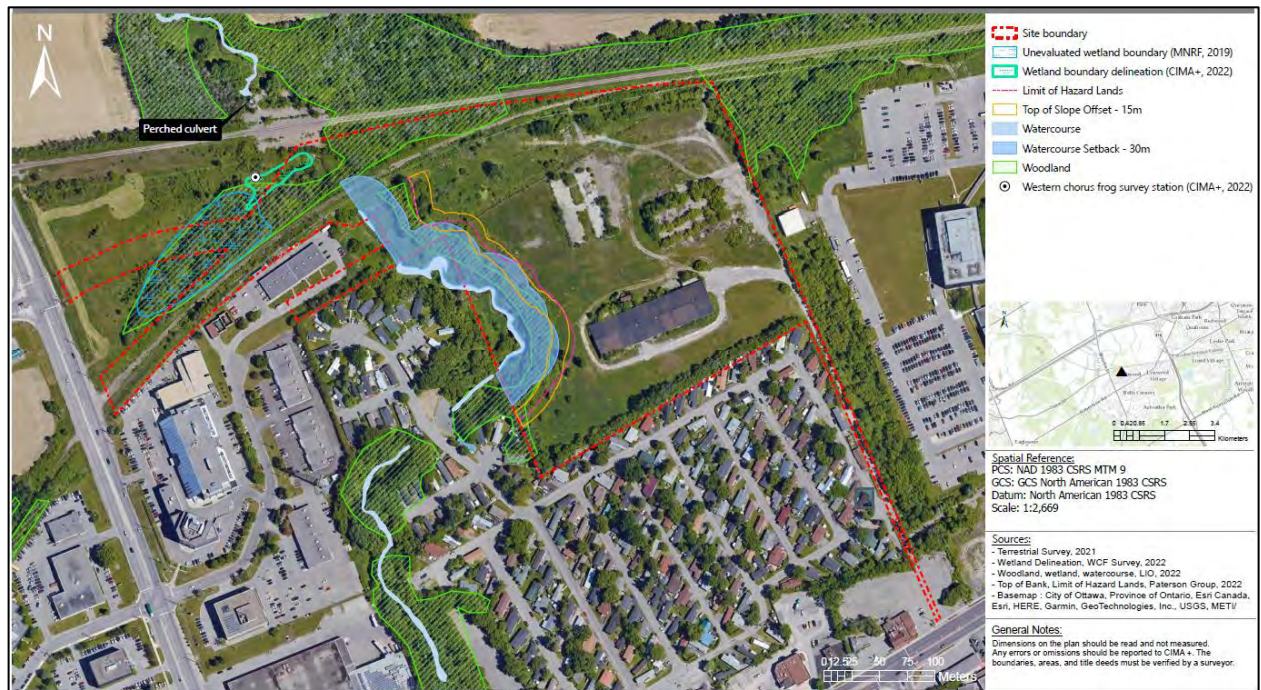
**Figure 4: Mapped Natural Heritage Features within the Stillwater Station Site**

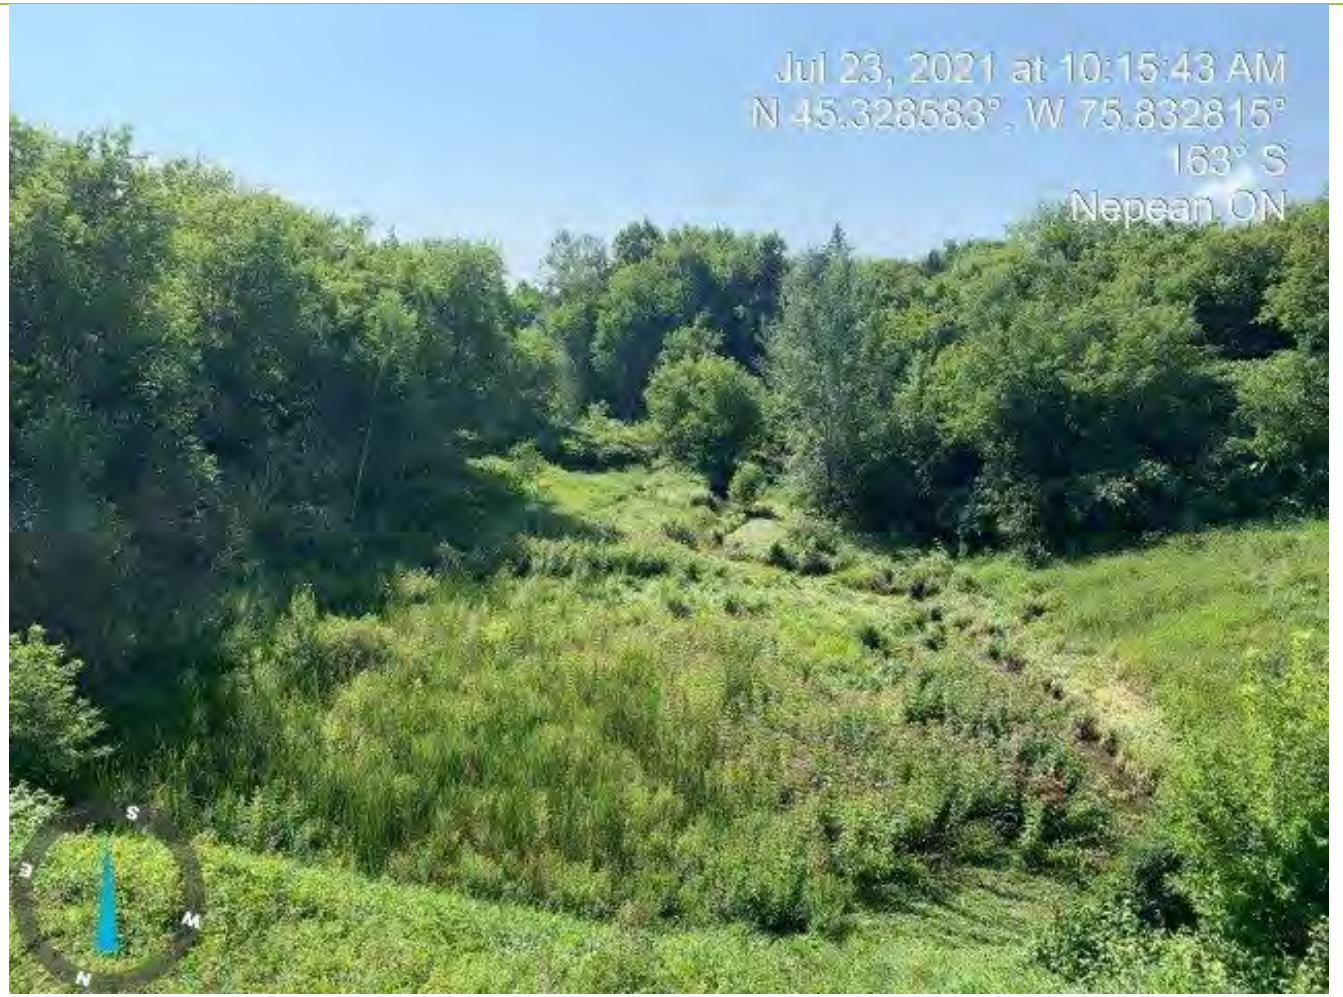
Site Location		
Stillwater Station Ltd – 1987 Robertson Road, Nepean, Ontario		
Photo #	Date	Cardinal Direction
11	2021/07/23	West
Description		
View of the CSP culvert conveying flow of Stillwater Creek under the abandoned railway.

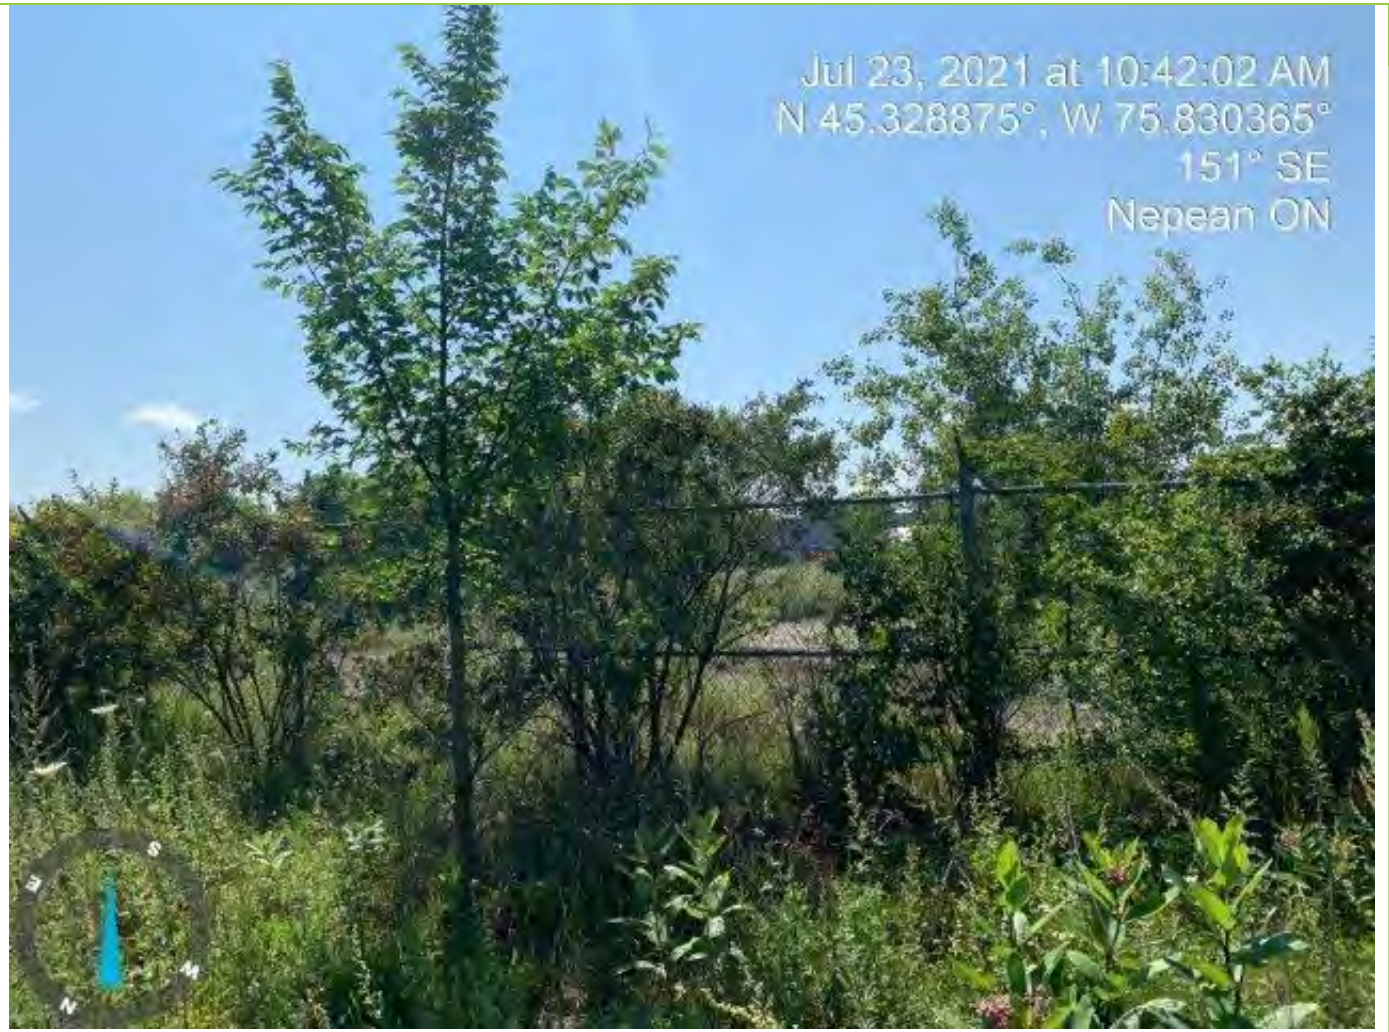
Site Location		
Stillwater Station Ltd – 1987 Robertson Road, Nepean, Ontario		
Photo #	Date	Cardinal Direction
19	2021/07/23	Northwest
Description		
View of the culvert inlet which conveys flow of Stillwater Creek under the 2 <sup>nd</sup> railway north of the Site, from the 1 <sup>st</sup> abandoned railway tracks.

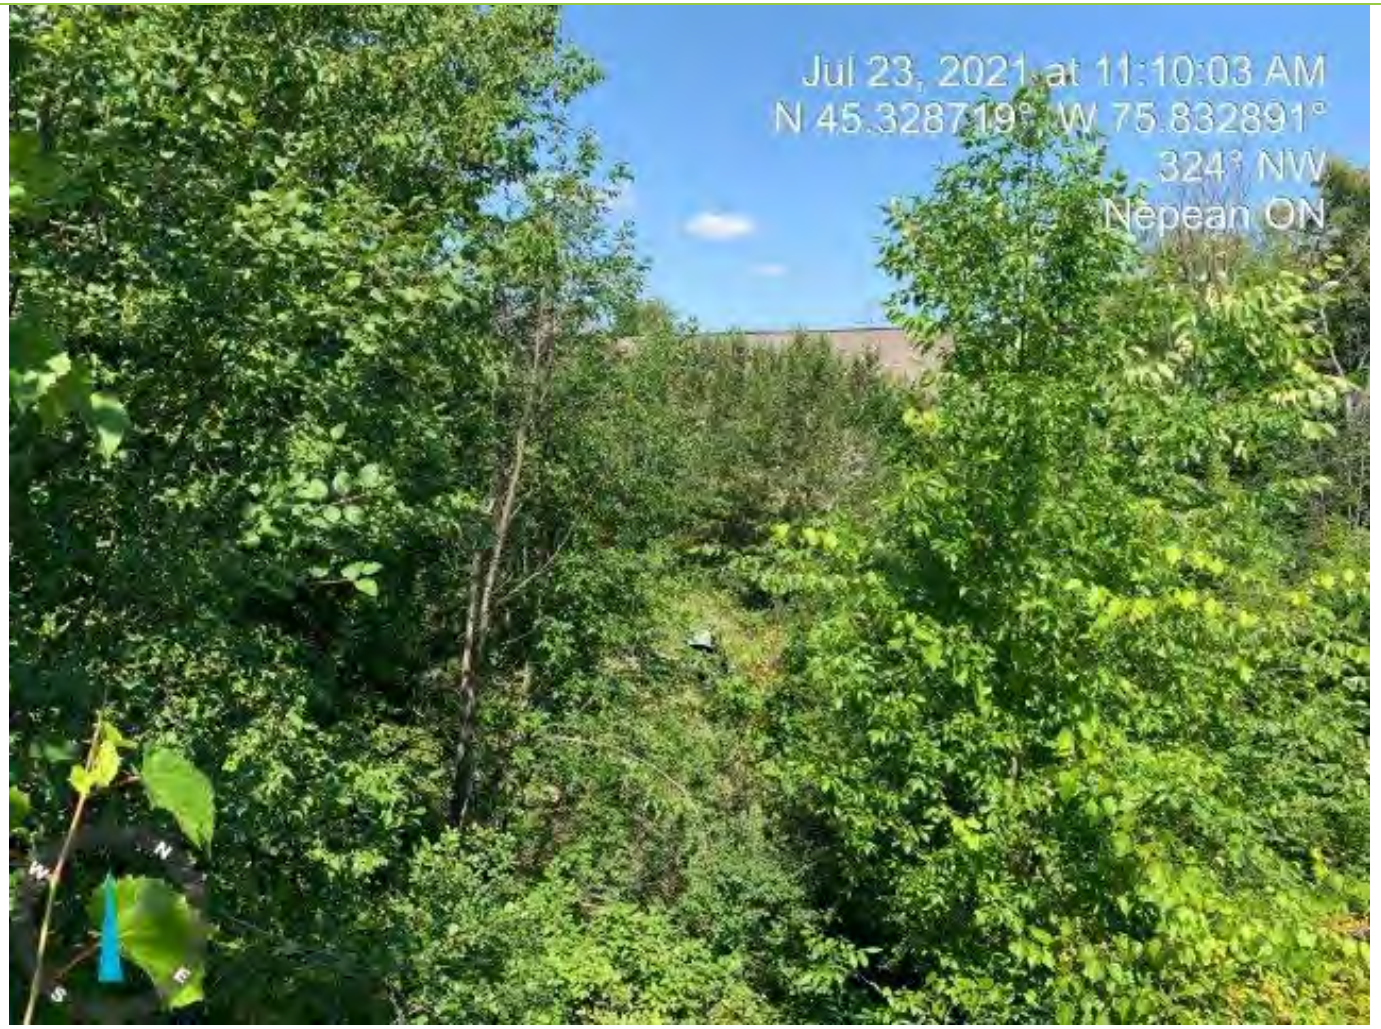
Site Location		
Stillwater Station Ltd – 1987 Robertson Road, Nepean, Ontario		
Photo #	Date	Cardinal Direction
20	2021/07/23	Southeast
Description		
View of the culvert outlet which conveys flow of Stillwater Creek northwards under the 1 <sup>st</sup> abandoned railway tracks.

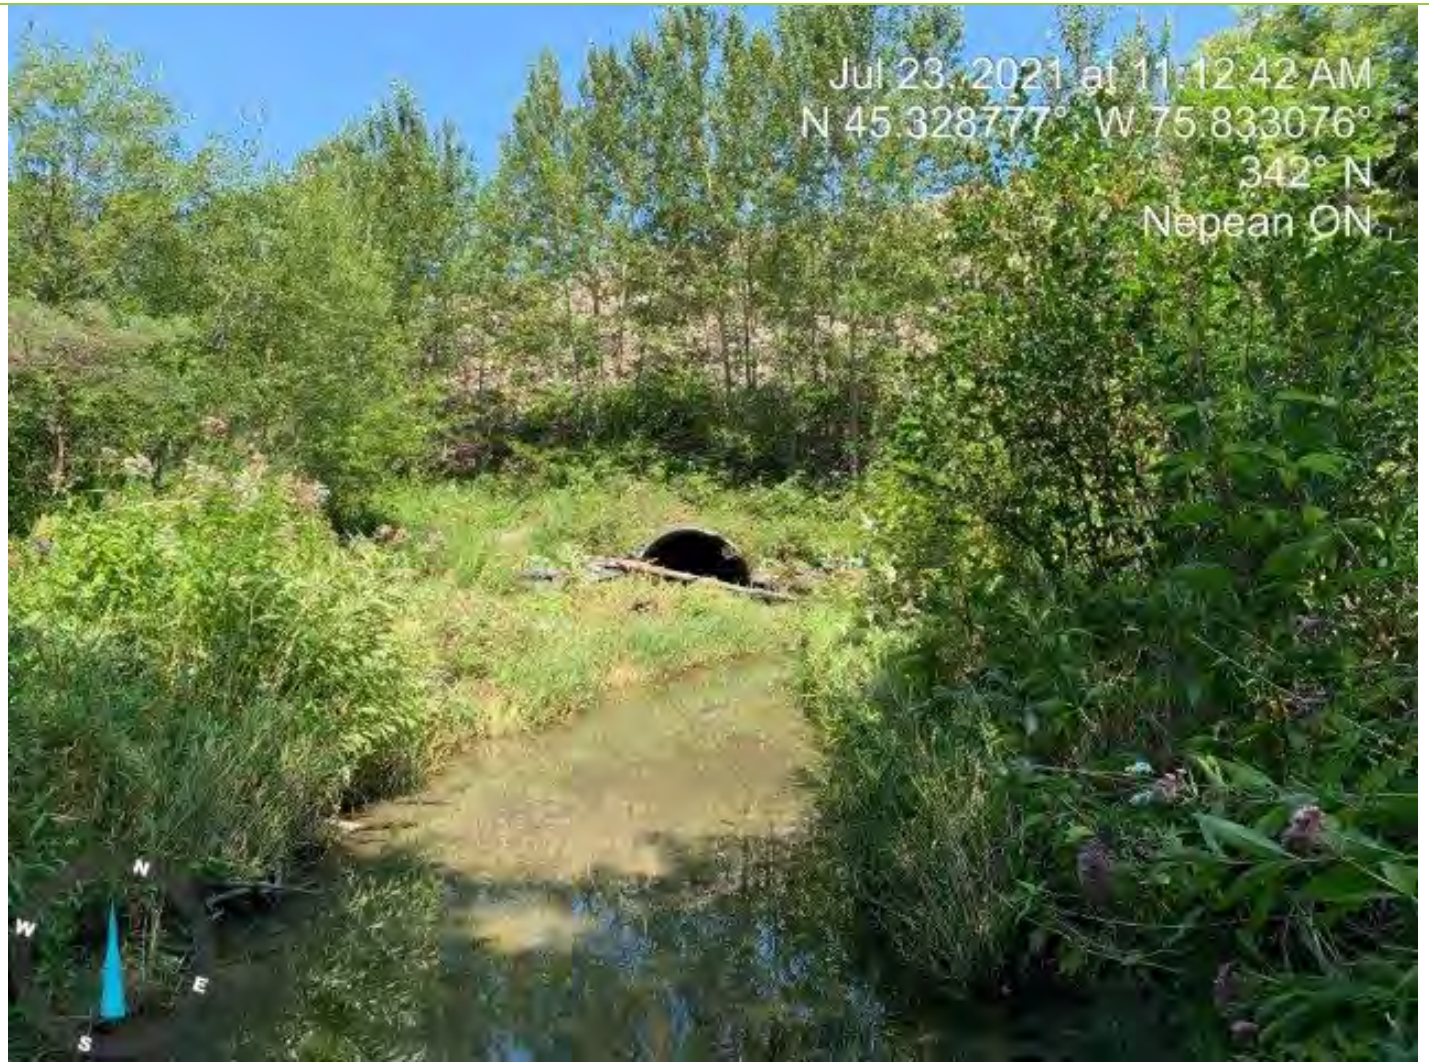
Site Location		
Stillwater Station Ltd – 1987 Robertson Road, Nepean, Ontario		
Photo #	Date	Cardinal Direction
22	2021/07/23	South
Description		
View of the culvert outlet conveying flow of Stillwater Creek northwards under the 1 <sup>st</sup> abandoned railway tracks, lined with a Mixed Meadow Marsh on either side.

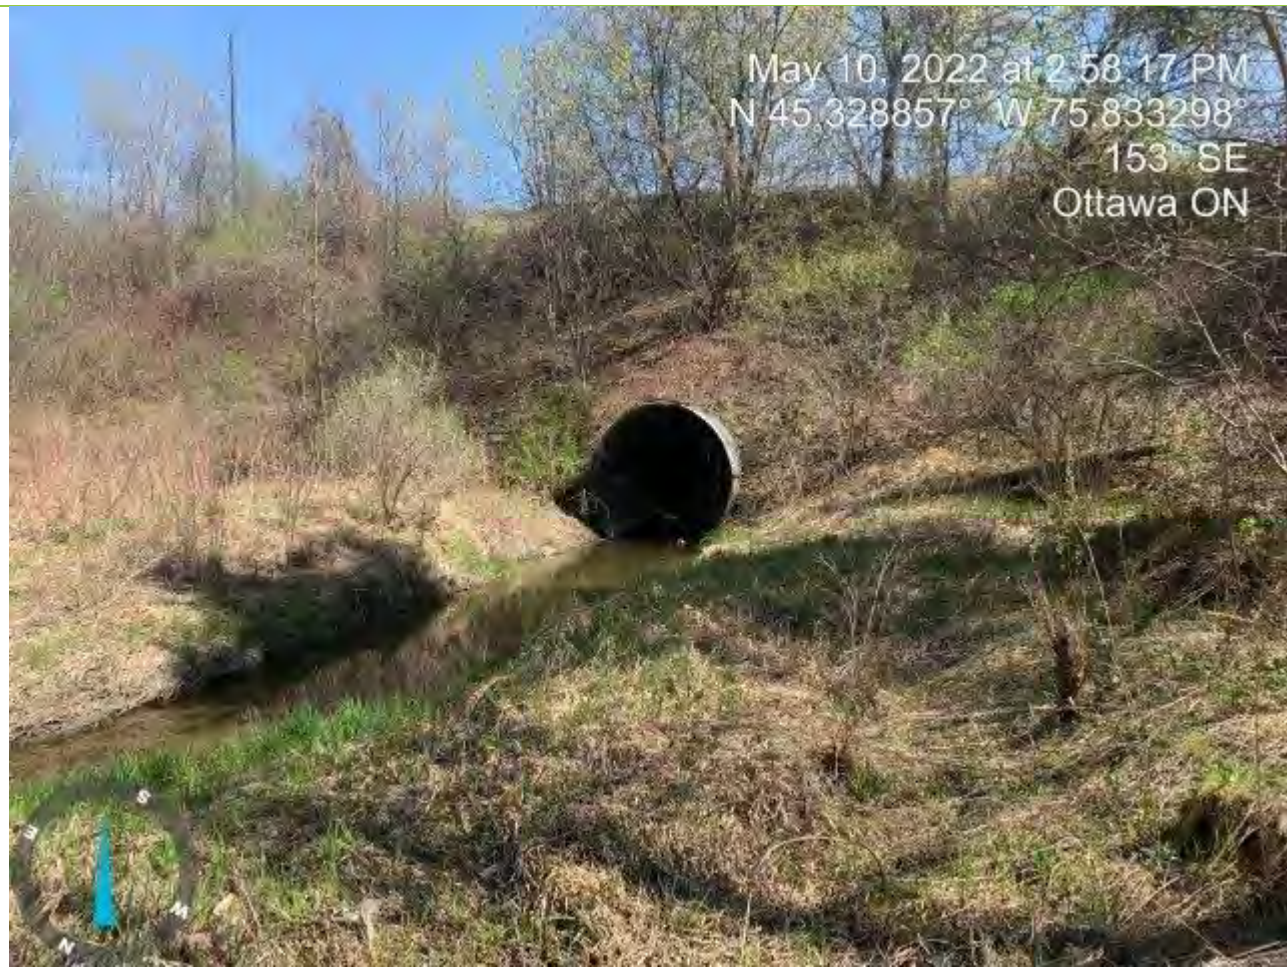
Site Location		
Stillwater Station Ltd – 1987 Robertson Road, Nepean, Ontario		
Photo #	Date	Cardinal Direction
54	2022/05/10	North
Description		
View of the culvert inlet along the eastern extent of the wetland boundary during the 2022 assessment.

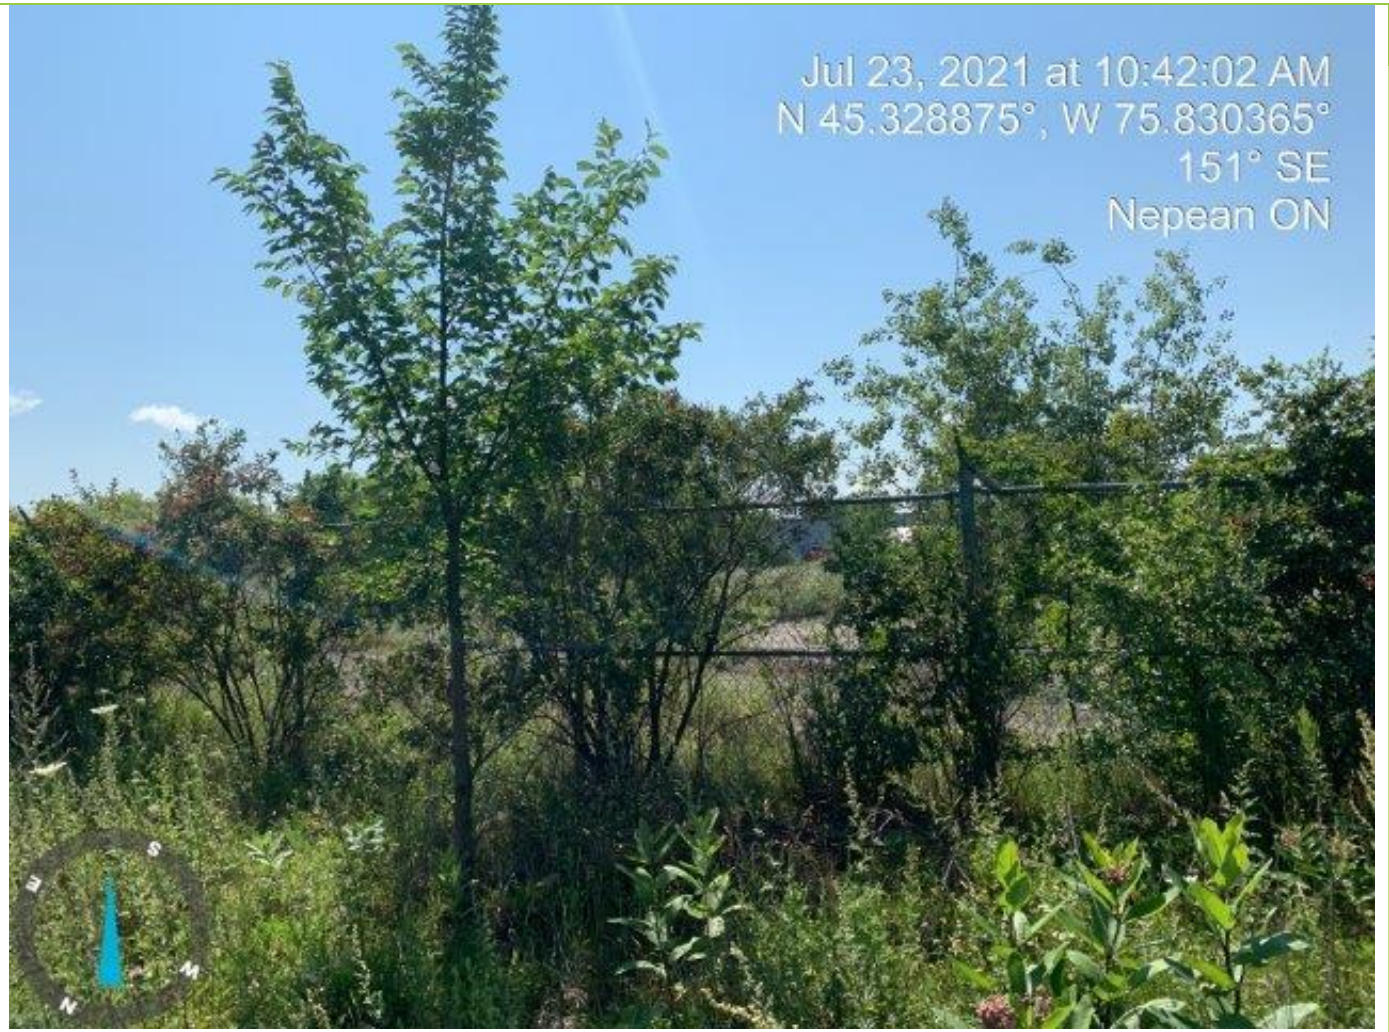
Site Location		
Stillwater Station Ltd – 1987 Robertson Road, Nepean, Ontario		
Photo #	Date	Cardinal Direction
19	2021/07/23	Northwest
Description		
View of the culvert inlet which conveys flow of Stillwater Creek under the 2 <sup>nd</sup> railway north of the Site, from the 1 <sup>st</sup> abandoned railway tracks.

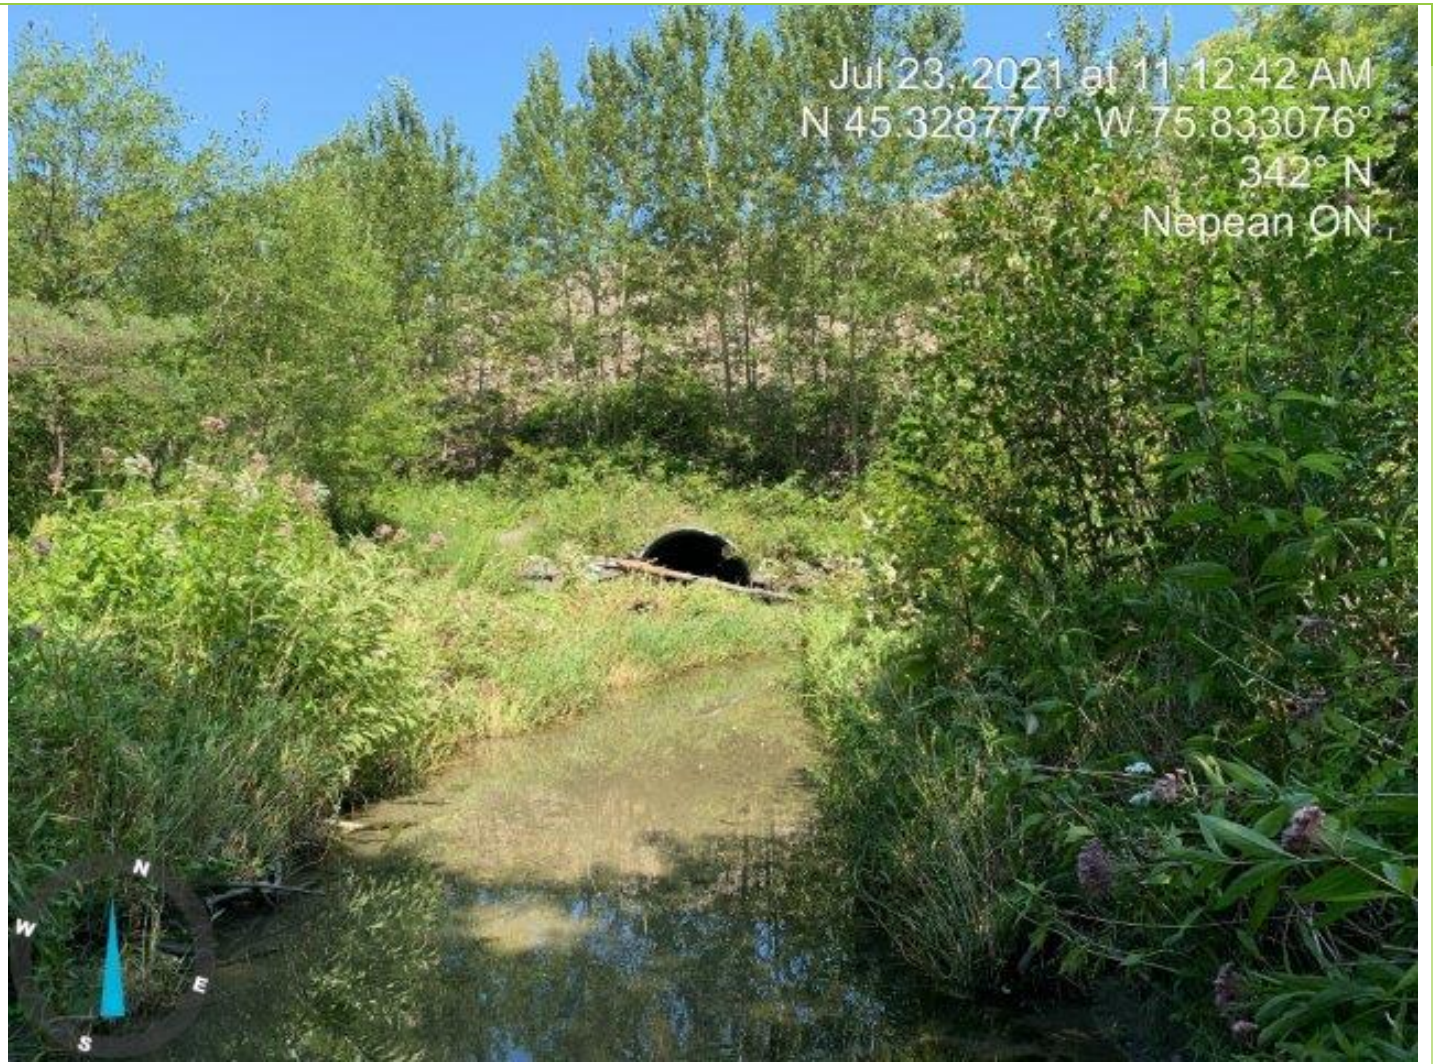
Site Location		
Stillwater Station Ltd – 1987 Robertson Road, Nepean, Ontario		
Photo #	Date	Cardinal Direction
22	2021/07/23	South
Description		
View of the culvert outlet conveying flow of Stillwater Creek northwards under the 1 <sup>st</sup> abandoned railway tracks, lined with a Mixed Meadow Marsh on either side.
