# Stillwater Station Ltd.

## Environmental Impact Statement

Proposed Site Redevelopment – Stillwater Station,  
1987 Robertson Road, Ottawa, Ontario

CIMA+ file number: A001177- 080  
February 28, 2024 – Revision 004

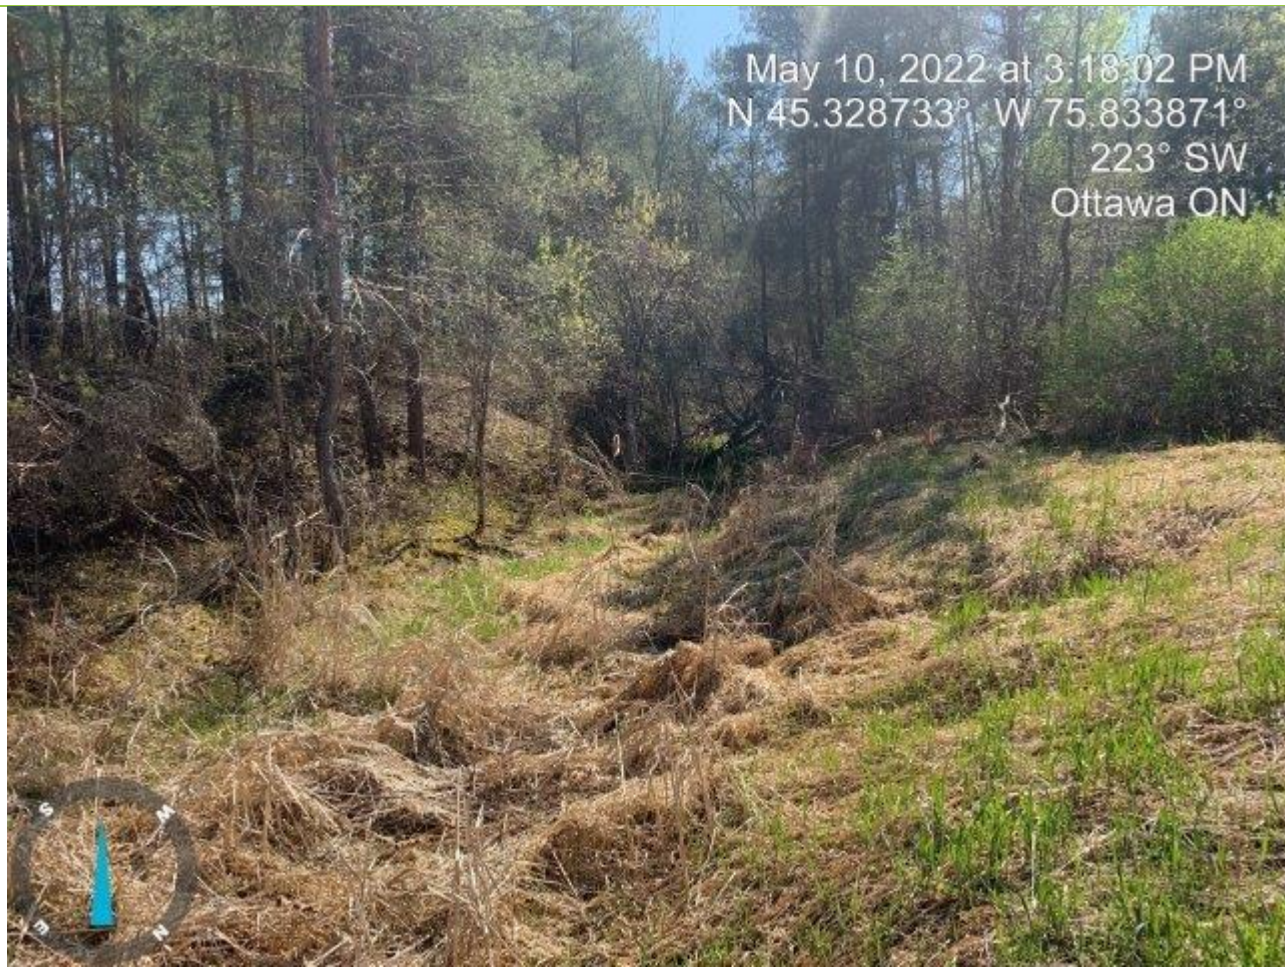
Site Location		
Stillwater Station Ltd – 1987 Robertson Road, Nepean, Ontario		
Photo #	Date	Cardinal Direction
50	2022/05/10	East
Description		
View from within the Mixed Meadow Marsh ecosite displaying the Red-osier Dogwood Thicket Swamp on the northern edge during the 2022 assessment.

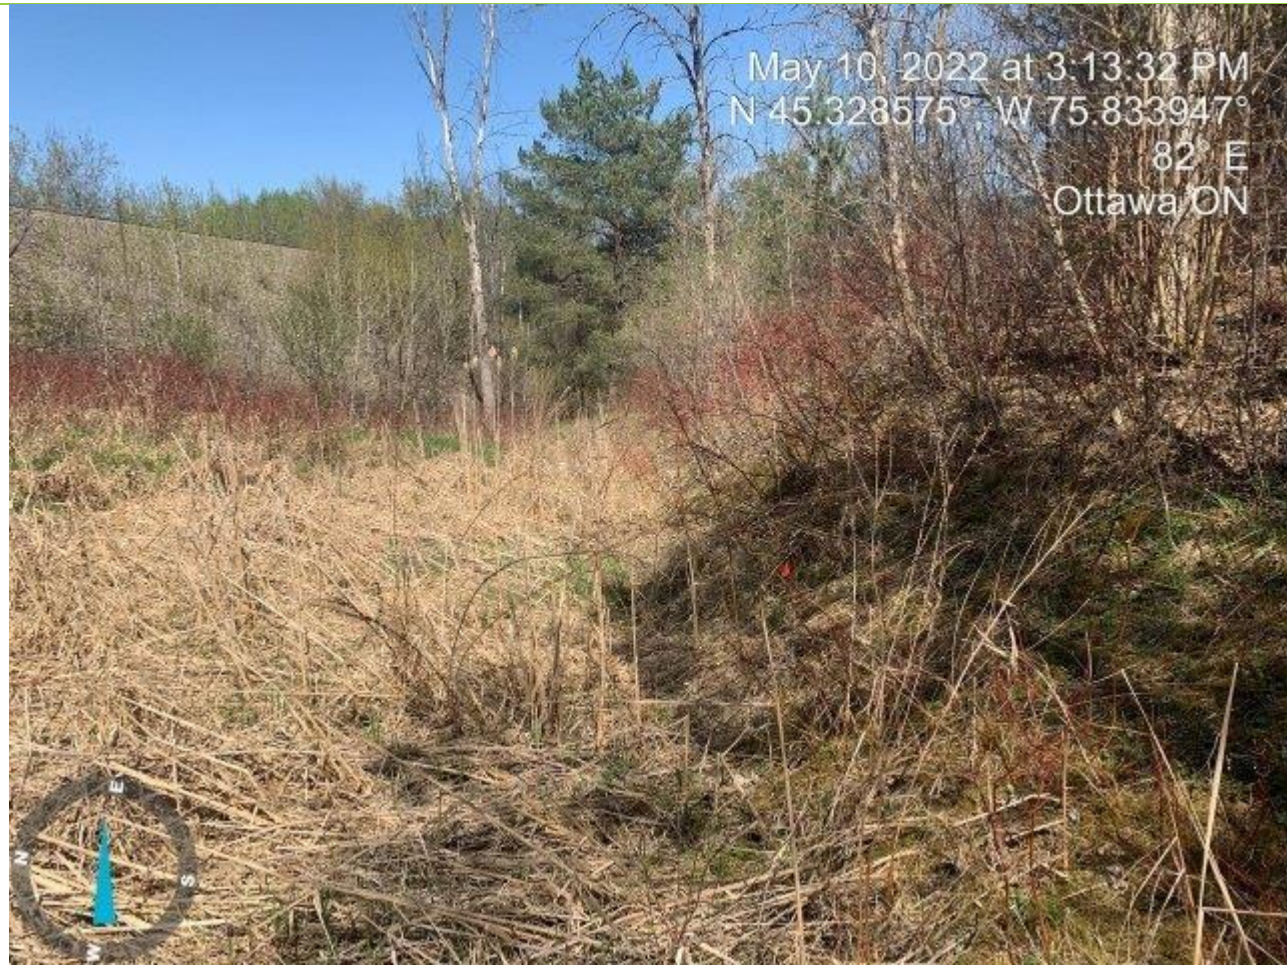
Site Location		
Stillwater Station Ltd – 1987 Robertson Road, Nepean, Ontario		
Photo #	Date	Cardinal Direction
51	2022/05/10	Northeast
Description		
View of the Mixed Meadow Marsh ecosite narrowing along the southern edge displaying the Red-osier Dogwood Thicket Swamp on the northern edge during the 2022 assessment.

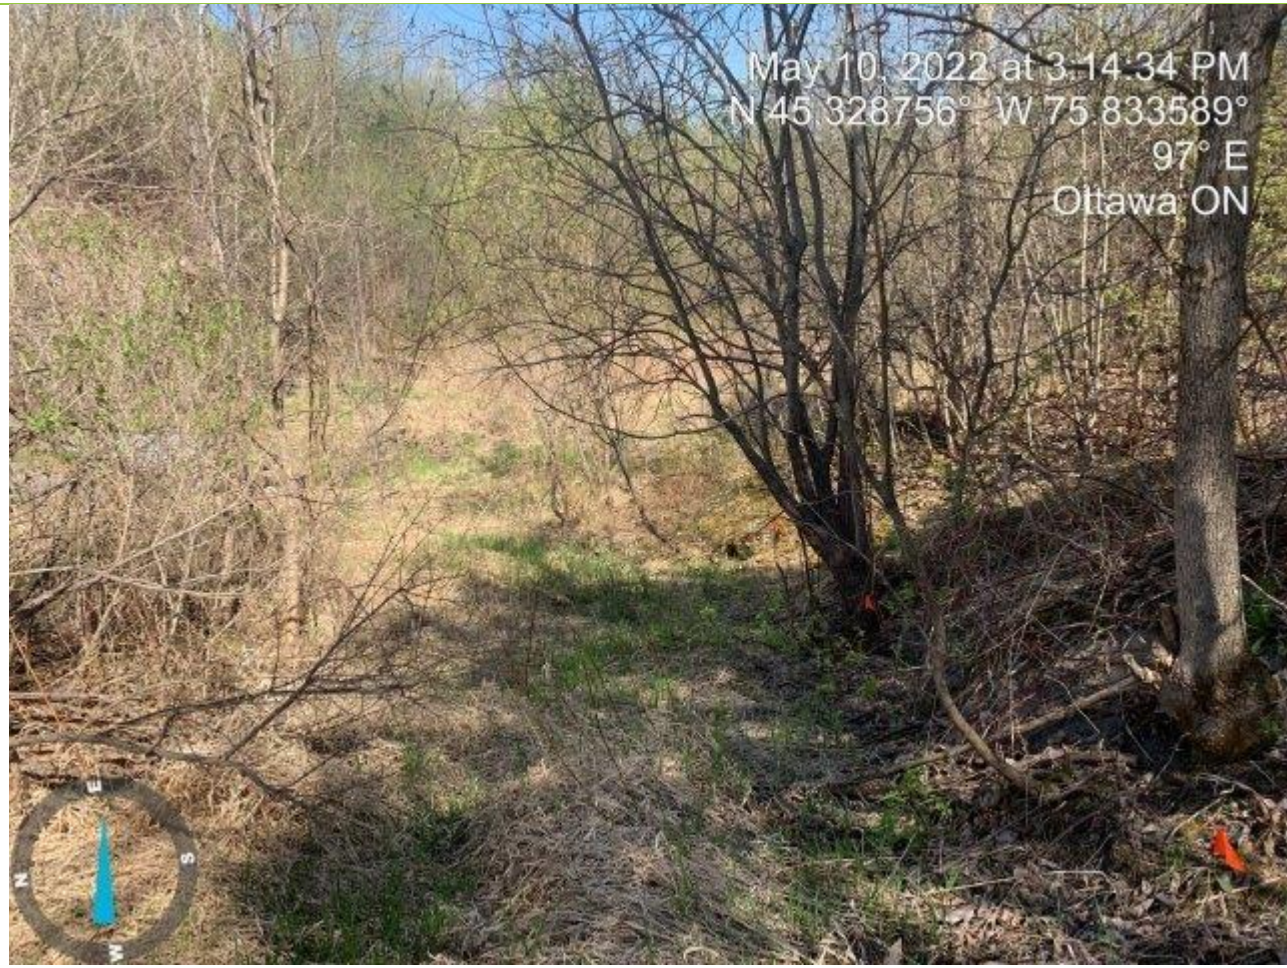
Site Location		
Stillwater Station Ltd – 1987 Robertson Road, Nepean, Ontario		
Photo #	Date	Cardinal Direction
53	2022/05/10	South
Description		
View of the culvert outlet along the eastern extent of the wetland boundary during the 2022 assessment.

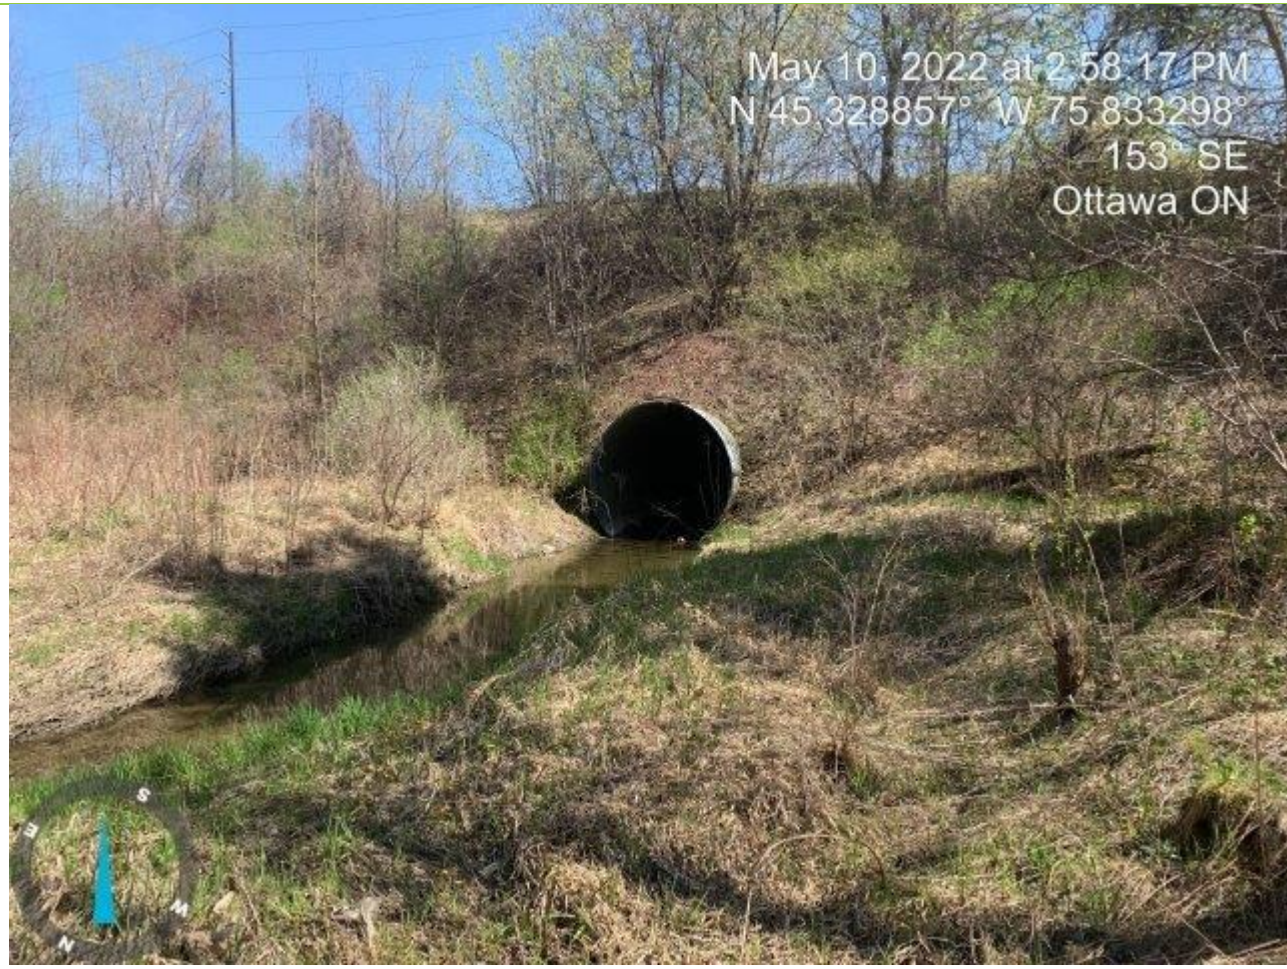
Site Location		
Stillwater Station Ltd – 1987 Robertson Road, Nepean, Ontario		
Photo #	Date	Cardinal Direction
54	2022/05/10	North
Description		
View of the culvert inlet along the eastern extent of the wetland boundary during the 2022 assessment.
