**Functional Site Servicing and
Stormwater Management
Report – 1987 Robertson Road
(Stillwater Station)**

Job #160401686

Prepared for:
The Properties Group
Management Ltd.

Prepared by:
Stantec Consulting Ltd.
1331 Clyde Avenue
Ottawa, Ontario
K2C 3G4

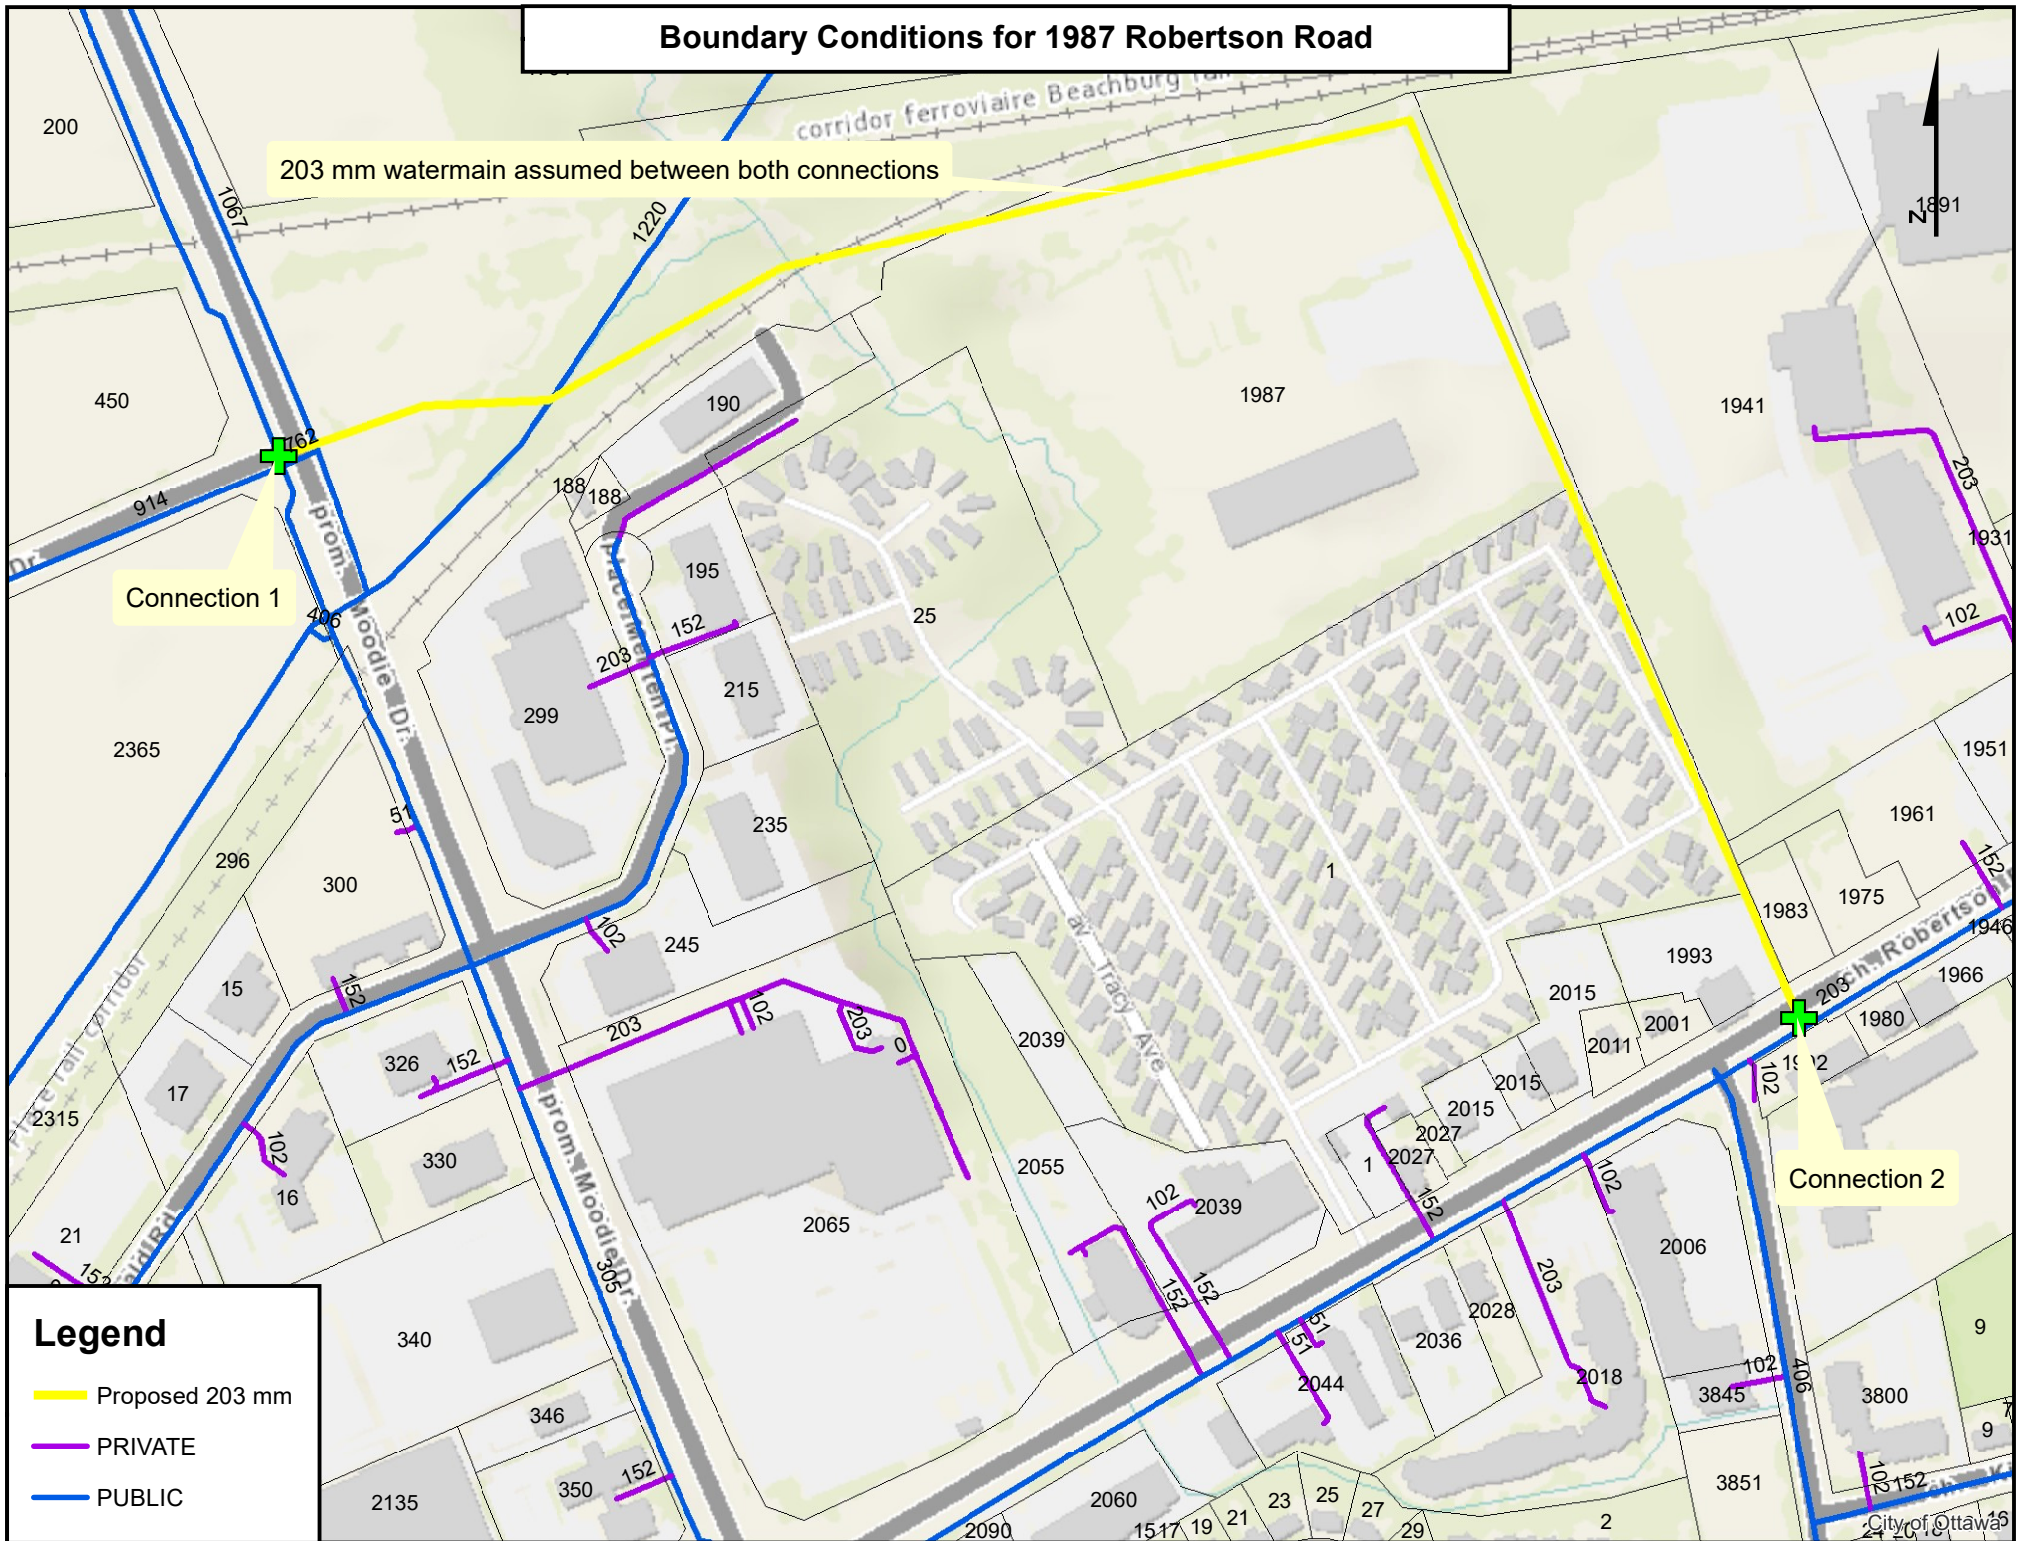
Boundary Conditions for 1987 Robertson Road

The following are boundary conditions, HGL, for hydraulic analysis at 1987 Robertson Road (zone 2W2C) assumed to be a looped private watermain, connecting to the 305 mm watermain on Moodie Drive and the 203 mm watermain on Robertson Road. (see attached PDF for location).

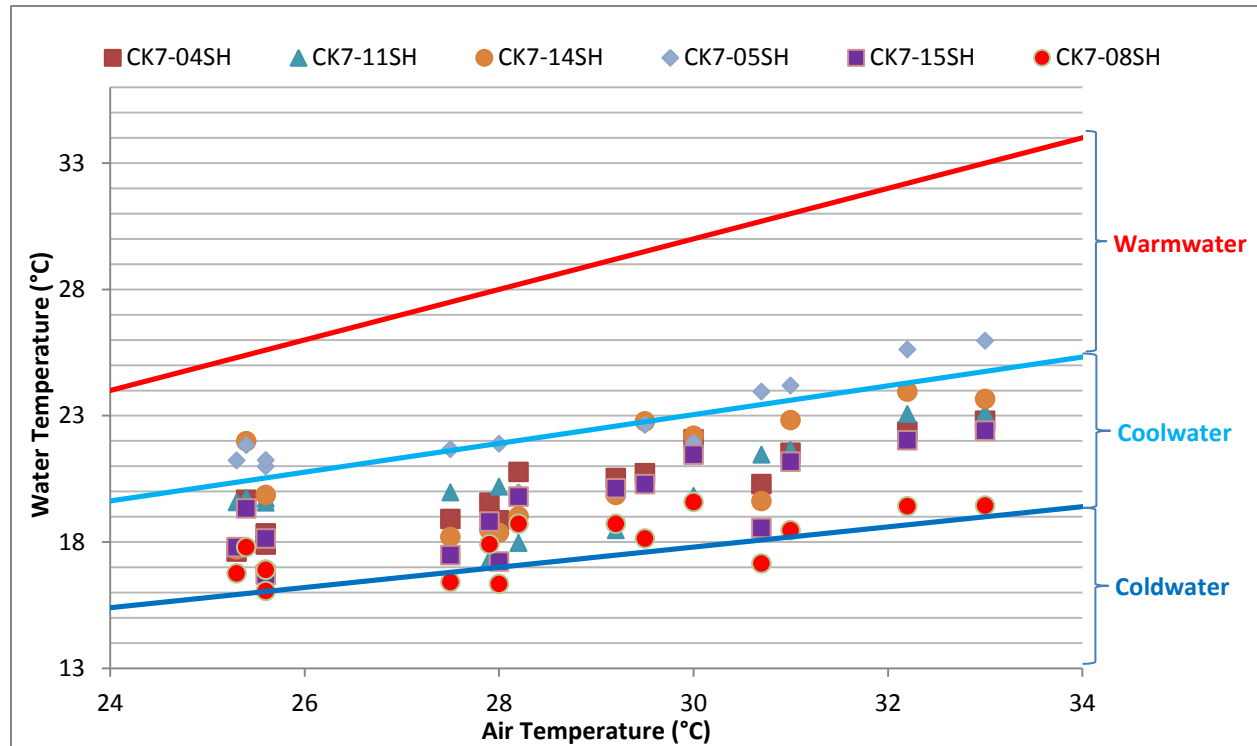
Figure 2. Thermal classification nomogram of Stillwater Creek

Based on the stream temperature methodology outlined by Stoneman & Jones, Stillwater Creek is classified as a coolwater system (Table 4). As represented in Figure 2, sampling reaches CK7-05SH and CK7-08SH lie along the boundaries of these classification limits and indicate a divergence from the coolwater class. Site CK7-05SH represents a transition towards warmer temperatures, although this trend is not common throughout the rest of the system. It is likely that this shift in temperatures is due to the lack of adequate buffer present in this sampling reach, as both solar input and potential runoff are uninhibited. Site CK7-08SH represents a transition towards colder temperatures and is likely due to groundwater/infrastructure influences.

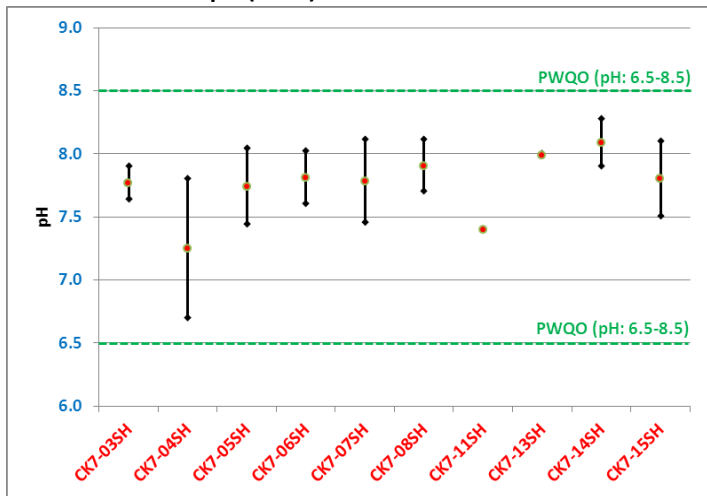
Figure 3. pH ranges recorded at each sampling site along Stillwater Creek. (PWQO outlined in green)

Based on the PWQO for pH, a range of 6.5 to 8.5 should be maintained in order to protect aquatic life. pH values for all sampled sites ranged between approximately 6.7 and 8.3, and thereby meet the provincial standard (Figure 3).

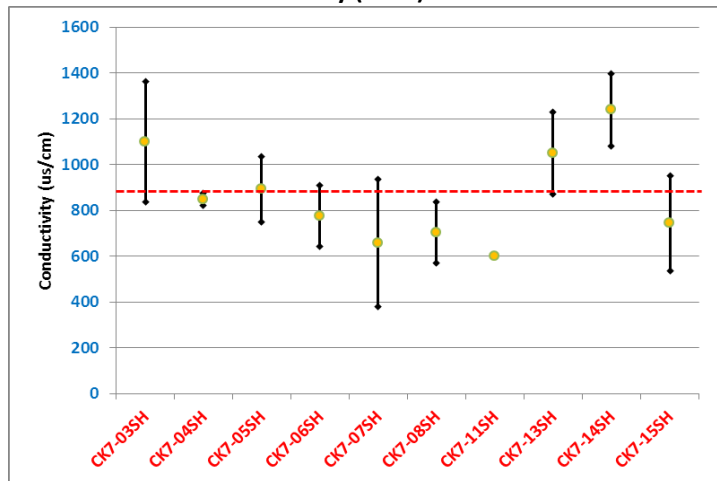
Figure 4. Conductivity ranges recorded at each sampling site along Stillwater Creek (Average conductance outlined in red)

Conductivity in streams/rivers is primarily influenced by the geology of the surrounding environment, but can vary drastically as a function of surface-water runoff. The average conductance observed across all sites was approximately 880 $\mu\text{s}/\text{cm}$ (Figure 4). Relative to this value, three sampling locations (CK7-03SH, CK7-13SH, CK7-14SH) revealed higher than average readings and may indicate a source of unmitigated discharge and/or stormwater input.

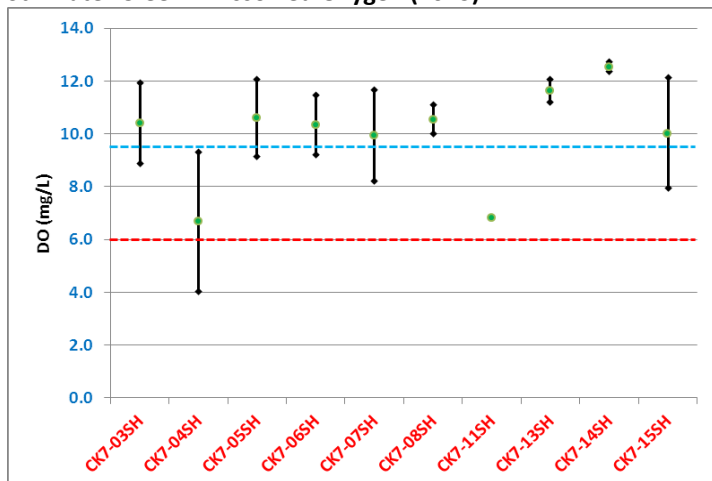
Figure 5. Dissolved oxygen ranges recorded at each sampling site along Stillwater Creek (CEQG: Red-Warmwater biota minimum tolerance – Blue: Coldwater biota minimum tolerance)

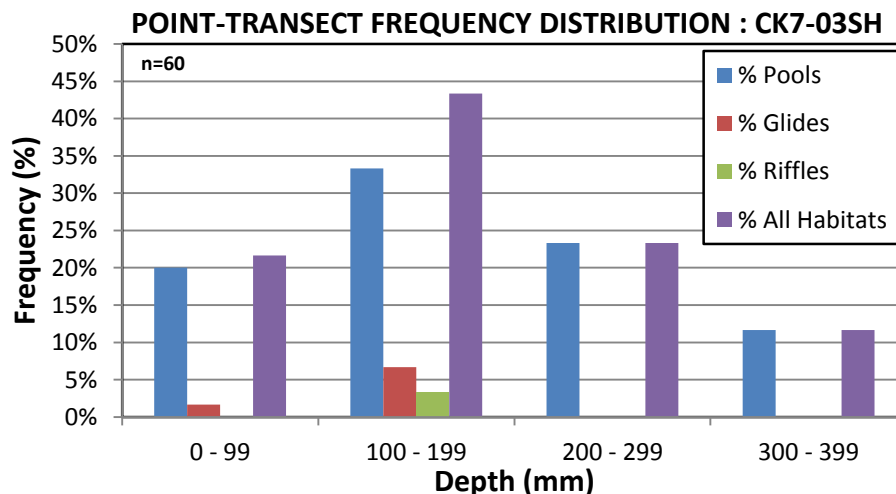
Figure 6. Frequency distribution of habitat types/stream velocities at 100mm intervals for site CK7-03SH

The results of the habitat assessment for site CK7-03SH are summarized in Figure 6. The analysis revealed a total habitat area of approximately 170.3m², consisting of 89% pool habitat, 8% glides and 3% riffles. Embedded cover was observed over approximately 30% of the site, and consisted primarily of rocks and macrophytes. Unembedded cover included rocks, macrophytes and wood, and was observed over approximately 70% of the site (Appendix IV).

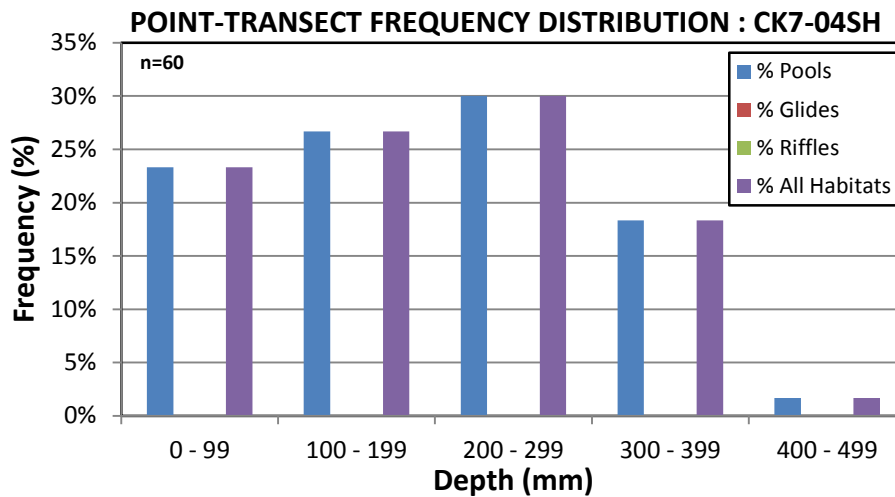
Figure 7. Frequency distribution of habitat types/stream velocities at 100mm intervals for site CK7-04SH

The results of the habitat assessment for site CK7-04SH are summarized in Figure 7. The analysis revealed a total habitat area of approximately 298.6m², consisting of 100% pool habitat. Embedded cover was observed over approximately 13% of the site, and consisted primarily of rocks, wood and macrophytes. Unembedded cover included rocks and wood, with the majority being macrophytes (66%); and was observed over approximately 86% of the site (Appendix IV).

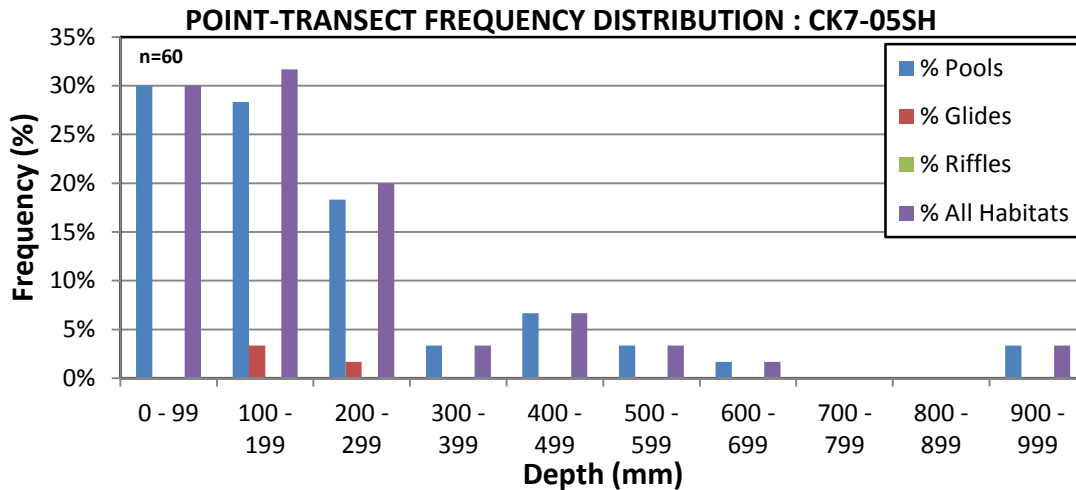
Figure 8. Frequency distribution of habitat types/stream velocities at 100mm intervals for site CK7-05SH

The results of the habitat assessment for site CK7-05SH are summarized in Figure 8. The analysis revealed a total habitat area of approximately 154.3m², consisting of 95% pool habitat, and 5% glides. Embedded cover was observed over approximately 17% of the site, and consisted primarily of wood, rocks and macrophytes. Unembedded cover included rocks, macrophytes and wood, and was observed over approximately 77% of the site (Appendix IV).

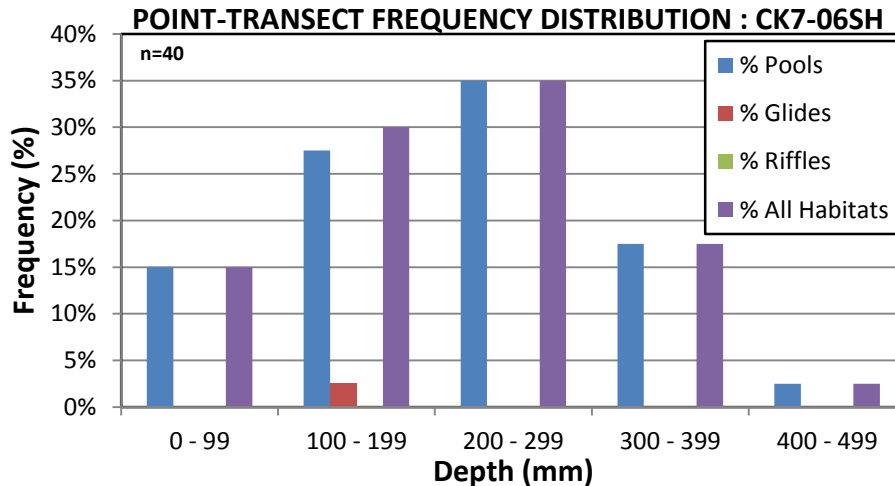
Figure 9. Frequency distribution of habitat types/stream velocities at 100mm intervals for site CK7-06SH

The results of the habitat assessment for site CK7-06SH are summarized in Figure 9. The analysis revealed a total habitat area of approximately 56.9m², consisting of 97% pool habitat, and 3% glides. Embedded cover was observed over approximately 5% of the site, and consisted solely of macrophytes. Unembedded cover included primarily macrophytes and wood, and was observed over approximately 68% of the site (Appendix IV).

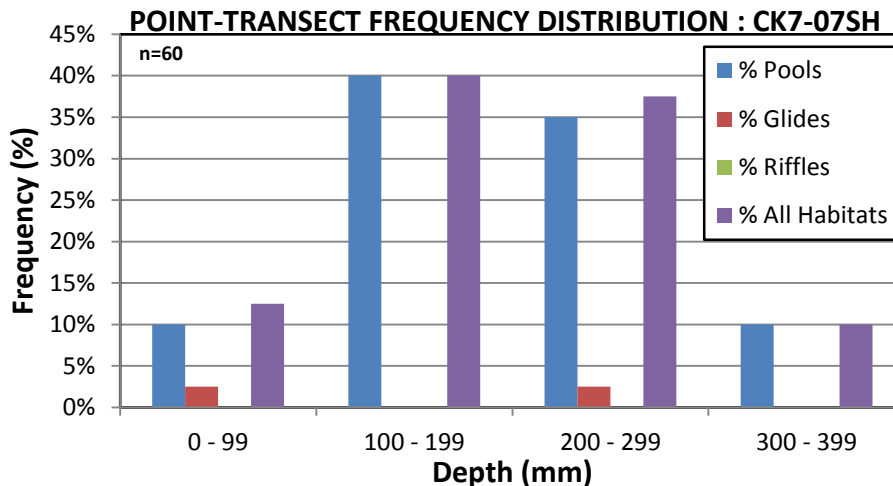
Figure 10. Frequency distribution of habitat types/stream velocities at 100mm intervals for site CK7-07SH

The results of the habitat assessment for site CK7-07SH are summarized in Figure 10.

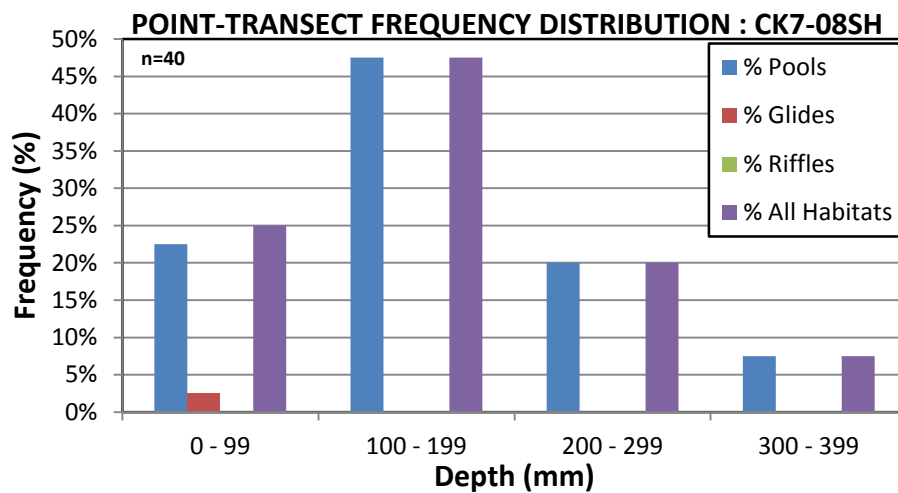
Figure 11. Frequency distribution of habitat types/stream velocities at 100mm intervals for site CK7-08SH

The results of the habitat assessment for site CK7-08SH are summarized in Figure 11. The analysis revealed a total habitat area of approximately 48.2m², consisting of 97% pool habitat, and 3% glides. Embedded cover was observed over approximately 15% of the site, and consisted primarily of rocks and macrophytes. Unembedded cover included rock, macrophytes and wood, and was observed over approximately 10% of the site (Appendix IV).

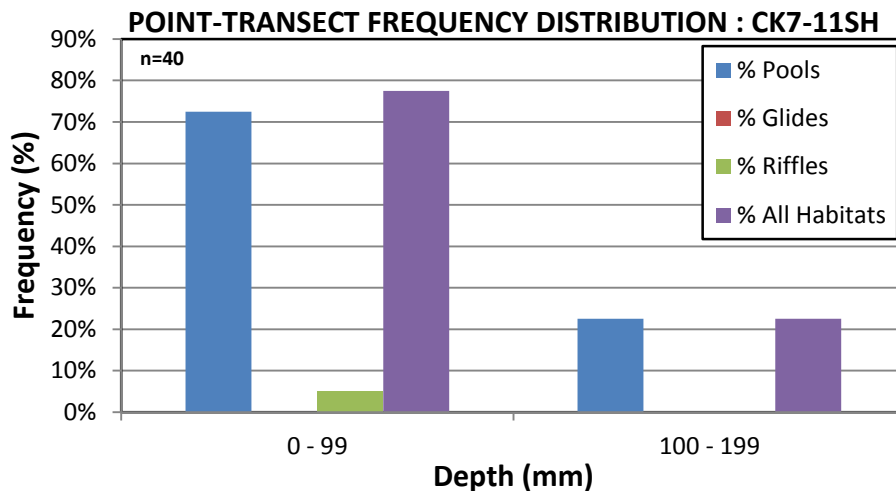
Figure 12. Frequency distribution of habitat types/stream velocities at 100mm intervals for site CK7-11SH

The results of the habitat assessment for site CK7-11SH are summarized in Figure 12. The analysis revealed a total habitat area of approximately 94.6m², consisting of 95% pool habitat, and 5% riffles. Embedded cover was observed over approximately 30% of the site, and consisted solely of wood materials. Unembedded cover included rock, macrophytes and wood, and was observed over approximately 10% of the site (Appendix IV).

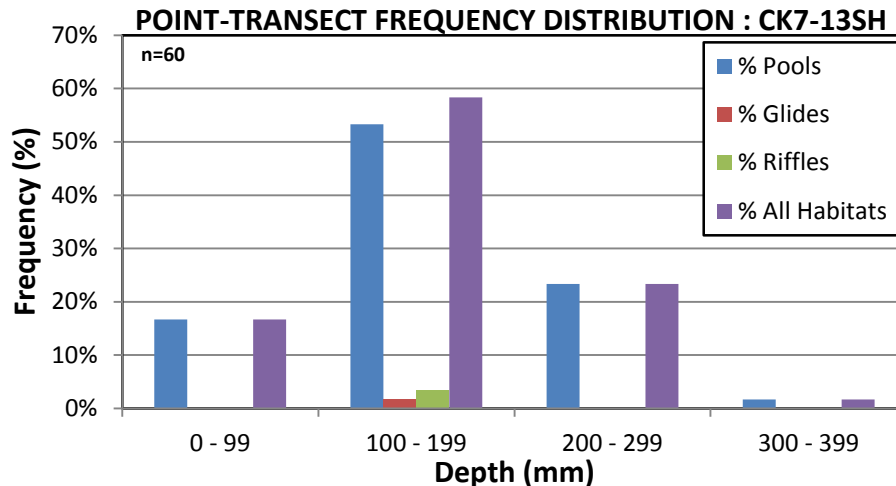
Figure 13. Frequency distribution of habitat types/stream velocities at 100mm intervals for site CK7-13SH

The results of the habitat assessment for site CK7-13SH are summarized in Figure 13. The analysis revealed a total habitat area of approximately 131.6m², consisting of 95% pool habitat, 2% glides and 3% riffles. Embedded cover was observed over approximately 12% of the site, and consisted solely of rock materials. Unembedded cover included flat and round rock, and was observed over approximately 57% of the site (Appendix IV).

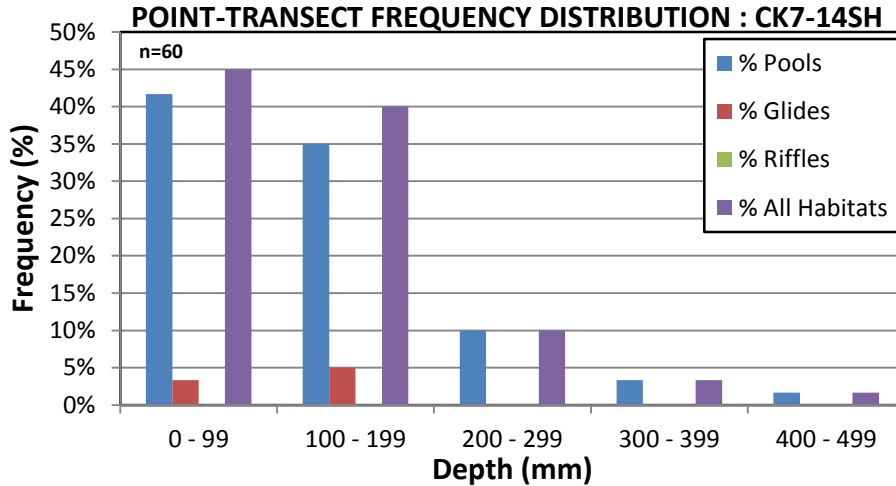
Figure 14. Frequency distribution of habitat types/stream velocities at 100mm intervals for site CK7-14SH

The results of the habitat assessment for site CK7-14SH are summarized in Figure 14. The analysis revealed a total habitat area of approximately 93.6m², consisting of 92% pool habitat, and 8% glides. Embedded cover was observed over approximately 23% of the site, and consisted of rock and woody materials. Unembedded cover included the same base materials, and was observed over approximately 30% of the site (Appendix IV).

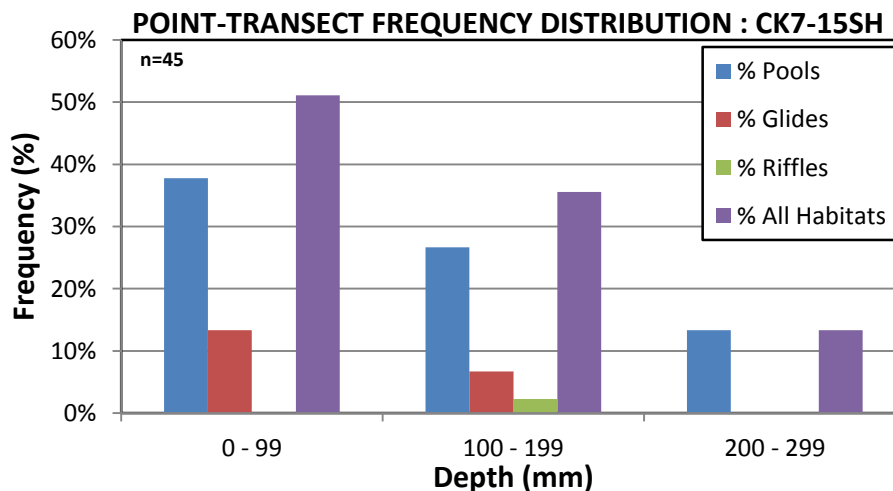
Figure 15. Frequency distribution of habitat types/stream velocities at 100mm intervals for site CK7-15SH

The results of the habitat assessment for site CK7-15SH are summarized in Figure 15. The analysis revealed a total habitat area of approximately 84.3m², consisting of 78% pool habitat, 20% glides and 2% riffles. Embedded cover was observed over approximately 9% of the site, and consisted solely of rock materials.

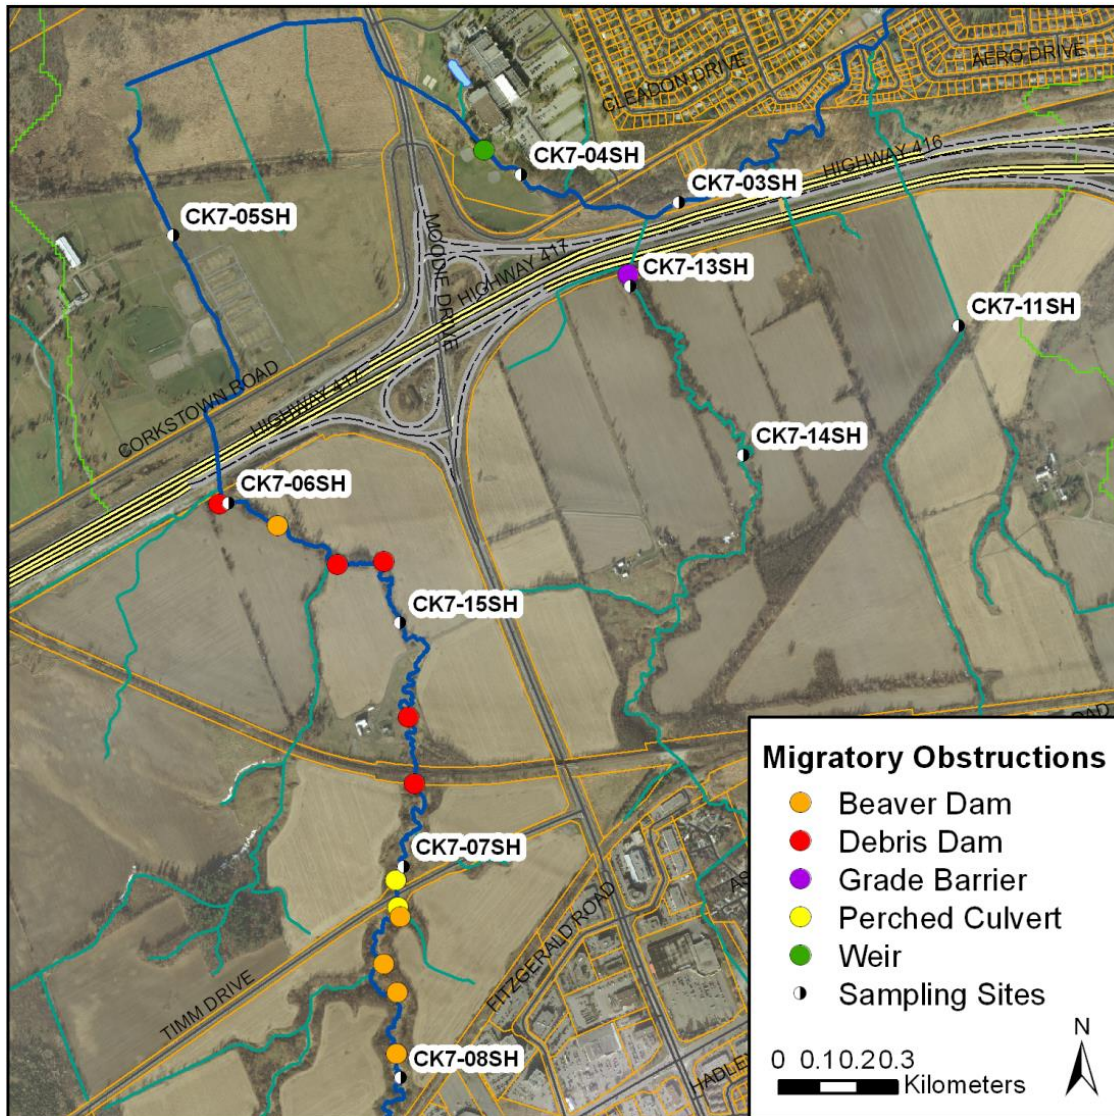
Figure 16. Migration barriers identified on Stillwater Creek

Migratory barrier information was compiled from the RVCA’s 2009 *City Stream Watch* study as well as current study observations. These barriers represent limitations to fish dispersal within the system and may restrict movement to alternate habitat. These features were categorized into 5 classes:

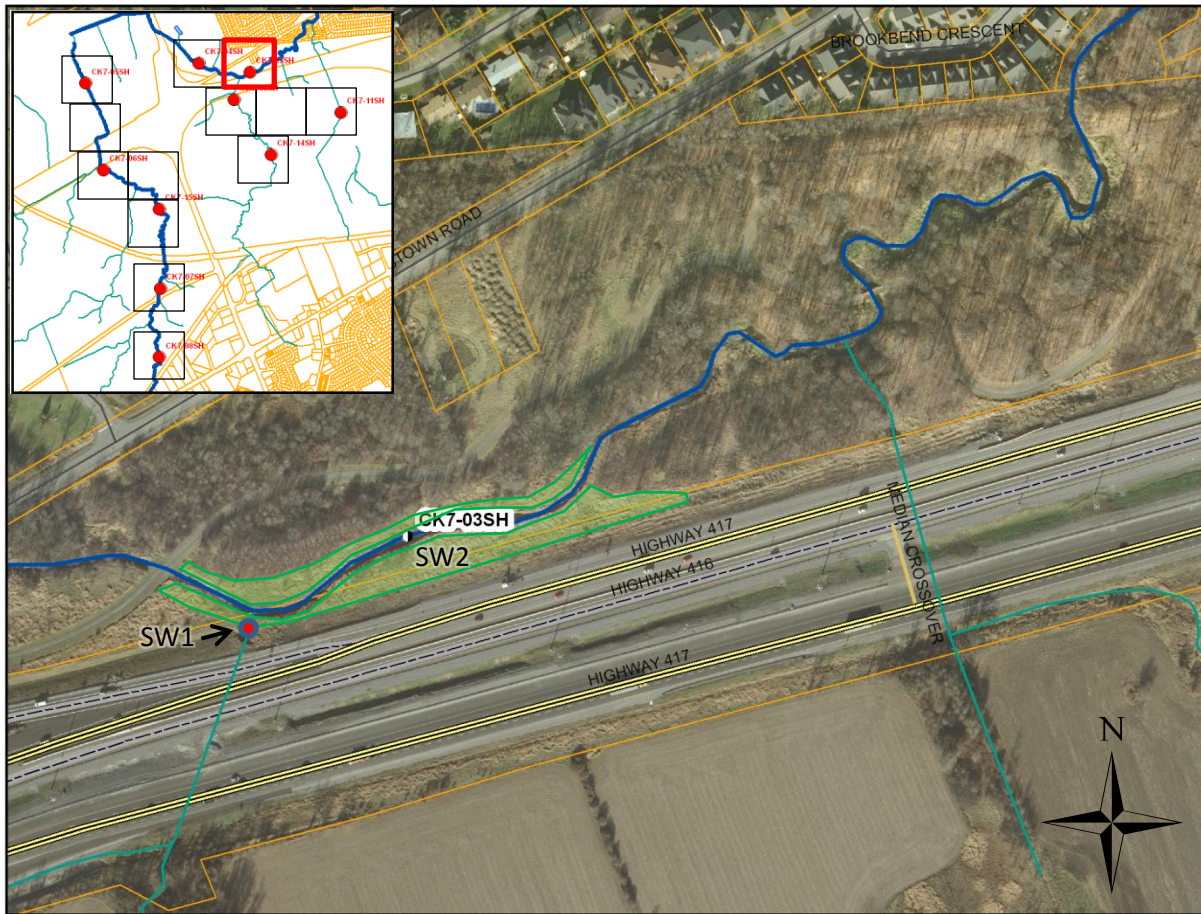
STILLWATER CREEK: RESTORATION PLAN – CK703SH

STILLWATER CREEK			
	STREAM REACH	EASTING	NORTHING	COST
	SW1	434616	5021201	HIGH
EXISTING PROBLEM	Potential source of storm-water input from adjacent tributary. This site is particularly susceptible due to its “High sensitivity” classification.			
CONSTRAINTS	Requires further study to determine impacts/potential management options			
SOLUTION	Consult with the City of Ottawa/Ministry of Transportation to examine opportunities to improve storm water management within the watershed			
WATERSHED OBJECTIVE	Protection/enhancement of Aquatic Habitat

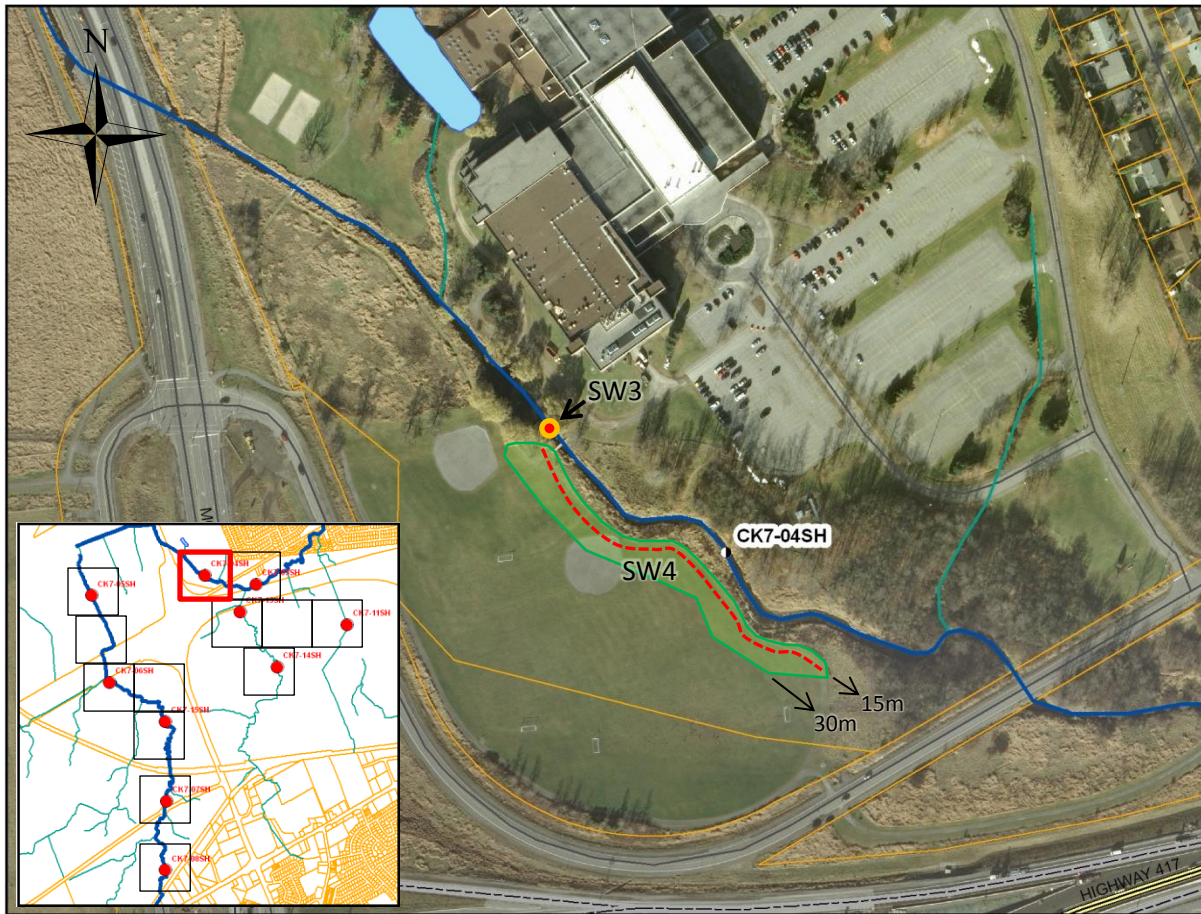
STILLWATER CREEK: RESTORATION PLAN – CK704SH

STILLWATER CREEK			
	STREAM REACH	EASTING	NORTHING	COST
	SW3	434202	5021374	MODERATE
EXISTING PROBLEM	Migratory obstruction upstream of study site. Altered flows have resulted in depleted oxygen concentrations (Section 3.3), reduced water levels, and extensive levels of algae/aquatic vegetation.			
CONSTRAINTS	Long-standing structure, with those who may have become accustomed to it			
SOLUTION	Removal of weir and implement natural channel design to improve oxygen/habitat conditions and fish dispersal. Improve plant community structure by introducing favorable species/varieties.			
WATERSHED OBJECTIVE	Protection/enhancement of Aquatic Habitat Promotion of Linkages and Natural Corridors

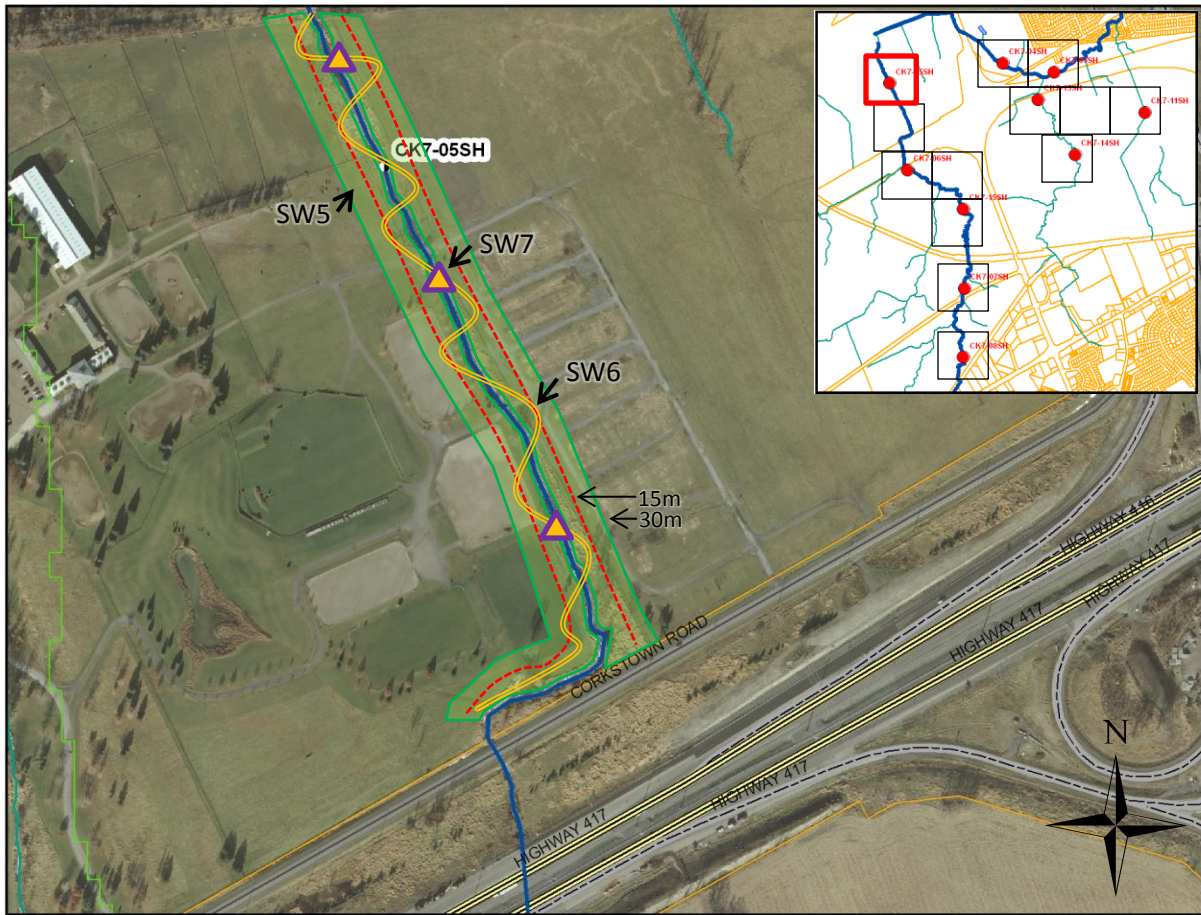
STILLWATER CREEK: RESTORATION PLAN – CK705SH

STILLWATER CREEK			
	STREAM REACH	EASTING	NORTHING	COST
	SW6, SW7	-	-	HIGH
EXISTING PROBLEM	Site is highly channelized with little or no structure available for aquatic biota. Sedimentation is prevalent throughout the reach.			
CONSTRAINTS	Future use of land is under review			
SOLUTION	Reconstruct channel and recreate floodplain connection by reintroducing natural stream meander sequences and restoring form/function. Install woody structure as habitat features for aquatic biota.			
WATERSHED OBJECTIVE	Protection/enhancement of Natural Processes Protection/enhancement of Aquatic Habitat

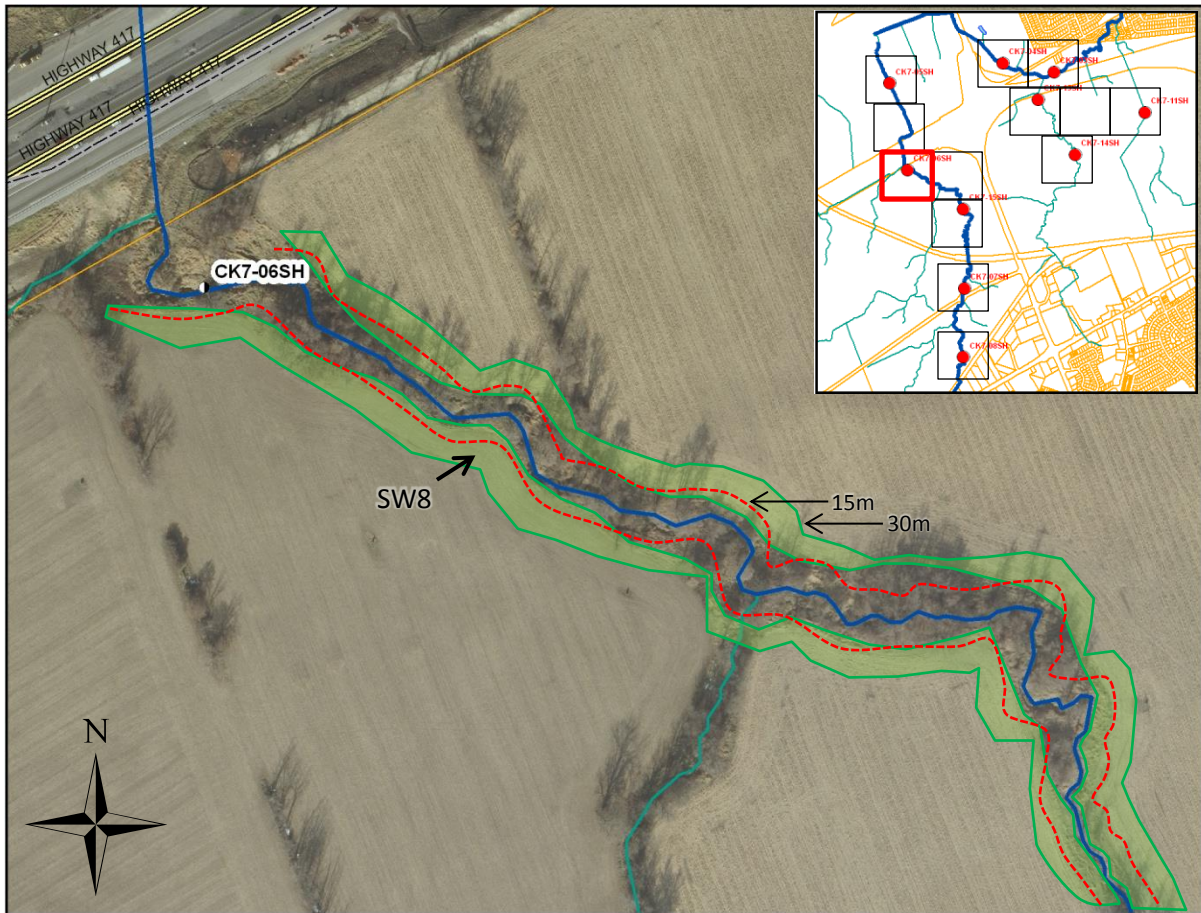
STILLWATER CREEK: RESTORATION PLAN – CK706SH

STILLWATER CREEK			
	STREAM REACH	EASTING	NORTHING	COST
	SW8	-	-	LOW
EXISTING PROBLEM	The buffer setback is not adequate for the complete protection of the stream. Recommended buffer guidelines are as follows: <ul style="list-style-type: none"> - 10 meters for the stabilization of bank materials - 15 meters for the protection of water quality through interception of surface runoff/contaminants - 30 meters for the maintenance of thermal/environmental stability (SW8) 			
CONSTRAINTS	Proposed buffer enhancement zone encroaches into agricultural field			
SOLUTION	Re-vegetation with native trees/shrubs to create riparian habitat. Plants considered for buffer enhancement should meet the following criteria: <ul style="list-style-type: none"> - Native - Adapted to site soil/moisture/light conditions - Provide for specific habitat objectives (e.g Stabilization, habitat enhancement, ect) - Support for the development of natural vegetation communities

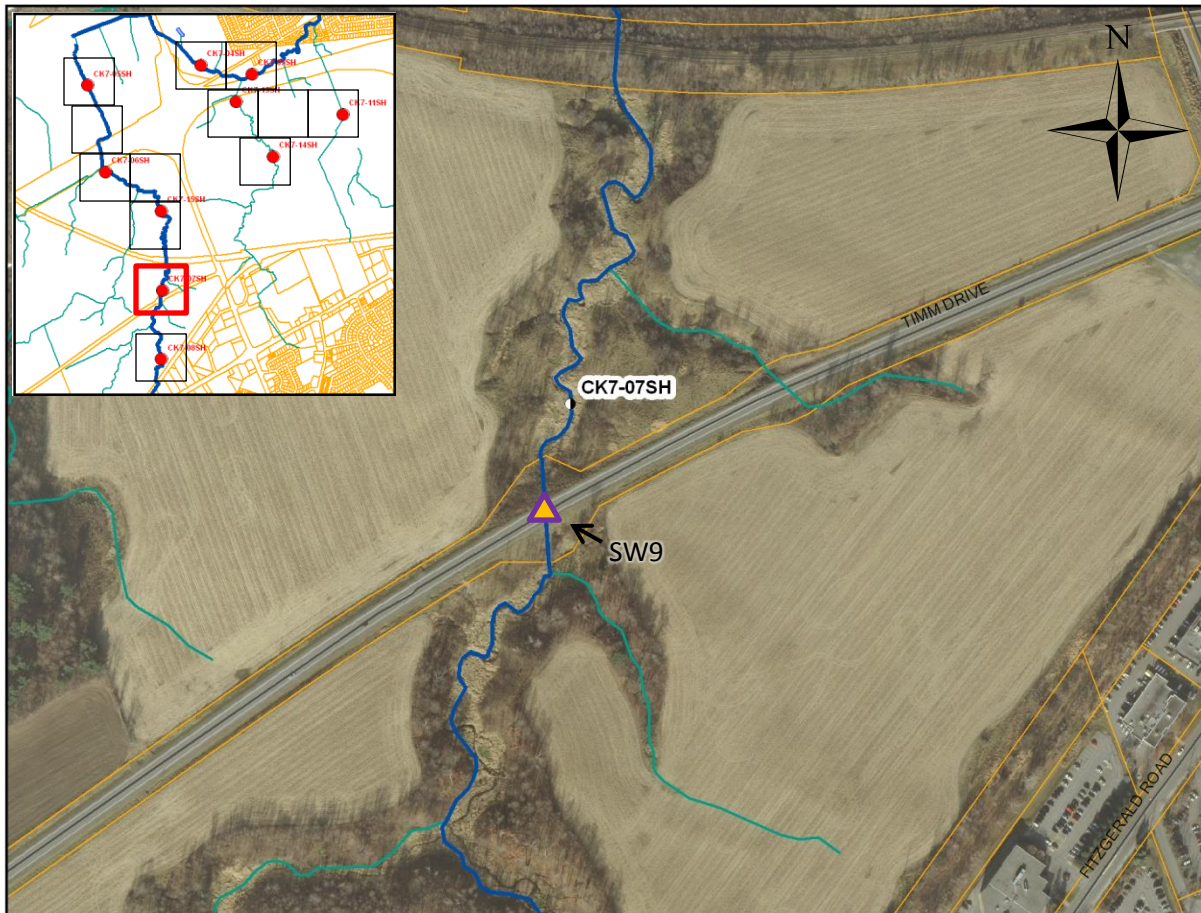
STILLWATER CREEK: RESTORATION PLAN – CK707SH

STILLWATER CREEK			
	STREAM REACH	EASTING	NORTHING	COST
	SW9	433978	5019525	HIGH
EXISTING PROBLEM	Culvert at Timm Dr. has been identified as a migration barrier (perched culvert)			
CONSTRAINTS	City of Ottawa culvert replacement maintenance program determines timing of replacement			
SOLUTION	Culvert would require replacement to mitigate migratory obstruction			
WATERSHED OBJECTIVE	Promotion of Linkages and Natural Corridors

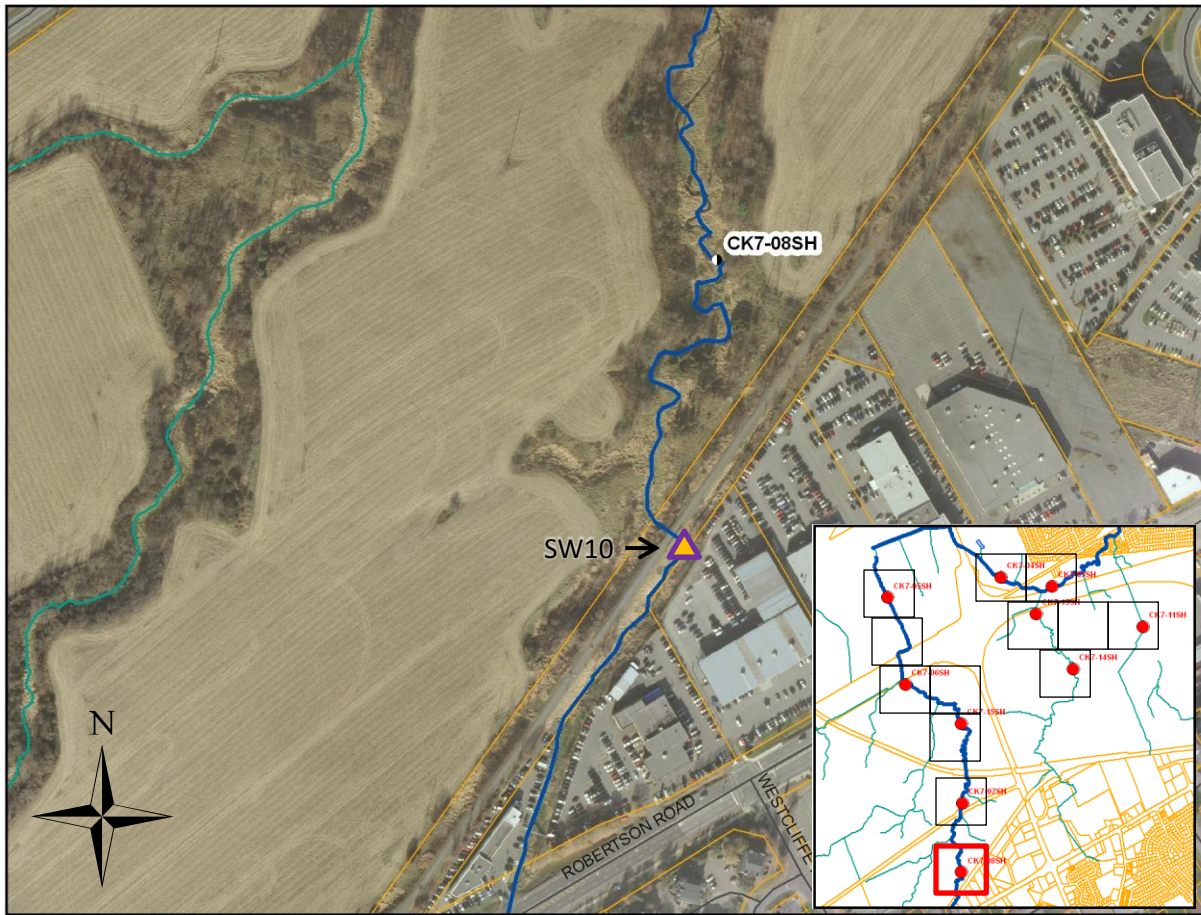
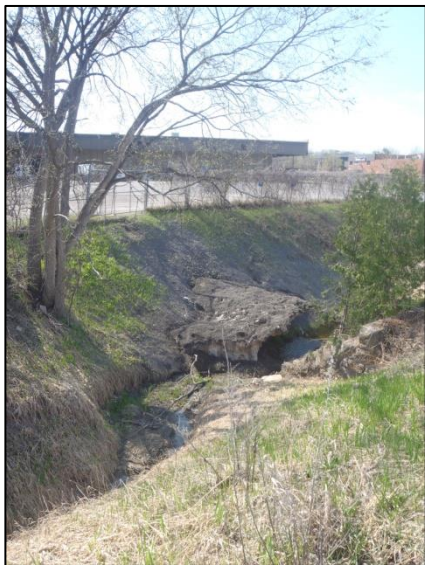
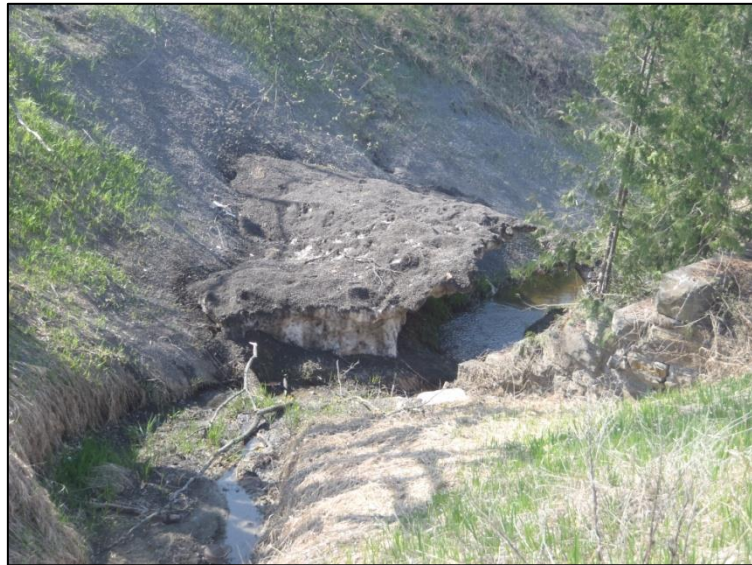
STILLWATER CREEK: RESTORATION PLAN – CK708SH

Snow dumping observed adjacent to study reach CK7-08SH

STILLWATER CREEK			
	STREAM REACH	EASTING	NORTHING	COST
	SW10	433969	5018839	LOW
EXISTING PROBLEM	Snow dumping/debris accumulation from adjacent commercial property			
CONSTRAINTS	Awareness of potential impacts to stream health from improper snow disposal practices			
SOLUTION	Sign installation along the fence line will inform contractors/property owners that snow dumping is not permitted into the watercourse. If this activity continues, potential enforcement measures may be utilized.			
WATERSHED OBJECTIVE	Protection of Water Quality/Aquatic Habitat

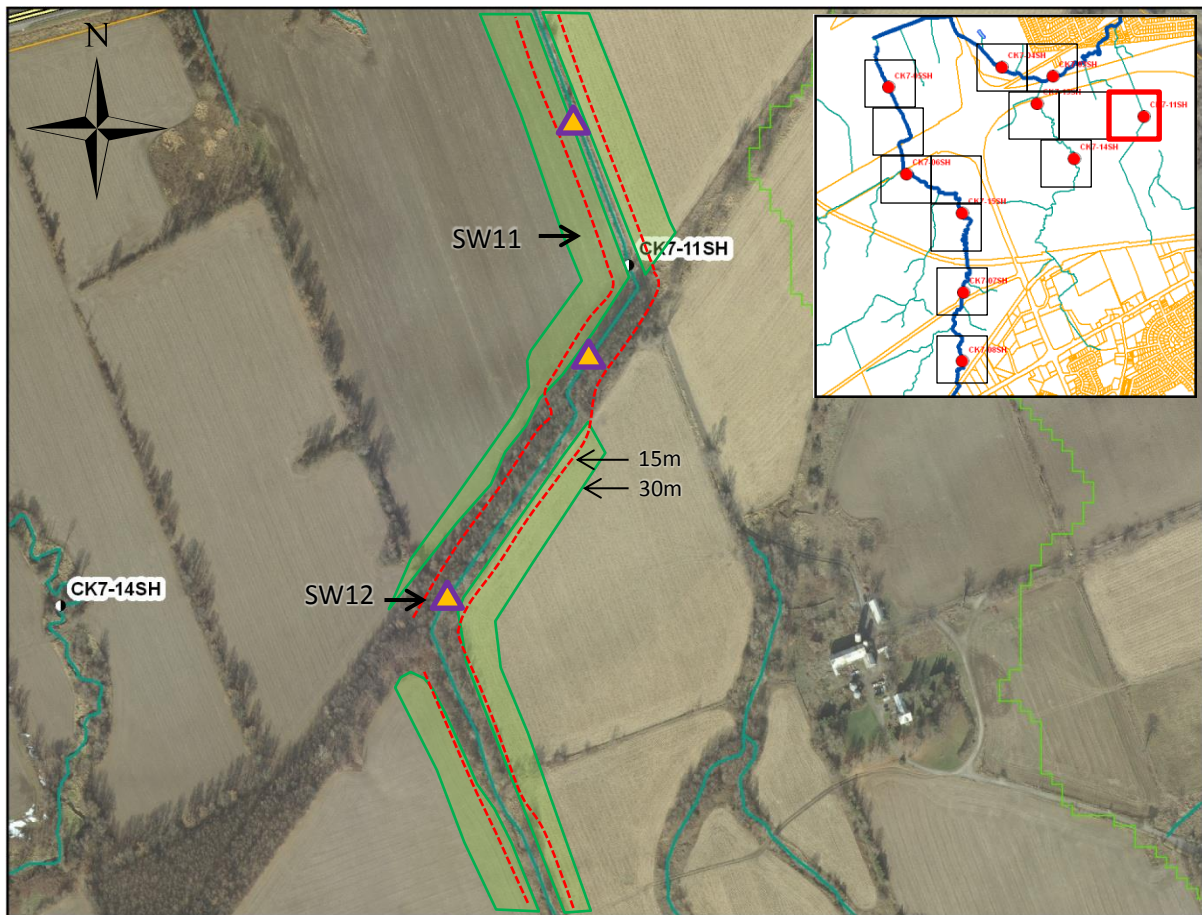
STILLWATER CREEK: RESTORATION PLAN – CK711SH

STILLWATER CREEK			
	STREAM REACH	EASTING	NORTHING	COST
	SW12			LOW
EXISTING PROBLEM	Site is highly channelized with little or no structure available for aquatic biota. Sedimentation is prevalent throughout the reach.			
CONSTRAINTS	Current landuse may restrict proposed restoration			
SOLUTION	Install woody structures as habitat features for aquatic biota.			
WATERSHED OBJECTIVE	Protection/enhancement of Aquatic Habitat
