**Functional Site Servicing and
Stormwater Management
Report – 1987 Robertson Road
(Stillwater Station)**

Job #160401686

Prepared for:
The Properties Group
Management Ltd.

Prepared by:
Stantec Consulting Ltd.
1331 Clyde Avenue
Ottawa, Ontario
K2C 3G4

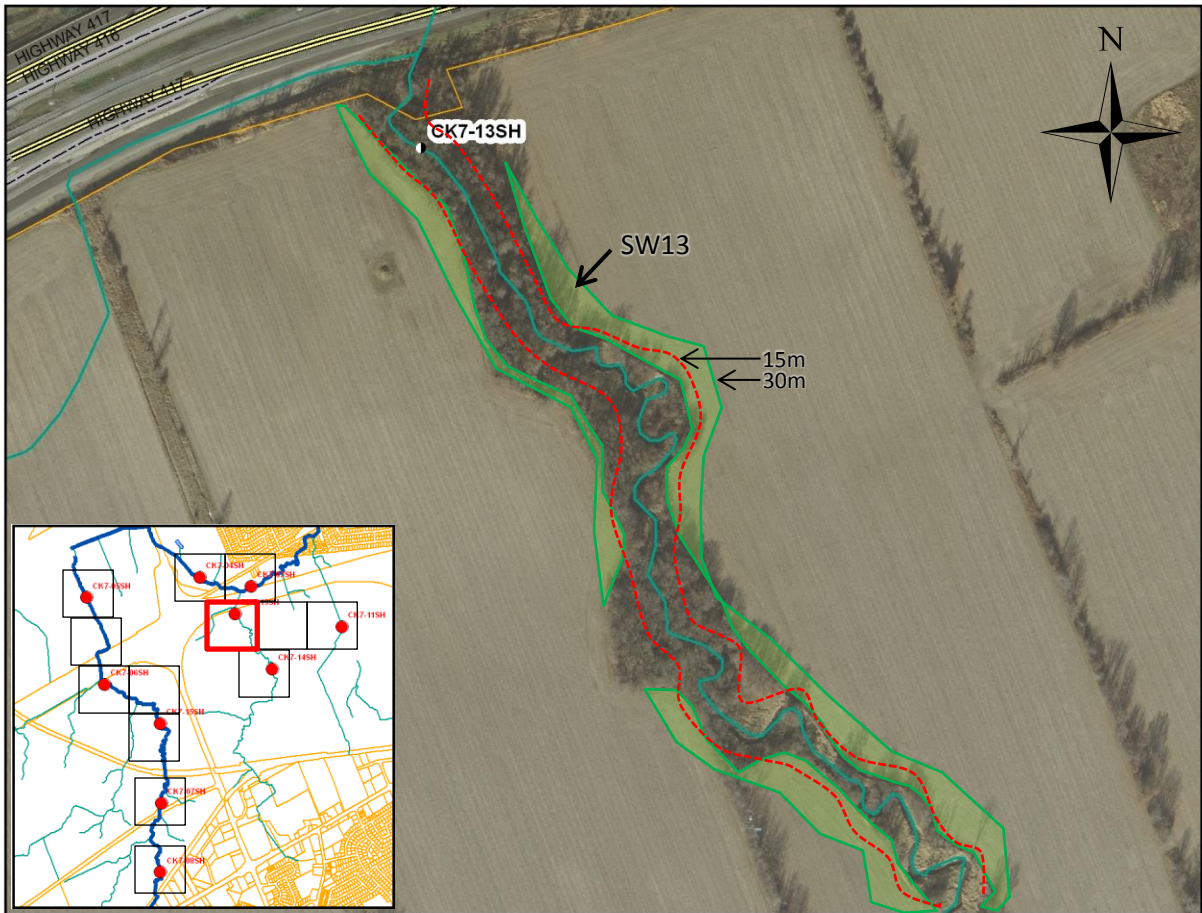
STILLWATER CREEK: RESTORATION PLAN – CK713SH

STILLWATER CREEK			
	STREAM REACH	EASTING	NORTHING	COST
	SW13	-	-	LOW
EXISTING PROBLEM	The buffer setback is not adequate for the complete protection of the stream. Recommended buffer guidelines are as follows: <ul style="list-style-type: none"> - 10 meters for the stabilization of bank materials - 15 meters for the protection of water quality through interception of surface runoff/contaminants - 30 meters for the maintenance of thermal/environmental stability (SW13) 			
CONSTRAINTS	Proposed buffer enhancement zone encroaches into agricultural field			
SOLUTION	Re-vegetation with native trees/shrubs to create riparian habitat. Plants considered for buffer enhancement should meet the following criteria: <ul style="list-style-type: none"> - Native - Adapted to site soil/moisture/light conditions - Provide for specific habitat objectives (e.g Stabilization, habitat enhancement, ect) - Support for the development of natural vegetation communities

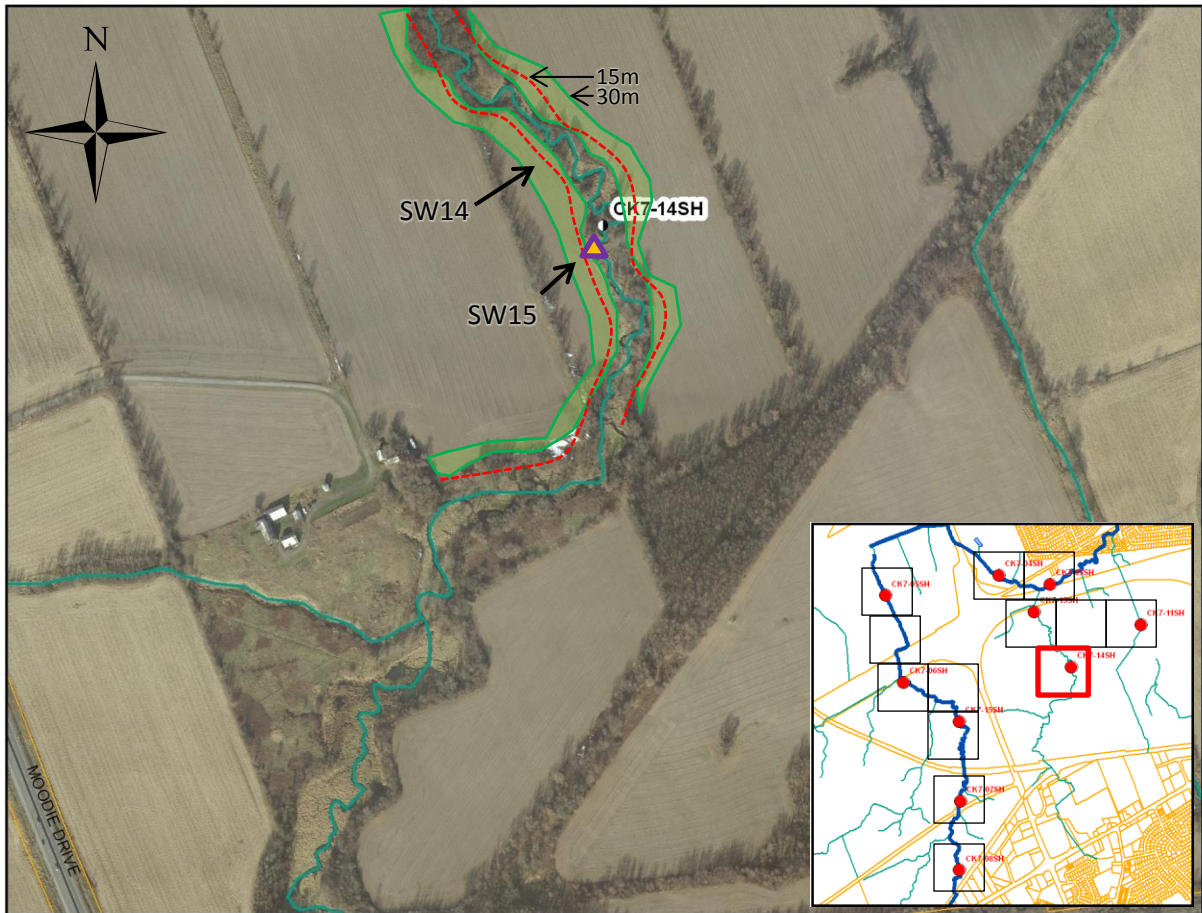
STILLWATER CREEK: RESTORATION PLAN – CK714SH

STILLWATER CREEK			
	STREAM REACH	EASTING	NORTHING	COST
	SW15	434855	5020575	
EXISTING PROBLEM	The orientation of the existing culvert has resulted in degraded instream habitat stability downstream			
CONSTRAINTS	Requires research as to the optimal orientation/design. Additional challenges include the presence of beaver dams within the reach			
SOLUTION	Realignment of the culvert and instream habitat improvements			
WATERSHED OBJECTIVE	Protection of Natural Processes Protection/enhancement of Aquatic Habitat

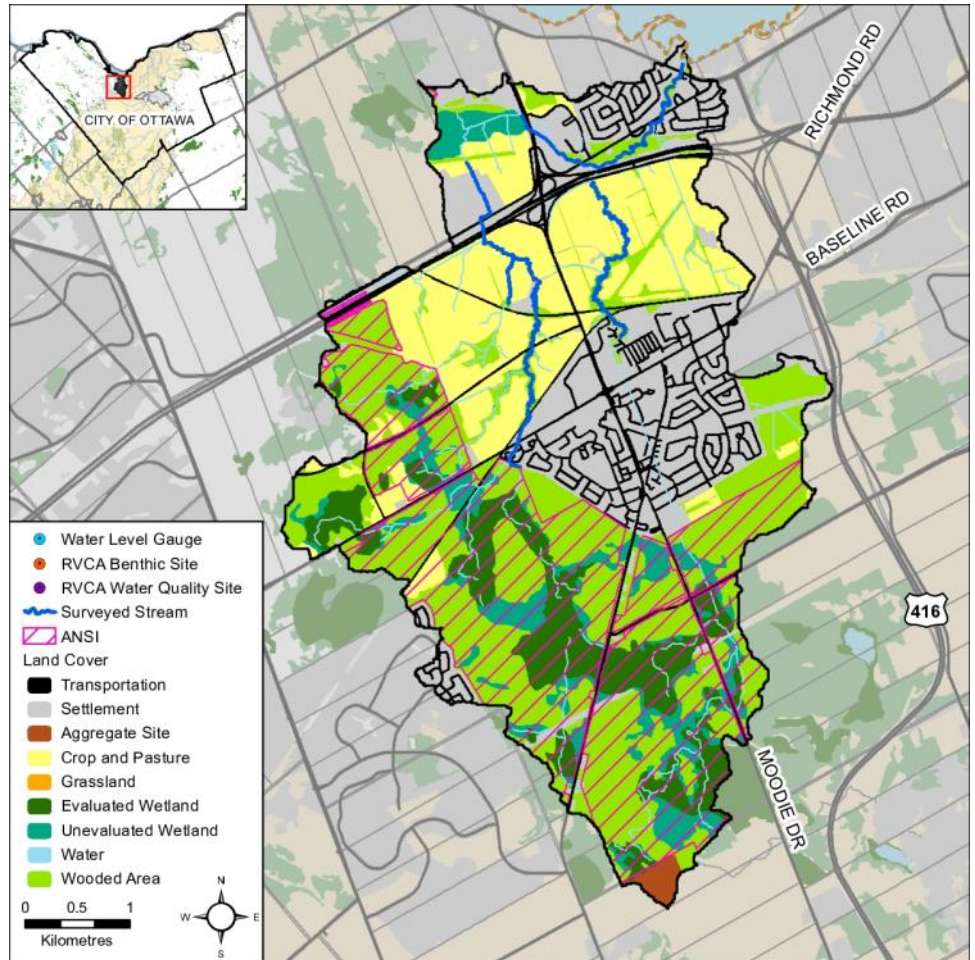
Figure 1 Land cover in the Stillwater Creek catchment

Area	23.48 square kilometres 0.55% of the Rideau Valley watershed
Land Use	33% forest 23% urban 19% agriculture 19% wetland 6% rural
Surficial Geology	35% clay 35% Paleozoic bedrock 14% organic deposits 12% diamicton 2% gravel 2% sand
Watercourse Type	<i>Watercourse Type:</i> 83% natural 17% channelized <i>Flow Type:</i> 96% permanent 4% intermittent
Invasive Species	There were twelve invasive species observed in 2015: purple loosestrife, common buckthorn, Manitoba maple, Himalayan balsam, flowering rush, wild parsnip, European frogbit, glossy buckthorn, garlic mustard, honey suckle, Japanese knotweed, yellow iris
Fish Community	41 fish species have been captured in Stillwater Creek historically including eight game fish species

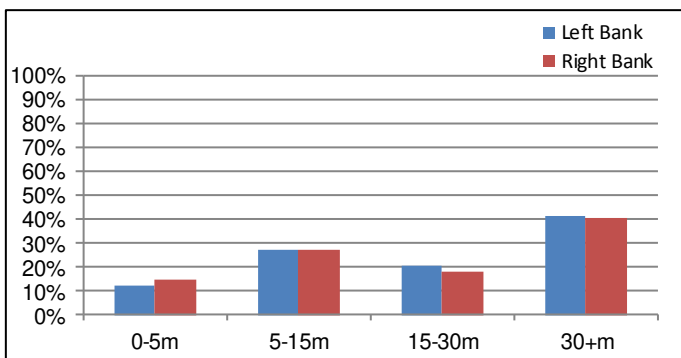
Figure 2 Vegetated buffer width along Stillwater Creek

The riparian or shoreline zone is that special area where the land meets the water. Well-vegetated shorelines are critically important in protecting water quality and creating healthy aquatic habitats, lakes and rivers. Natural shorelines intercept sediments and contaminants that could impact water quality conditions and harm fish habitat in streams. Well established buffers protect the banks against erosion, improve habitat for fish by shading and cooling the water and provide protection for birds and other wildlife that feed and rear young near water. A recommended target (from Environment Canada's Guideline: How Much Habitat is Enough?) is to maintain a minimum 30 meter wide vegetated buffer along at least 75 percent of the length of both sides of rivers, creeks and streams. Stillwater Creek does not meet the target above as it has a buffer of greater than 30 meters along 40 percent of the right bank and 41 percent of the left bank. Figure 2 demonstrates the buffer conditions of the left and right banks separately.

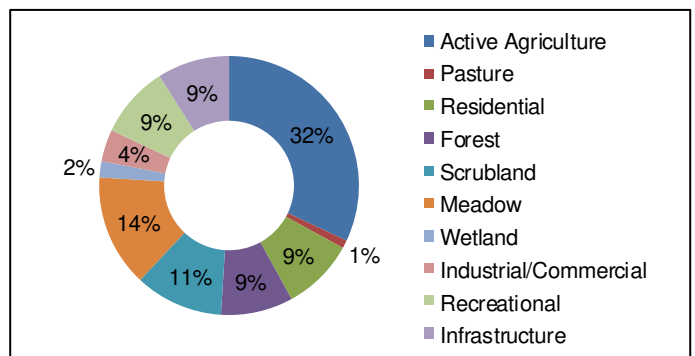
Figure 3 Land use along Stillwater Creek

The RVCA's City Stream Watch Program identifies 10 different land uses beside Stillwater Creek (Figure 3). Surrounding land use is considered from the beginning to end of each survey section (100m) and up to 100m on each side of the creek. Land use outside of this area is not considered for the surveys but is nonetheless part of the subwatershed and will influence the creek. Natural areas made up 36 percent of the surveyed stream, characterized by forest, scrubland, meadow and wetland. Thirty three percent of the land use along the surveyed sections of the stream was made up of agriculture and pasture. The remaining 31 percent of the land use surveyed was composed of residential, recreational and infrastructure uses at nine percent each, as well as industrial/commercial which was recorded as four percent of the land use.

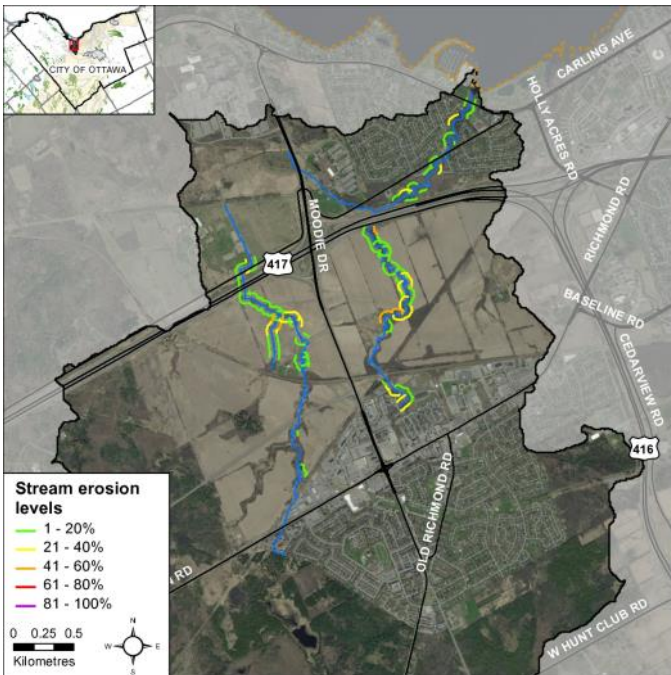
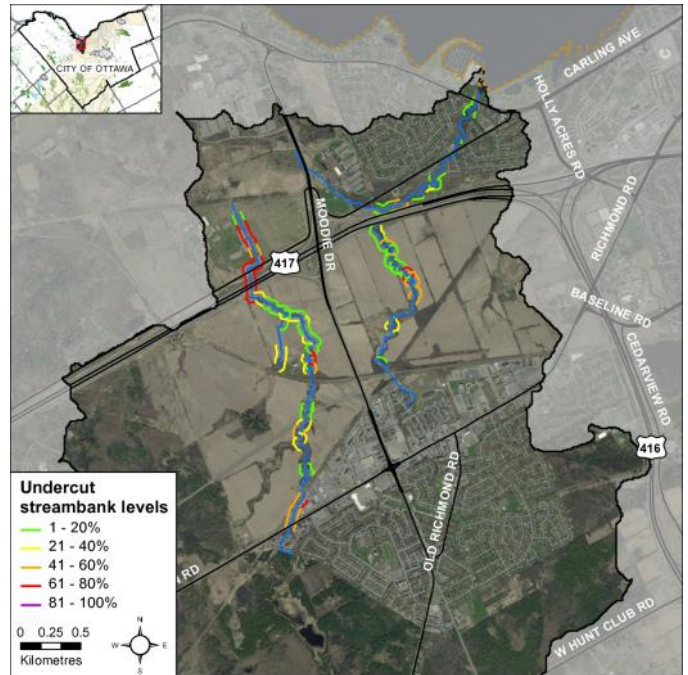
Undercut banks are a normal and natural part of stream function and can provide excellent refuge areas for fish. Figure 5 shows that the bank undercutting on Stillwater Creek varied considerably. Much of the creek had low levels of bank undercutting but these were interspersed with areas of moderate to high level undercutting. The highest levels of undercutting were observed where highway 417 crosses Stillwater Creek. The bank and substrate composition in this area is dominated by clay and the riparian vegetation is predominantly grasses so there is a possibility that the bank undercutting in section of the creek may lead to bank failure over time.

Figure 4 Erosion along Stillwater Creek

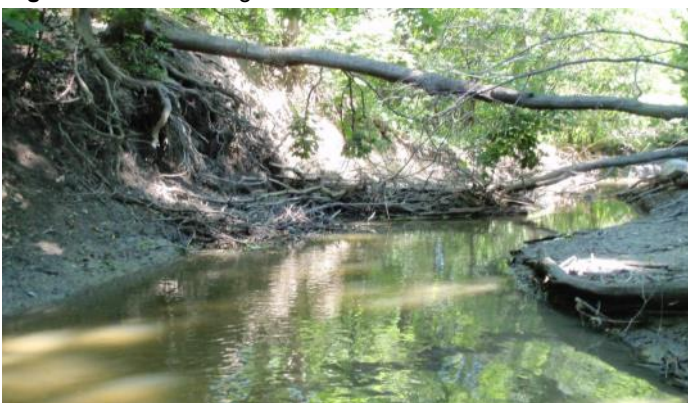
Erosion is a normal, important stream process and may not affect actual bank stability; however, excessive erosion and deposition of sediment within a stream can have a detrimental effect on important fish and wildlife habitat. Poor bank stability can greatly contribute to the amount of sediment carried in a waterbody as well as loss of bank vegetation due to bank failure, resulting in trees falling into the stream and the potential to impact instream migration. Figure 4 shows low to moderate levels of bank erosion were observed along many sections of Stillwater Creek. Most of the areas where erosion was observed were in the agricultural lands south of Highway 417 on the main channel of the creek and its tributary. Shoreline stability in this area could be improved by increasing the vegetated buffer width along the creek.

Stream bank erosion along Stillwater Creek

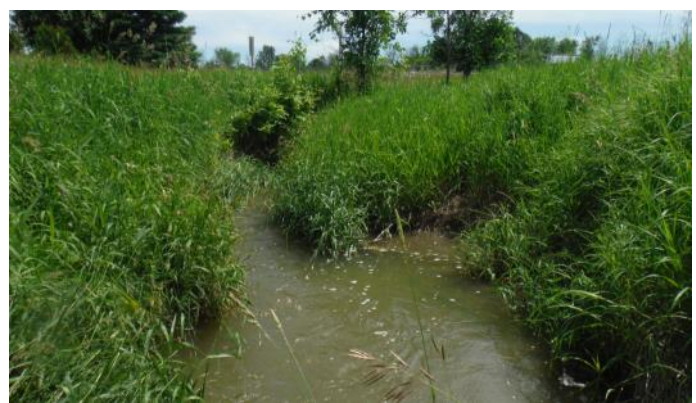
Section downstream of Hwy 417 with high levels of undercutting

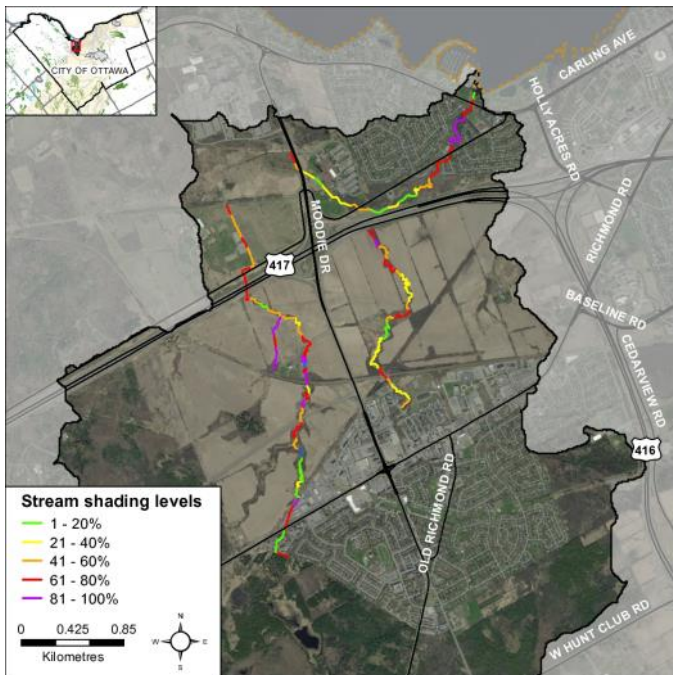
Figure 6 Stream shading along Stillwater Creek

Grasses, shrubs and trees all contribute towards shading a stream. Shade is important in moderating stream temperature, contributing to food supply and helping with nutrient reduction within a stream. Figure 6 shows stream shading along Stillwater Creek. High levels of shading were seen along most of the creek with some sections having more moderate shading. In areas where trees and shrubs were not present in the buffer zone, tall overhanging grasses serve to shade the sections of Stillwater Creek with narrow stream width.

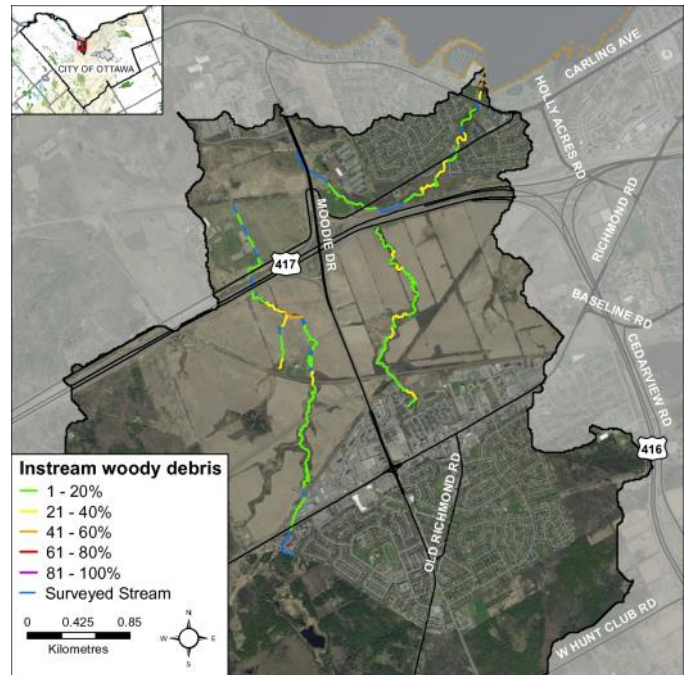
Figure 7 Instream woody debris along Stillwater Creek

Figure 7 shows that overall, the surveyed sections along Stillwater Creek had moderate levels of instream woody debris in the form of branches and trees. Instream woody debris is important for fish and benthic habitat, by providing refuge and feeding areas.

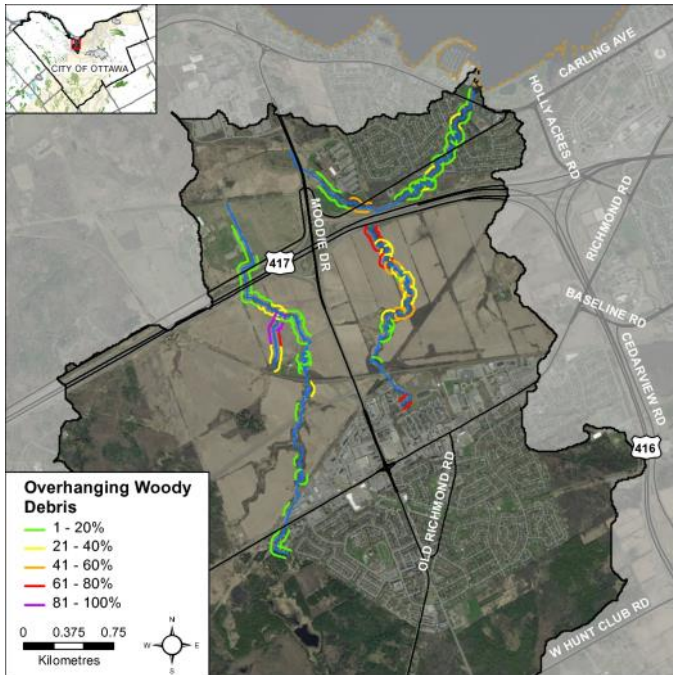
Figure 8 Overhanging trees and branches

Figure 8 shows that Stillwater Creek had highly variable levels of overhanging branches and trees ranging from low to high levels. Trees and branches that are less than one meter from the surface of the water are defined as overhanging. At this proximity to the water branches and trees provide a food source, nutrients and shade which helps to moderate instream water temperatures.

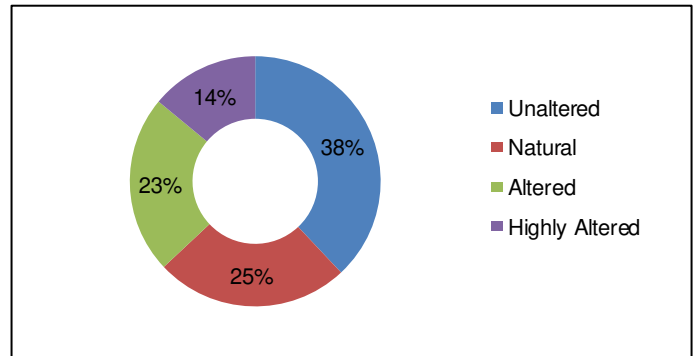
Figure 9 Anthropogenic alterations along Stillwater Creek

Figure 9 demonstrates that 63 percent of the sections on Stillwater Creek remain “unaltered” or “natural”. Sections considered “altered” account for 23 percent of the stream, while 14 percent of the sections sampled were considered “highly altered”. The highly altered sections of Stillwater Creek refer to those that are channelized as well as those that run through a culvert or road crossing with associated instream and shoreline modifications.

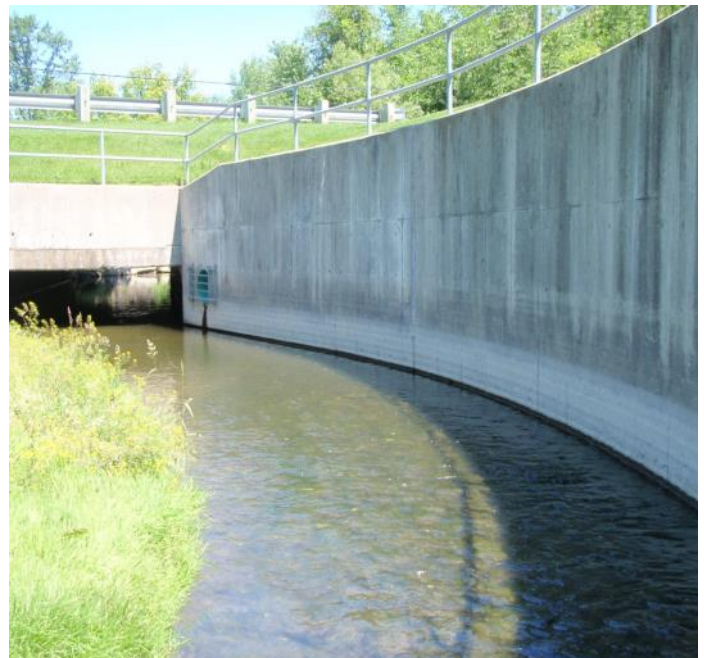
A highly altered section of Stillwater Creek at the Corkstown Road crossing

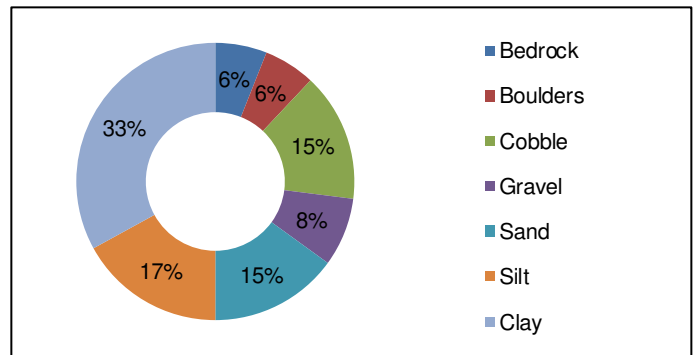
Figure 11 Instream substrate along Stillwater Creek

Diverse substrate is important for fish and benthic invertebrate habitat because some species have specific substrate requirements and, for example, will only reproduce on certain types of substrate. Figure 11 shows that the substrate composition of Stillwater Creek was very diverse. Thirty three percent of the instream substrate observed on Stillwater Creek was clay. Thirty two percent of the substrate was recorded as silt and sand. Twenty one percent was cobble and boulder, while eight percent was gravel. The remaining six percent was made up of bedrock. Figure 12 shows the distribution of the dominant substrate types along the system. Clay was recorded most often as the dominant substrate, with outcroppings of bedrock between Corkstown Road and Highway 417 as well as near Robertson Road. A significant amount of silt substrate was also recorded between Corkstown Road and Moodie Drive.

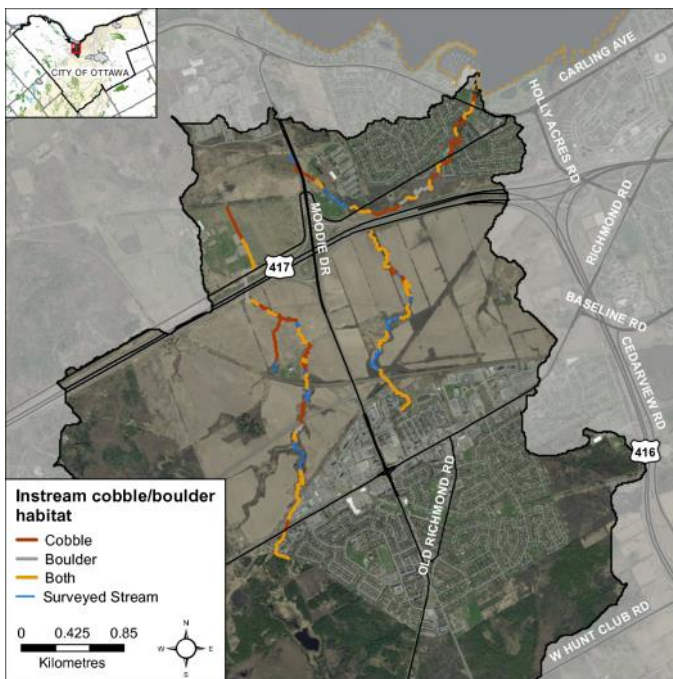
Figure 13 Cobble and boulder habitat in Stillwater Creek

Boulders create instream cover and back eddies for large fish to hide and/or rest out of the current. Cobble provides important over-wintering and/or spawning habitat for small or juvenile fish. Cobble can also provide habitat conditions for benthic invertebrates that are a key food source for many fish and wildlife species. Figure 13 shows the distribution of cobble and boulder habitat along Stillwater Creek. Areas of cobble and boulder habitat are well distributed along the entire length of the creek.

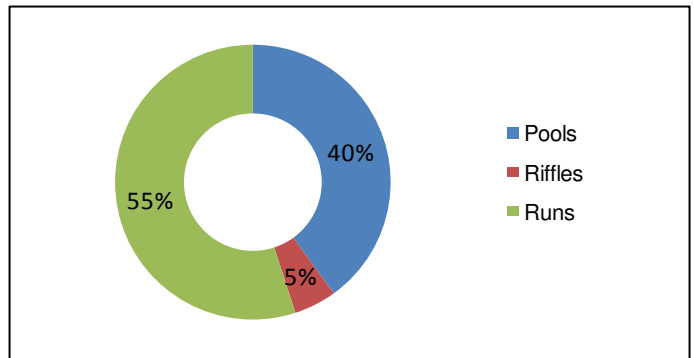
Figure 14 Instream morphology along Stillwater Creek

Figure 14 shows that Stillwater Creek has good variability in instream morphology; 55 percent consists of runs, 40 percent consists of pools and five percent consists of riffles. Figure 15 shows where areas of riffle habitat was observed in Stillwater Creek. Although the riffle habitat was only five percent it was dispersed well across most of the creek.

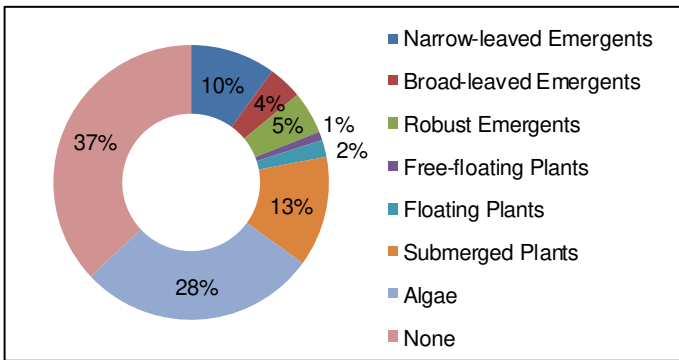
Figure 16 Vegetation types along Stillwater Creek

Instream vegetation provides a variety of functions and is a critical component of the aquatic ecosystem. For example, emergent plants along the shoreline can provide shoreline protection from wave action and important rearing habitat for species of waterfowl. Submerged plants provide habitat for fish to find shelter from predator fish while they feed. Floating plants such as water lilies shade the water and can keep temperatures cool while reducing algae growth. Figure 16 depicts the high diversity of plant community structure in Stillwater Creek. Even though the diversity was high in most stream sections, areas with no vegetation were recorded most often, at 37 percent. Areas with no vegetation were dominated by bedrock and clay substrates where plants have difficulty establishing. Algae, submerged plants and narrow-leaved emergents were also recorded in high percentage at 28 percent, 13 percent and 10 percent respectively.

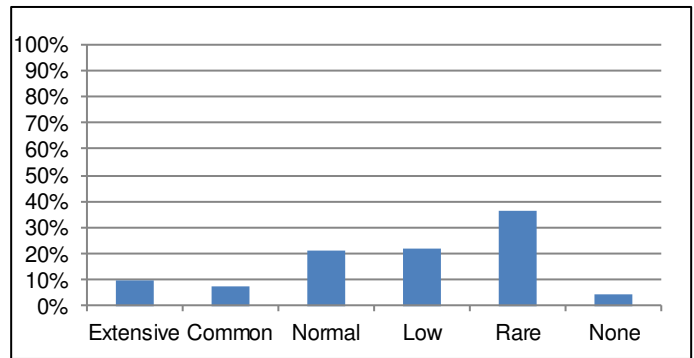
Figure 18 Instream vegetation abundance in Stillwater Creek

Instream vegetation is an important factor for a healthy stream ecosystem. Vegetation helps to remove contaminants from the water, contributes oxygen to the stream, and provides habitat for fish and wildlife. Too much vegetation can also be detrimental. Figure 18 demonstrates that the vegetation abundance of Stillwater Creek varied considerably from extensive to rare and no vegetation. Rare and low levels were recorded most often and accounted for 58 percent, normal levels accounted for 21 percent, common levels accounted for seven percent and extensive levels accounted for 10 percent. The remaining four percent were areas with no vegetation. The vegetation levels varied considerably depending on the substrate types which were highly variable along Stillwater Creek. Areas with rare and low levels of vegetation were dominated by high flows as well as clay and bedrock substrates. Most types of vegetation have difficulty establishing in these conditions.

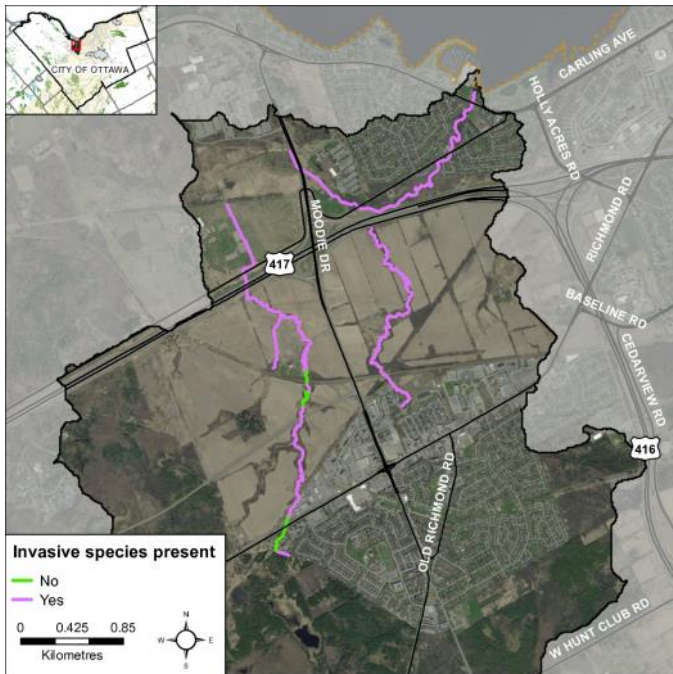
Figure 19 Presence of invasive species along Stillwater Creek

Invasive species can have major implications on streams and species diversity. Invasive species are one of the largest threats to ecosystems throughout Ontario and can outcompete native species, having negative effects on local wildlife, fish and plant populations. Invasive species were observed along 94 percent of the sections surveyed along Stillwater Creek (Figure 19). Figure 20 shows the variety of invasive species observed along Stillwater Creek. The invasive species that were observed most often were purple loosestrife (*Lythrum salicaria*), common buckthorn (*Rhamnus cathartica*), and Manitoba maple (*Acer negundo*). Most of the sections where invasive species were present had more than one invasive species recorded.

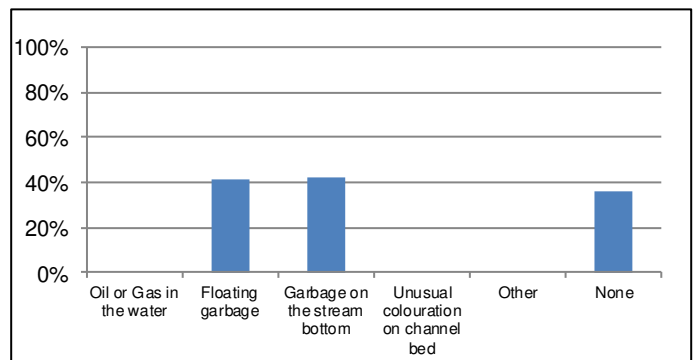
Figure 21 Pollution observed along Stillwater Creek

Figure 21 demonstrates the incidence of pollution/garbage in Stillwater Creek. Thirty six percent of the sections surveyed did not have any observable garbage. Forty two percent had garbage on the stream bottom and 41 percent had floating garbage. Many of the sections had both garbage on the stream bottom and floating garbage. These areas were located near road crossings or in the developed areas near Robertson Road and Corkstown Road.

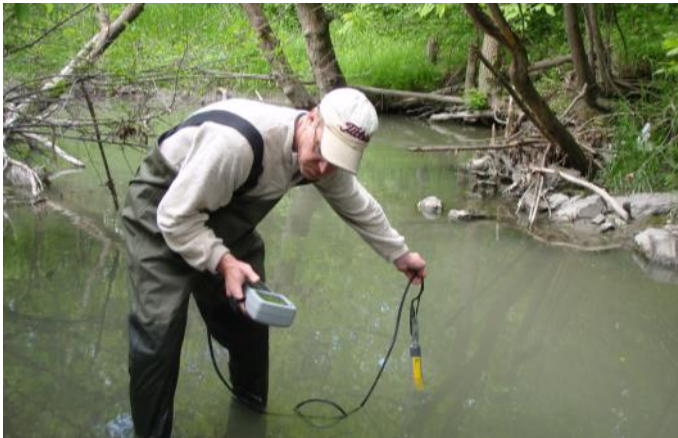
During the stream characterization survey, a YSI probe is used to collect water chemistry information. Dissolved oxygen, conductivity and pH are measured at the start and end of each section.

A volunteer measuring water chemistry using a YSI

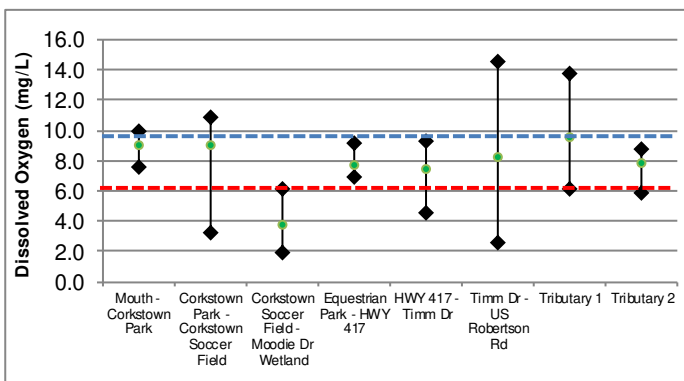
Figure 22 Dissolved oxygen ranges in Stillwater Creek

Dissolved oxygen is a measure of the amount of oxygen dissolved in water. The Canadian Environmental Quality Guidelines of the Canadian Council of Ministers of the Environment (CCME) suggest that for the protection of aquatic life the lowest acceptable dissolved oxygen concentration should be 6 mg/L for warmwater biota (red line in Figure 22) and 9.5 mg/L for coldwater biota (blue line in Figure 22) (CCME, 1999). Figure 22 shows that most of the stretches of Stillwater Creek meet the standard for warmwater biota. With an average dissolved oxygen level of 3.8 mg/L, the stretch of creek between Corkstown Road and Moodie Drive had much lower average dissolved oxygen compared to other stretches of the creek. This section is influenced by a weir and doesn't meet standard of 6 mg/L for warmwater biota.

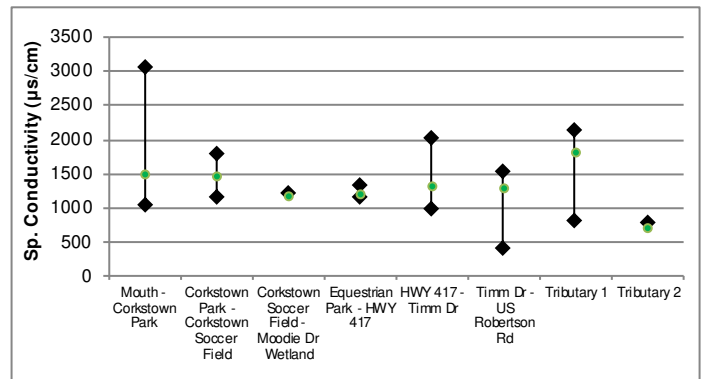
Figure 23 Conductivity ranges in Stillwater Creek

Conductivity in streams is primarily influenced by the geology of the surrounding environment, but can vary drastically as a function of surface water runoff. Currently there are no CCME guideline standards for stream conductivity, however readings which are outside the normal range observed within the system are often an indication of unmitigated discharge and/or stormwater input. The average specific conductivity observed within Stillwater Creek was 1309 $\mu\text{s}/\text{cm}$. Figure 23 shows that the conductivity readings varied moderately along the course of the creek. The lowest average specific conductivity reading at 717 $\mu\text{s}/\text{cm}$, was observed on the tributary of Stillwater Creek surveyed to the west of Moodie Drive. There is a significant spike in conductivity in the tributary east of Moodie Drive where the average recorded conductivity was 1813 $\mu\text{s}/\text{cm}$. The tributary east of Moodie Drive conveys flow from the highly developed area of Bells Corners around Robertson Road. As a result, the water chemistry of the tributary is significantly influenced by stormwater runoff.

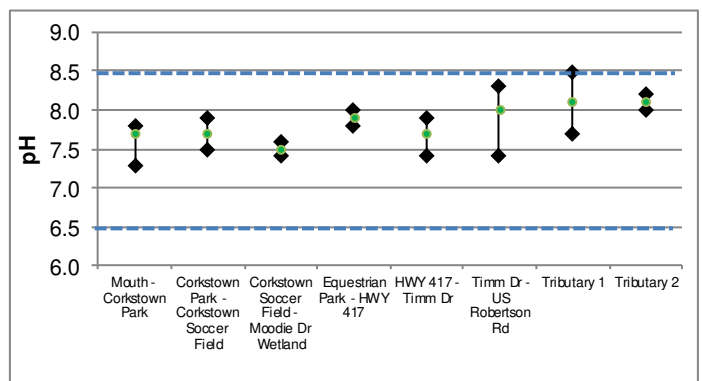
Figure 24 pH ranges in Stillwater Creek

Based on the PWQO for pH, a range of 6.5 to 8.5 should be maintained for the protection of aquatic life. Average pH values for Stillwater Creek ranged between 7.7 and 8.1, thereby meeting the provincial standard.

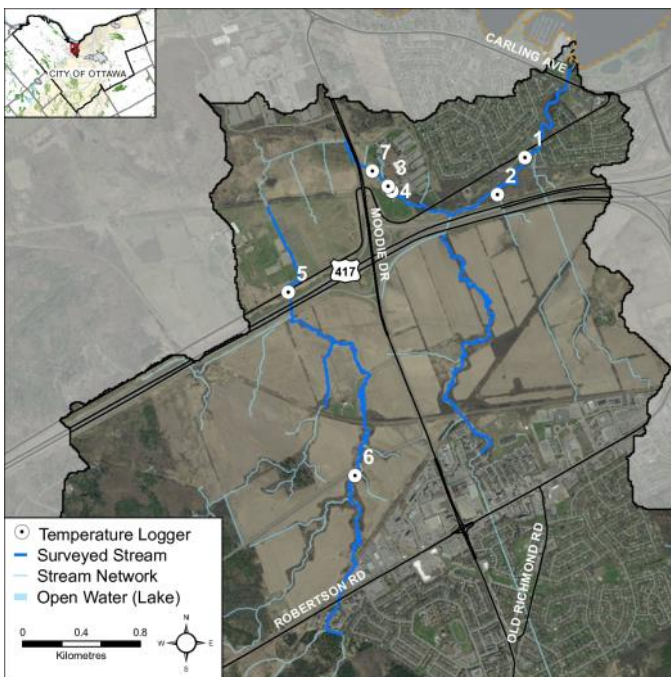
Figure 25 Temperature loggers along Stillwater Creek

Many factors can influence fluctuations in stream temperature, including springs, tributaries, precipitation runoff, discharge pipes and stream shading from riparian vegetation. Seven temperature loggers were deployed in late April to monitor water temperature in Stillwater Creek. Water temperature is used along with the maximum air temperature (using a revised Stoneman and Jones method) to classify sampling reaches into one of five categories that correspond to the thermal preferences of local fish communities (figure 27). Figure 25 shows the locations where temperature loggers were installed on Stillwater Creek.

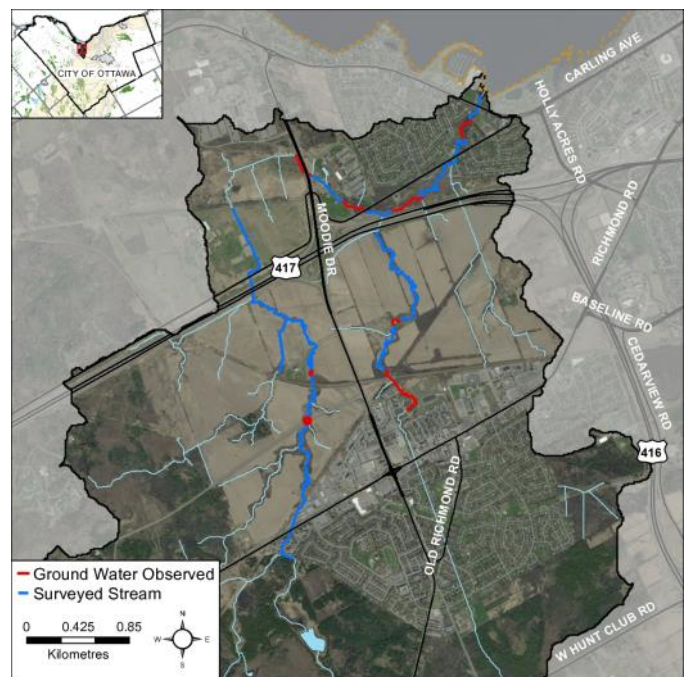
Figure 26 Groundwater indicators observed

Groundwater discharge areas can influence stream temperature, contribute nutrients, and provide important stream habitat for fish and other biota. During stream surveys, indicators of groundwater discharge are noted when observed. Figure 26 shows areas where one or more groundwater indicators were observed during stream surveys on Stillwater Creek. Most of the groundwater indicators were observed downstream of Moodie Drive and in the tributary surveyed east of Moodie Drive.

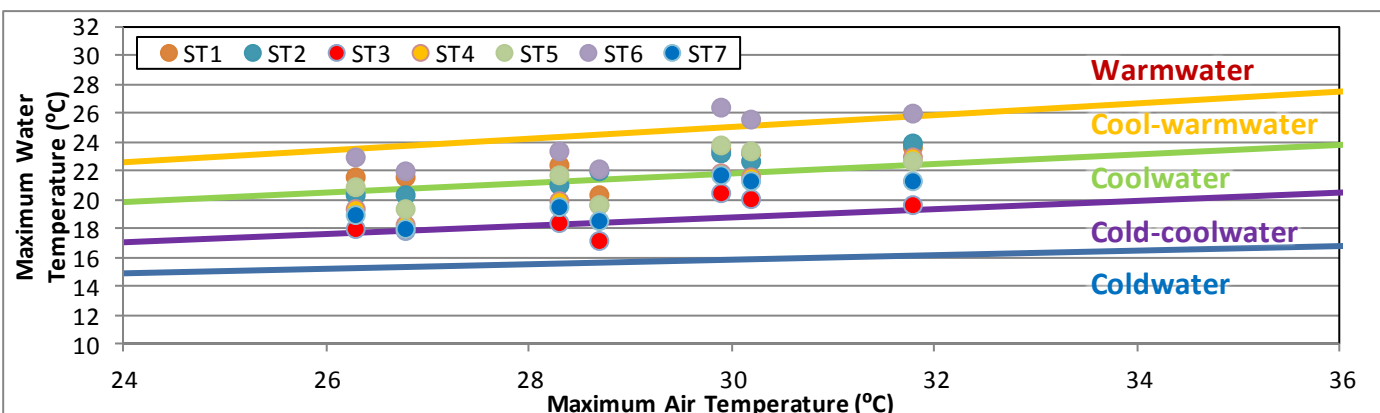
Figure 27 Thermal Classification for Stillwater Creek

Analysis of the data collected indicates that the thermal classification of Stillwater Creek is cool water with a cool-warm water reach towards Robertson Road. (Figure 27). The site of logger 3 between Corkstown Road and Moodie Drive represents a colder reach of the creek and is likely influenced by groundwater input.

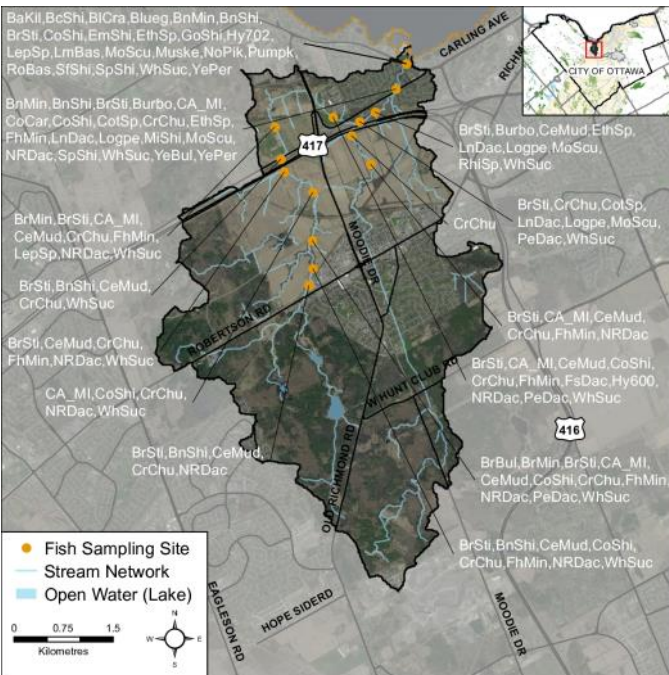
Figure 28 Stillwater Creek fish community

Fish sampling sites located along Stillwater Creek are shown in Figure 28. The provincial fish codes shown in Figure 28 are listed (in Table 2) beside the common name of those fish species identified in Stillwater Creek. The thermal classification of Stillwater Creek is cool water, with 41 fish species having been observed historically including eight game fish species.

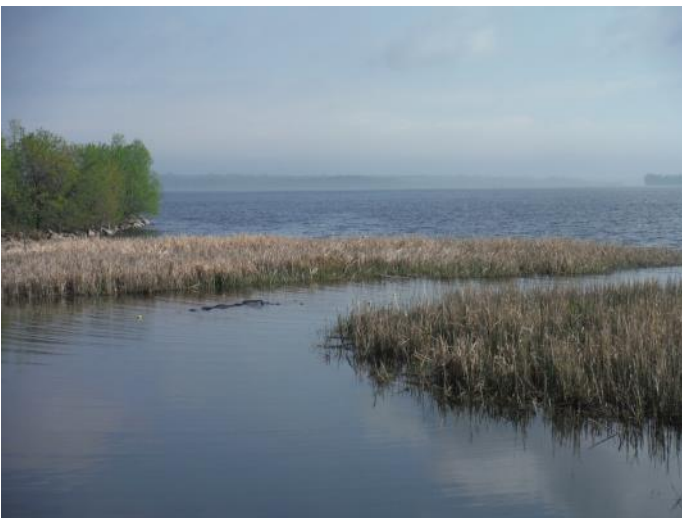
Fyke net set at the mouth of Stillwater Creek near the Ottawa River

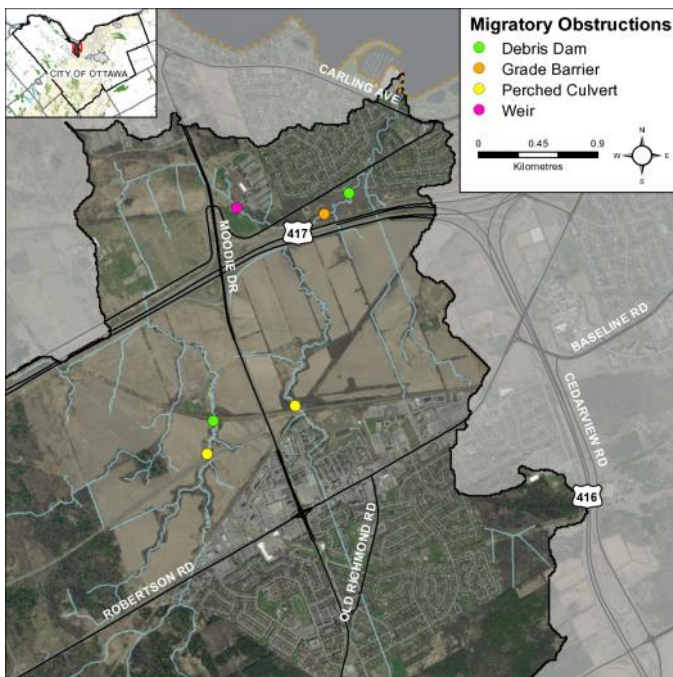
Figure 29 Stillwater Creek migratory obstructions

It is important to know locations of migratory obstructions because these can prevent fish from accessing important spawning and rearing habitat. Migratory obstructions can be natural or manmade, and they can be permanent or seasonal. Figure 29 shows that along Stillwater Creek, two perched culverts, two debris dams, one grade barrier and one weir were observed. Fish migration is currently being impacted by the weir near Moodie Drive and the perched culverts identified on the main channel of the creek at Timm Drive and the tributary east of Moodie Drive at the old railway line.

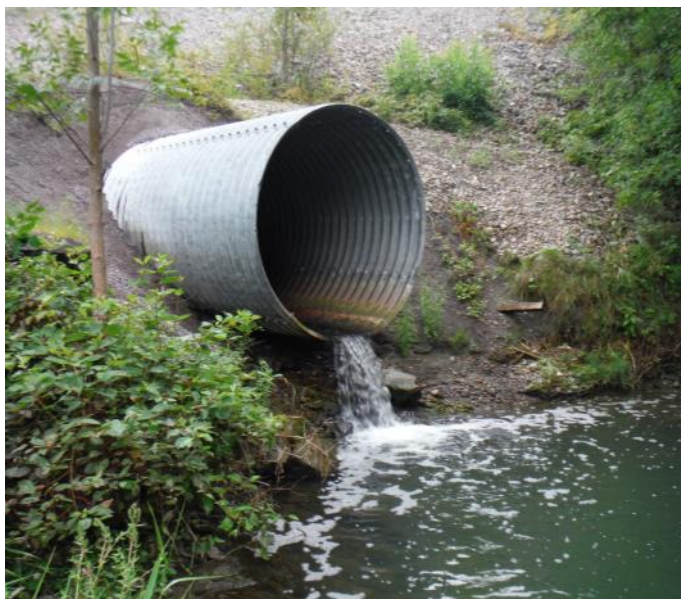
A perched culvert observed along a tributary of Stillwater Creek

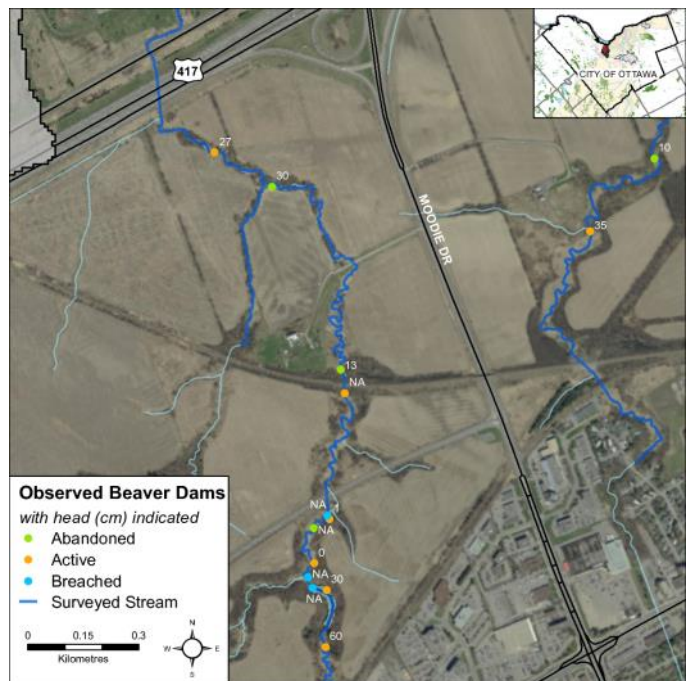
Figure 30 Beaver dams observed on Stillwater Creek

Beaver dams can also act as obstructions to fish migration. Figure 30 shows that a number of active, abandoned and breached beaver dams were observed on Stillwater Creek. Most of the beaver activity was observed between Highway 417 and Robertson Road as well as on the tributary east of Moodie Drive. The head, or difference between the water level up and down stream, of the beaver dams ranged from 0 cm to 60 cm.

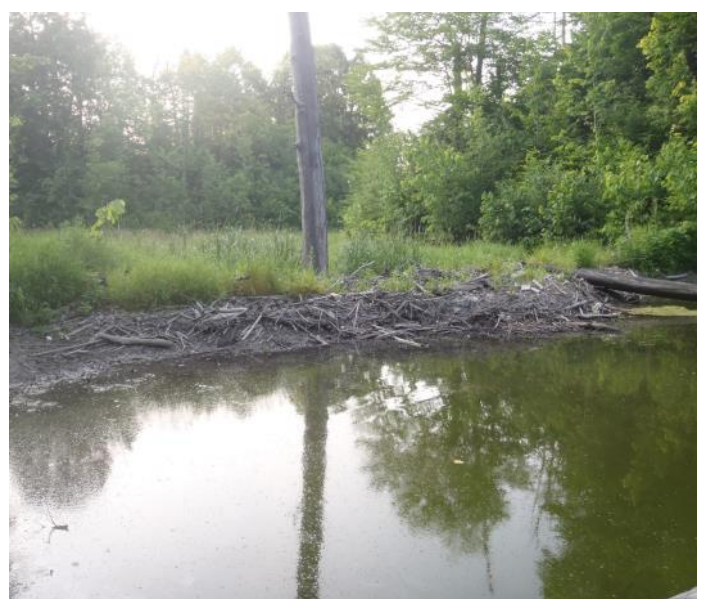
A large beaver dam observed on Stillwater Creek

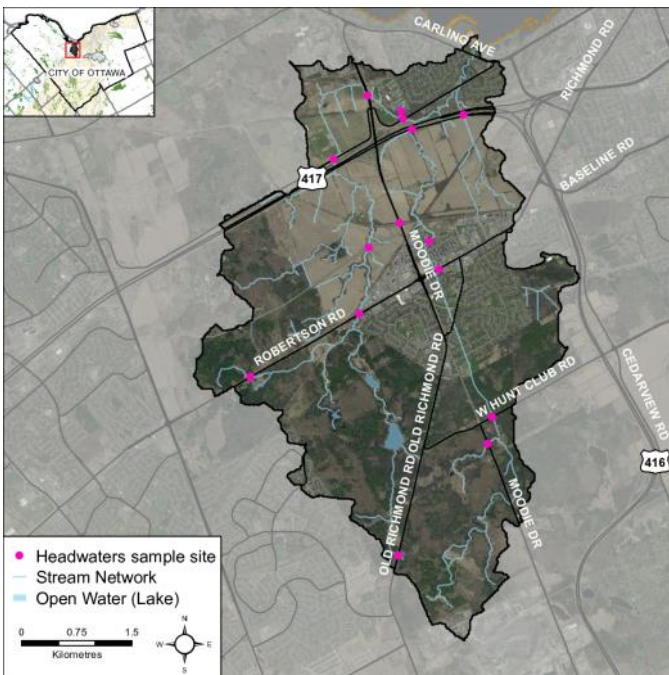
Figure 31 Stillwater Creek HDF sampling sites

The RVCA City Stream Watch program assessed Headwater Drainage Features for Barrhaven Creek, Bilberry Creek, Mosquito Creek and Stillwater Creek in 2015. This protocol measures zero, first and second order headwater drainage features (HDF). It is a rapid assessment method characterizing the amount of water, sediment transport, and storage capacity within headwater drainage features (HDF). RVCA is working with other Conservation Authorities and the Ministry of Natural Resources and Forestry to implement the protocol with the goal of providing standard datasets to support science development and monitoring of headwater drainage features. An HDF is a depression in the land that conveys surface flow. Additionally, this module provides a means of characterizing the connectivity, form and unique features associated with each HDF (OSAP Protocol, 2013). In 2015 the program sampled 13 sites in the Stillwater Creek catchment area. Figure 31 demonstrates the 2015 Stillwater Creek sampling locations.

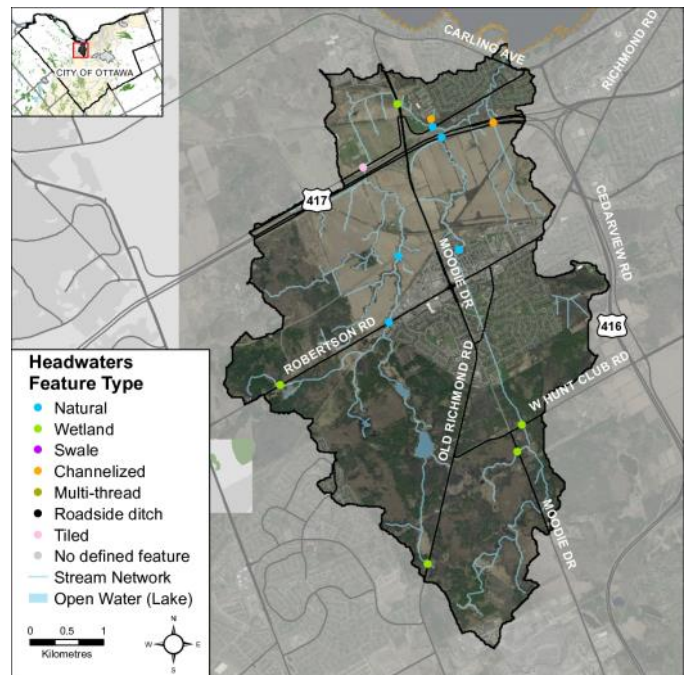
Figure 32 Stillwater Creek HDF feature types

The headwater sampling protocol assesses the feature type in order to understand the function of each feature. The evaluation includes the following classifications: defined natural channel, channelized or constrained, multi-thread, no defined feature, tiled, wetland, swale, roadside ditch and pond outlet. By assessing the values associated with the headwater drainage features in the catchment area we can understand the ecosystem services that they provide to the watershed in the form of hydrology, sediment transport, and aquatic and terrestrial functions. The Stillwater Creek catchment is dominated by natural channel and wetland headwater drainage feature types with two channelized sites and one tiled site. Figure 32 shows the feature type of the primary feature at the sampling locations on Stillwater Creek.

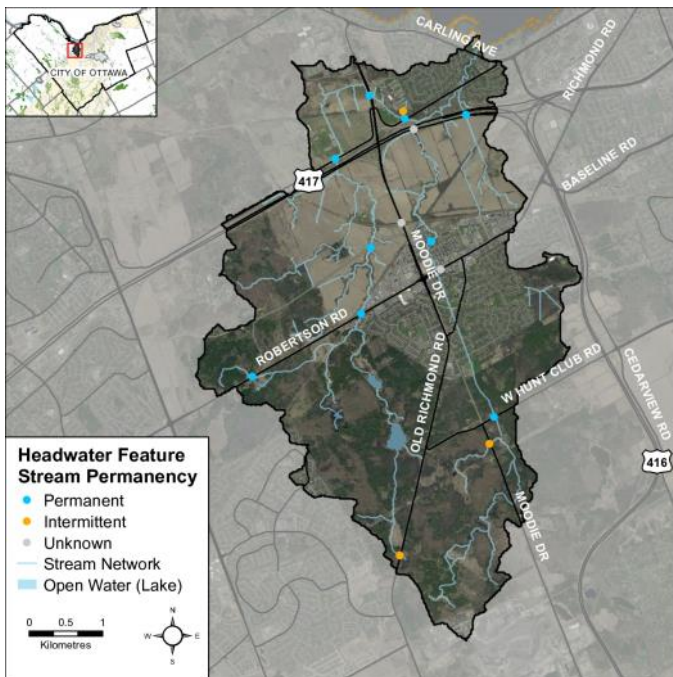
Figure 33 Stillwater Creek HDF flow conditions

The observed flow condition within headwater drainage features can be highly variable depending on timing relative to the spring freshet, recent rainfall, soil moisture, etc. Flow conditions are assessed in the spring and in the summer to determine if features are perennial and flow year round, if they are intermittent and dry up during the summer months or if they are ephemeral systems that do not flow regularly and generally respond to specific rainstorm events or snowmelt. Flow conditions in headwater systems can change from year to year depending on local precipitation patterns. Figure 33 shows the observed flow conditions at the sampling locations in the Stillwater Creek catchment.

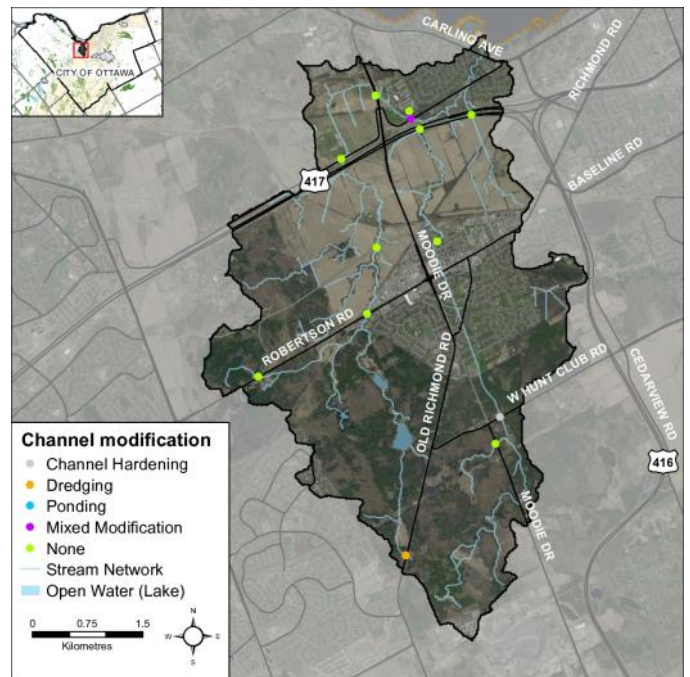
Figure 34 Mosquito Creek HDF channel modifications

Channel modifications were assessed at each headwater drainage feature sampling location. Modifications include channelization, dredging, hardening and realignments. Land use in the Stillwater Creek catchment varies widely from developed land to agriculture and natural forested and wetland areas. The majority of the sampling locations for the Stillwater Creek catchment area had no channel modifications but one site had mixed modifications, one site had channel hardening and one site had dredging. Figure 34 shows the channel modifications observed at the sampling locations for Stillwater Creek.
