**Functional Site Servicing and
Stormwater Management
Report – 1987 Robertson Road
(Stillwater Station)**

Job #160401686

Prepared for:
The Properties Group
Management Ltd.

Prepared by:
Stantec Consulting Ltd.
1331 Clyde Avenue
Ottawa, Ontario
K2C 3G4

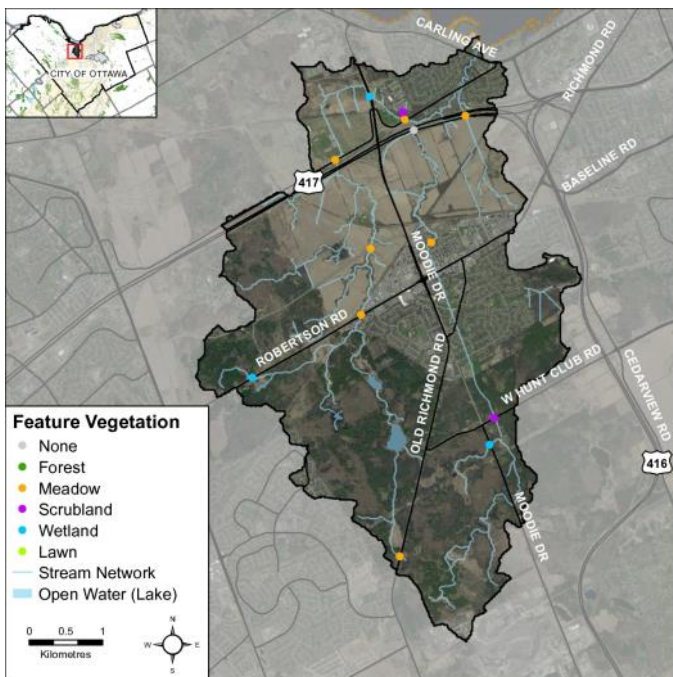
Figure 35 Stillwater Creek HDF feature vegetation

Headwater feature vegetation evaluates the type of vegetation that is found within the drainage feature. The type of vegetation within the channel influences the aquatic and terrestrial ecosystem values that the feature provides. For some types of headwater features the vegetation within the feature plays a very important role in flow and sediment movement and provides wildlife habitat. The following classifications are evaluated: no vegetation, lawn, wetland, meadow, scrubland and forest. Headwaters features in the Stillwater Creek catchment were dominated by meadow, wetland and scrubland vegetation. Figure 35 depicts the dominant vegetation observed at the sampled headwater sites in the Stillwater Creek catchment.

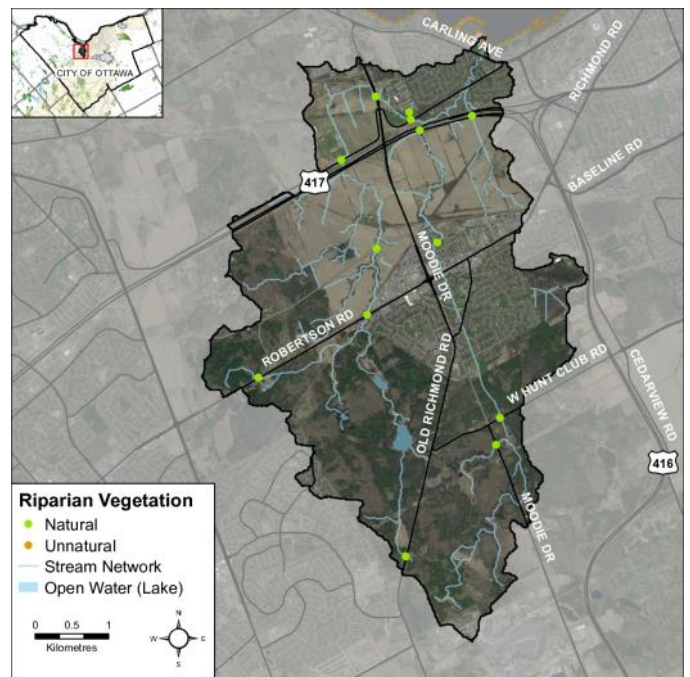
Figure 36 Stillwater Creek HDF riparian vegetation

Headwater riparian vegetation evaluates the type of vegetation that is found along the headwater drainage feature. The type of vegetation within the riparian corridor influences the aquatic and terrestrial ecosystem values that the feature provides to the watershed. All of the sample locations in the Stillwater Creek catchment area were dominated by natural vegetation in the form of scrubland, meadow, wetland and forest. Figure 36 depicts the type of riparian vegetation observed at the sampled headwater sites in the Stillwater Creek catchment.

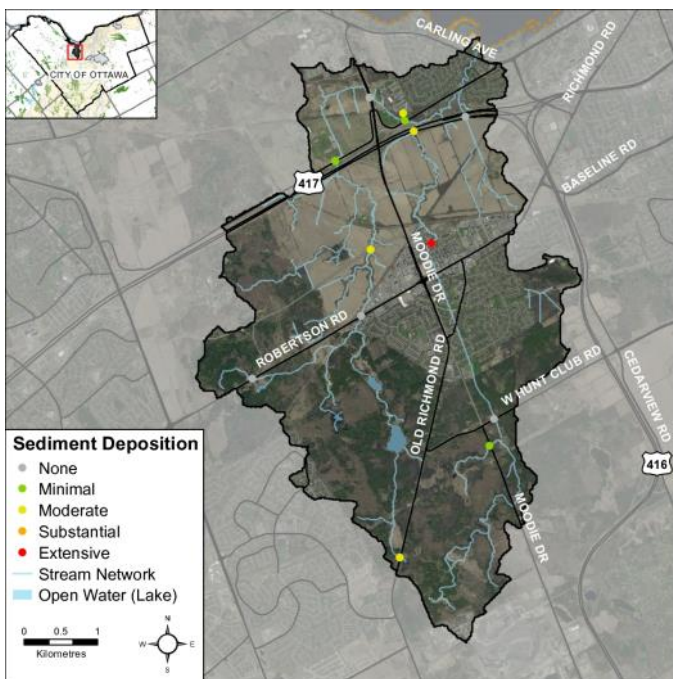
Figure 37 Stillwater Creek HDF sediment deposition

Assessing the amount of recent sediment deposited in a channel provides an index of the degree to which the feature could be transporting sediment to downstream reaches (OSAP, 2013). Evidence of excessive sediment deposition might indicate the requirement to follow up with more detailed targeted assessments upstream of the site location to identify potential best management practices to be implemented. Conditions ranged from no deposition observed to moderate levels of sediment deposition observed. Overall, most sites had minimal or moderate levels of sediment deposition. Figure 37 depicts the degree of sediment deposition observed at the sampled headwater sites in the Stillwater Creek catchment.

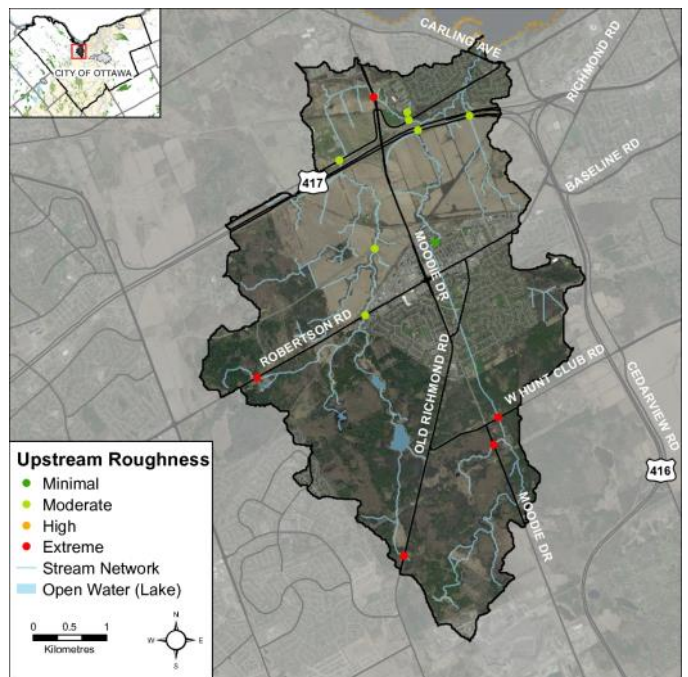
Figure 38 Stillwater Creek HDF feature roughness

Feature roughness will provide a measure of the amount of materials within the bankfull channel that could slow down the velocity of water flowing within the headwater feature (OSAP, 2013). Materials on the channel bottom that provide roughness include vegetation, woody debris and boulders/cobble substrates. Roughness can provide benefits in mitigating downstream erosion on the headwater drainage feature and the receiving watercourse by reducing velocities. Roughness also provides important habitat conditions to aquatic organisms. Most of the feature roughness of the sample locations in the Stillwater Creek catchment were classified as either moderate or extreme levels. Figure 38 shows the feature roughness conditions at the sampling locations in the Stillwater Creek catchment.

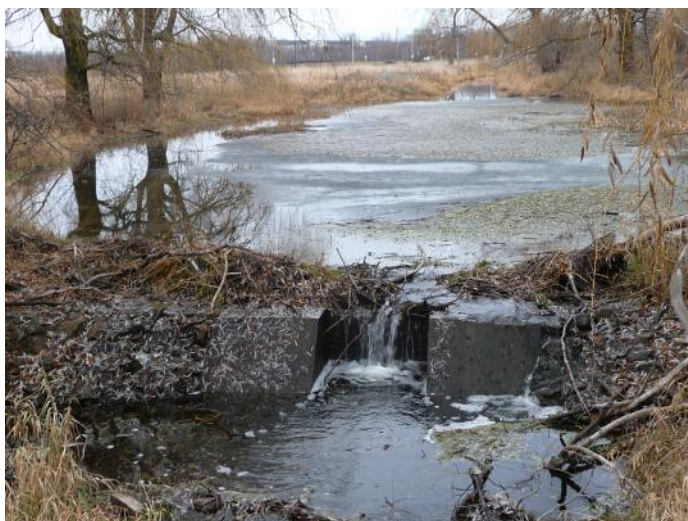
A weir constructed along Stillwater Creek downstream of Moodie Drive that was observed in 2009 and 2015

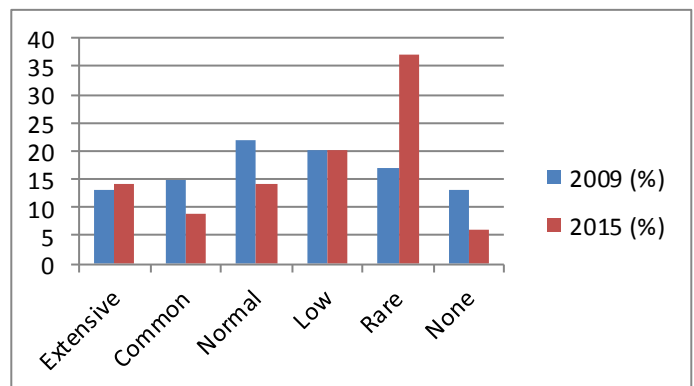
Figure 39 Comparison of instream vegetation levels between 2009 and 2015

Figure 39 shows that there has been a decrease in instream vegetation in Stillwater Creek since 2009. The amount of areas with no vegetation and rare levels of vegetation totaled 30 percent in 2009, and that number has increased to 43 percent in 2015. Low levels have remained the same at 20 percent in both 2009 and 2015. Normal levels of vegetation have decreased from 22 percent in 2009 to 14 percent in 2015. Finally, the number of areas classified as having common and extensive levels of vegetation has decreased from 28 percent in 2009 to 23 percent in 2015. The decrease in instream vegetation may be in part attributed to increased sedimentation in the system but vegetation growth is also dependent on climatic variables as well as the stage of the growing season when observations took place.

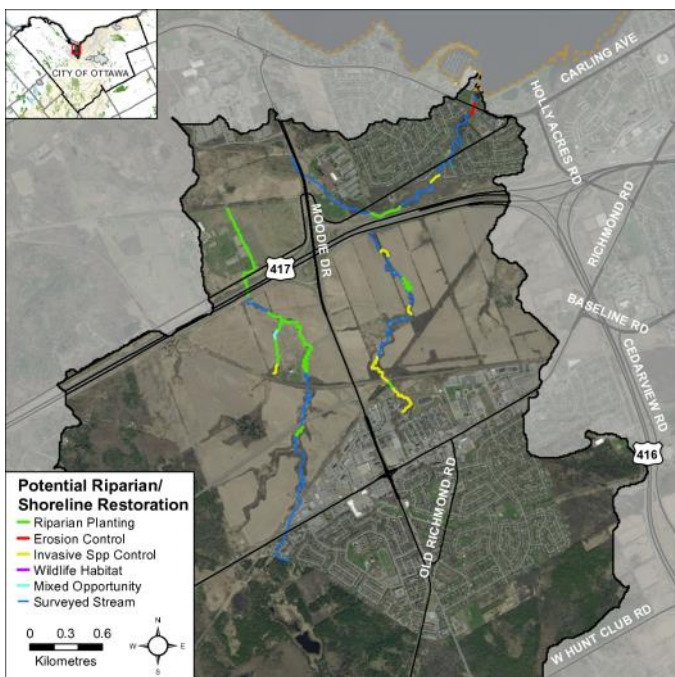
Figure 40 Potential riparian/shoreline restoration opportunities

Figure 40 depicts the locations where City Stream Watch staff and volunteers observed areas where the riparian zone could be restored or enhanced using one or more of the following techniques: riparian planting, erosion control, invasive species control and wildlife habitat creation.

The majority of the opportunities listed were riparian planting and invasive species control. Himalayan balsam is prolific along the tributary east of Moodie Drive and numerous riparian planting opportunities were observed along the main channel of the creek and the tributaries surveyed.

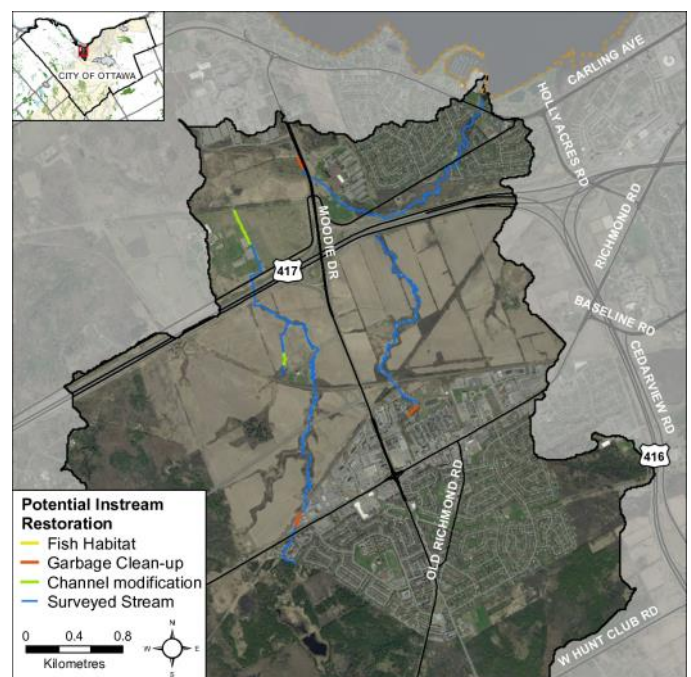
Figure 41 Potential instream restoration opportunities

Figure 41 depicts the locations where City Stream Watch staff and volunteers made note of areas where there were one or more of the following instream restoration opportunities: fish habitat enhancement, garbage cleanup and channel modification.

Three areas were identified for stream cleanups, all near road crossings in the developed areas of Stillwater Creek. In addition, two locations where stream channelization had occurred were identified for channel modifications. An additional opportunity exists to remove the weir located downstream of Moodie Drive.

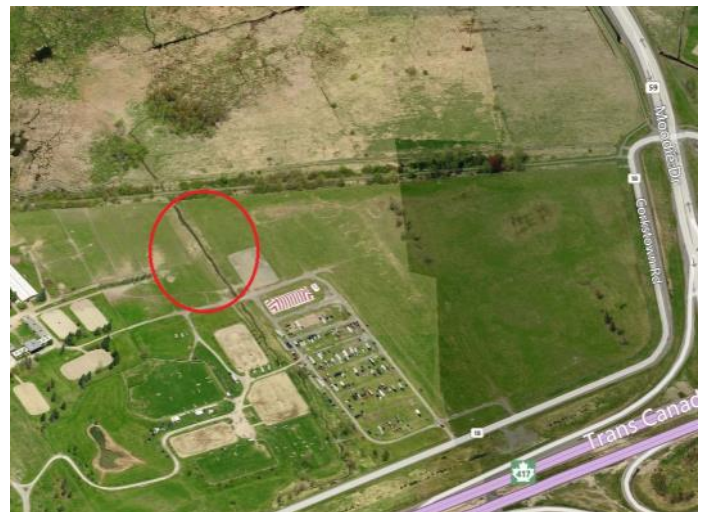
Location where channel modification opportunity was identified on Stillwater Creek

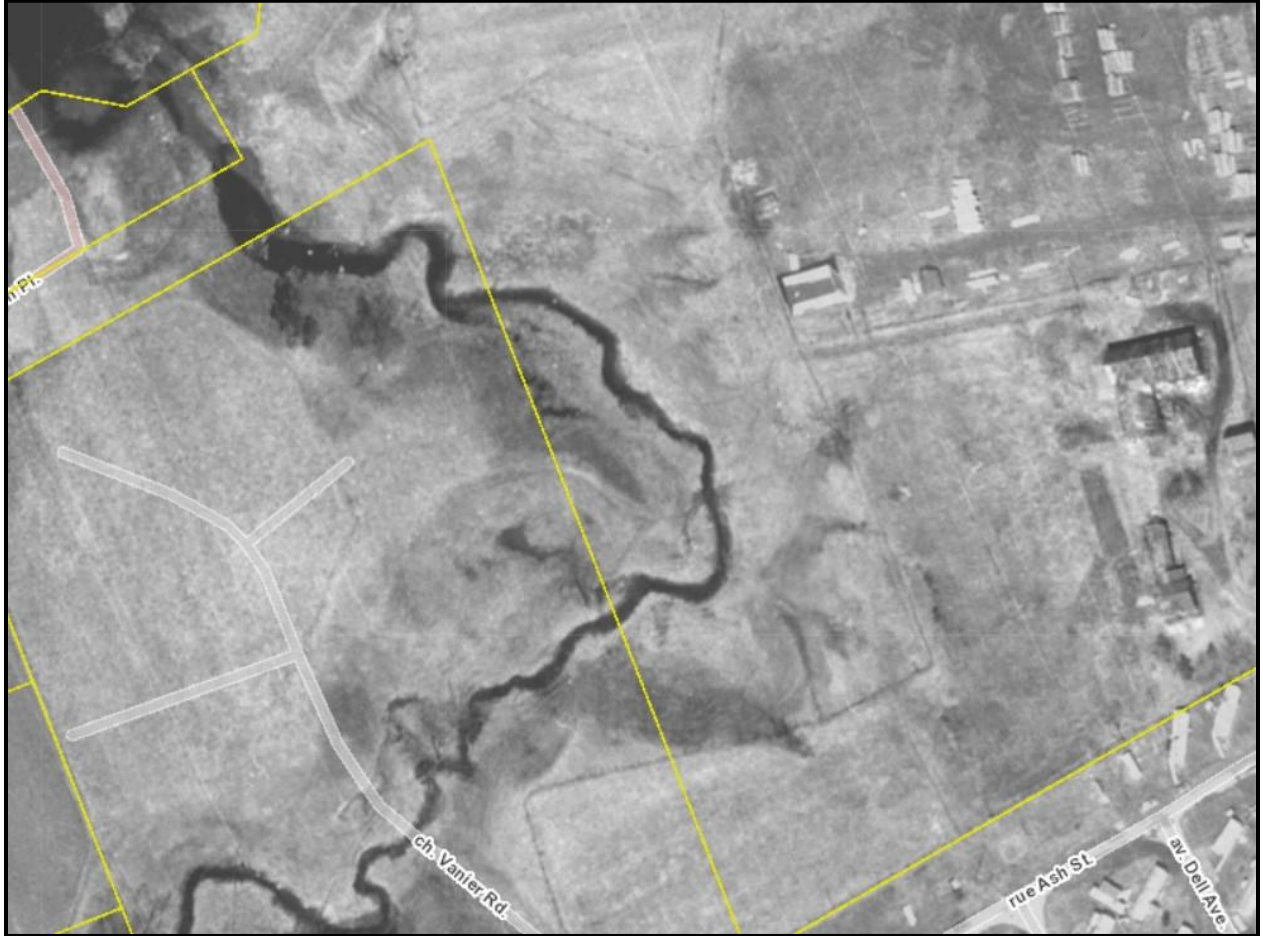
FIGURE 2

1958 AERIAL IMAGE

Based on historical aerial images of the slope face obtained from GeoOttawa, the natural course of the creek has been altered due to fill placement within the subject site. When aerial images of the creek from 1958 and 2011, shown in Figures 2 to 4 in Appendix 2, are compared the natural course of the creek was observed to have shifted to the west and the meander shapes were altered. In-filling at the site has forced the water course to re-establish further west.

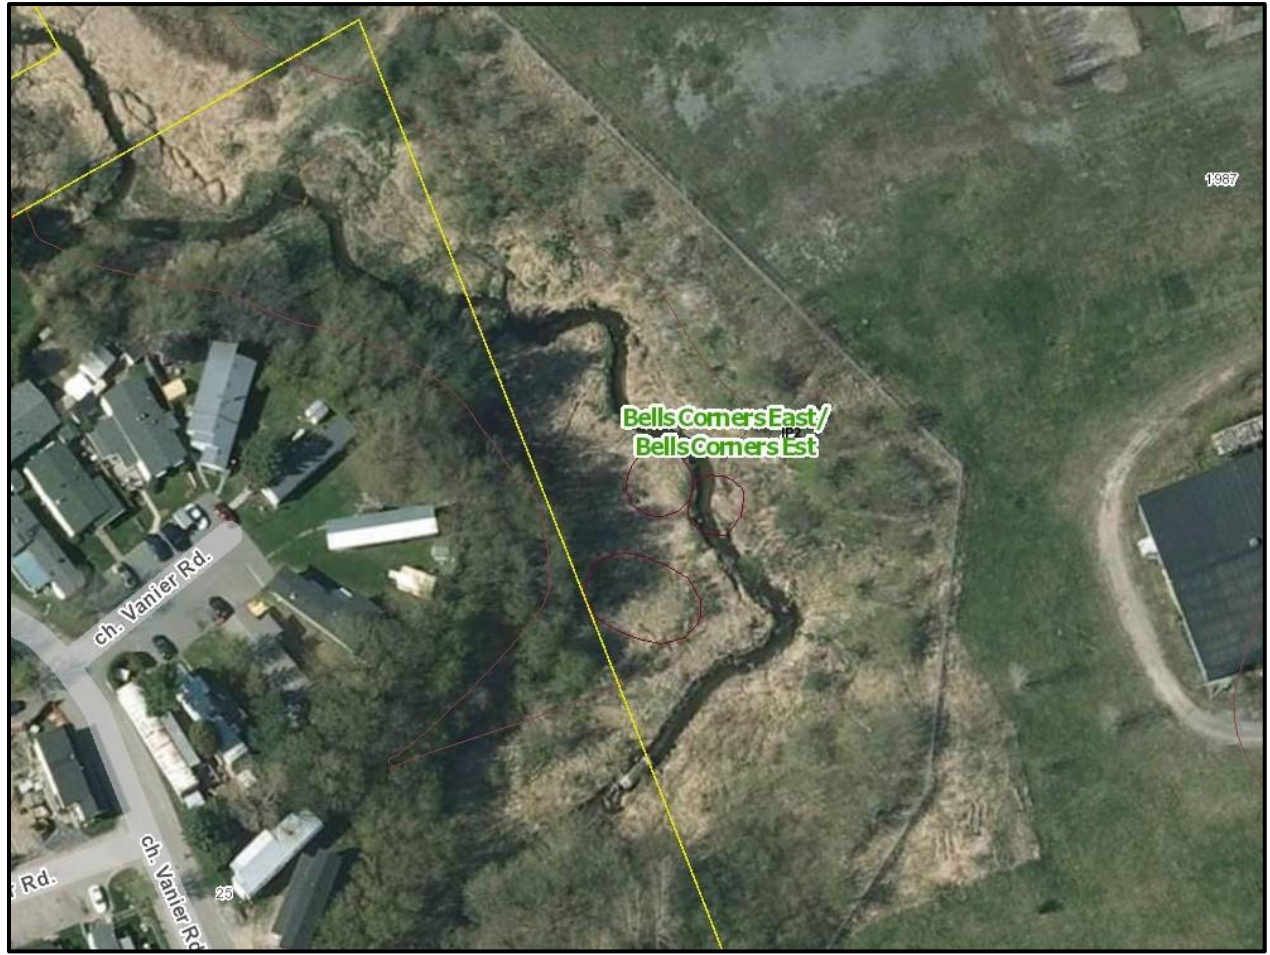
FIGURE 3

2011 AERIAL IMAGE

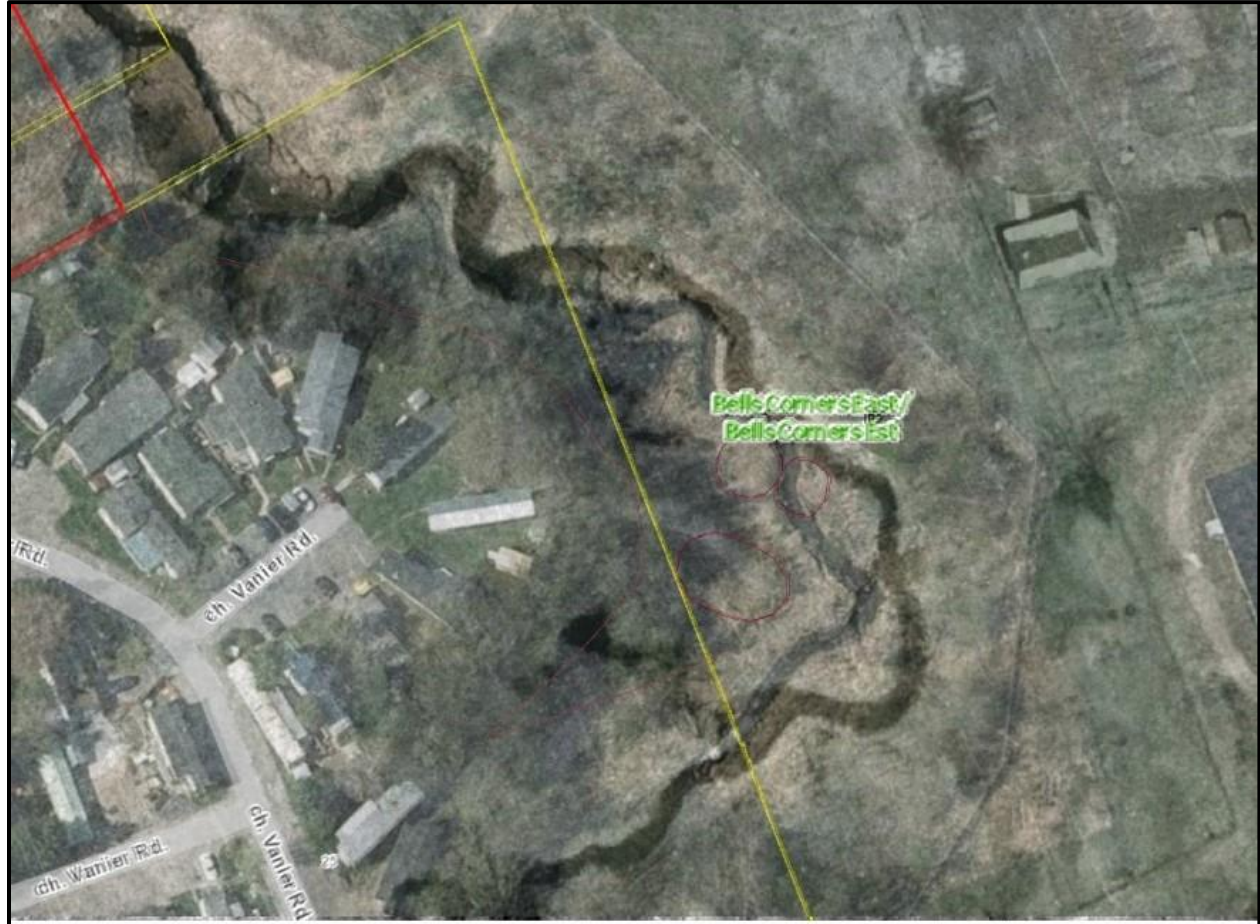
FIGURE 4

OVERLAY OF 1958 & 2011 AERIAL IMAGES

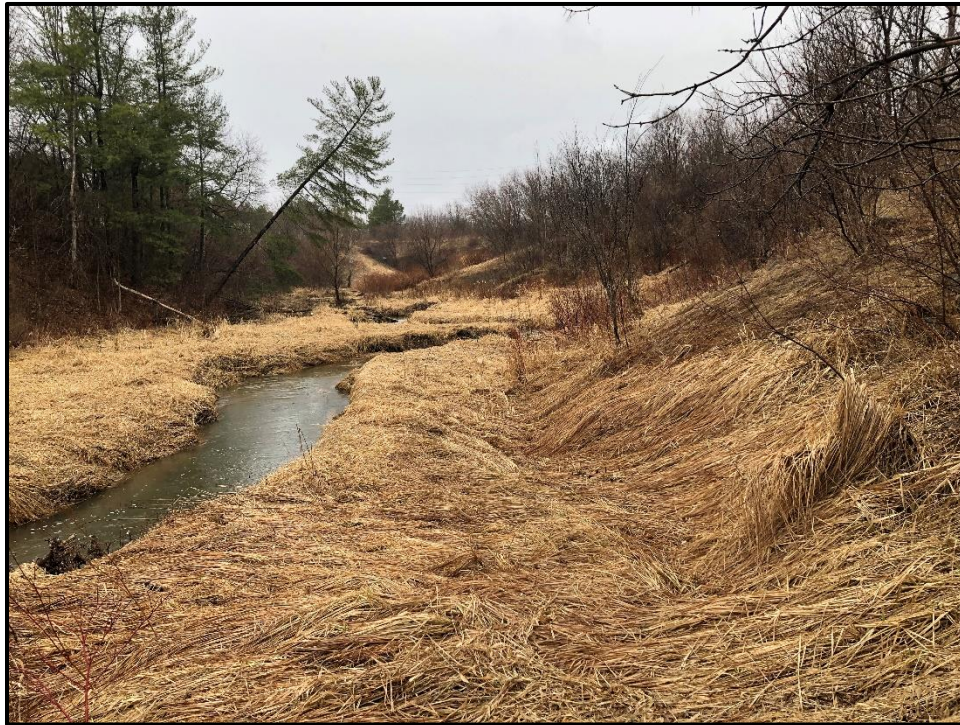
Photo 2: Photograph of Stillwater Creek and toe of slope taken at the west portion of the site towards the north illustrating grass covered side slopes, minor toe erosion was observed.

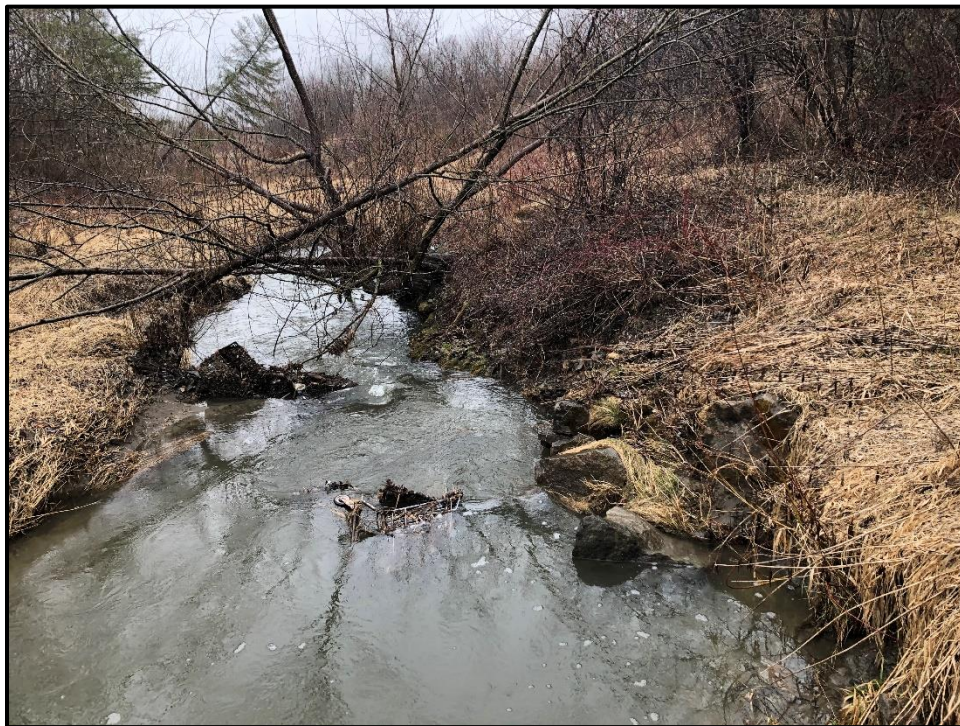
Photo 3: Photograph from the creek looking east towards the top of slope illustrating fill on the slope.

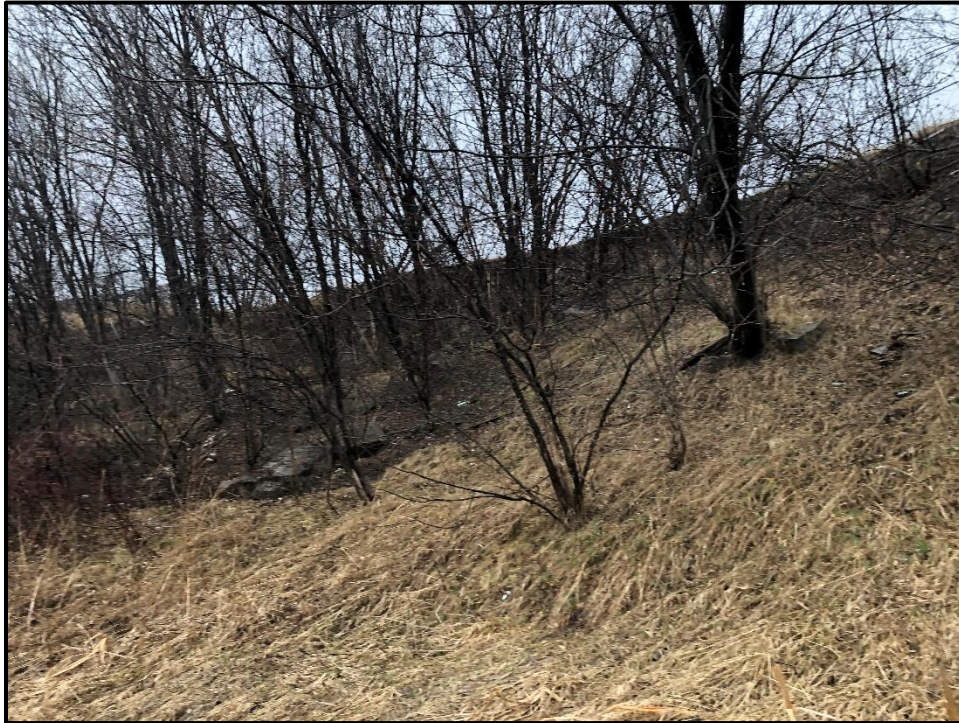
Photo 4: Photograph from the top of slope looking west towards the creek illustrating fill on the slope.

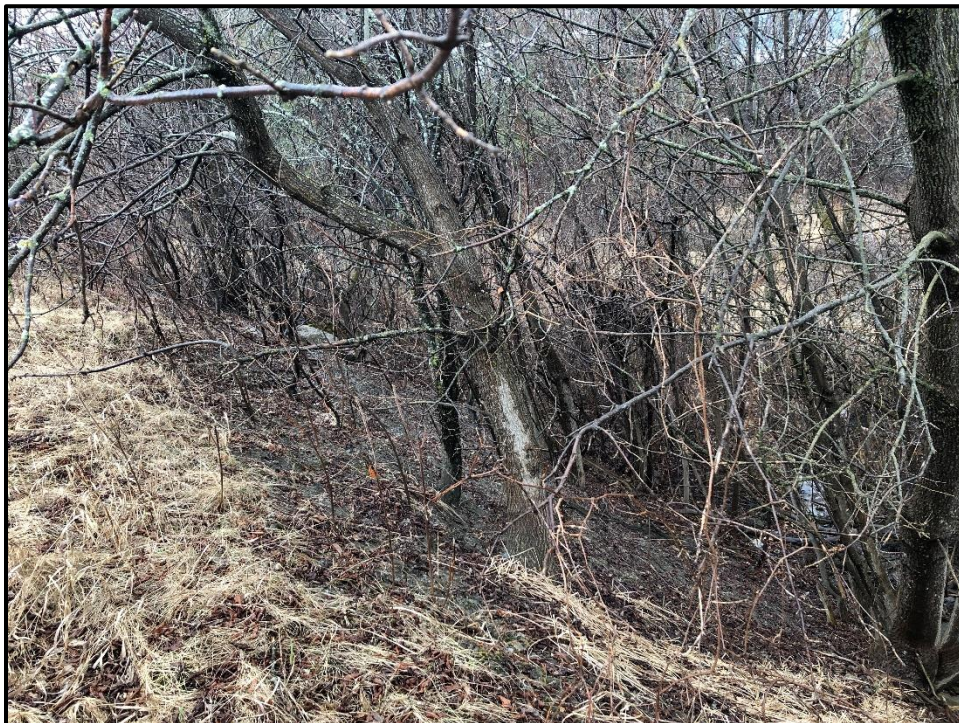
Figure 5 - Section A - Static Conditions

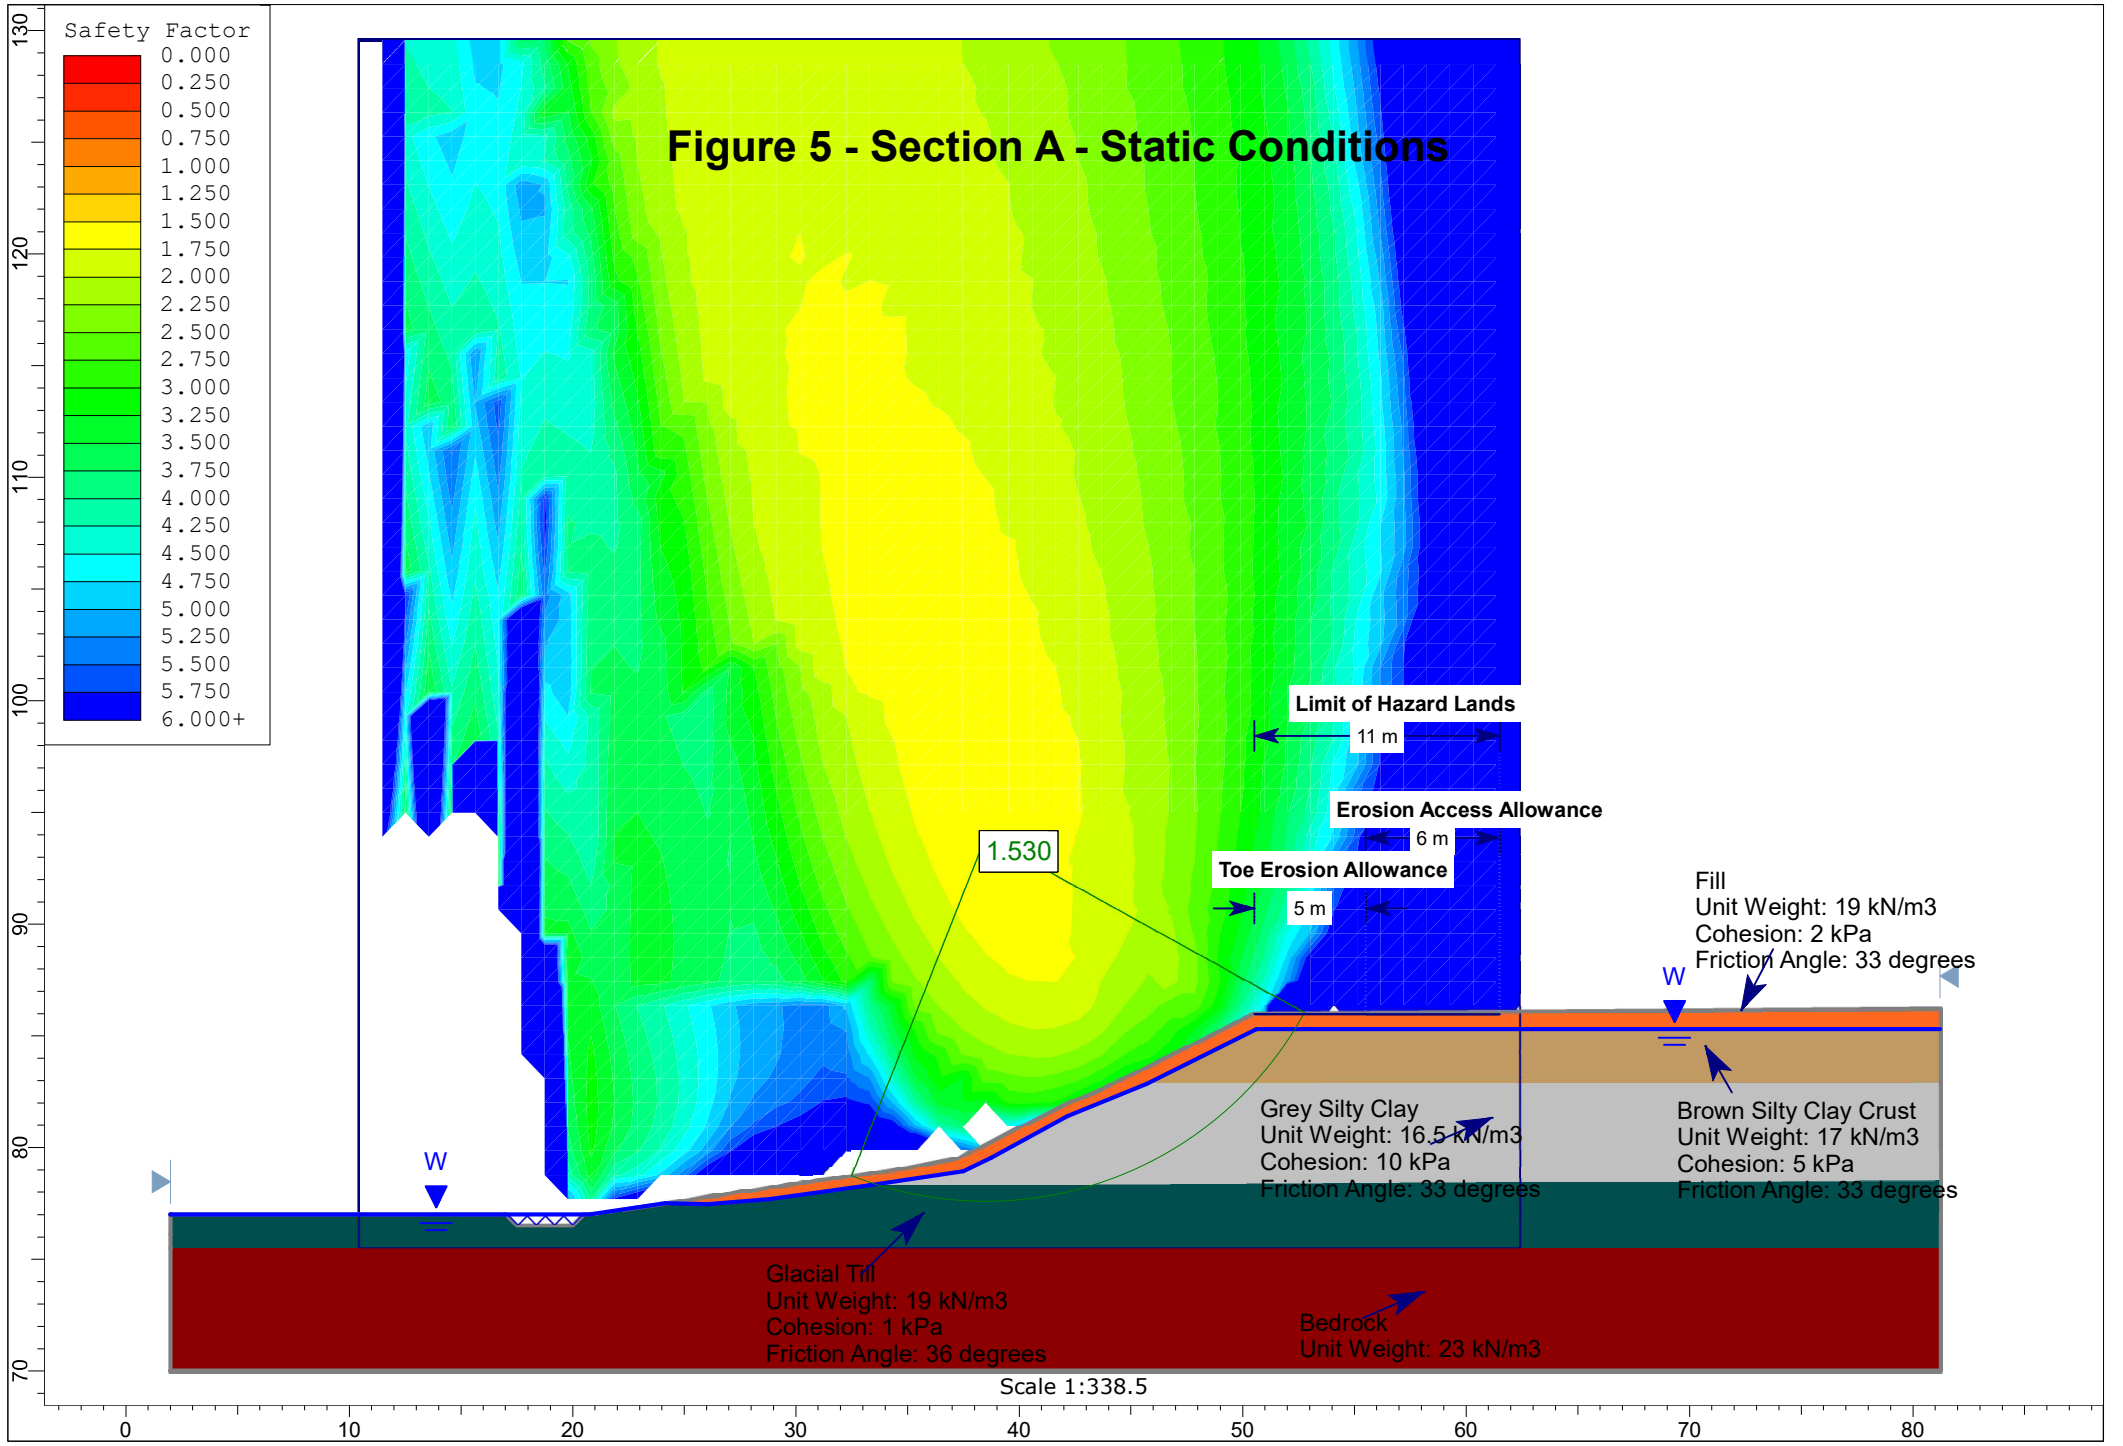
Limit of Hazard Lands

Bedrock
Unit Weight: 23 kN/m3

Subsoil conditions at the cross-sections were inferred based on nearby boreholes. For a conservative review of the groundwater conditions, the silty clay deposit was noted to be fully saturated for our analysis and existing at the toe of the slope. The results are shown in Figures 5, 7, 9 and 11 in Appendix 2. The results indicate a slope with a factor of safety of 1.53 at Section A and slopes with factors of safety less than 1.5 beyond the top of slope at Section B, C and D. Based on these results, a stable slope setback varying between 9 and 15 m from the top of the slope are required to achieve a factor of safety of 1.5 for the limit of the hazard lands in the area of Sections B, C and D.

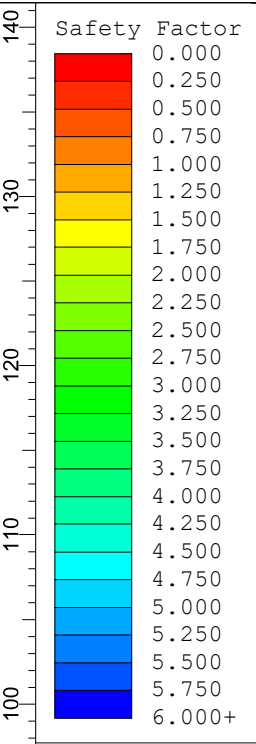
Figure 6 - Section A - Seismic Conditions

1.358

Limit of Hazard Lands

Bedrock
Unit Weight: 23 kN/m³

The results of the analyses including seismic loading are shown in Figures 6, 8, 10 and 12 in Appendix 2. The results indicate a slope with a factor of safety of 1.36 at Section A and 1.30 at Section D and slopes with factors of safety less than 1.1 beyond the top of slope at Section B and C. Based on these results, a stable slope setback varying between 1 and 5 m from the top of the slope is required to achieve a factor of safety of 1.1 for the limit of the hazard lands. However, it should be noted that the stable slope setback associated with our seismic loading analysis is superseded by the required stable slope setback required for static conditions.

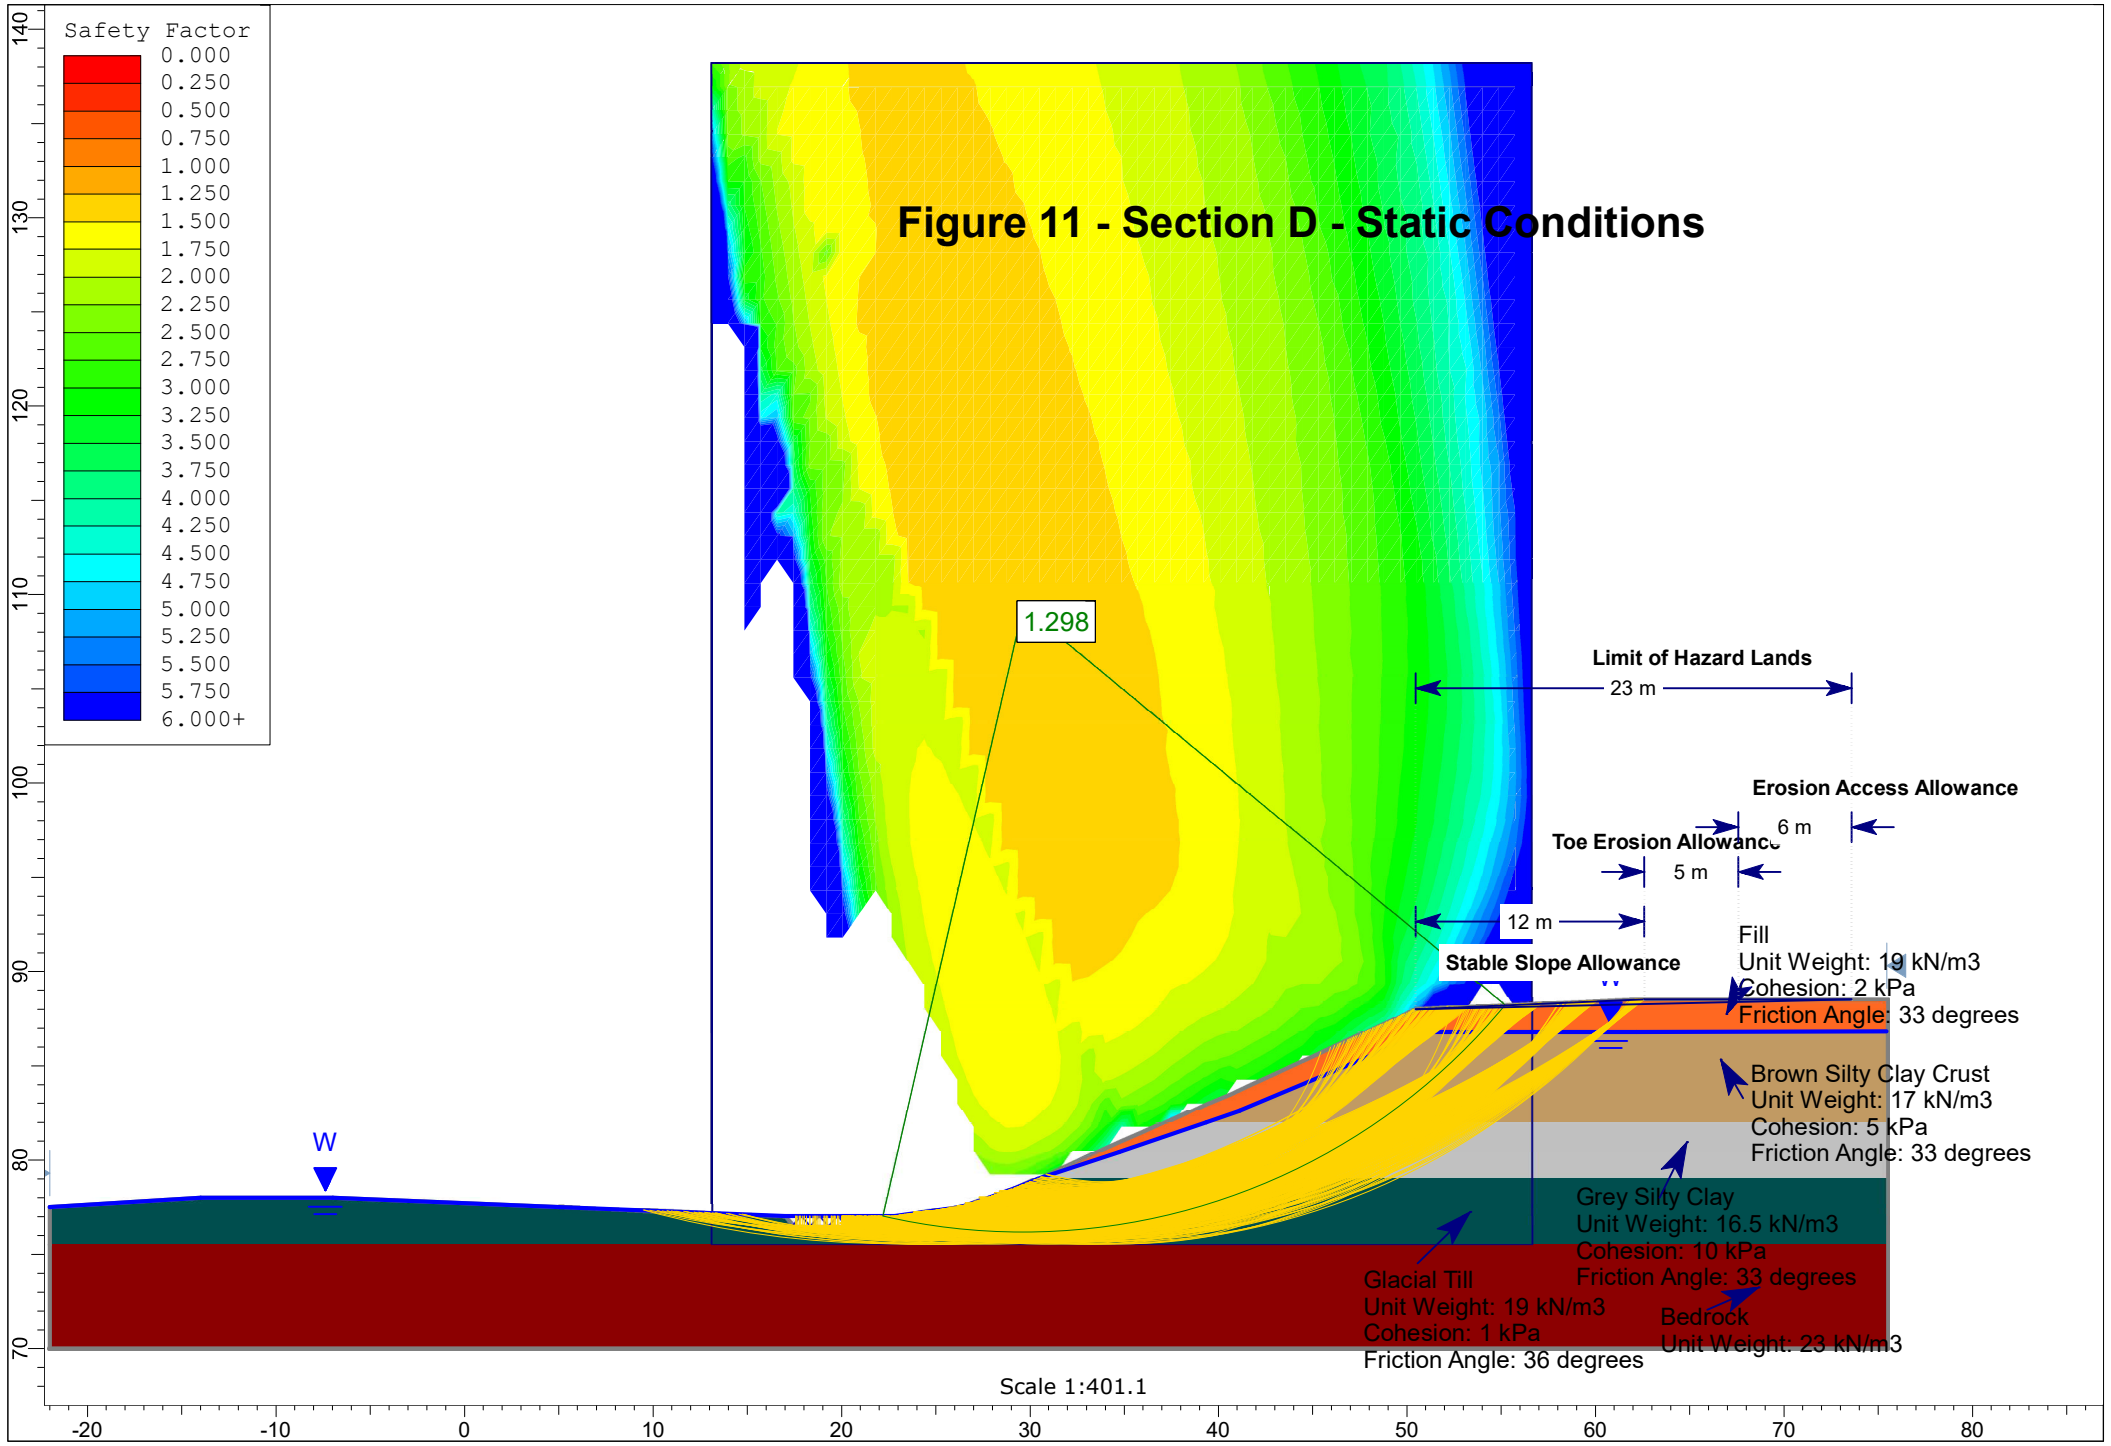
Figure 11 - Section D - Static Conditions

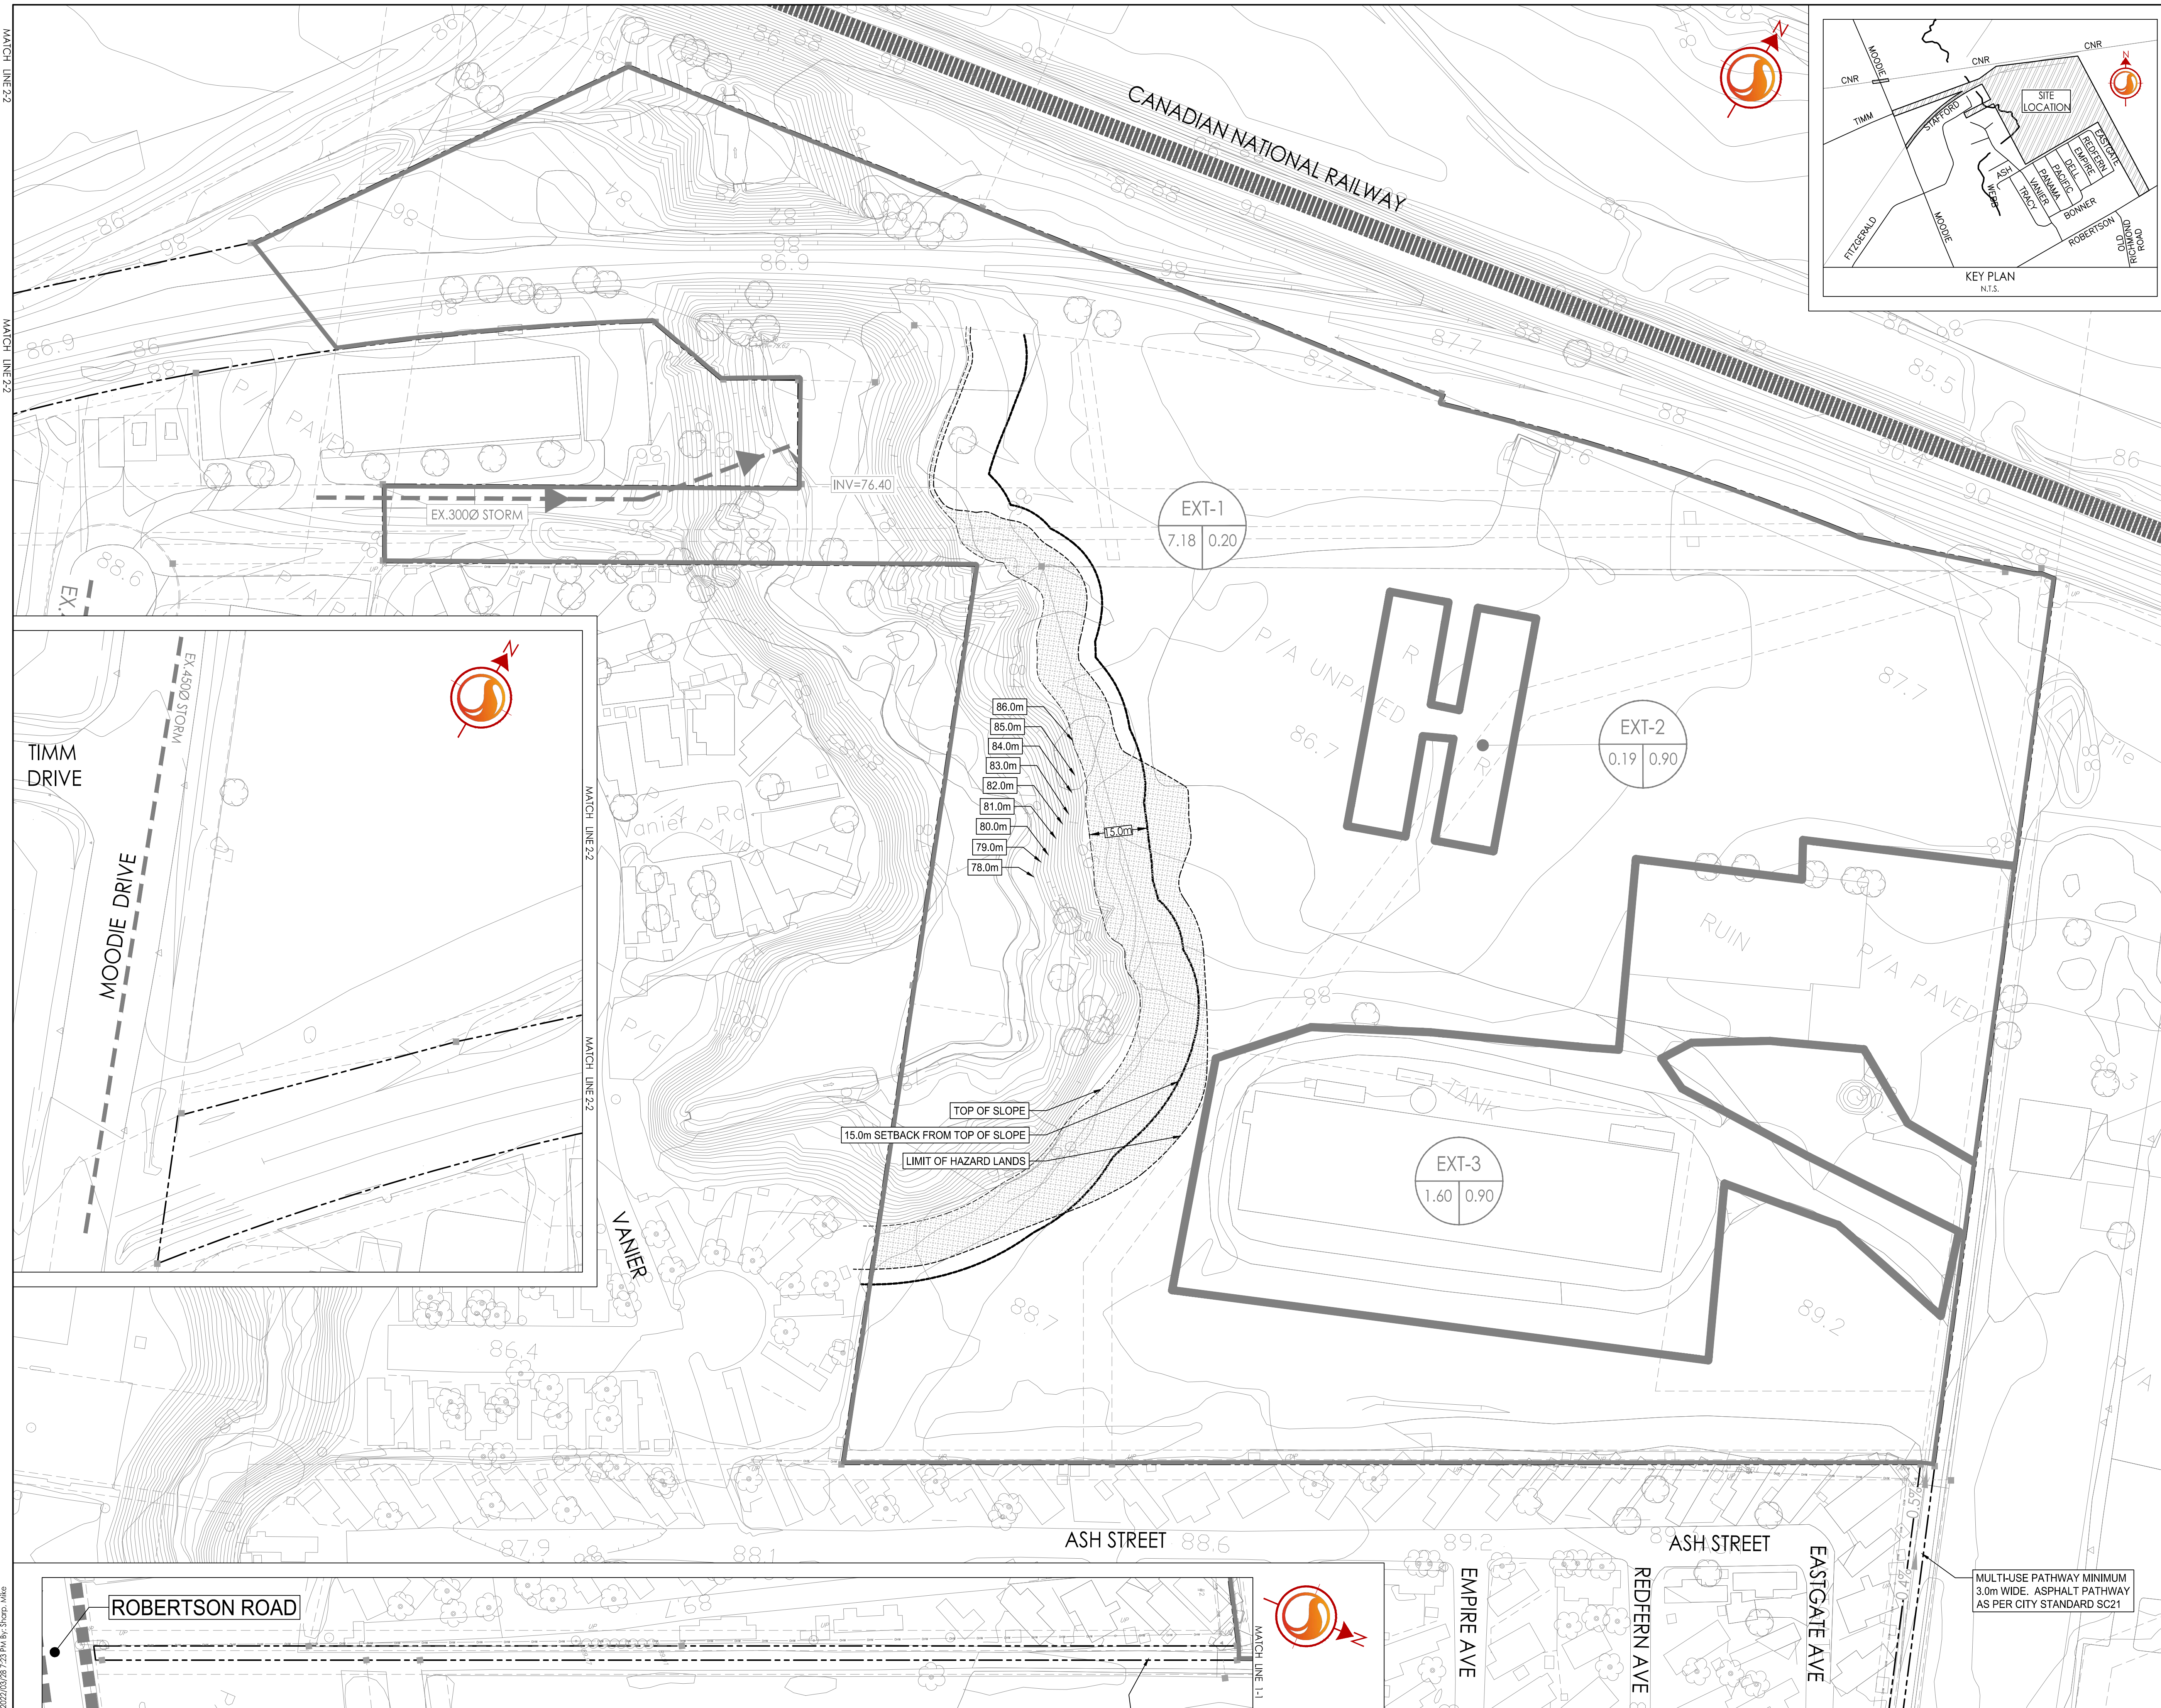
EX STM-1 1 of 5 1

- TWO OGS SYSTEMS ARE PROPOSED TO TREAT RUNOFF FROM THE SITE. OGS 1 (JFO6) IS TO BE LOCATED IN CATCHMENT AREA C109A TREATING RUNOFF FROM THE COLLECTOR ROAD PRIOR TO DISCHARGING TO THE CREEK. OGS 2 (JFO12) IS TO BE LOCATED DOWNSTREAM OF THE CISTERN IN THE CELEBRATORY SPACE.
