**Functional Site Servicing and
Stormwater Management
Report – 1987 Robertson Road
(Stillwater Station)**

Job #160401686

Prepared for:
The Properties Group
Management Ltd.

Prepared by:
Stantec Consulting Ltd.
1331 Clyde Avenue
Ottawa, Ontario
K2C 3G4

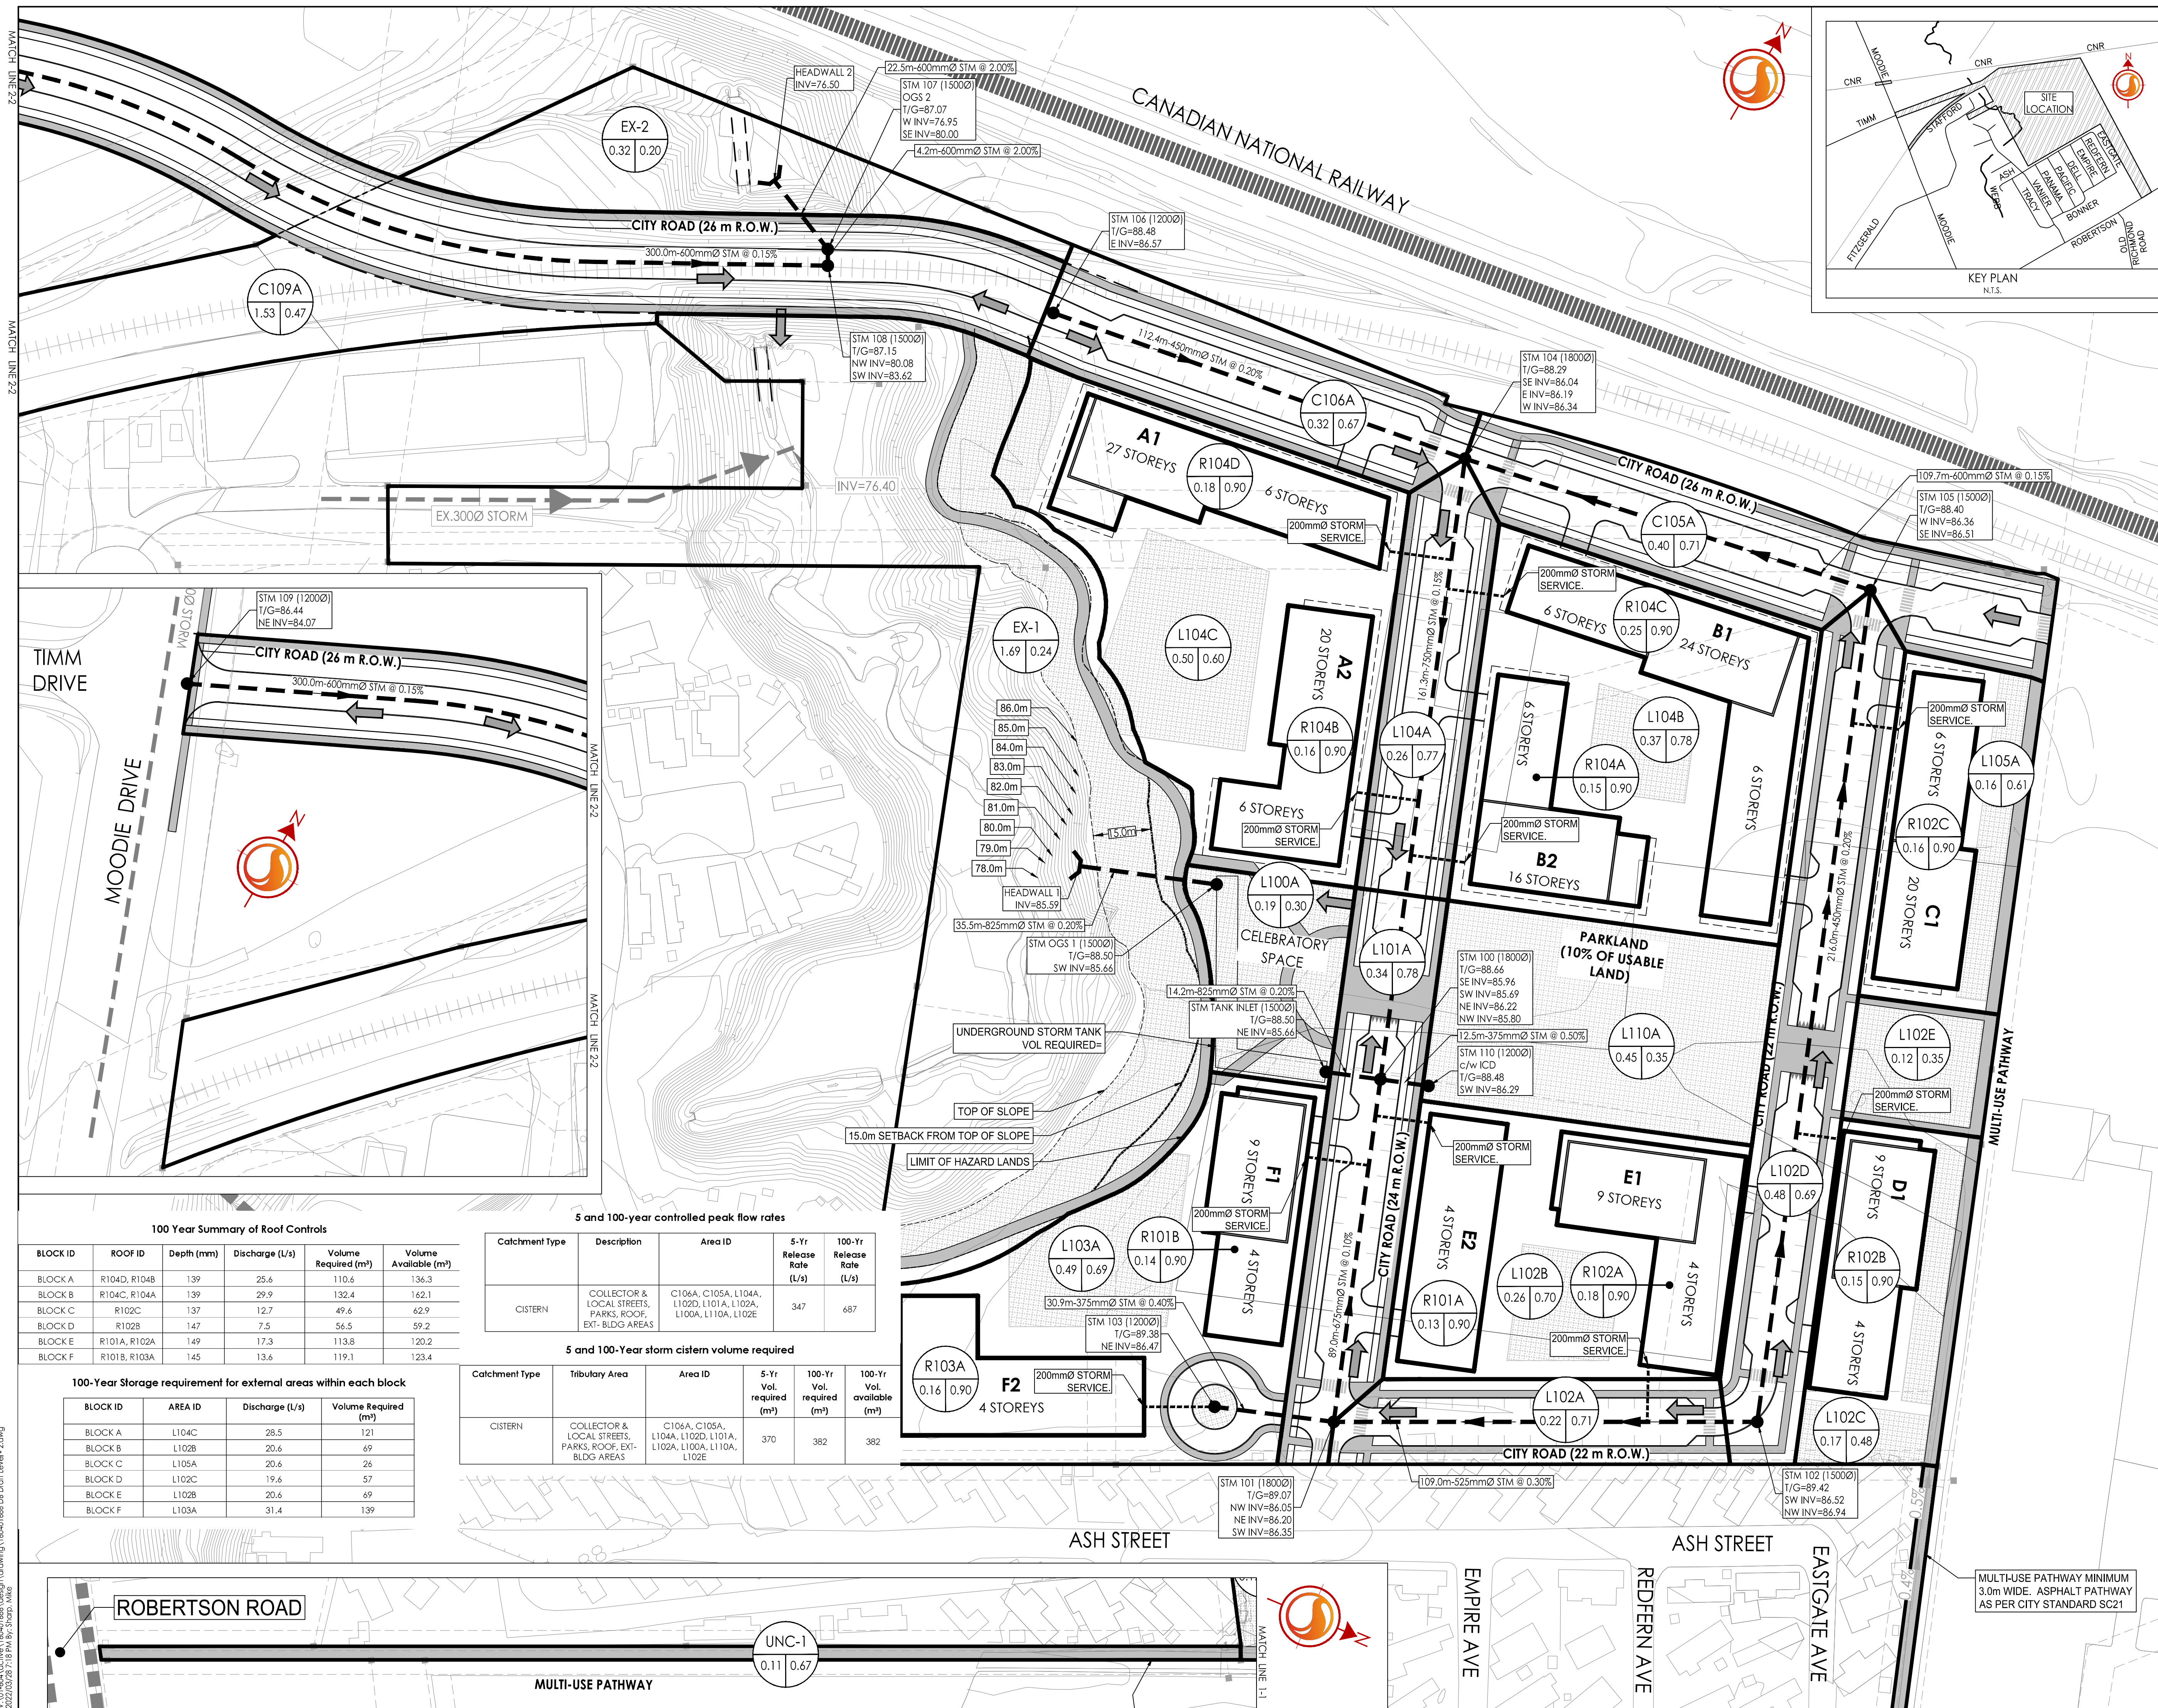
STORM SEWER NETWORK AND
DRAINAGE PLAN

100 Year Summary of Roof Controls

BLOCK ID	ROOF ID	Depth (mm)	Discharge (L/s)	Volume Required (m³)	Volume Available (m³)
BLOCK A	R104D, R104B	139	25.6	110.6	136.3
BLOCK B	R104C, R104A	139	29.9	132.4	162.1
BLOCK C	R102C	137	12.7	49.6	62.9
BLOCK D	R102B	147	7.5	56.5	59.2
BLOCK E	R101A, R102A	149	17.3	113.8	120.2
BLOCK F	R101B, R103A	145	13.6	119.1	123.4
