**Stillwater Station Functional
Site Servicing and Stormwater
Management Report**

Job #160401686

Prepared for:
The Properties Group
Management Ltd.

Prepared by:
Stantec Consulting Ltd.
1331 Clyde Avenue
Ottawa, Ontario
K2C 3G4

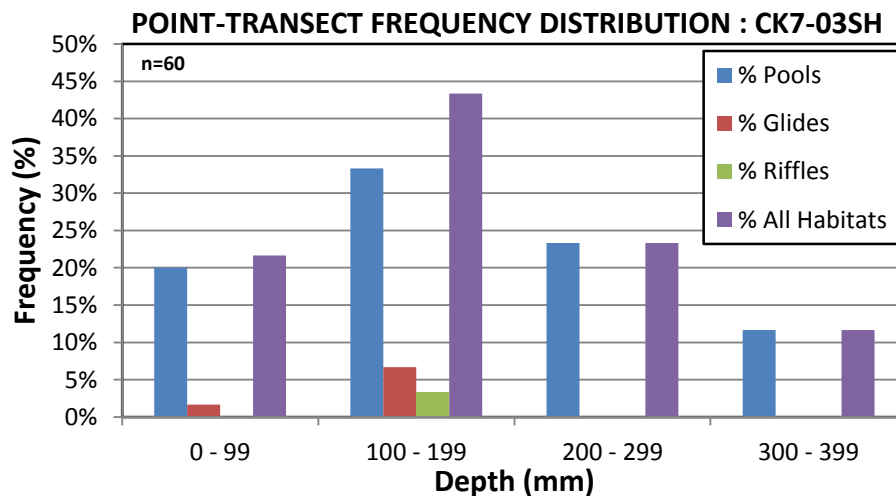
The results of the habitat assessment for site CK7-03SH are summarized in Figure 6. The analysis revealed a total habitat area of approximately 170.3m², consisting of 89% pool habitat, 8% glides and 3% riffles. Embedded cover was observed over approximately 30% of the site, and consisted primarily of rocks and macrophytes. Unembedded cover included rocks, macrophytes and wood, and was observed over approximately 70% of the site (Appendix IV).

Figure 6. Frequency distribution of habitat types/stream velocities at 100mm intervals for site CK7-03SH

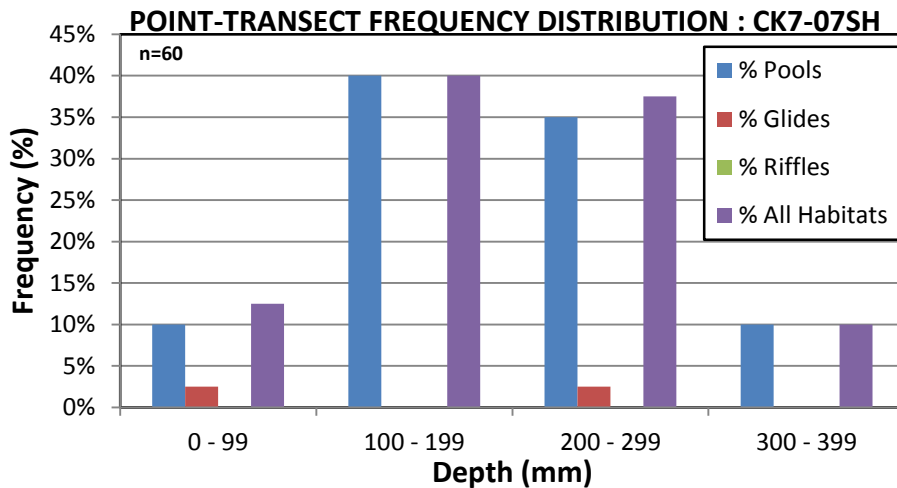
The results of the habitat assessment for site CK7-07SH are summarized in Figure 10.

Figure 10. Frequency distribution of habitat types/stream velocities at 100mm intervals for site CK7-07SH

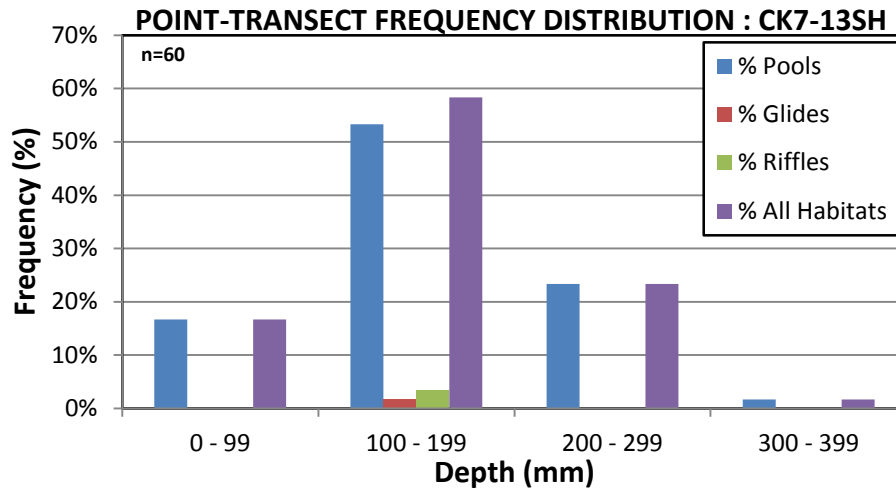
The results of the habitat assessment for site CK7-13SH are summarized in Figure 13. The analysis revealed a total habitat area of approximately 131.6m², consisting of 95% pool habitat, 2% glides and 3% riffles. Embedded cover was observed over approximately 12% of the site, and consisted solely of rock materials. Unembedded cover included flat and round rock, and was observed over approximately 57% of the site (Appendix IV).

Figure 13. Frequency distribution of habitat types/stream velocities at 100mm intervals for site CK7-13SH

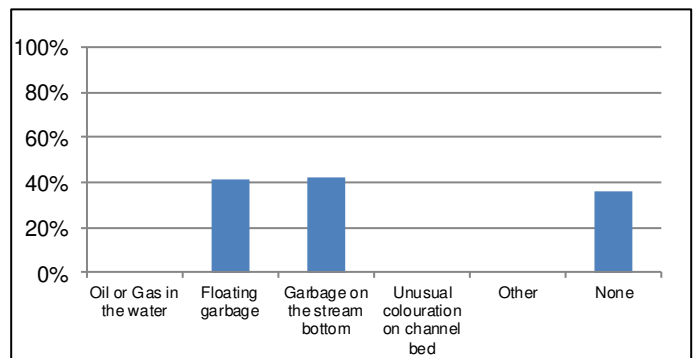
Figure 21 demonstrates the incidence of pollution/garbage in Stillwater Creek. Thirty six percent of the sections surveyed did not have any observable garbage. Forty two percent had garbage on the stream bottom and 41 percent had floating garbage. Many of the sections had both garbage on the stream bottom and floating garbage. These areas were located near road crossings or in the developed areas near Robertson Road and Corkstown Road.

Figure 21 Pollution observed along Stillwater Creek
