232 Donald B. Munro Drive

Headwater Drainage Feature Assessment

Bowfin Environmental Consulting Inc.
168 Montreal Road
Cornwall, Ontario
K6H 1B3

October 2021

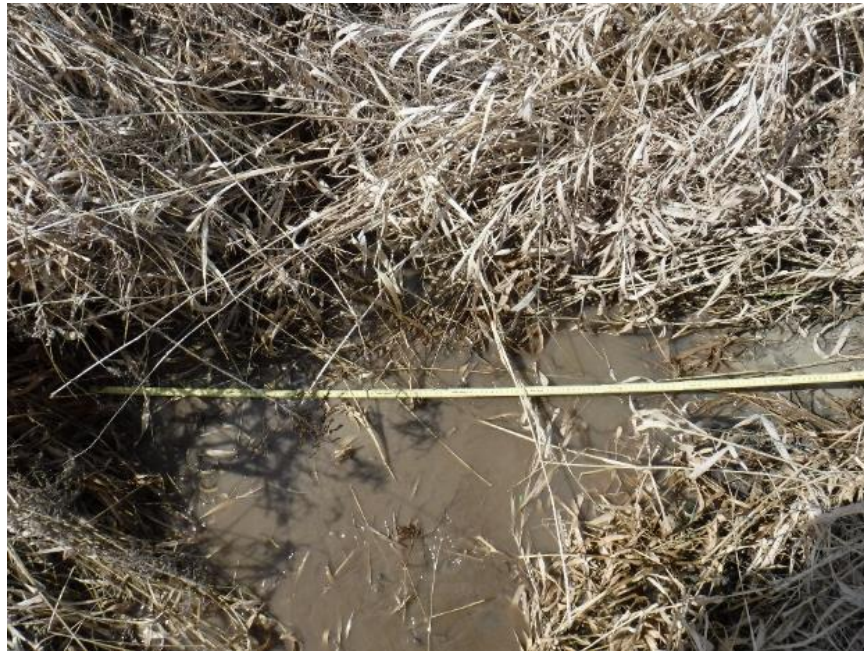
Photo A Downstream end of channel (vegetation was manually removed to allow for measurements) (March 30, 2021)

There are several barriers to fish, the first being the permanent, inlet catch basin at the downstream end which prevents Feature 1 from being fish habitat (confirmed with sampling April 2021). Just upstream of the drain the channel was heavily choked with reed canary grass without a distinct channel which would make movement difficult. Further upstream there are several smaller steps that could function as barriers to fish. The entire watercourse was dip netted downstream from station 1.
