patersongroup remedial action plan

to:	2828727 Ontario Inc Mr. Matthew Maxsom - mattm@ystreetcapital.com							
re:	Environmental Remedial Action Plan							
	Proposed Residential Development - 249 & 255 Richmond Road and 372							
	Tweedsmuir Avenue,							
	Ottawa, Ontario							
date:	March 4, 2022							
file:	PE5365-RAP.01							
from:	Nick Sullivan

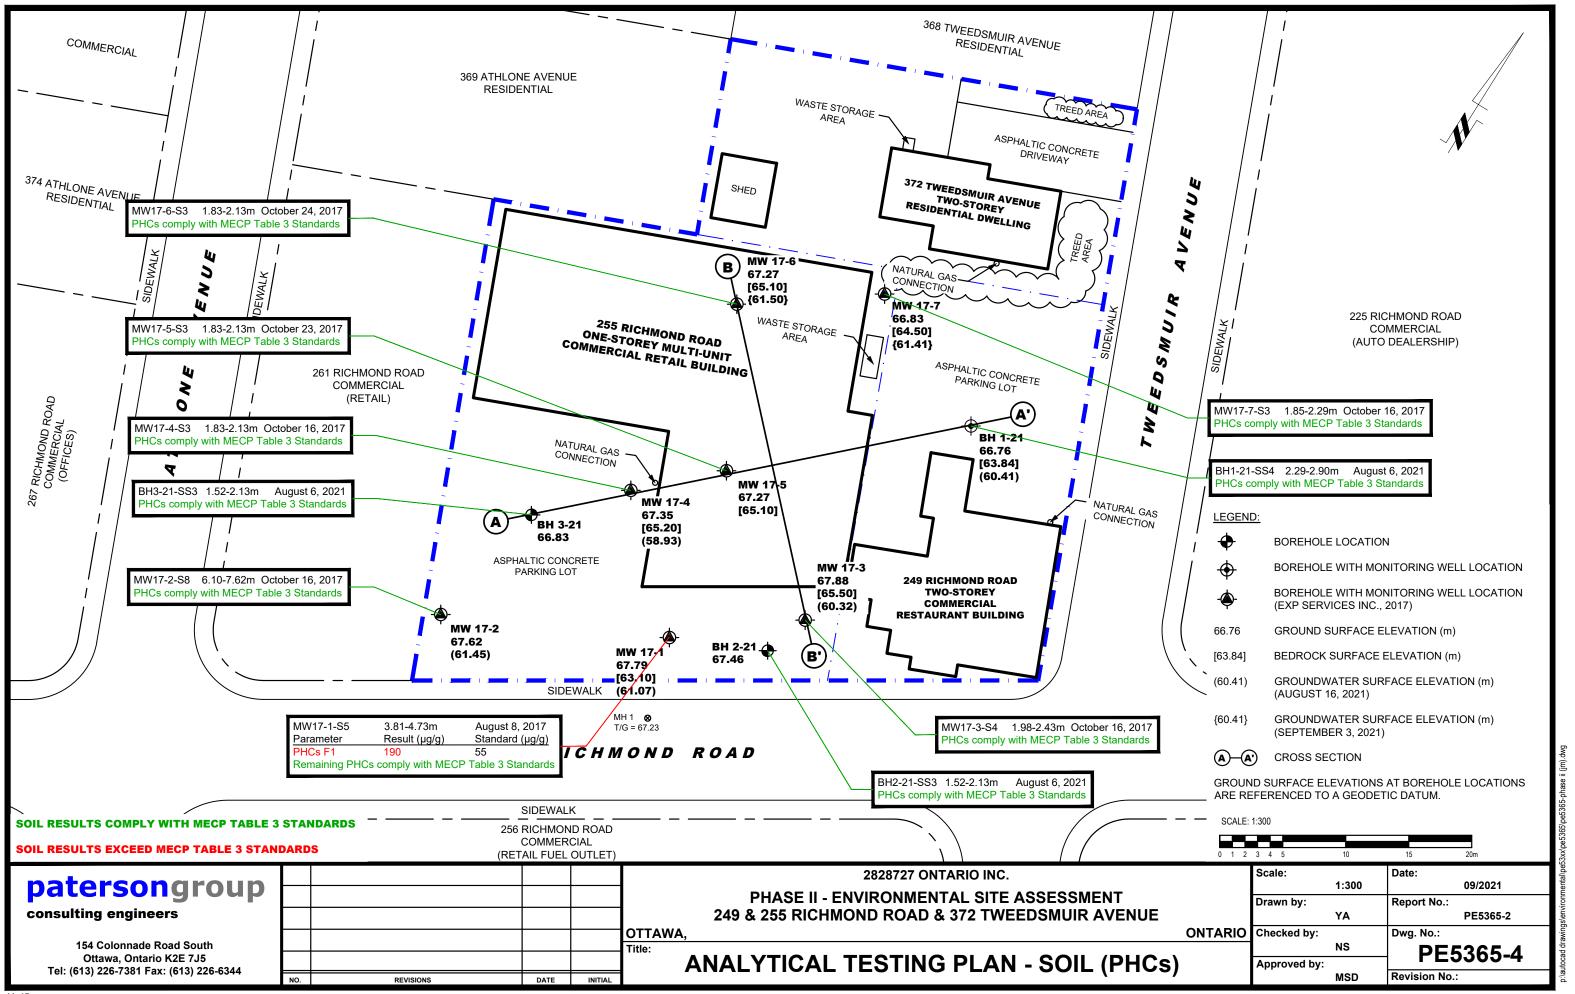
)	Drawing	PE5365-4 -	- Analvtical	Testina	Plan	- Soil	(PHC	s'
1	Drawing	PE5365-4 -	- Analytical	i esting	Plan	- 5011	(Pi	٦C

Five soil samples were submitted for laboratory analysis of BTEX, PHCs (F1-F4), metals, EC, SAR, and pH parameters. Based on the analytical test results, all detected parameter concentrations are in compliance with the MECP Table 3 residential soil standards. Based on the analytical test results obtained from EXP's 2017 Phase II ESA, the concentration of PHCs F1 in the soil beneath the southern portion of the subject site (MW17-1) is in excess of the MECP Table 3 residential soil standards.

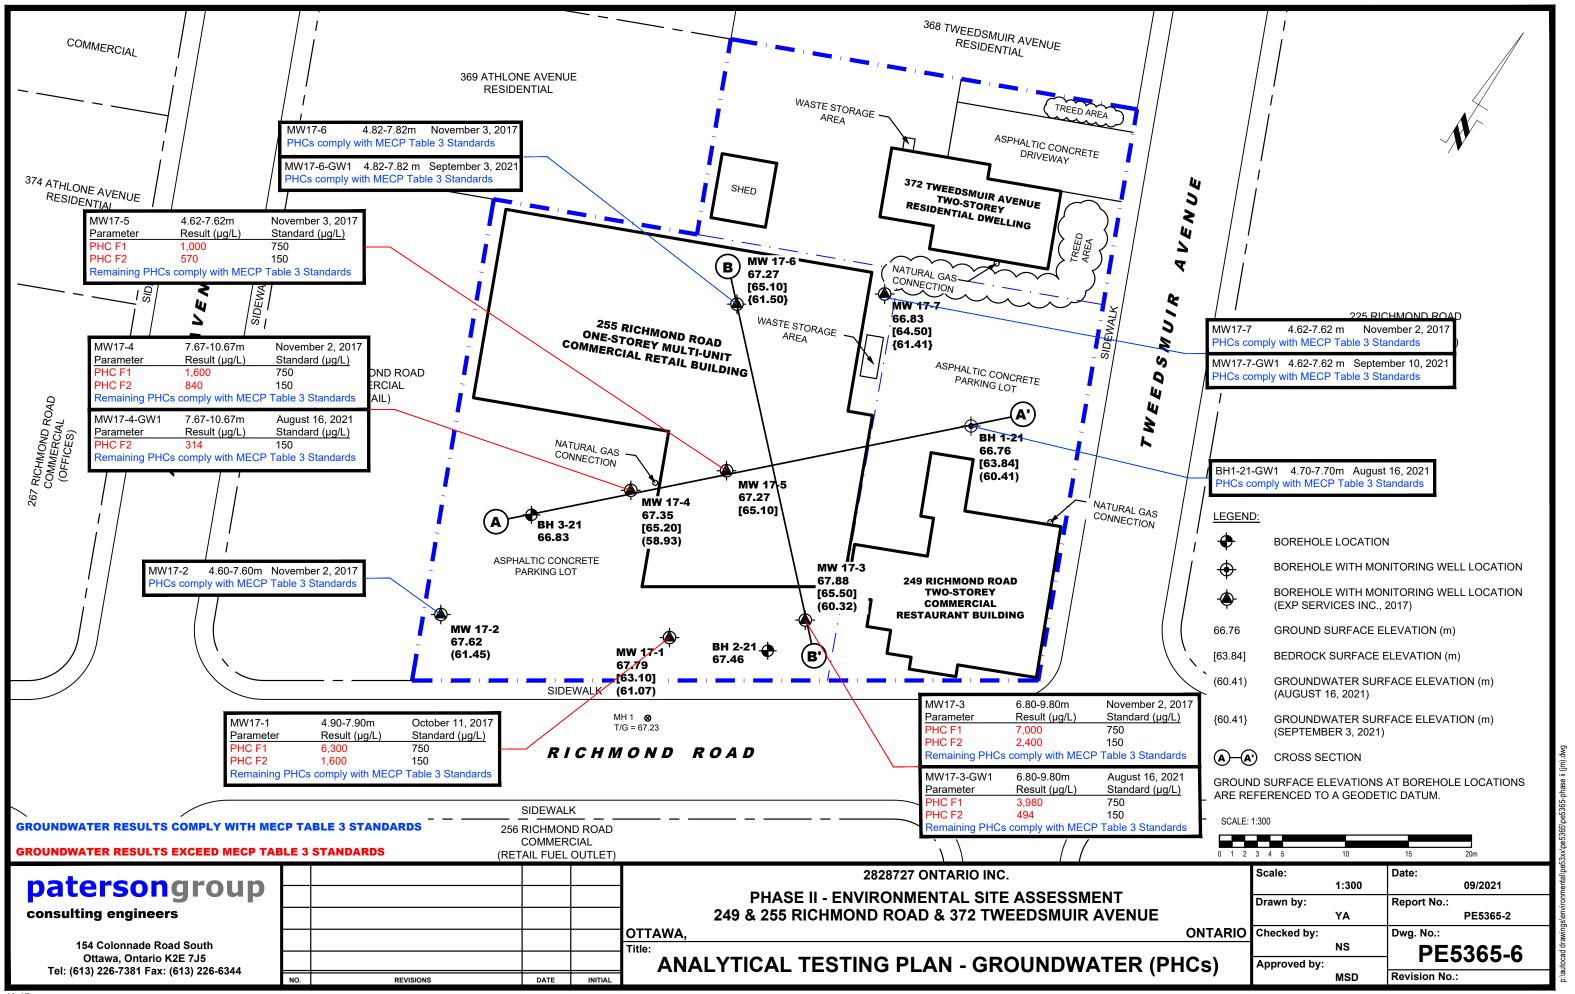
- □ Drawing PE5365-6 Analytical Testing Plan Groundwater (PHCs)
- ☐ Drawing PE5365-7 Analytical Testing Plan Groundwater (VOCs)

Groundwater samples were recovered from the monitoring wells installed in BH1-21, MW17-2, MW17-3, MW17-4, MW17-6, and MW17-7 and submitted for laboratory analysis of PHCs (F1-F4) and/or VOCs. Based on the analytical results, the concentrations of benzene and PHCs (F1 and/or F2) detected in the groundwater at MW17-1, MW17-3, MW17-4, as well as MW17-5 are in excess of the selected MECP Table 3 non-potable groundwater standards.
