PH4593-LET.01

Subject: **Hydrogeological Risk Brief**

**Proposed Multi-Story Building**

5497 Manotick Main Street, Ottawa, Ontario

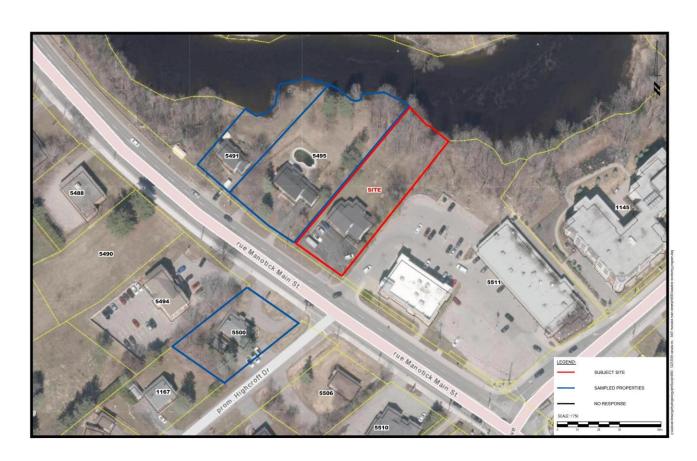
Figure 1 – Sample Location Plan

The municipal addresses selected, as shown in Figure 1 - Sampling Location Plan, are as follows:

- ☐ 5491 Manotick Main Street
- ☐ 5495 Manotick Main Street
- ☐ 5500 Manotick Main Street
