PHASE ONE ENVIRONMENTAL SITE ASSESSMENT

5497 MANOTICK MAIN STREET, OTTAWA, ONTARIO

Client: 12213559 Canada Inc.
Date: September 20, 2021
Project #: 11462

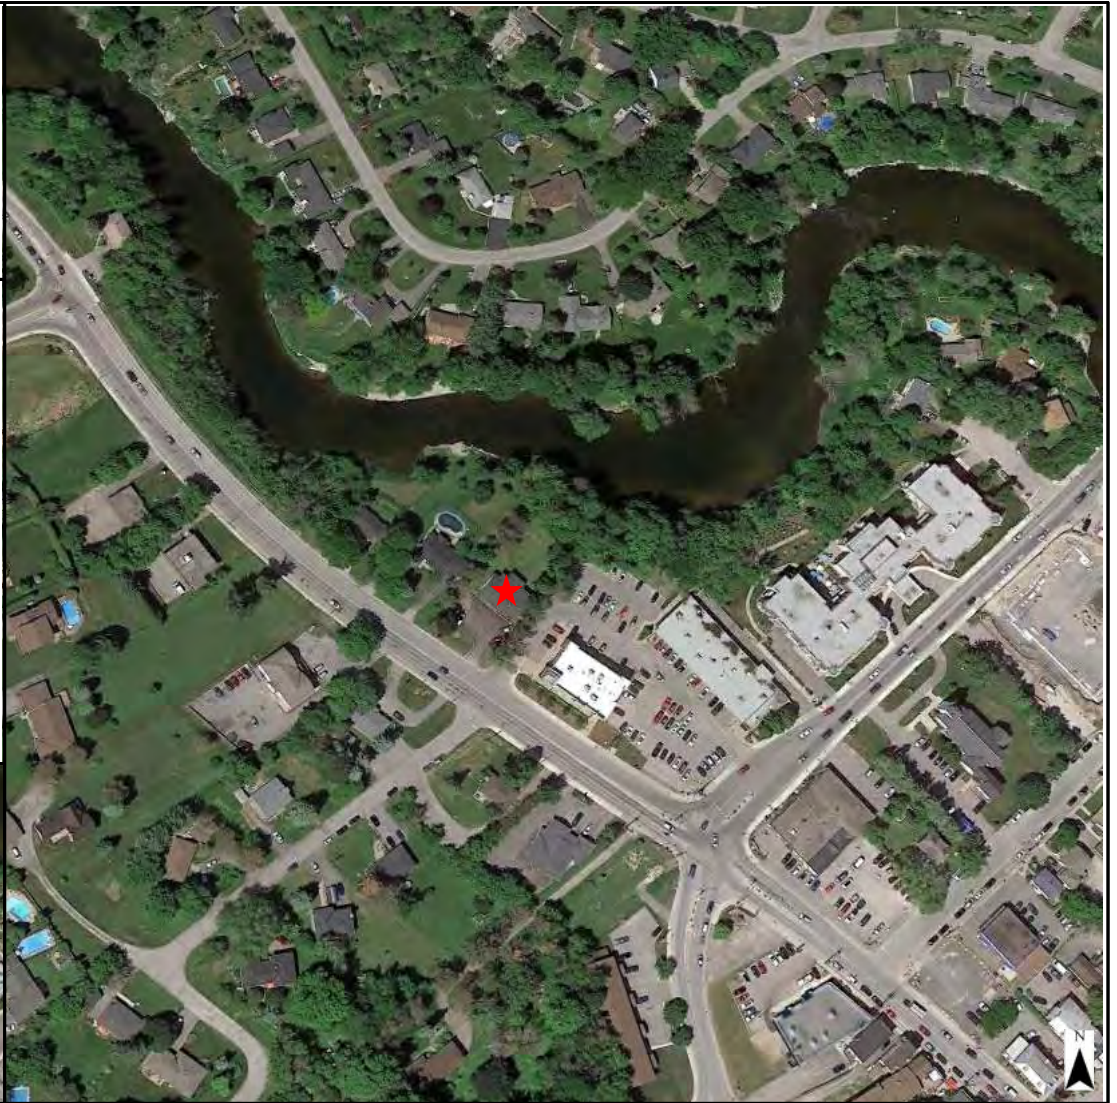
Phase 1 Site Assessment Ontario Base Map Figure 3

According to LIO, the site at an approximate elevation of 85.88 m asl. The local site topography significantly slopes southwest to northeast towards the river (see Figure 3).

The closest visible body of water is Rideau River, located <5m north of the site (see Figure 3). Based on local and regional topography the inferred direction of groundwater flow is to the northeast.

The closest visible body of water is Rideau River, located <5m north of the site (see Figure 3). Based on local and regional topography the inferred direction of groundwater flow is to the northeast.

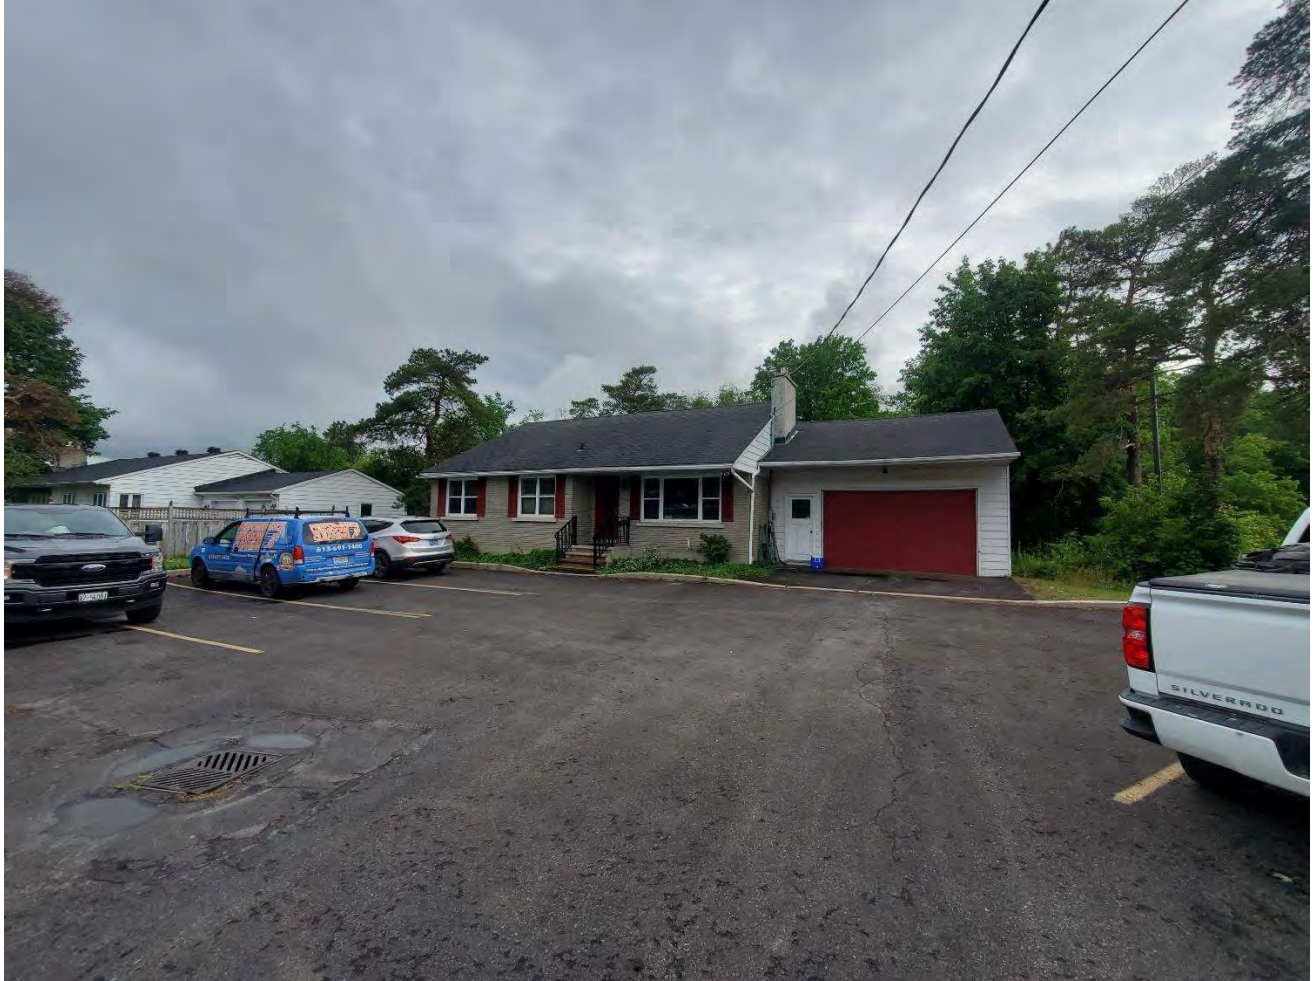
Photo 1: Facing North, the “site” consists of one storey residential building. The southern portion of the site is asphalt covered and serves as a parking area. The property until 2020 was used as a commercial real estate brokerage (Solid Rock Realty).

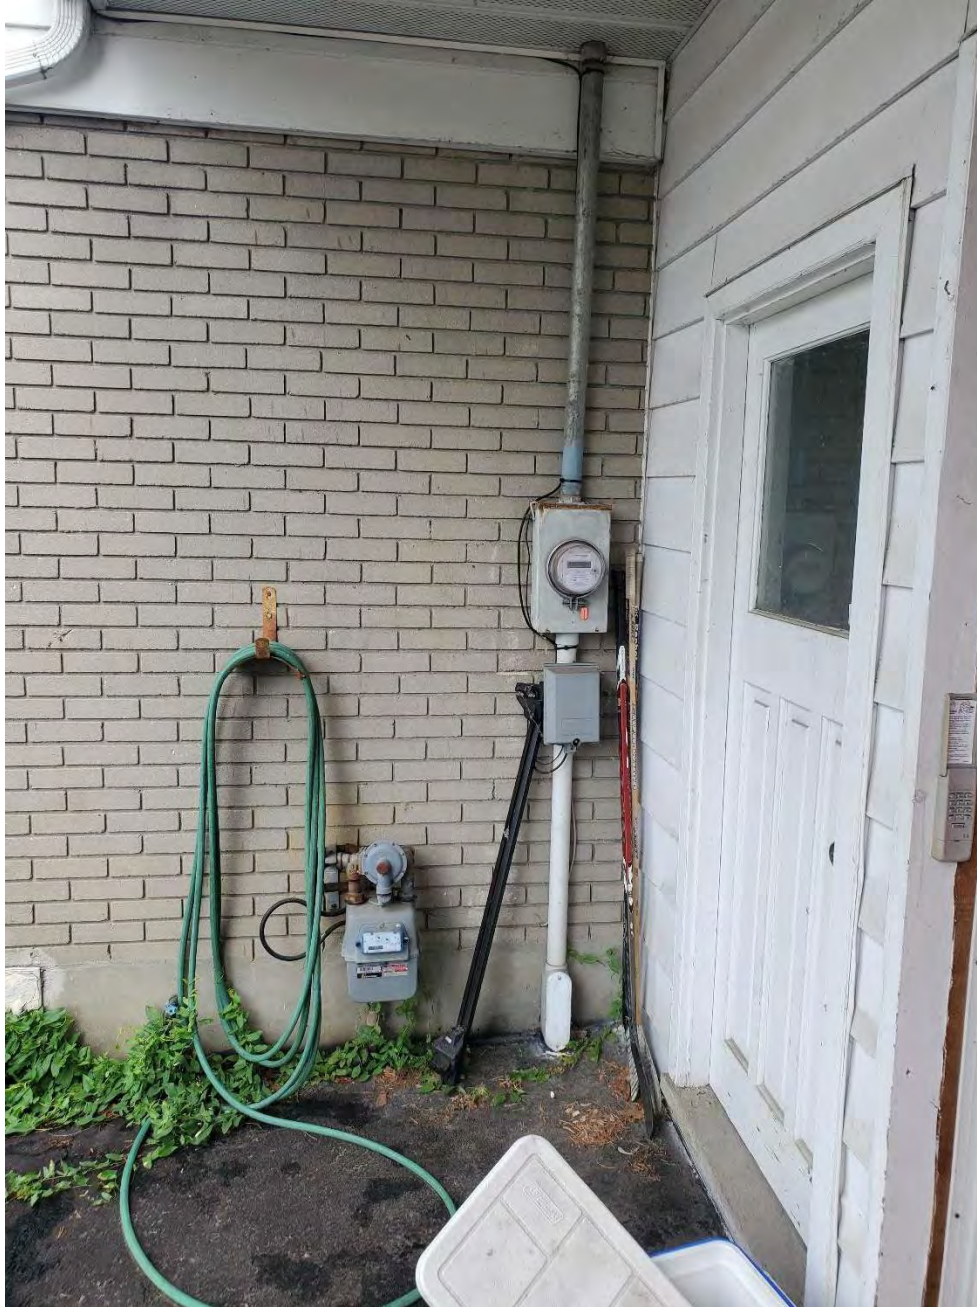
Photo 2: Facing northwest, Gas and overhead hydro lines enter the property from the east side of the building.

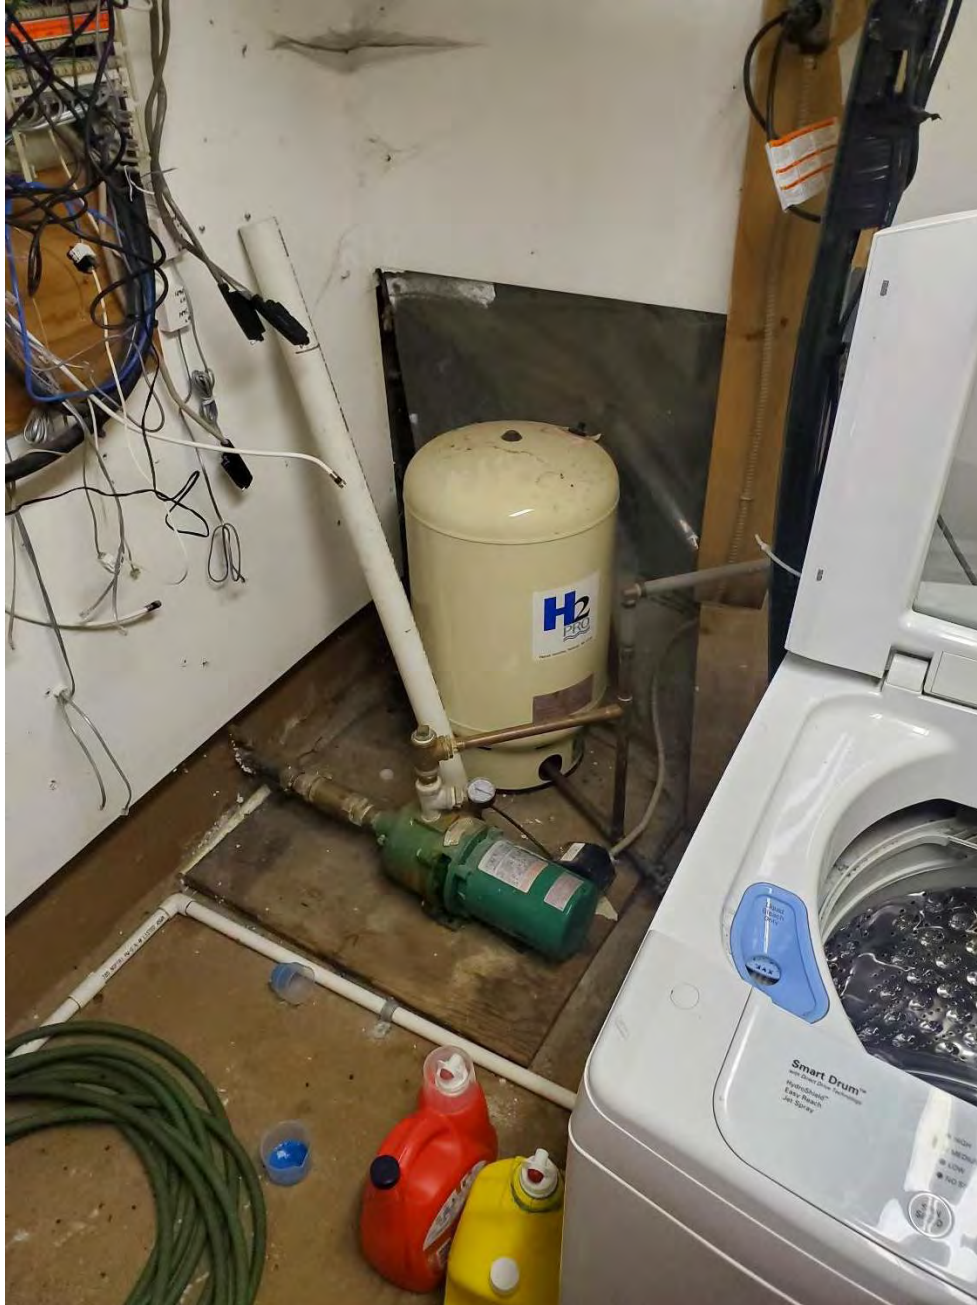
Photo 3: Facing northwest, sump pump and a well tank located in the basement of the site. The site is serviced by a potable water supply well.

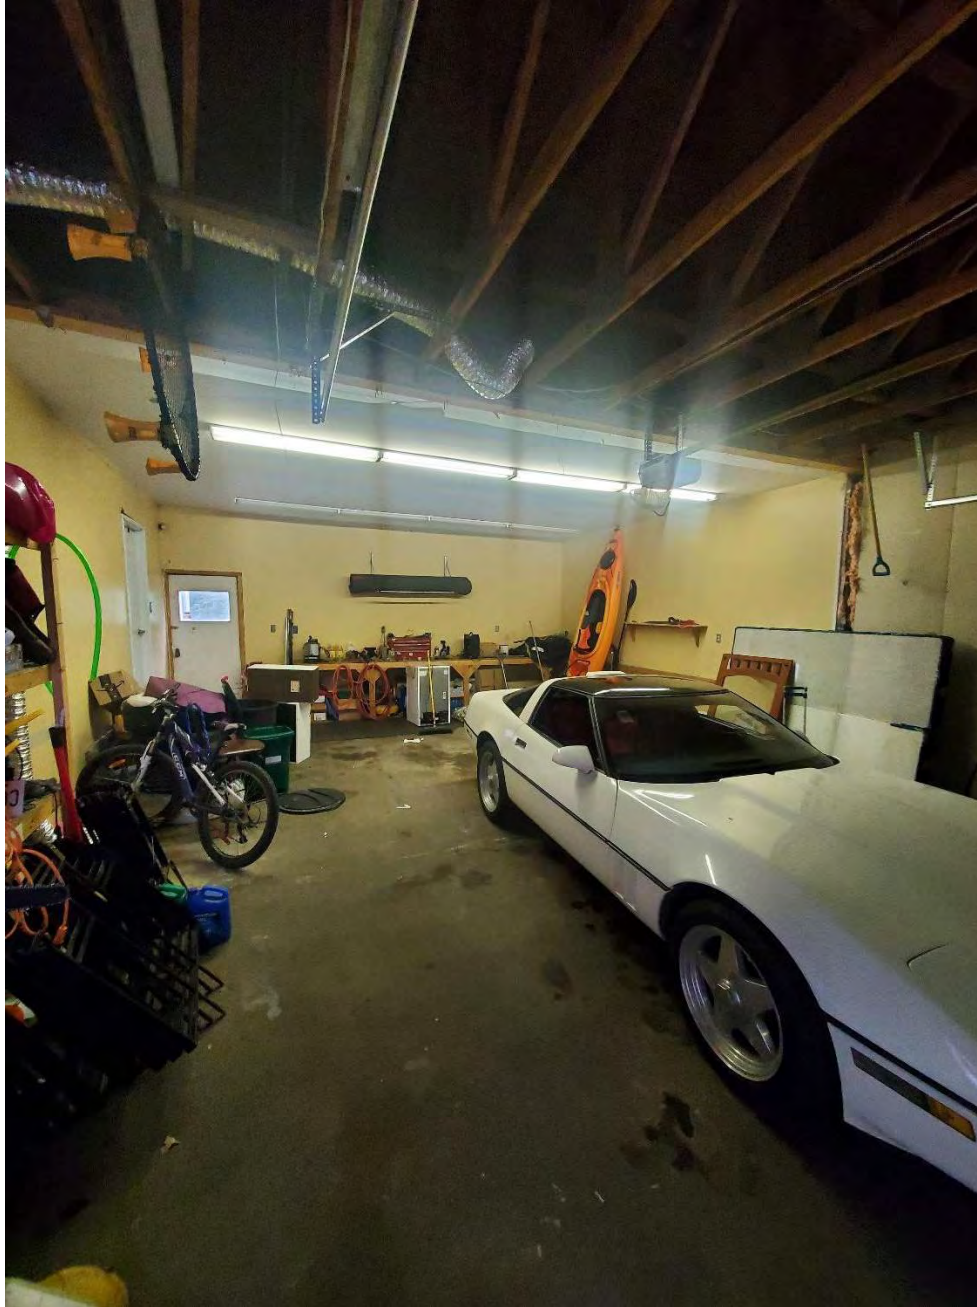
Photo 4: Facing northeast, the attached garage located on the east side of the building had minor oil stains present

Minor staining was noted in the garage.
