Our File Ref.: 210216

Subject: Slope Stability Analysis

6001-6005 Renaud Road

Orleans, Ontario

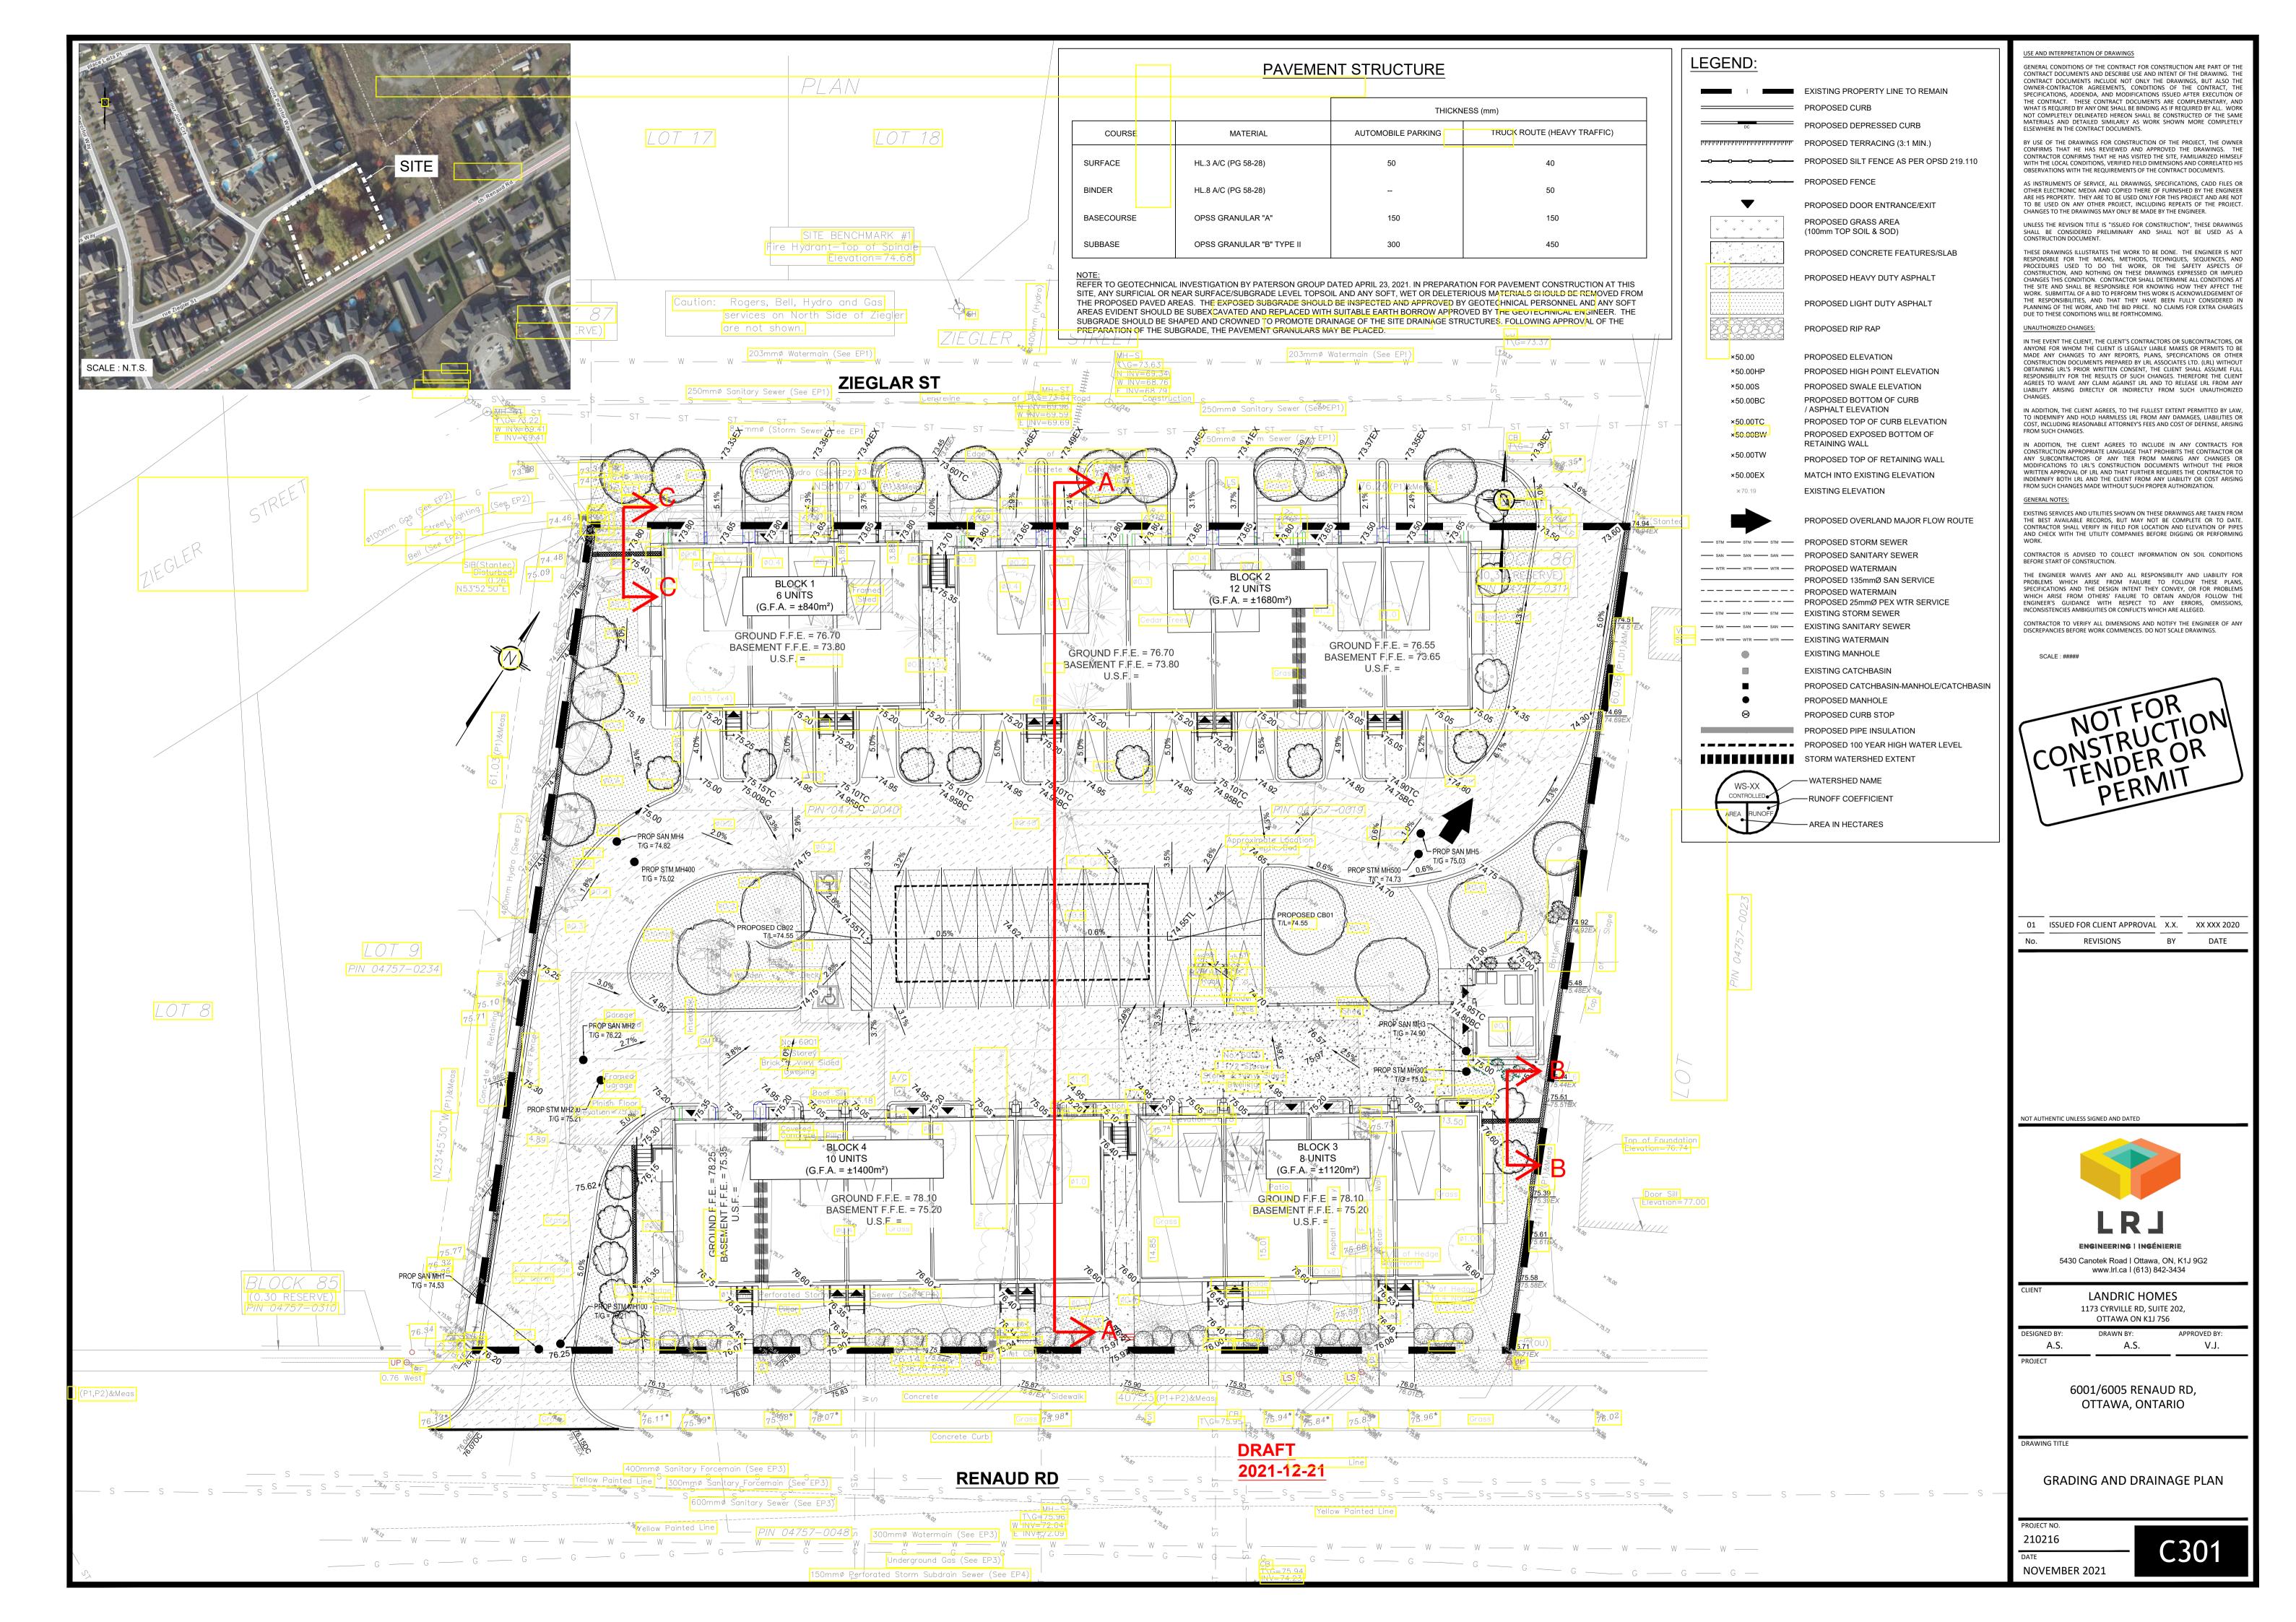
Encl. Mark-up of Grading Plan Showing Slope Profile Liocations Slope Stability Analysis Results

The results of the analyses are potentially dependent on the assumption of groundwater condition. During the development of this report, no information on the groundwater level was available throughout the year. However, as a conservative approach the analysis was completed assuming full saturation throughout the slope profile. The location of the slope profile (Section A-A) as well as the location of the retaining walls that were checked for global stability are shown on the Grading Plan, attached to this report.

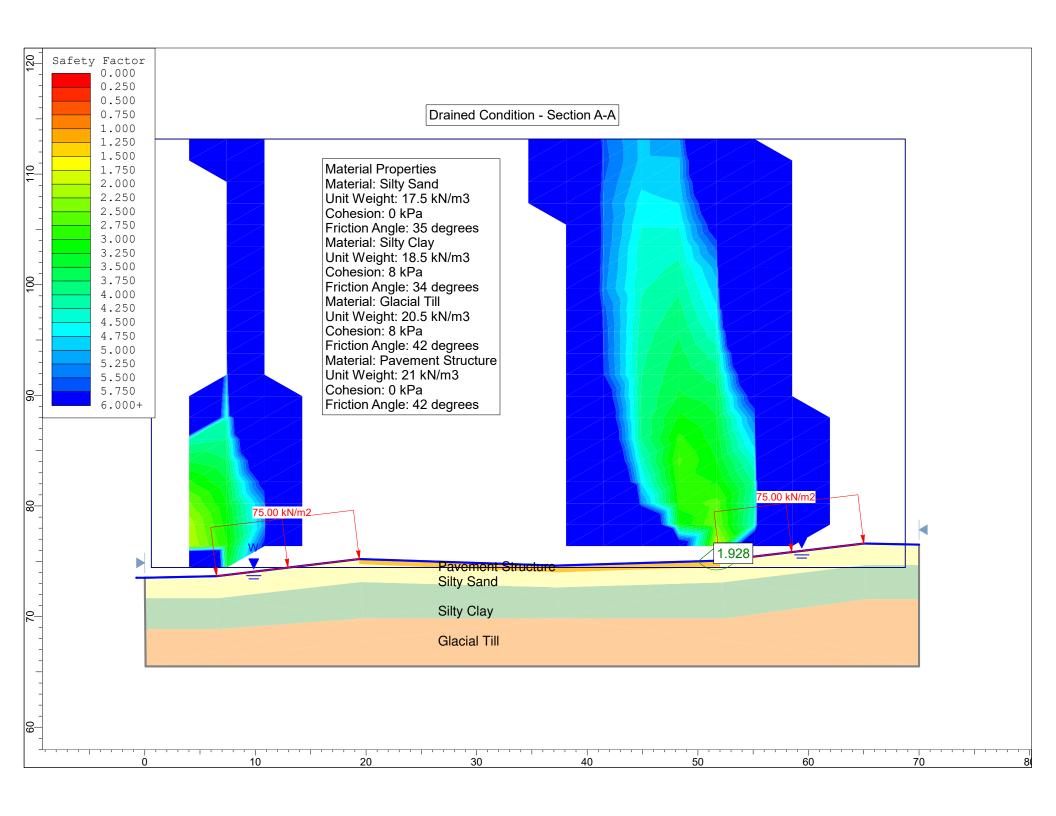
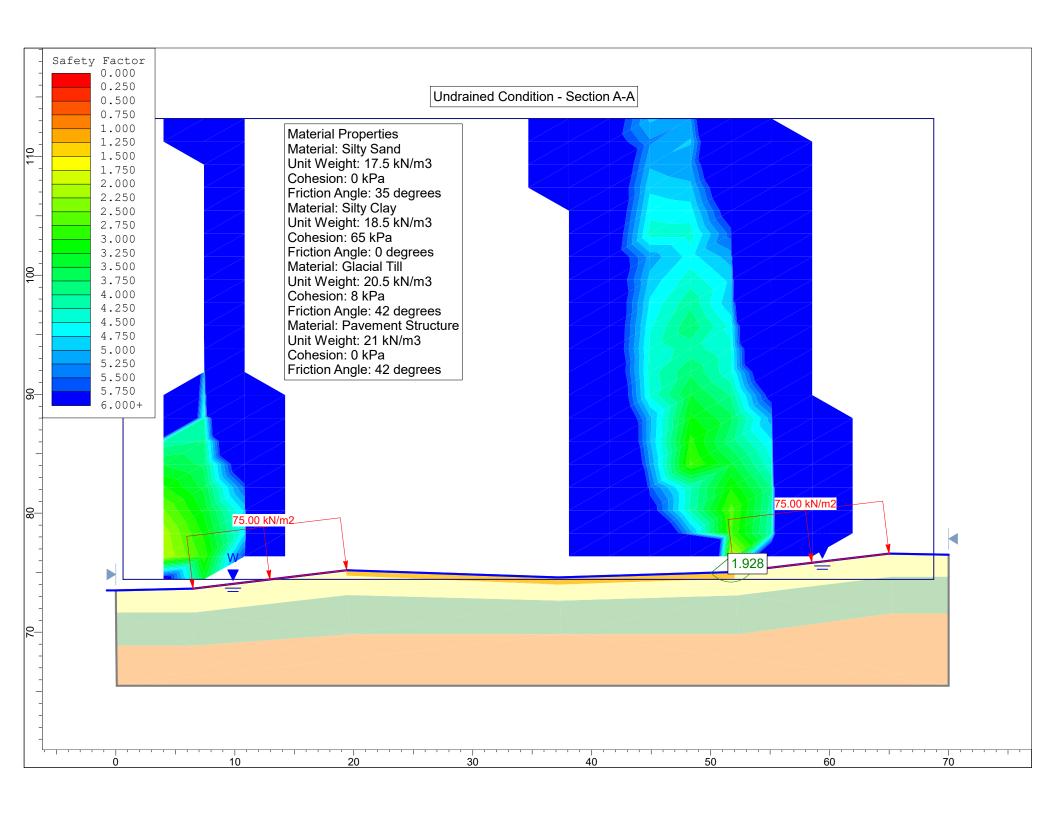
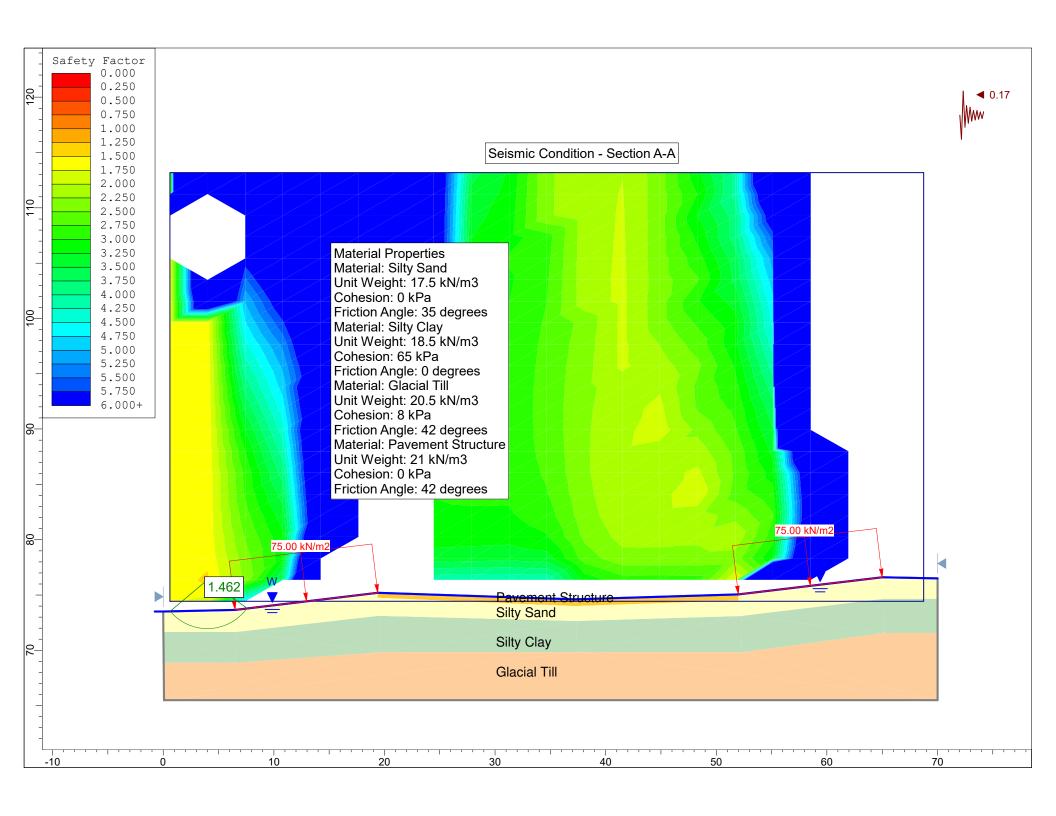
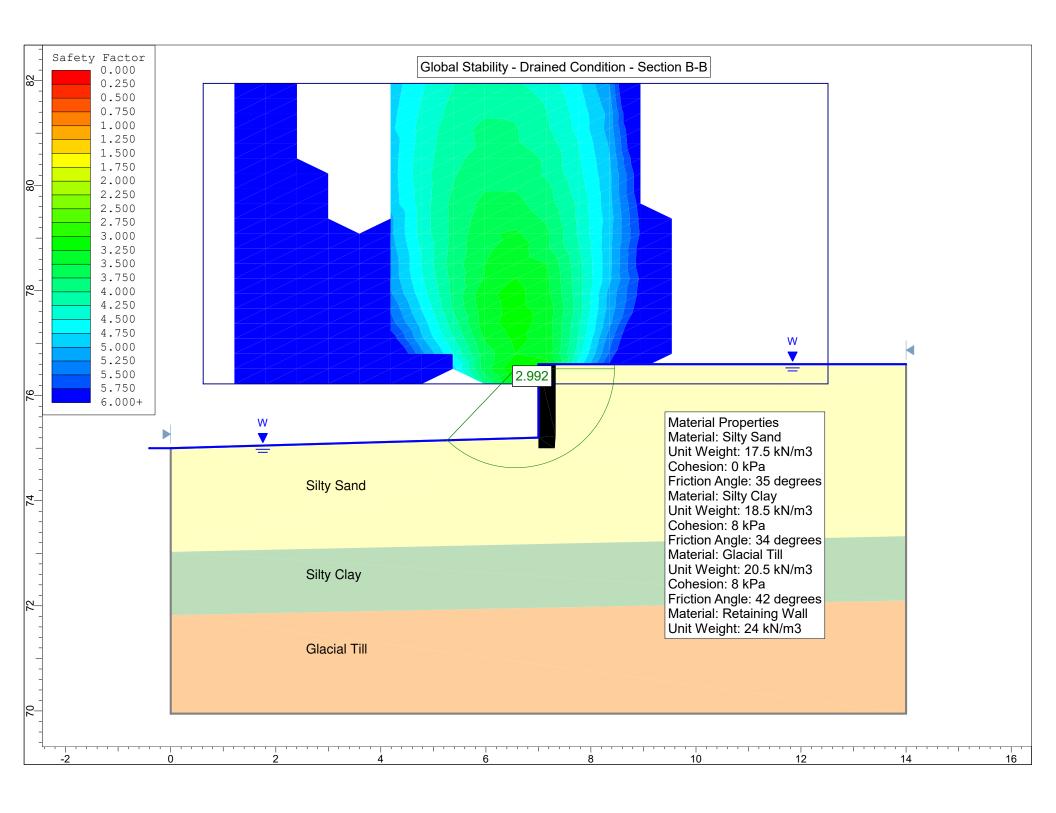
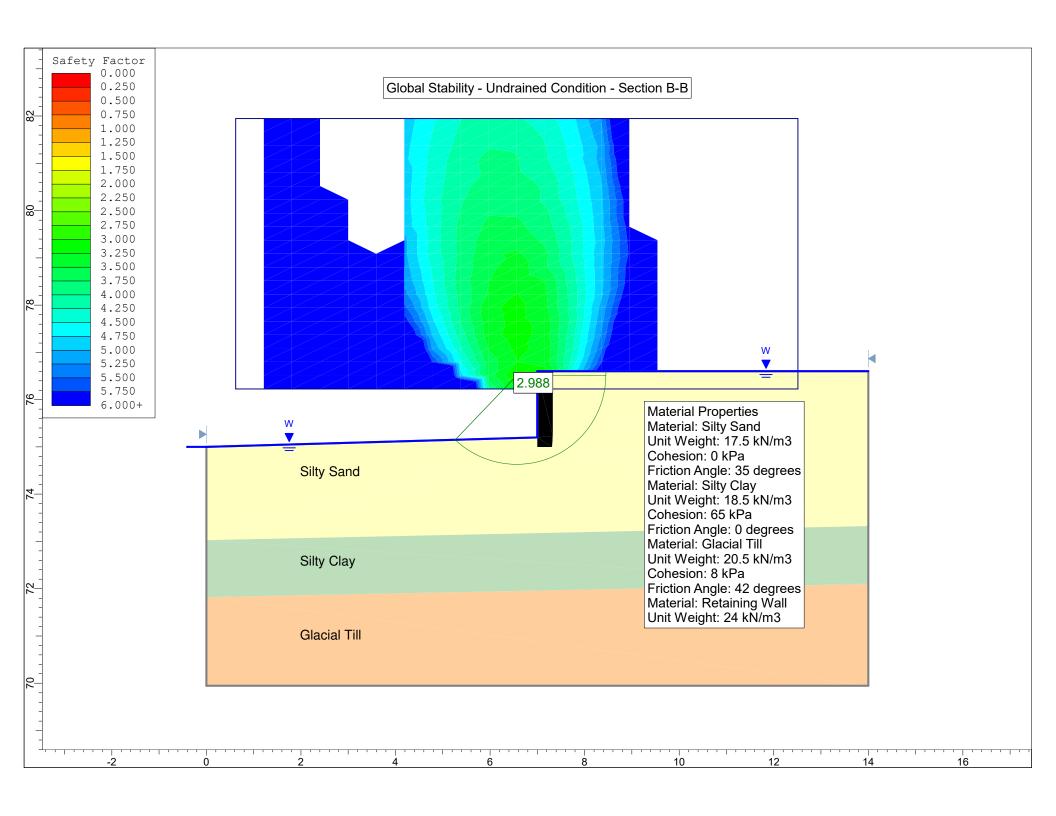
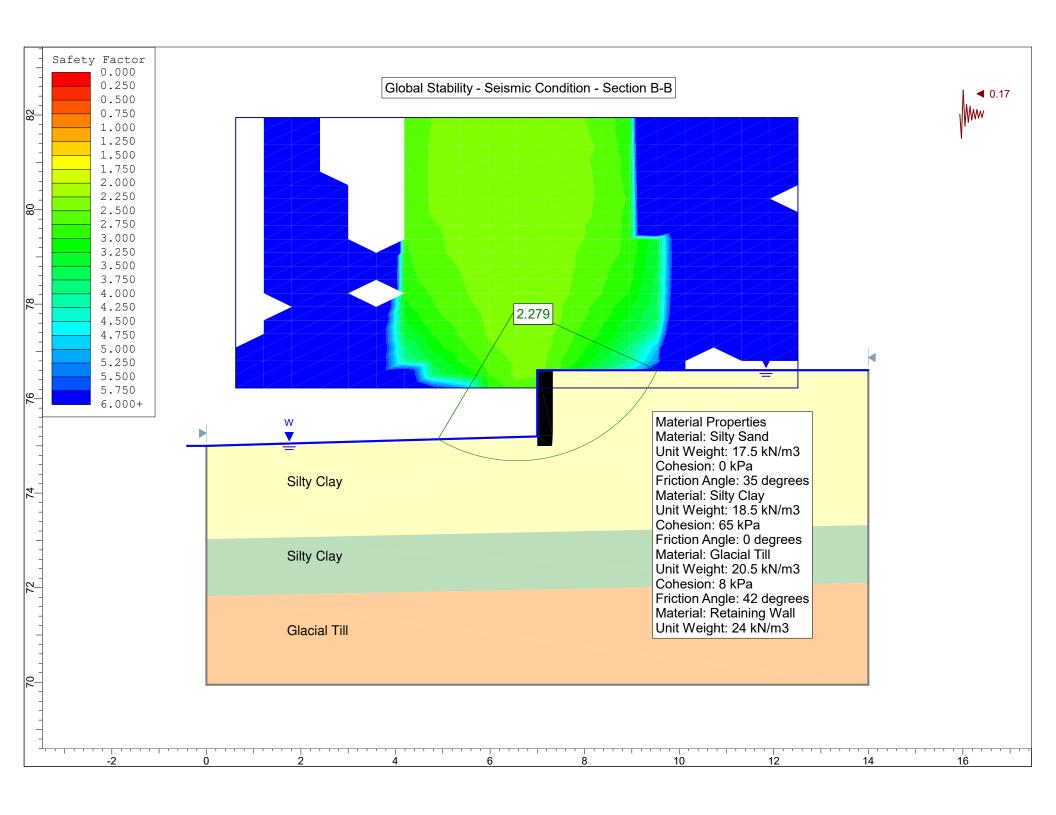
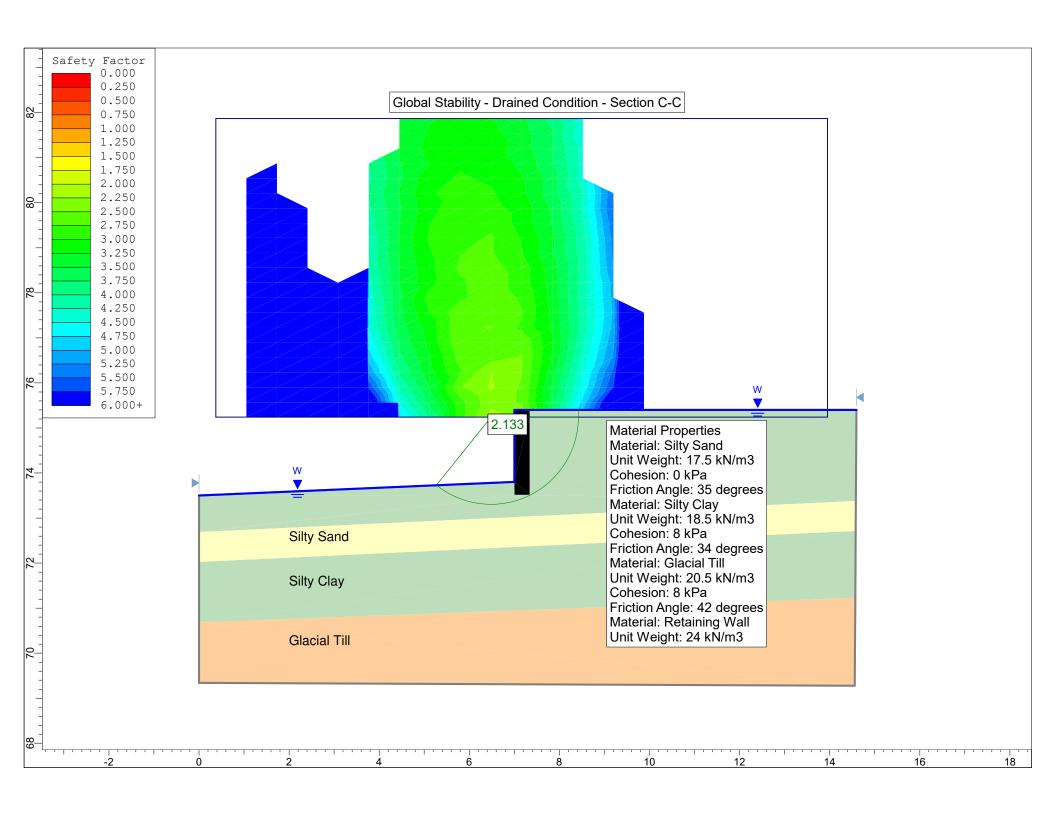
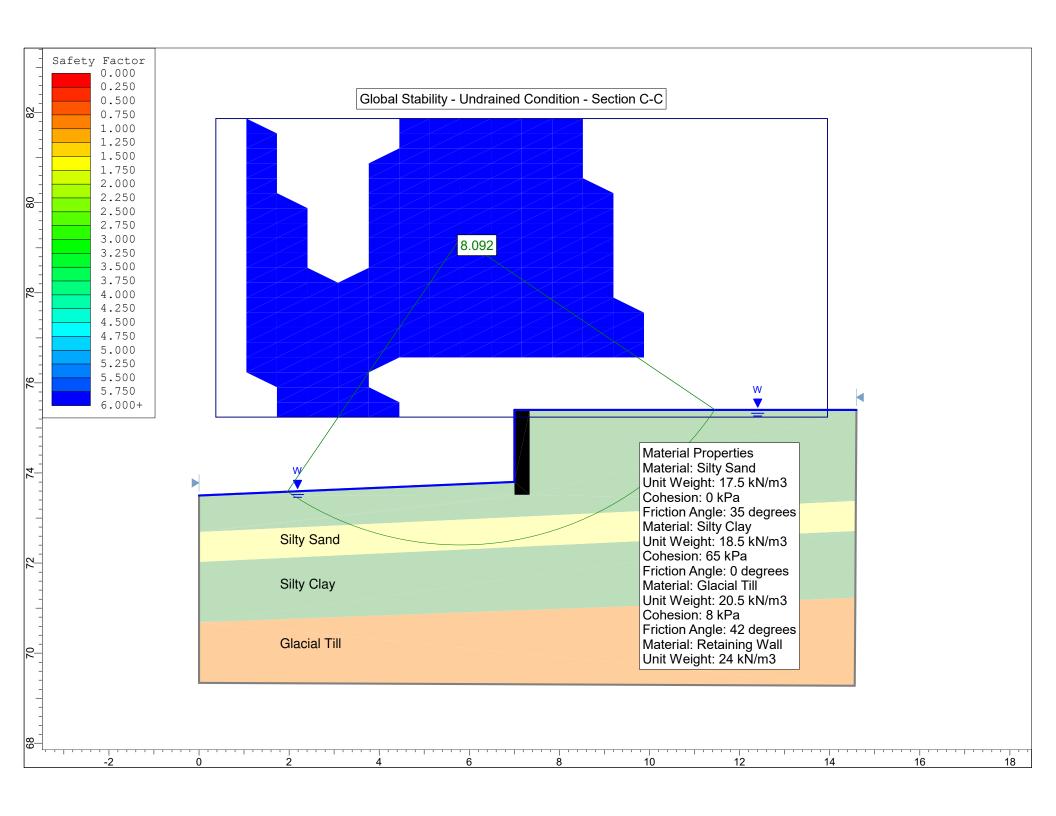
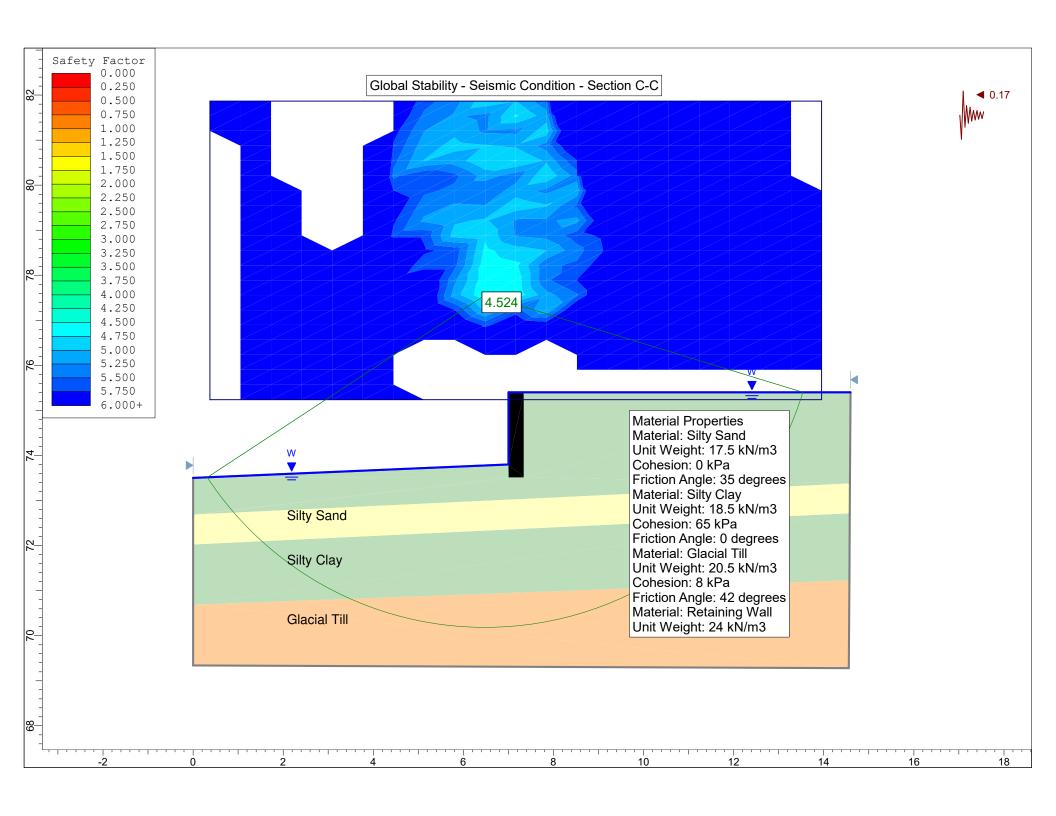
Section	Drained Condition	Undrained Condition	Seismic		
Factor of Safety					
A-A (Overall Stability)	1.928	1.928	1.462		
B-B (Global Stability)	2.992	2.988	2.279		
C-C (Global Stability)	2.133	8.092	4.524		
Min. Required	1.500	1.500	1.100

The model results are attached for your reference.

The slope modelling program, Slide 5.0 (Rocscience), was used to implement the Bishop simplified method of slices. One (1) slope profile named Section A-A was selected for the proposed condition and modeled to check the conditions of the slope. The proposed loading for the residential units was included in the model. The slope was analyzed under both the undrained (short term failure) and drained (long term failure) conditions.

The seismic analysis was performed by incorporating the seismic coefficient  $(k_h)$  into the modelling. The peak ground acceleration (PGA) for this area is equal to 0.33 for the 2% in 50 year probability of exceedance as per the NBC 2015. The value for  $k_h$  was taken as 50% of the PGA, which equates to 0.17. The minimum factor of safety (FoS) with regards to seismic condition is 1.10.
