# PHASE I ENVIRONMENTAL SITE ASSESSMENT 2050 DUNROBIN ROAD CITY OF OTTAWA, ONTARIO

Euroamber Inc. 165 Constance Lake Road Kanata, Ontario K2K 1X7

REVISED DATE June 6, 2023 DATE: February 18, 2022

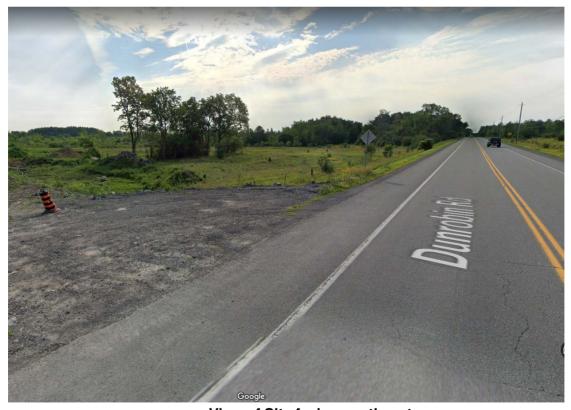
**View of Site facing southeast**

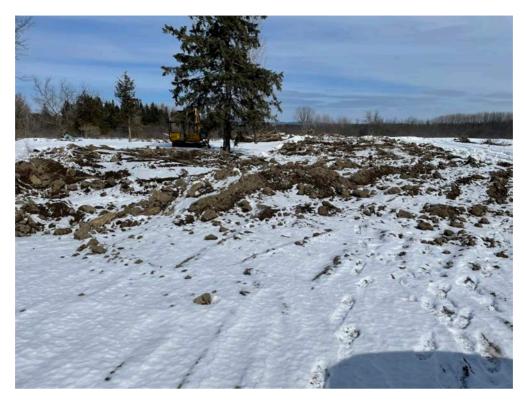
Front of site facing east

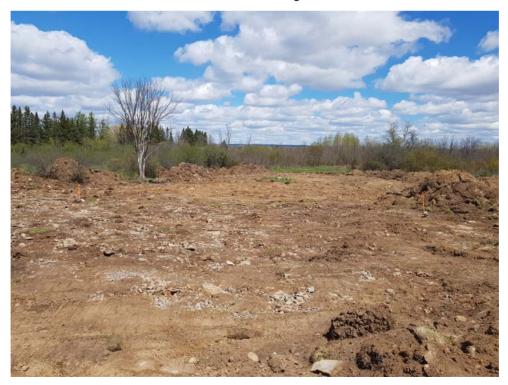
View of roadway construction after topsoil was stripped

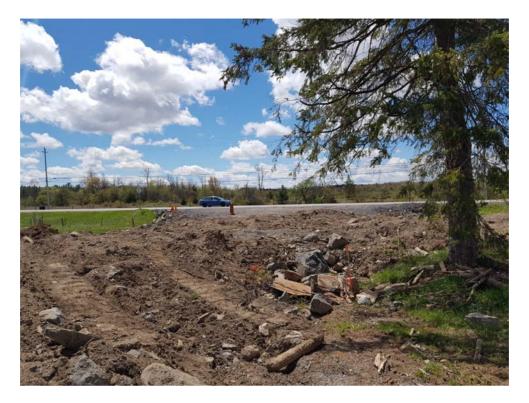
Some fill materials was observed to have been imported to the site as part of construction of a future roadway that will service the proposed residential subdivision. The fill materials consist of a mixture of sand, gravel, cobbles, boulders, silty clay, trace to some concrete, plastic and wood debris. It is understood that the fill materials originated from properties in Almonte and Kanata. Quality testing of the fill materials was completed by Paterson Group

View of some fill materials used in roadway

- Fill materials was observed to have been imported to the site as part of the roadway construction for the proposed residential subdivision. The fill materials were tested as part of Excess Soil Management and are considered to be acceptable quality.

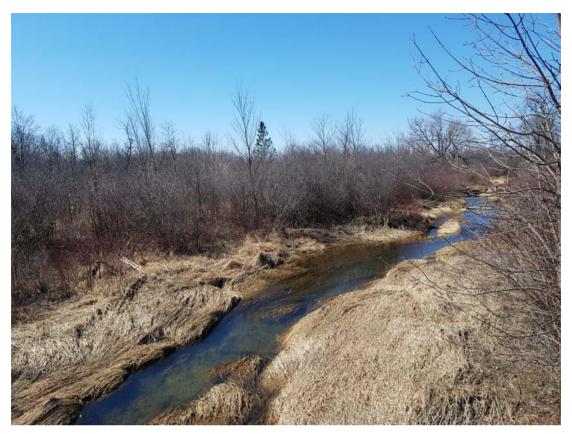
View of creek located in southeast portion of site. Creek flows east.

Roadside ditches were observed along Dunrobin Road. A ditch was also observed near the centre of the site. Water was observed in the ditch flowing north to south. Based on a review of topographical maps for the site area it is expected that the upper groundwater flow is to the northeast towards Constance Lake which exists about 1.1 kilometres east of the site.

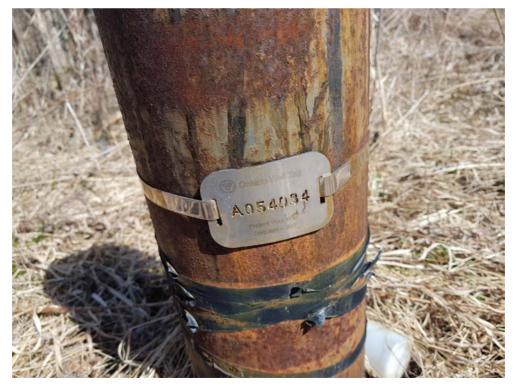
Three steel cased wells were observed at the site. The three steel cased wells are test wells for the hydrogeological investigation for the proposed residential subdivision at the site. Future dwellings for the residential subdivision will be serviced by individual steel cased wells.

View of steel cased well at site.
