ENVIRONMENTAL IMPACT STATEMENT

2050 Dunrobin Road, Kanata, Ontario
MP Project No.: CCO-21-1873

ENVIRONMENTAL IMPACT STATEMENT
2050 DUNROBIN ROAD, KANATA, ONTARIO

Version 002
November 5, 2021

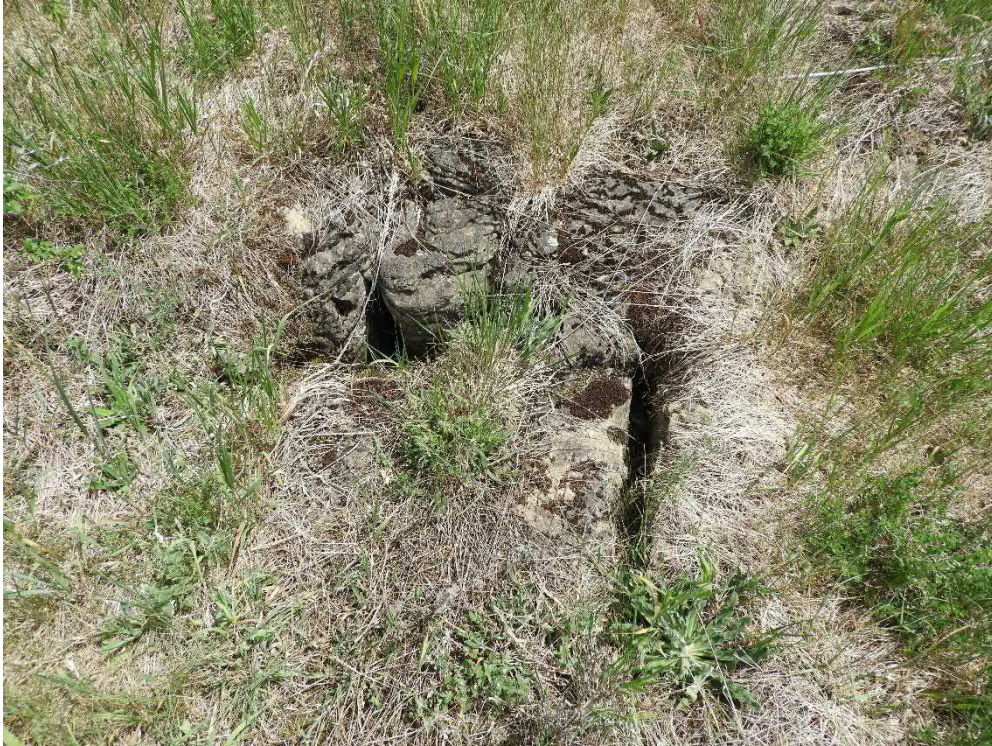
Photo 3: Potential SAR snake hibernacula habitat identified within the Dry – Fresh Non-Calcareous Bedrock Graminoid Meadow Ecosite (MEGR2) in the west end of the study area during the preliminary EIS. During the 2021 field investigations, it was determined that this area does not provide SAR snake habitat. 28 May 2021.

During the preliminary field investigation on October 30, 2020, potential SAR snake habitat was identified in the west end of the study area. This area consists of the open Dry – Fresh Non-Calcareous Bedrock Graminoid Meadow Ecosite (MEGR2) containing exposed bedrock and crevices into the ground which may provide potential habitat for Eastern Milksnakes, including areas for foraging and hibernacula. This species is a habitat generalist and may be found in a variety of habitats. The Eastern Milksnake is designated as ‘Special Concern’ under SARA and does not receive habitat protection. However, individuals of this species are protected under the FWCA (1997). Targeted surveys for SAR snakes were conducted following parameters outlined in the Ministry of Natural Resources and Forestry’s (MNRF) the Survey Protocol for Ontario’s Species at Risk Snakes (MNRF, 2016a). The surveys were conducted within potential snake habitat identified in the west portion of the study area during the preliminary field investigation. No SAR snakes or evidence of SAR snakes were observed during the 2021 targeted surveys. It was determined that the study area is not suitable for SAR snakes.

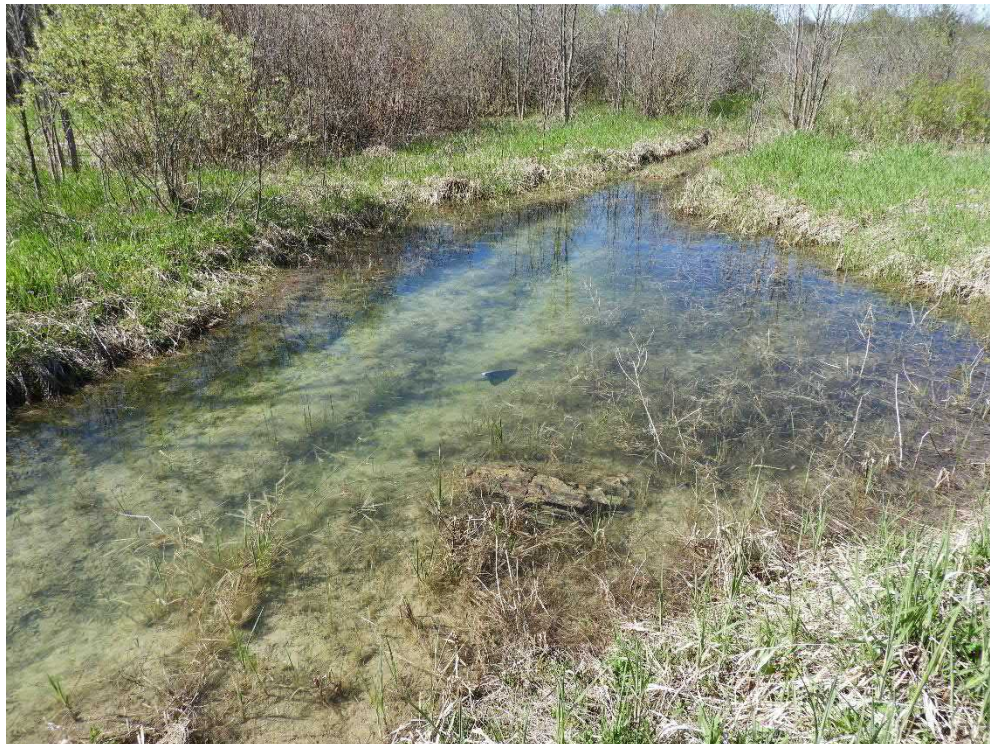
Photo 9: A flooded trail in the east end of the study area during early spring conditions. This area is part of the identified floodplain under MVCA regulation limits. 12 May 2021.

During the 2020 field investigation, standing water was observed in a depression area along the recreational vehicle trails within the east end of the property. The standing water is part of the Harwood Creek floodplain, according to the MVCA Regulation Public Mapping Browser (MVCA, 2021). The floodplain area outlined by MVCA was confirmed during the May 12, 2021 field investigation where seasonally inundated areas were observed across the northeastern portion of the study area. These areas are not considered fish-bearing. Based on the Stormwater Management Report (Kollaard Associates, 2021), the floodplain within the study area is considered a backwater area that does not contribute to the storage capacity of Harwood Creek.

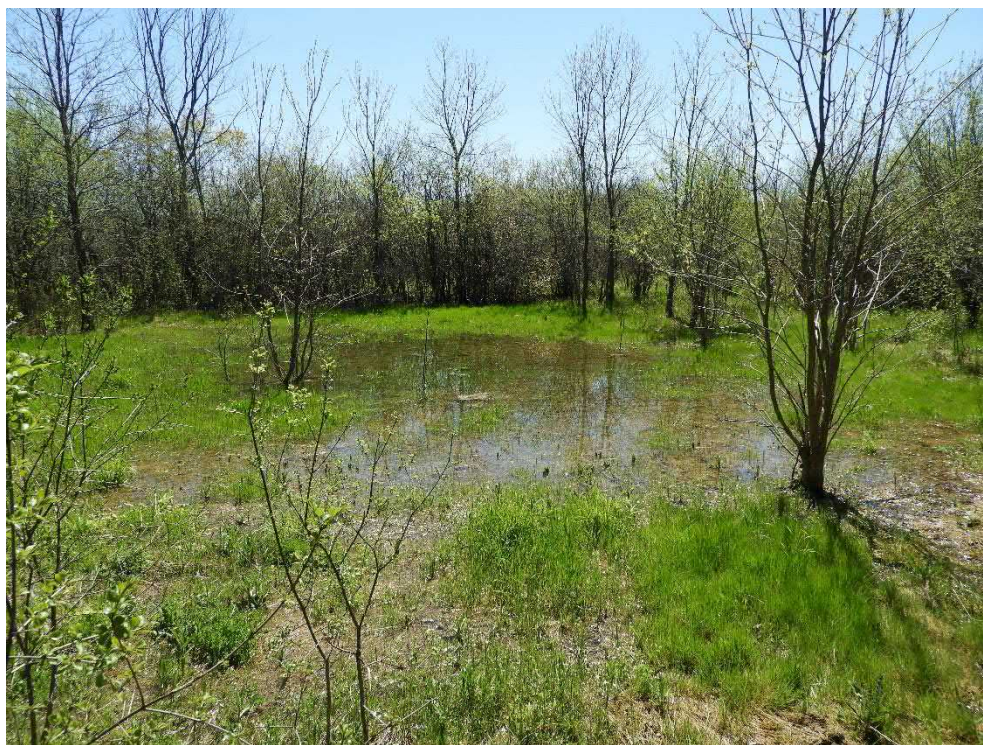
Photo 10: A flooded area in the west end of the study area during early spring conditions. This area is the western extent of the identified floodplain within the study area under MVCA regulation limits. 12 May 2021.

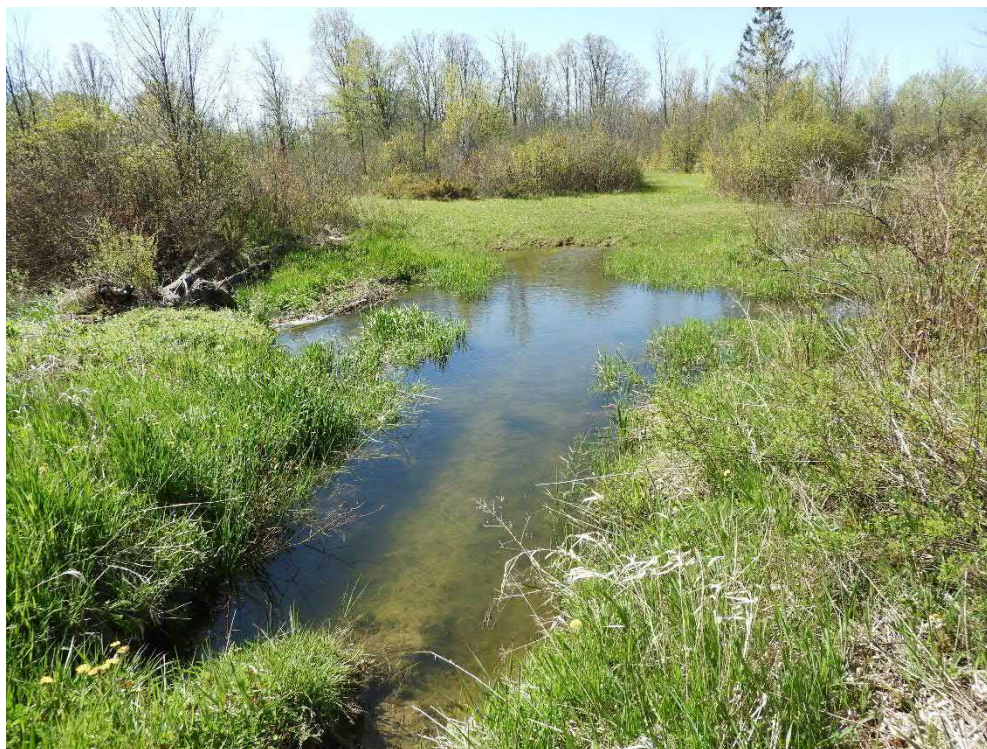
Photo 12: Harwood Creek flowing through the eastern extent of the study area. An off-road vehicle crossing is present within the watercourse located within the study area, creating a pool. 12 May 2021.

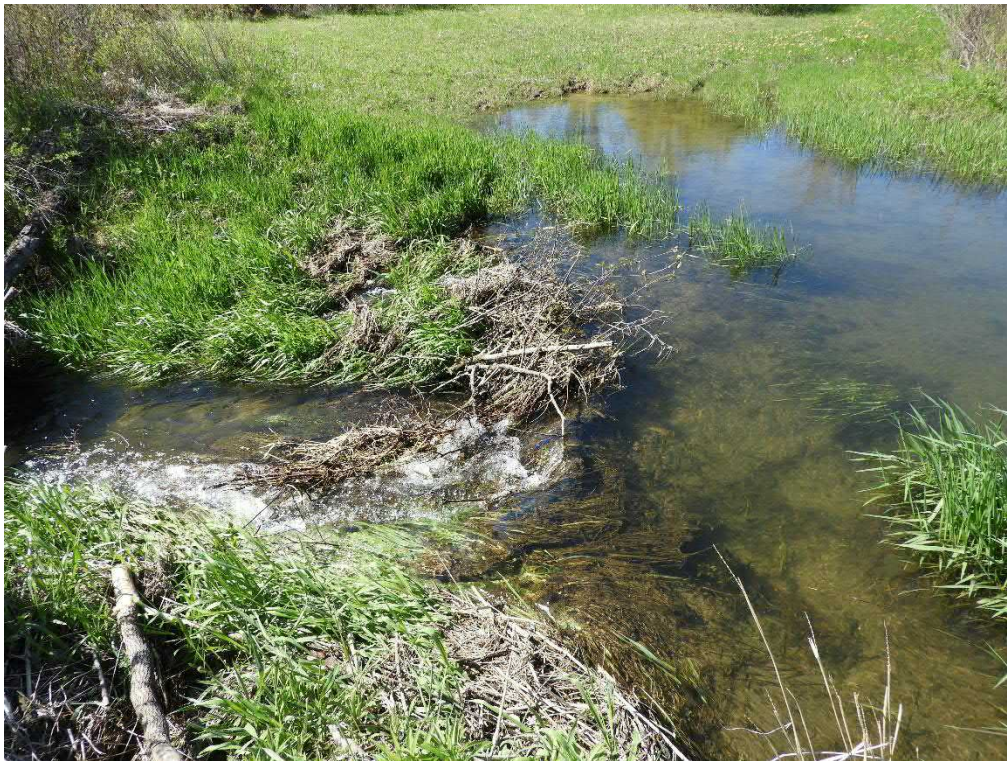
Photo 13: A beaver dam/debris within Harwood Creek directly downstream of one of the off-road vehicle crossings (right), which creates a potentially permanent barrier to fish migration. 12 May 2021.

An electrofishing survey was conducted to determine fish species present within the study area. White Sucker adults (Photo 18) and young-of-year (YOY) were caught and/or observed within Harwood Creek in the study area during the June 6, 2021 field investigation. This species and its habitat are afforded protection under the Fisheries Act (1985). Specialized baitfish spawning habitat (including White Sucker) is present within the study area within the riffles and runs with gravel substrate; however, the beaver dam/debris is a potential barrier to fish migration within the watercourse.

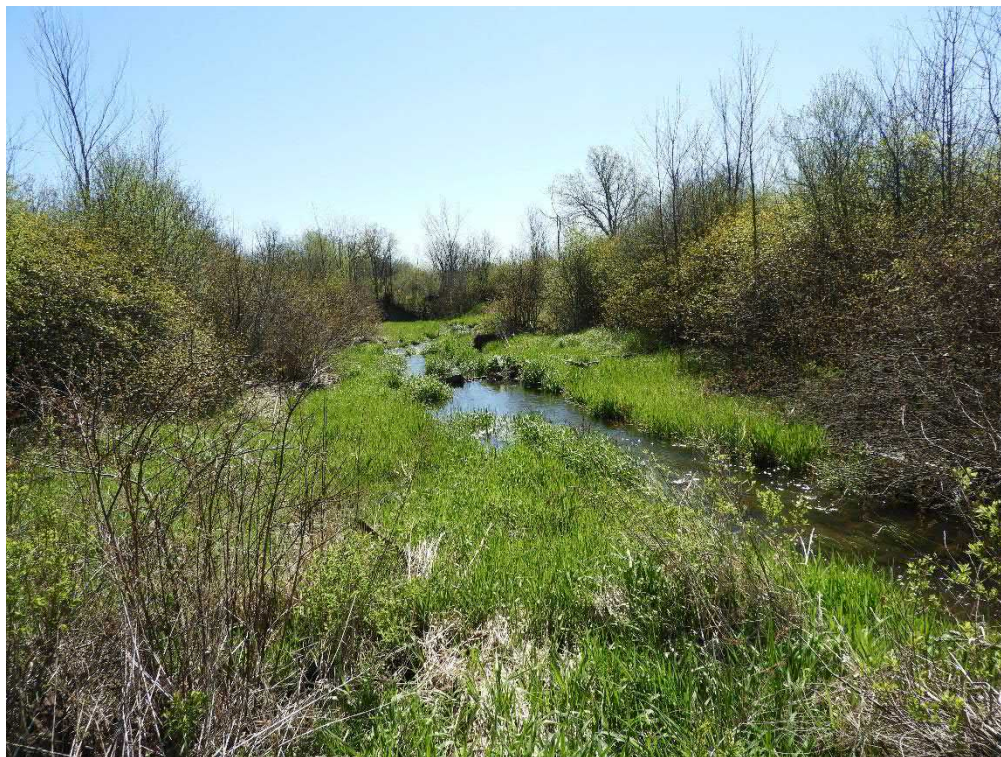
Photo 15: Harwood Creek looking downstream (east) from the beaver dam. The majority of the watercourse within the study area is downstream of the beaver dam. 12 May 2021.

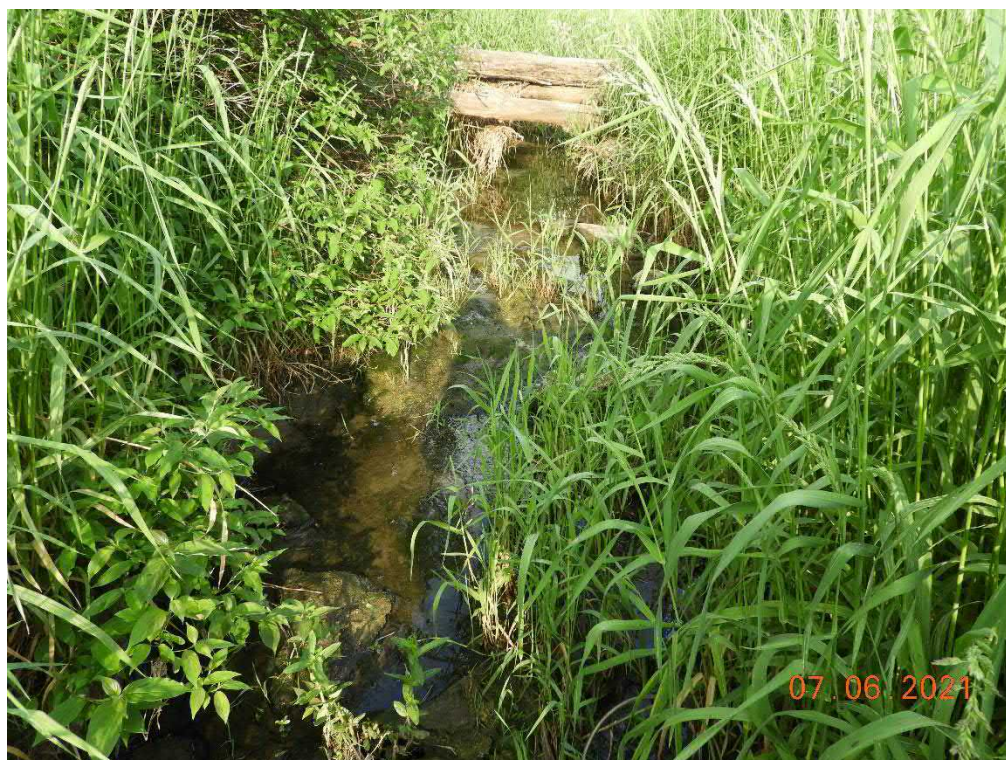
Photo 16: Upstream view (west) of Harwood Creek from downstream of the beaver dam/debris within the study area. 07 June 2021.

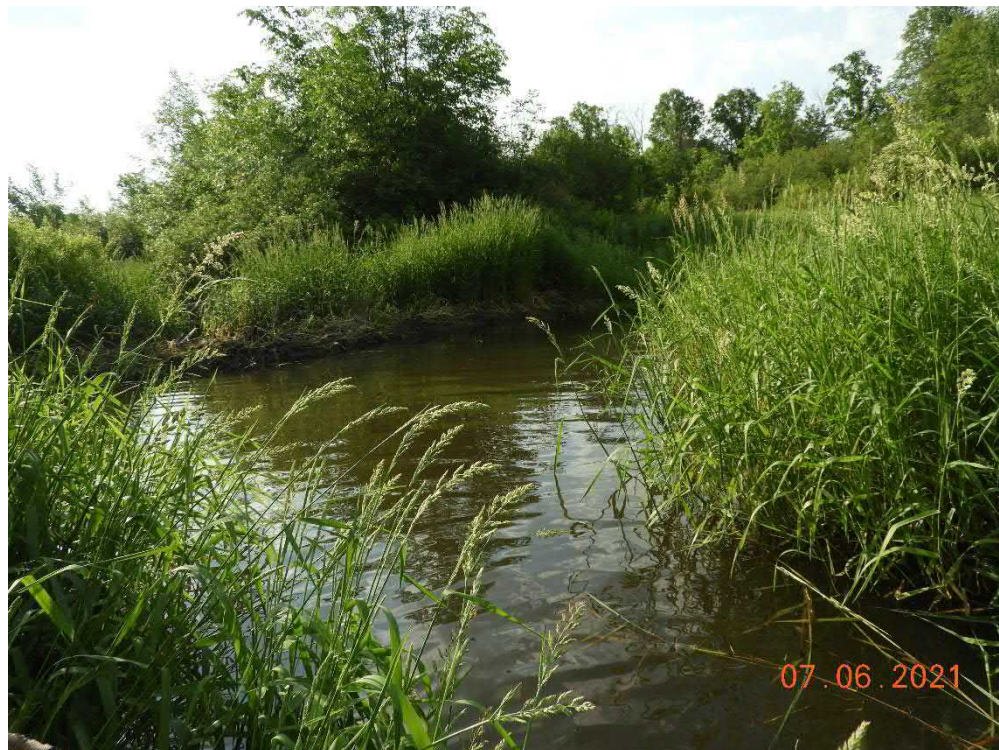
Photo 17: Upstream view (west) of Harwood Creek from upstream of the beaver dam/debris within the study area. 07 June 2021.

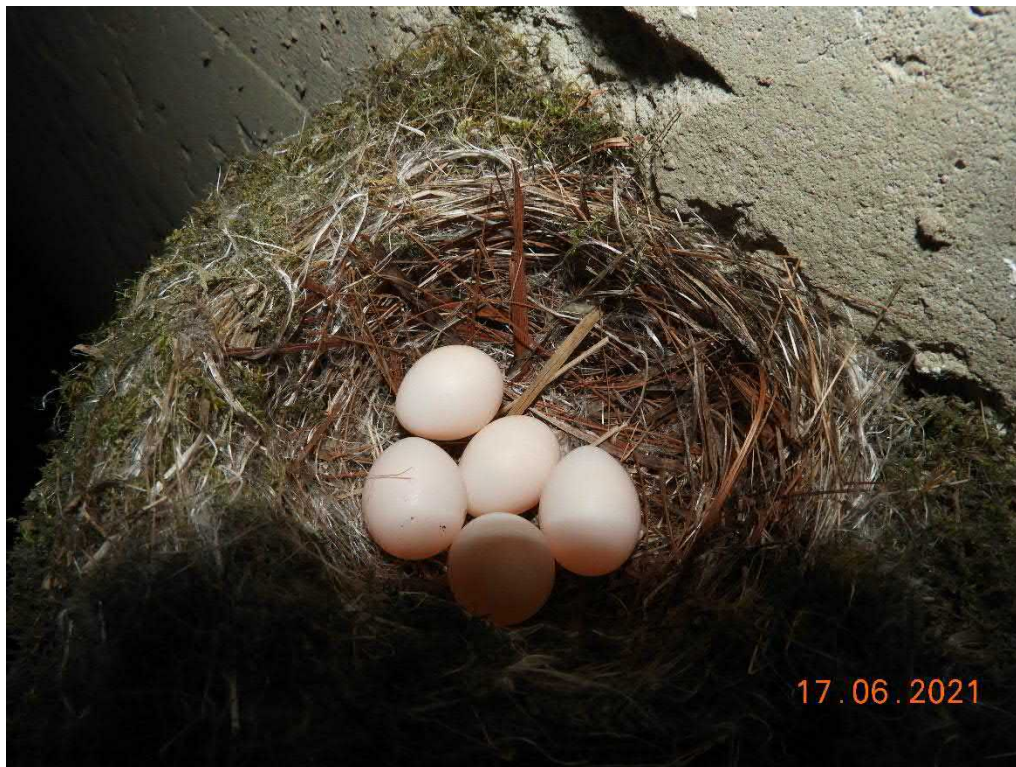
Photo 19: An active Eastern Phoebe (*Phoebe sayornis*) nest with eggs observed within the decommissioned railway culvert directly adjacent to the eastern extent of the study area. 17 June 2021.
