# PHASE I ENVIRONMENTAL SITE ASSESSMENT 2050 DUNROBIN ROAD CITY OF OTTAWA, ONTARIO

Euroamber Inc. 165 Constance Lake Road Kanata, Ontario K2K 1X7

DATE: February 18, 2022

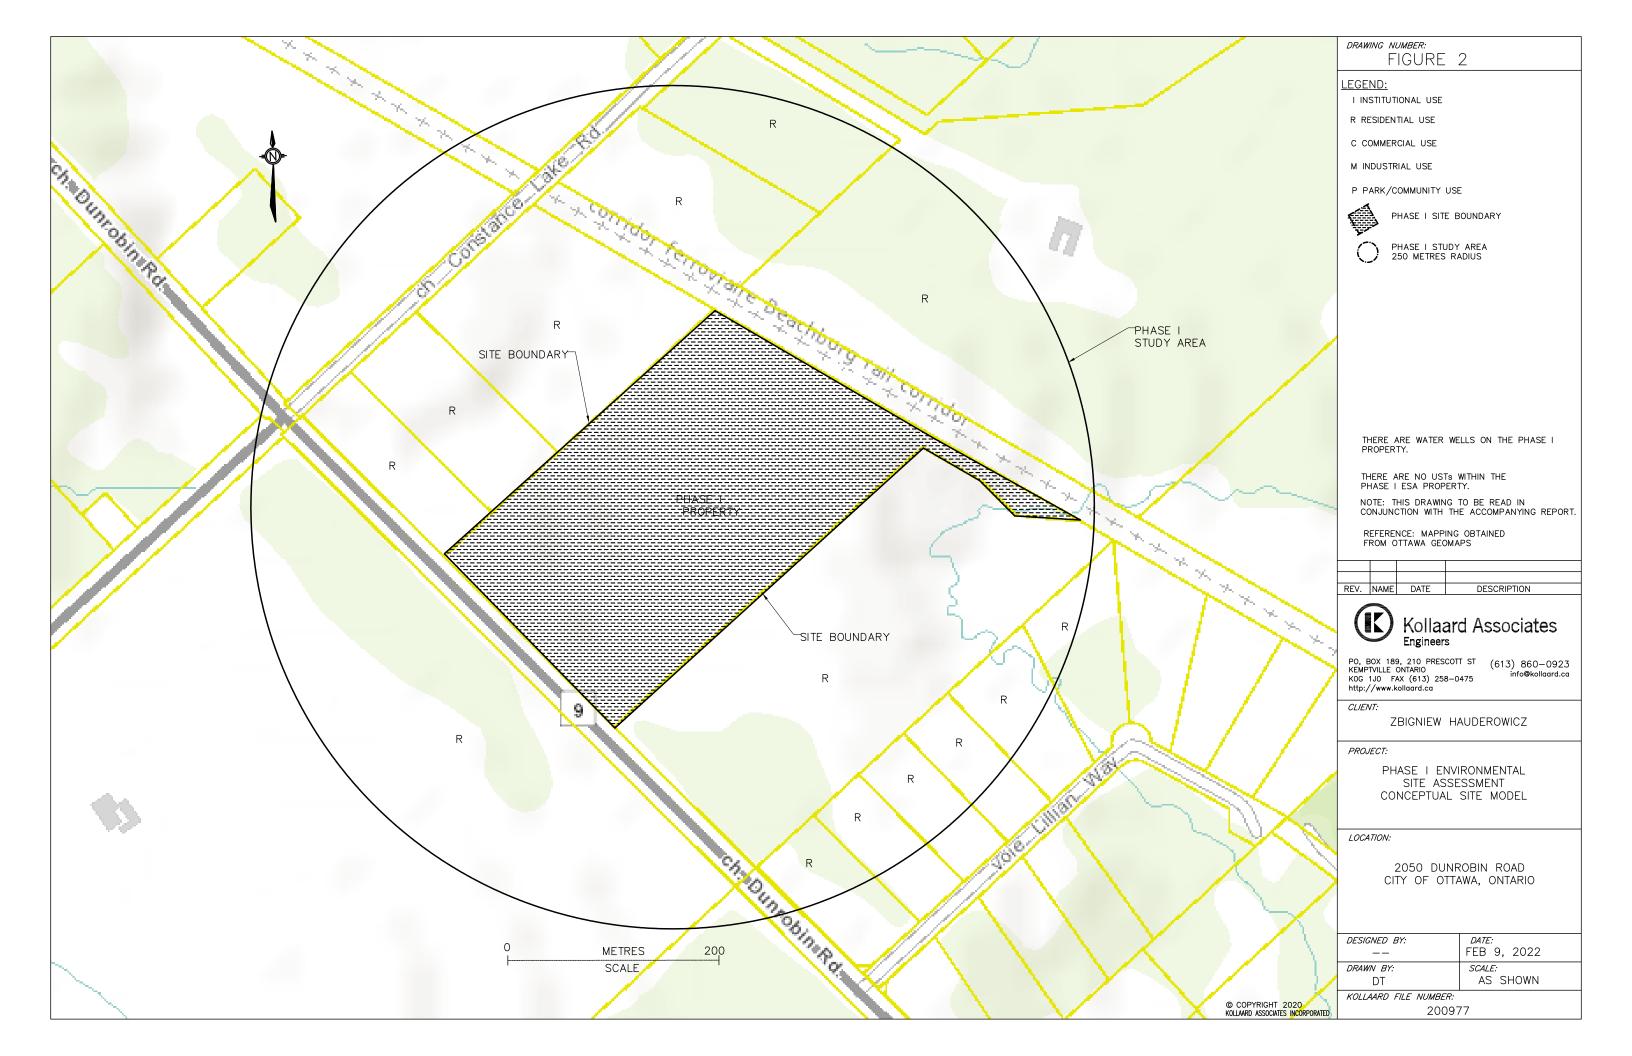
FIGURE 2 – PHASE I CONCEPTUAL MODEL PLAN-PHASE ONE STUDY AREA

Contaminant distribution, transport and underground utilities: The soils at the site and within the Phase I study area consist of a thin veneer of glacial till underlain by shallow bedrock. Contamination would tend to migrate downward until saturated conditions are encountered which likely occurs in shallow fractured bedrock. Once saturated conditions are encountered, and depending on contaminant mobility, solubility, volatility, etc., the contaminants could be expected to

dissolve into the groundwater and migrate laterally in the direction of groundwater flow through bedrock fractures. In this case, the topographical information indicates that the groundwater flow gradient is moving towards Constance's Lake located approximately 1.1 kilometres east of the site.
