ENVIRONMENTAL IMPACT STUDY

2050 Dunrobin Road, Kanata, Ontario
MP Project No.: CCO-21-1873

**ENVIRONMENTAL IMPACT STUDY
2050 DUNROBIN ROAD, KANATA, ONTARIO**

**Version 004
June 7, 2023**

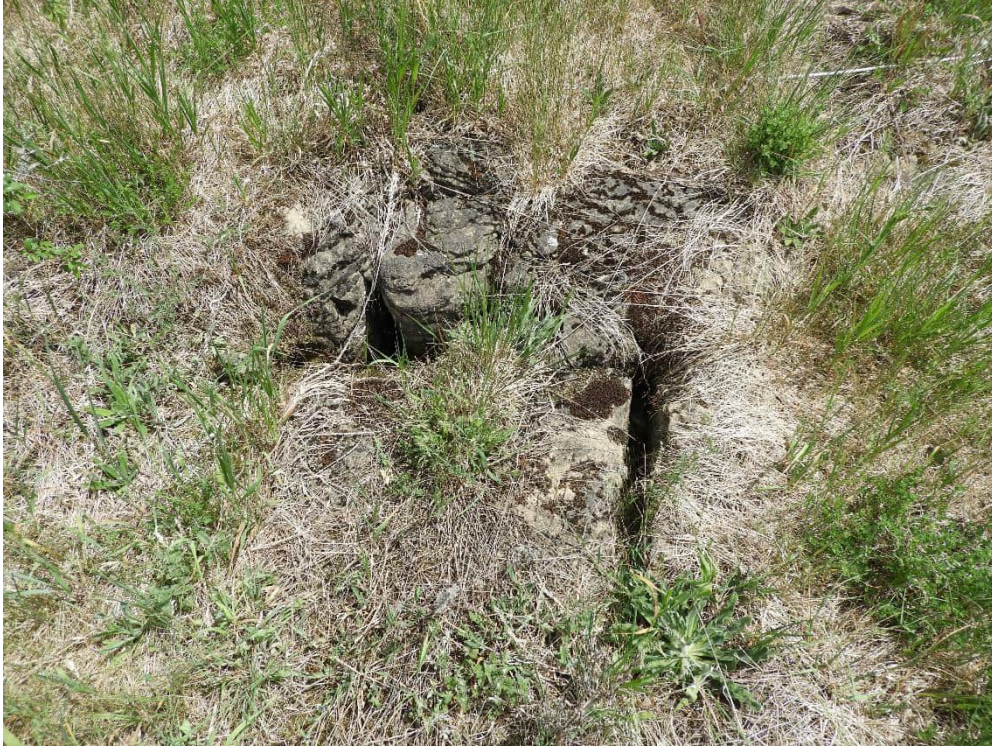
Photo 3: Potential SAR snake hibernacula habitat identified within the Dry – Fresh Non-Calcareous Bedrock Graminoid Meadow Ecosite (MEGR2) in the west end of the study area during the preliminary EIS. During the 2021 field investigations, it was determined that this area does not provide SAR snake habitat. 28 May 2021.

During the preliminary field investigation on October 30, 2020, potential SAR snake habitat was identified in the west end of the study area. This area consists of the open Dry – Fresh Non-Calcareous Bedrock Graminoid Meadow Ecosite (MEGR2) containing exposed bedrock and crevices into the ground which may provide potential habitat for Eastern Milksnakes, including areas for foraging and hibernacula. This species is a habitat generalist and may be found in a variety of habitats. The Eastern Milksnake is designated as ‘Special Concern’ under SARA and does not receive habitat protection. However, individuals of this species are protected under the FWCA (1997). Targeted surveys for SAR snakes were conducted following parameters outlined in the Ministry of Natural Resources and Forestry’s (MNRF) *the Survey Protocol for Ontario’s Species at Risk Snakes* (MNRF, 2016a). The surveys were conducted within potential snake habitat identified in the west portion of the study area during the preliminary field investigation. No SAR snakes or evidence of SAR snakes were observed during the 2021 targeted surveys. It was determined that the study area is not suitable for SAR snakes.

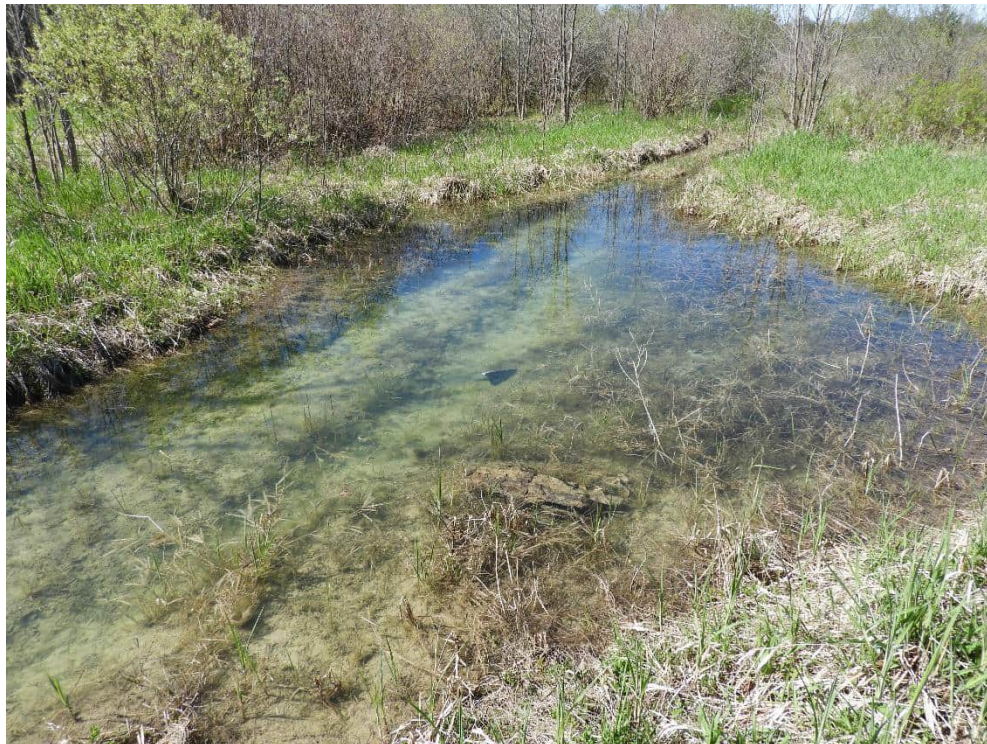
Photo 9: A flooded trail in the east end of the study area during early spring conditions. This area is part of the identified floodplain under MVCA regulation limits. 12 May 2021.

During the 2020 field investigation, standing water was observed in a depression area along the recreational vehicle trails within the east end of the property. The standing water is part of the Harwood Creek floodplain, according to the MVCA Regulation Public Mapping Browser (MVCA, 2021). The floodplain area outlined by MVCA was confirmed during the May 12, 2021 field investigation where seasonally inundated areas were observed across the northeastern portion of the study area. These areas are not considered fish-bearing. Based on the *Stormwater Management Report* (Kollaard Associates, 2021), the floodplain within the study area is considered a backwater area that does not contribute to the storage capacity of Harwood Creek.

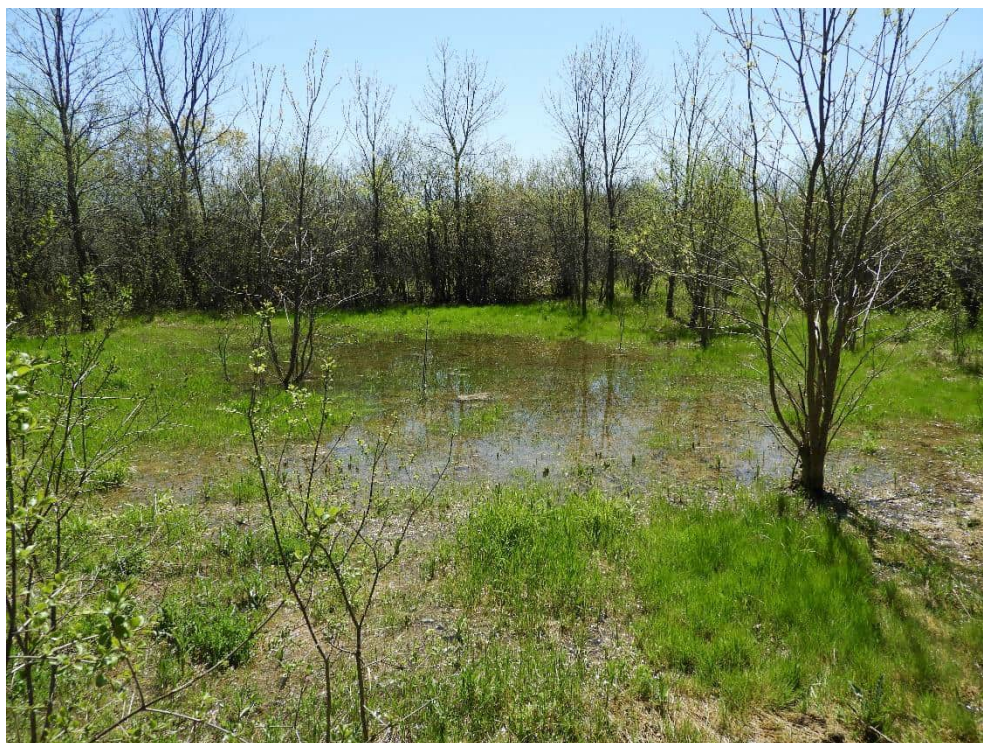
Photo 10: A flooded area in the west end of the study area during early spring conditions. This area is the western extent of the identified floodplain within the study area under MVCA regulation limits. 12 May 2021.

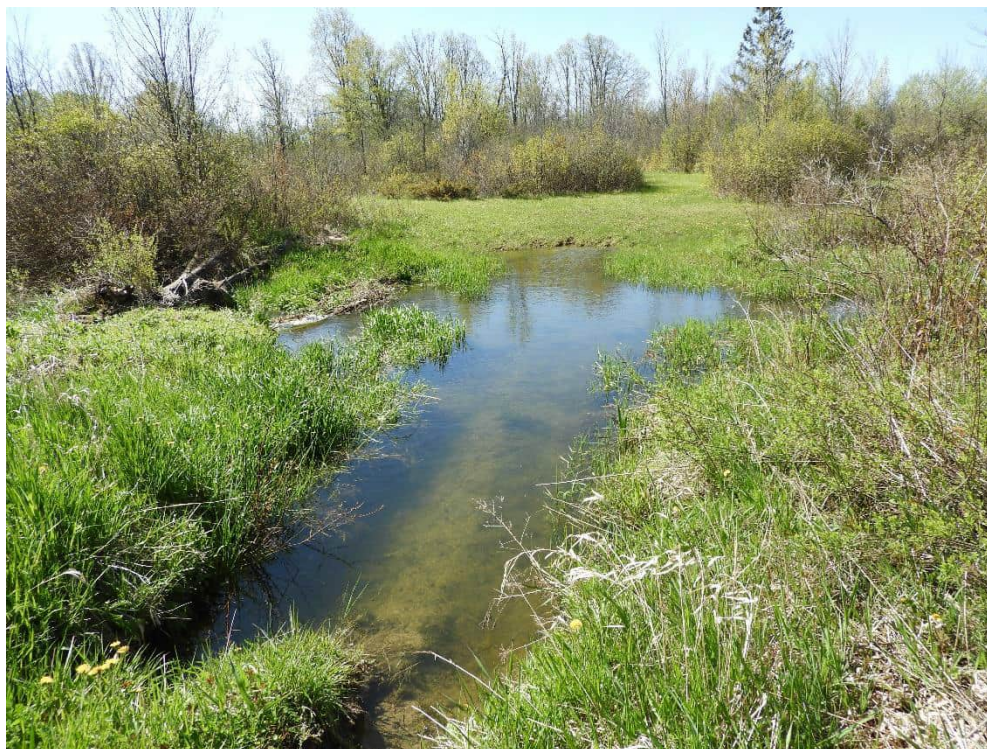
Photo 12: Harwood Creek flowing through the eastern extent of the study area. An off-road vehicle crossing is present within the watercourse located within the study area, creating a pool. 12 May 2021.

During the June 6, 2021 field investigation, a fisheries survey was conducted by McIntosh Perry staff on Harwood Creek within the study area. Harwood Creek is a permanent warm-water system within the study area consisting of a mix of runs and pools with some riffles. A wide pool is present at an access path within the study area. The pool is located directly upstream of a beaver dam/debris. Evidence of off-road vehicle access into the pool was observed (i.e., tire ruts crossing the pool). Runs with moderate depths (approximately 75 cm) are present upstream of the pool as well as another off-road vehicle crossing. The watercourse consists of shallow runs and riffles

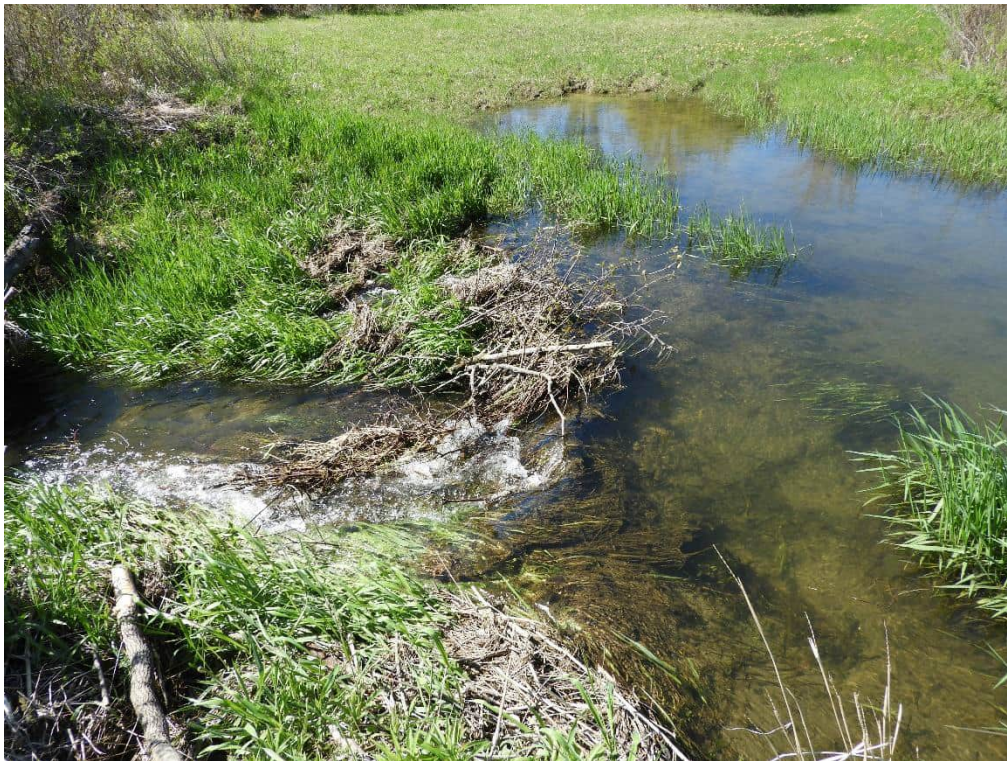
Photo 13: A beaver dam/debris within Harwood Creek directly downstream of one of the off-road vehicle crossings (right), which creates a potentially permanent barrier to fish migration. 12 May 2021.

An electrofishing survey was conducted to determine fish species present within the study area. White Sucker adults (**Photo 18**) and young-of-year (YOY) were caught and/or observed within Harwood Creek in the study area during the June 6, 2021 field investigation. This species and its habitat are afforded protection under the *Fisheries Act* (1985). Specialized baitfish spawning habitat (including White Sucker) is present within the study area within the riffles and runs with gravel substrate; however, the beaver dam/debris is a potential barrier to fish migration within the watercourse.

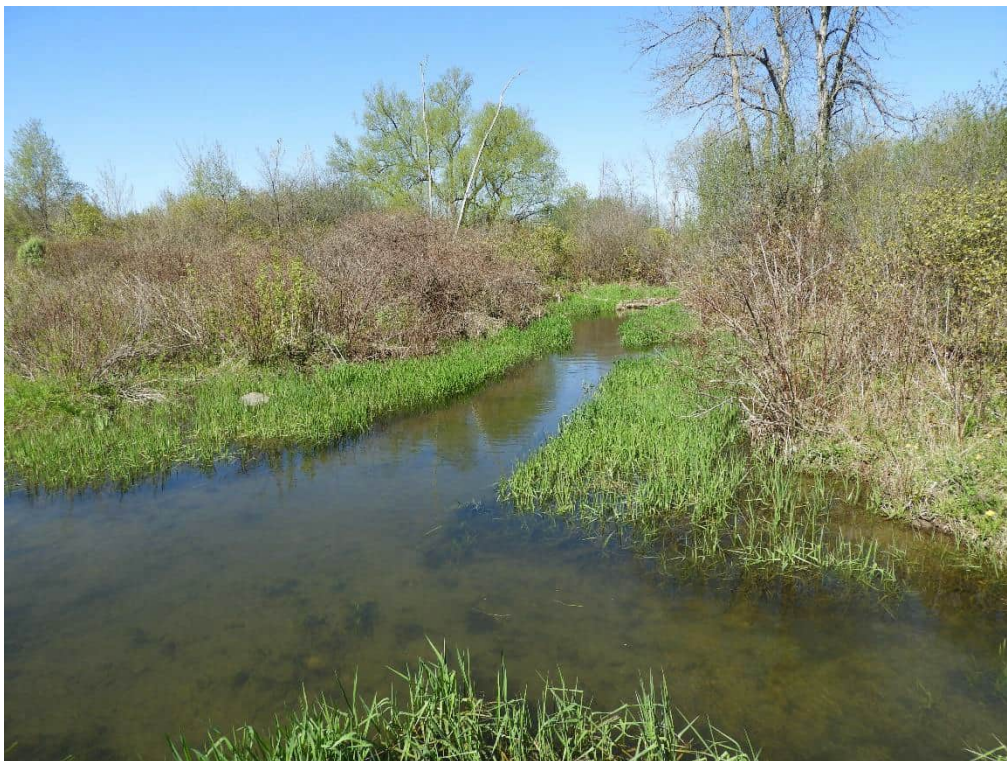
Photo 14: Harwood Creek looking upstream (west) from the off-road vehicle crossing within the study area. Another off-road vehicle crossing is present upstream at the boundary of the study area (background). 12 May 2021.

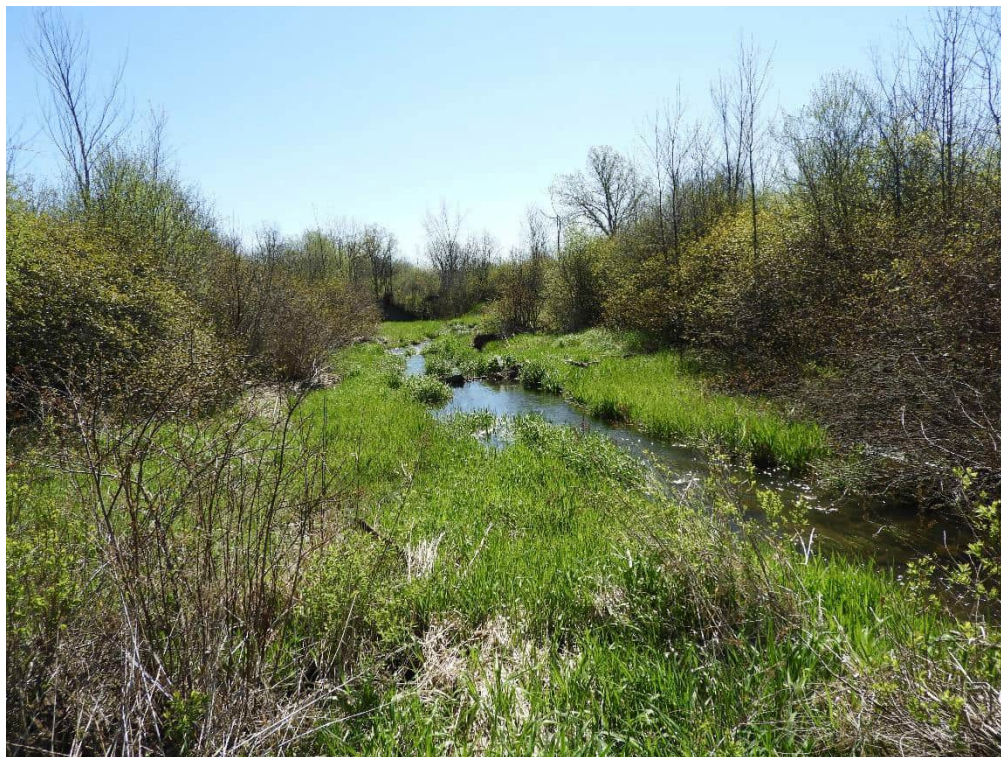
Photo 15: Harwood Creek looking downstream (east) from the beaver dam. The majority of the watercourse within the study area is downstream of the beaver dam. 12 May 2021.

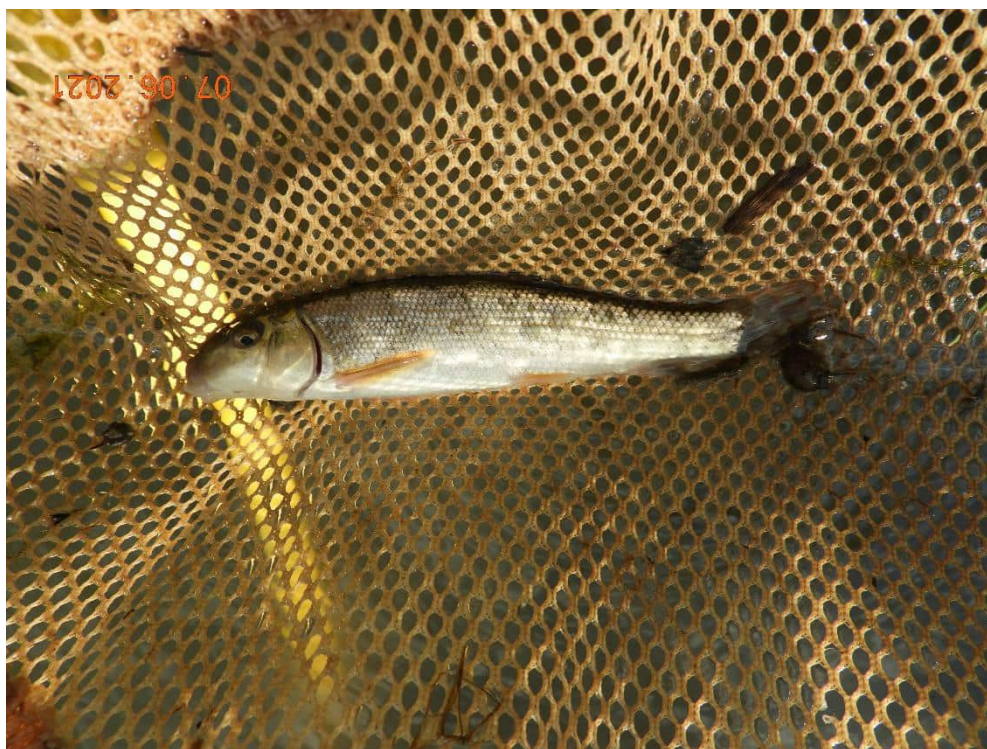
Photo 18: White Sucker (*Catostomus commersonii*) caught in Harwood Creek within the study area. The watercourse within the study area provides specialized baitfish spawning habitat. 07 June 2021.

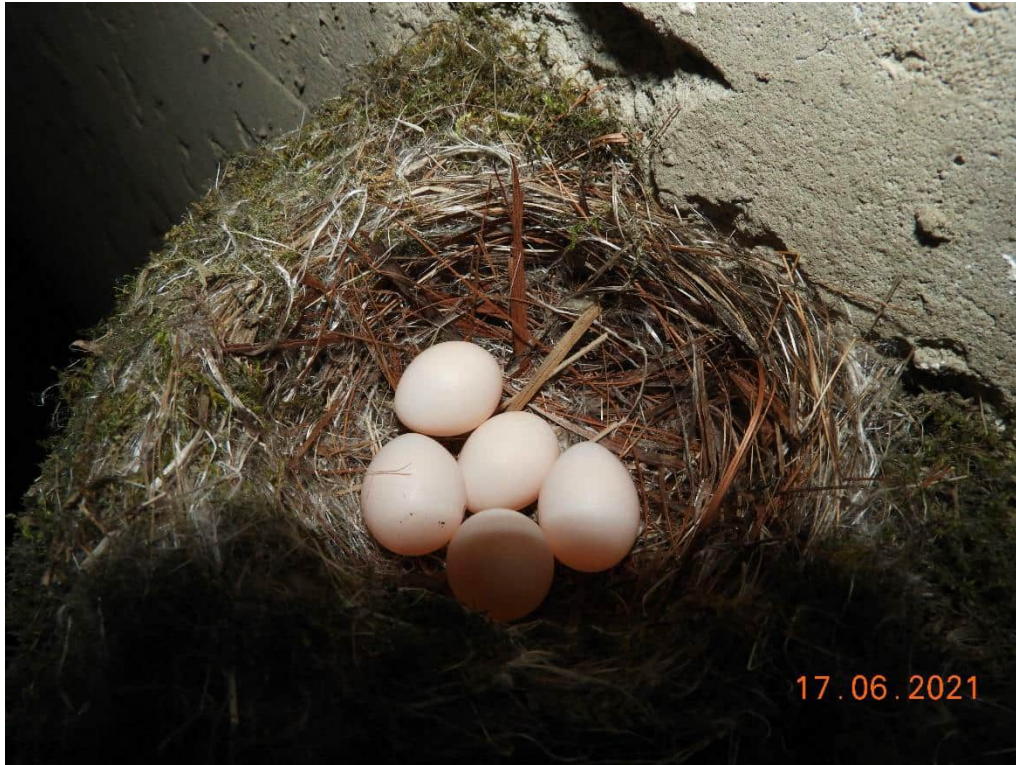
Photo 19: An active Eastern Phoebe (*Phoebe sayornis*) nest with eggs observed within the decommissioned railway culvert directly adjacent to the eastern extent of the study area. 17 June 2021.
