**TW21-1C Water Supply Assessment
Proposed Residential Development
Creekside 2 - Village of Richmond
2770 Eagleson Road
Ottawa, Ontario**

December 14, 2021
Project: 61899.03

**Re: TW21-1C Water Supply Assessment, Proposed Residential Development
Creekside 2 – Village of Richmond, 2770 Eagleson, Ottawa, Ontario**

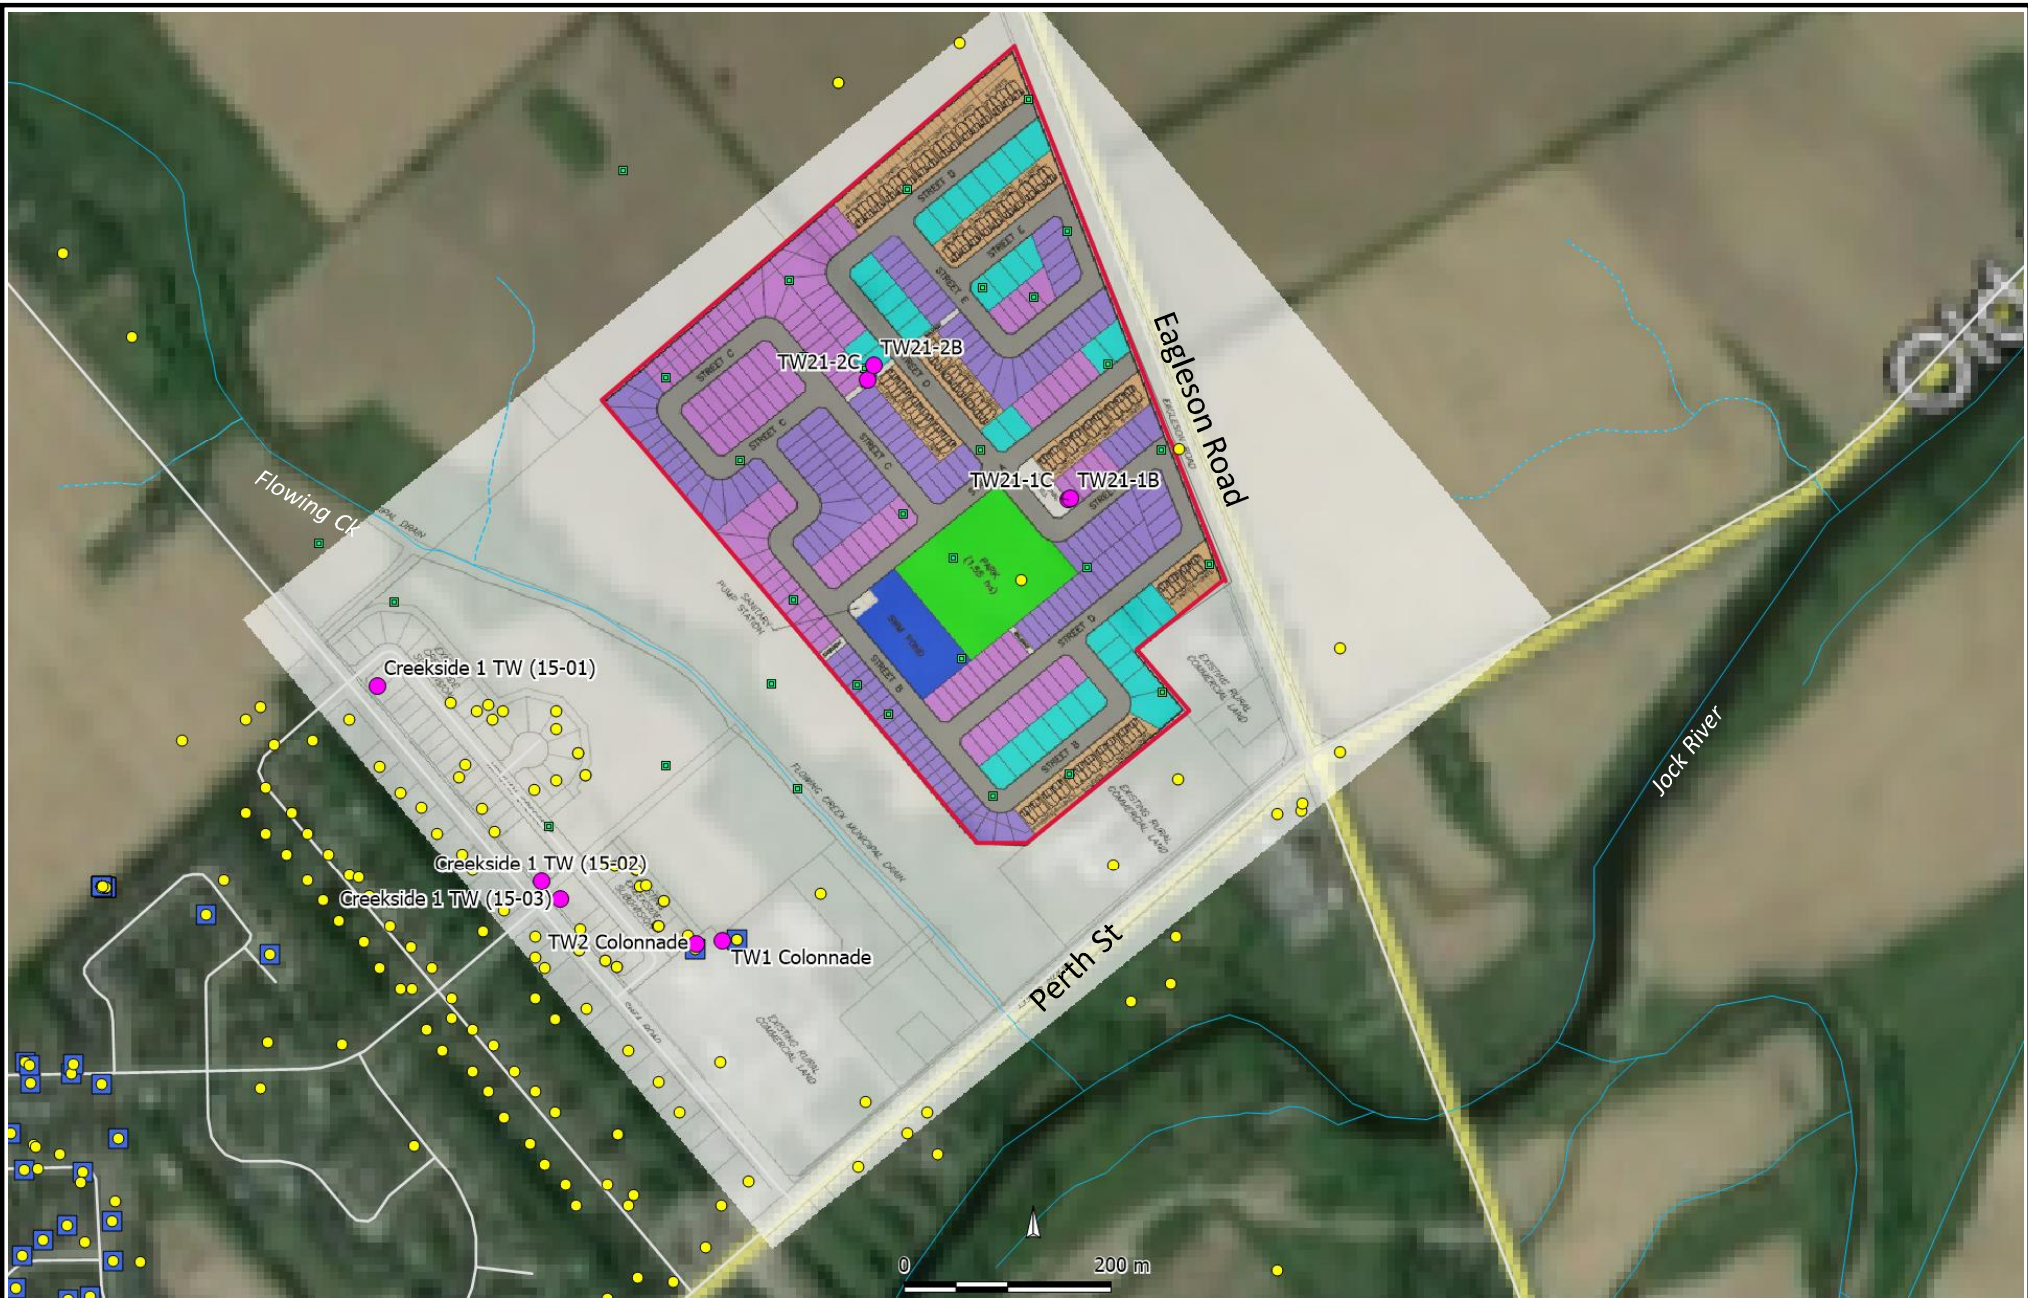
Site Map and Cross-Section Locations

Creekside Development
Conceptual Site Model

- Site Boundary
- Road
- Stream/River
- Open Hole Well Extending into Nepean Fm
- Geotechnical Well/ Potential Monitoring Well
- Potential Monitoring/ Test Well
- Water Wells

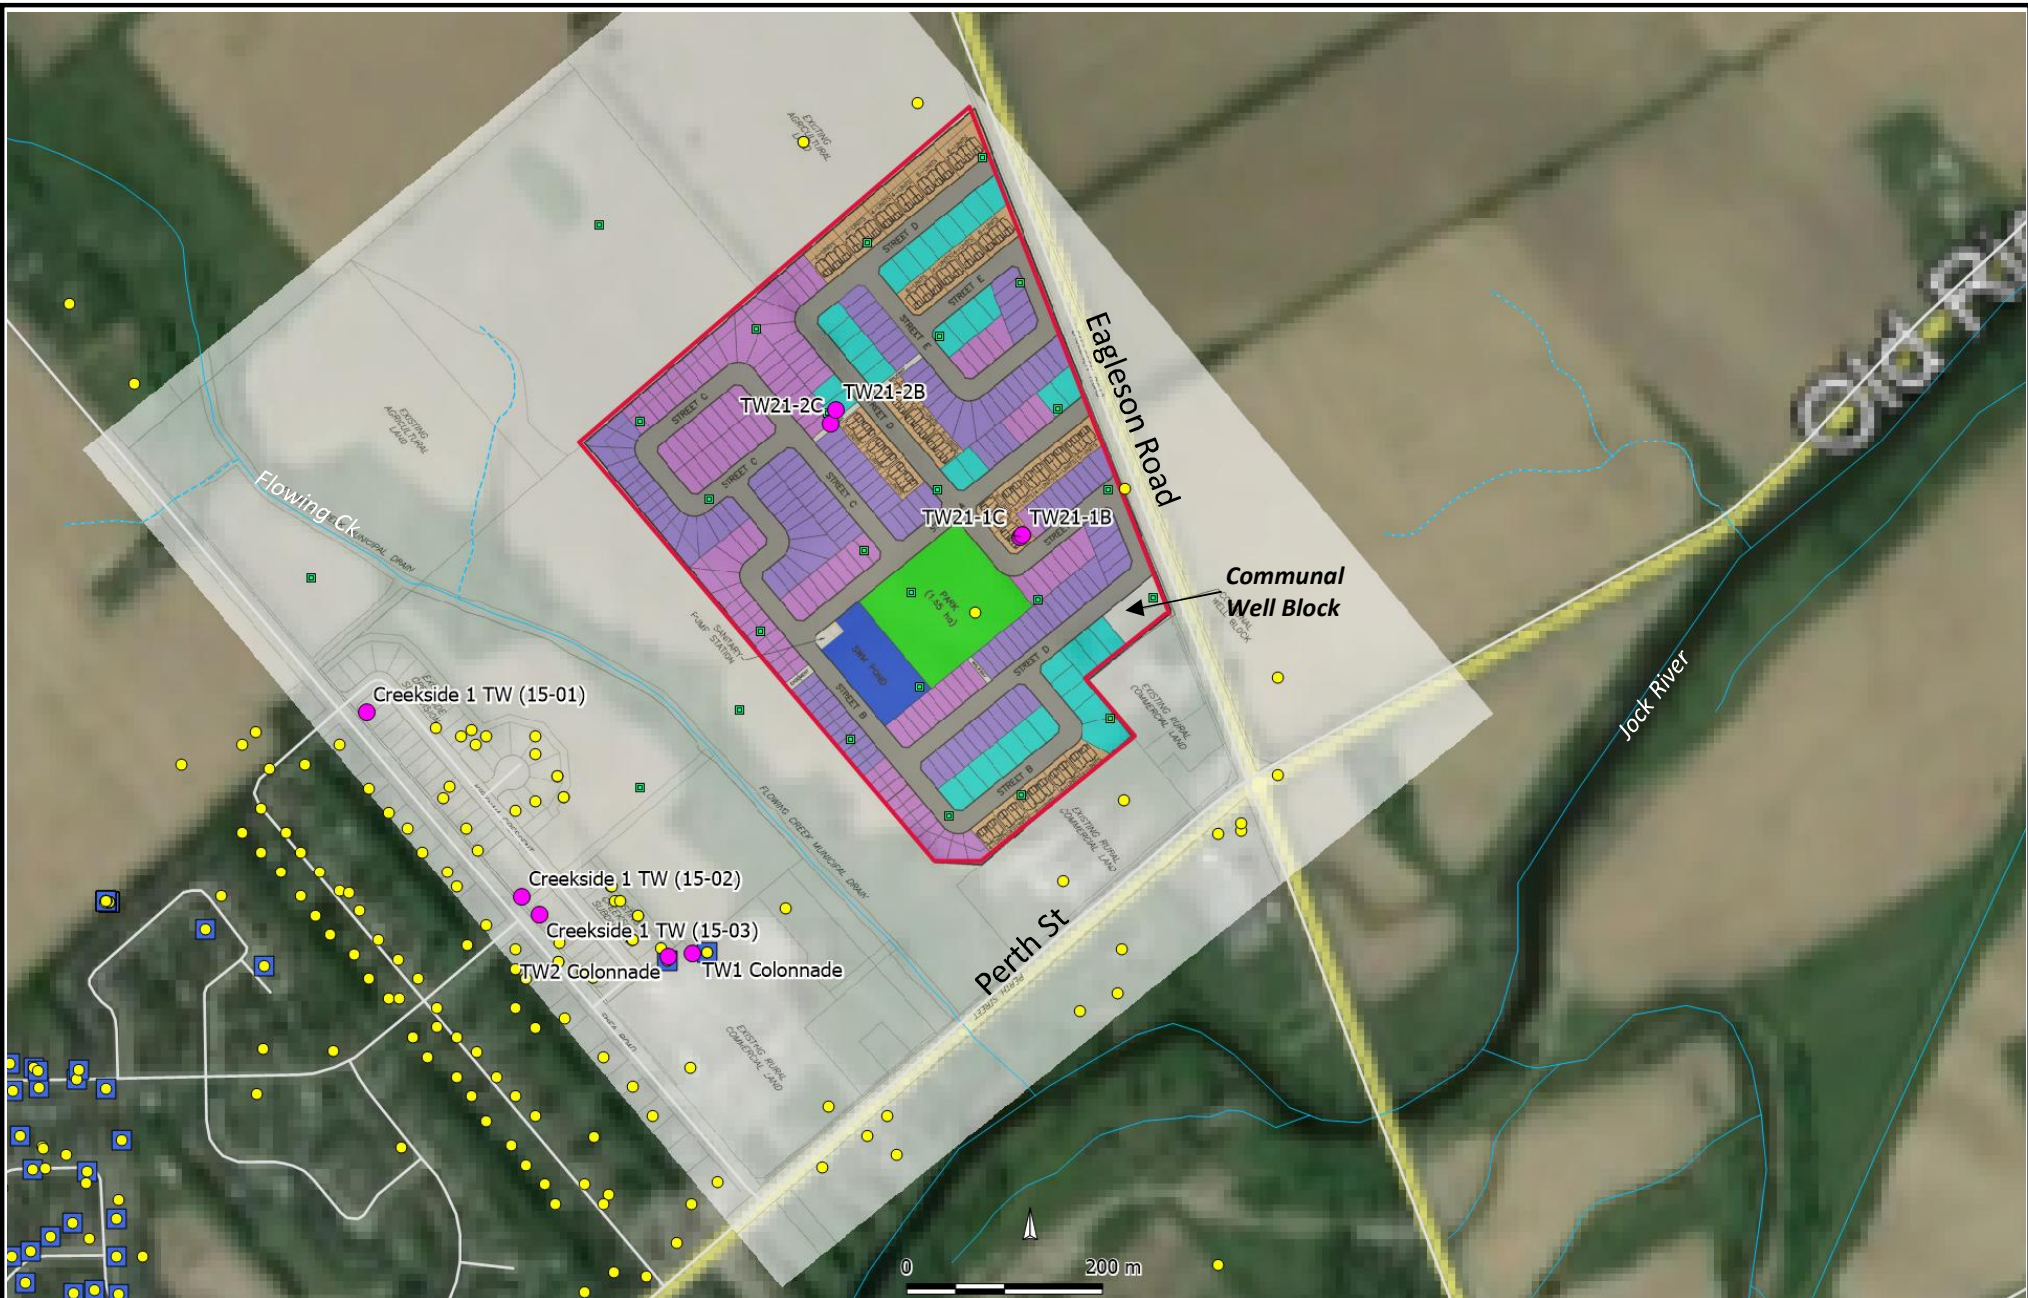
Site Map

Creekside Development
Conceptual Site Model

- Site Boundary
- Road
- Stream/River
- Open Hole Well Extending into Nepean Fm
- Geotechnical Well/ Potential Monitoring Well
- Potential Monitoring/ Test Well
- Water Wells

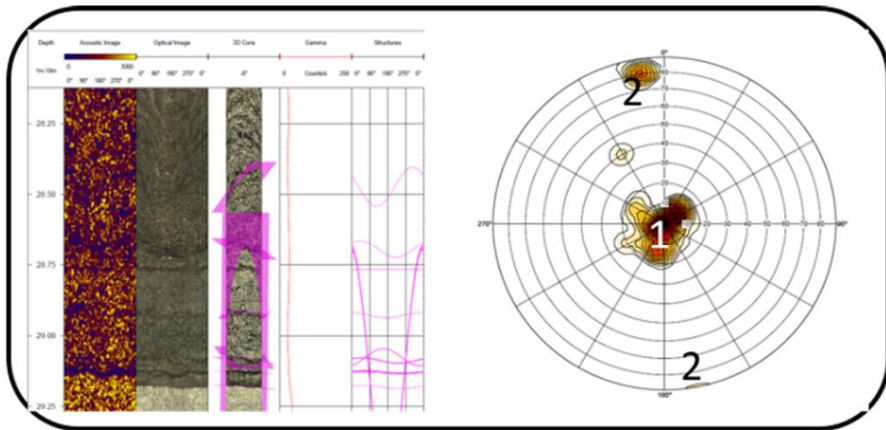
Fractures in Oxford/March Formations

Illustration displaying primary fractures noted in Oxford/March and Nepean Formations.

Fracture set 1 represents bedding plane fractures. These fractures are relatively flat lying in both formations but the bedding in the Nepean Sandstone dips more uniformly at 5 to 10 degrees in an east – northeast direction. Fracture set 2 is sub-vertical and strikes at approximately 170 degrees but dips more prominently to the north in the deeper sandstone unit. The presence of a similarly orientated sub-vertical fracture set in both upper and lower bedrock formations may indicate a similar genesis. Fracture set 2 may transmit groundwater from the shallow limestone bedrock to the deeper sandstone unit.
