Muncaster
Environmental
Planning Inc.

April 29, 2020

RE: Creekside Phase 2 Residential Development, Richmond
Environmental Impact Statement and Tree Conservation Report

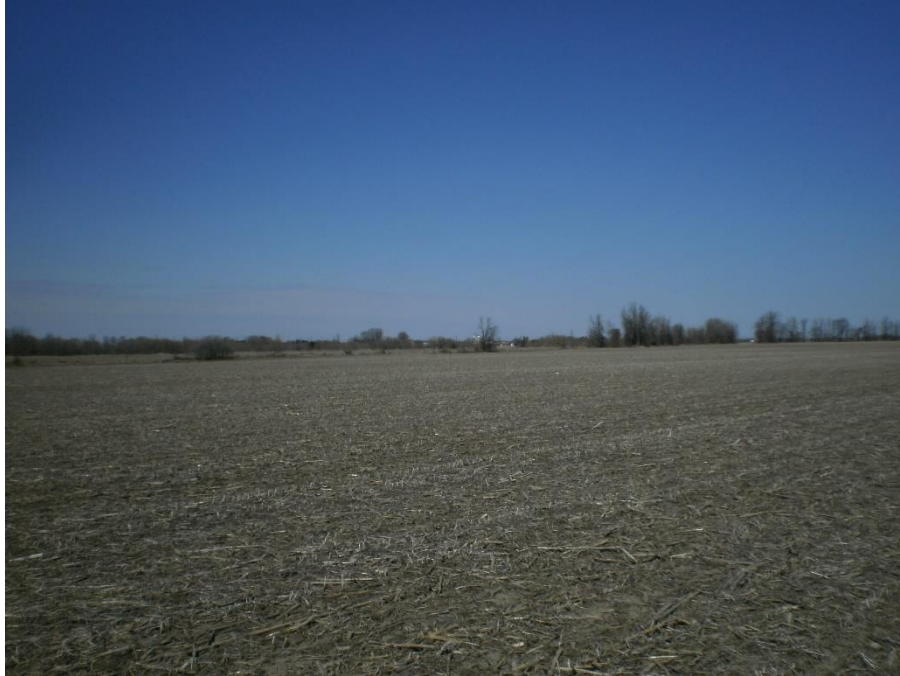
The topography of the site is generally level, with a very gentle slope to the south. The soils on the site are mapped as poorly drained silty clay (Schut and Wilson, 1987). The site is dominated by active cultivated fields, planted in soybeans and corn in 2019 (Photos 1 and 2). No swales with aquatic habitat potential were observed on the site.

*Photo 1 – Cultivated fields dominate the site.
This view is looking northwest from the southeast corner of the site*

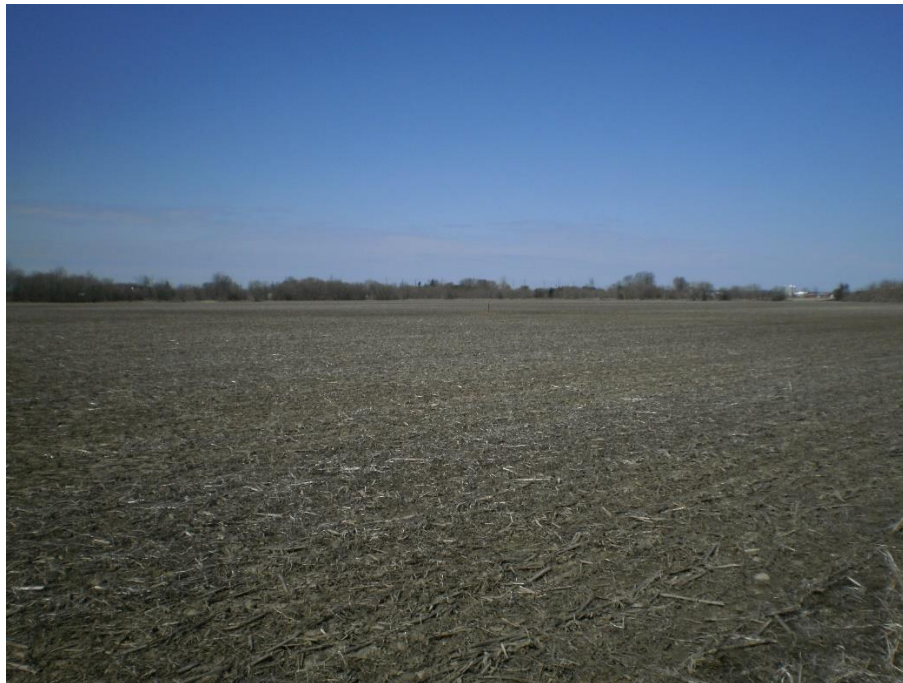
*Photo 2 – Cultivated fields in the northwest portion of the site.
View looking northwest from the middle of the site*

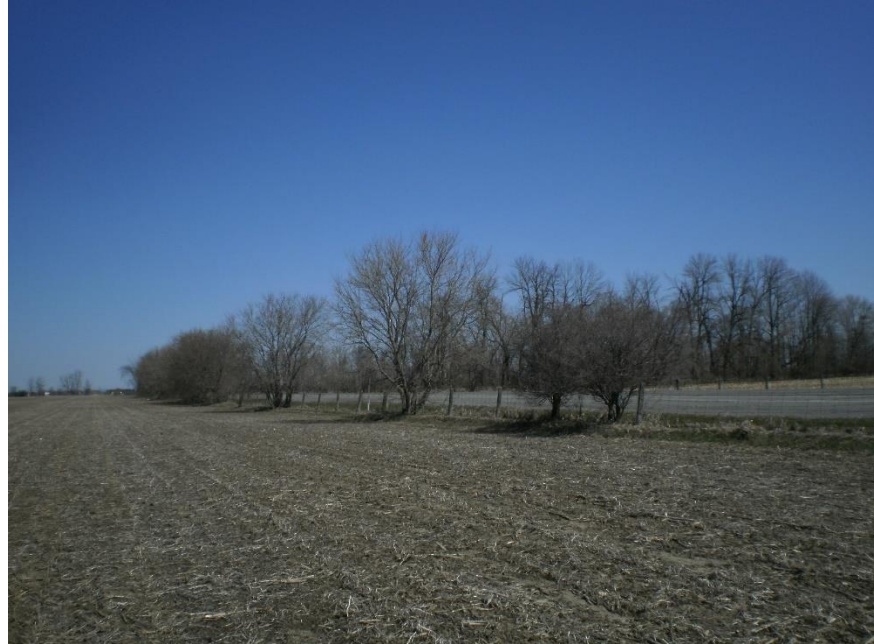
Scattered deciduous trees are along the field edges. Coppice (multi-stem) Manitoba maples with individual stems up to 34cm diameter at breast height (dbh) dominate the deciduous trees along the central portion of the east site edge, on the west side of Eagleson Road (Photo 3). A few white elm are to the north of the Manitoba maples. Many of these elms appear dead, but a 38cm dbh white elm in the northwest corner of the site appeared to be in better condition (Photo 4). Hawthorn shrubs and regenerating Manitoba maple stems were among the deciduous trees.

*Photo 3 – Scattered Manitoba maple along the east site edge, west of Eagleson Road.
View looking northeast*

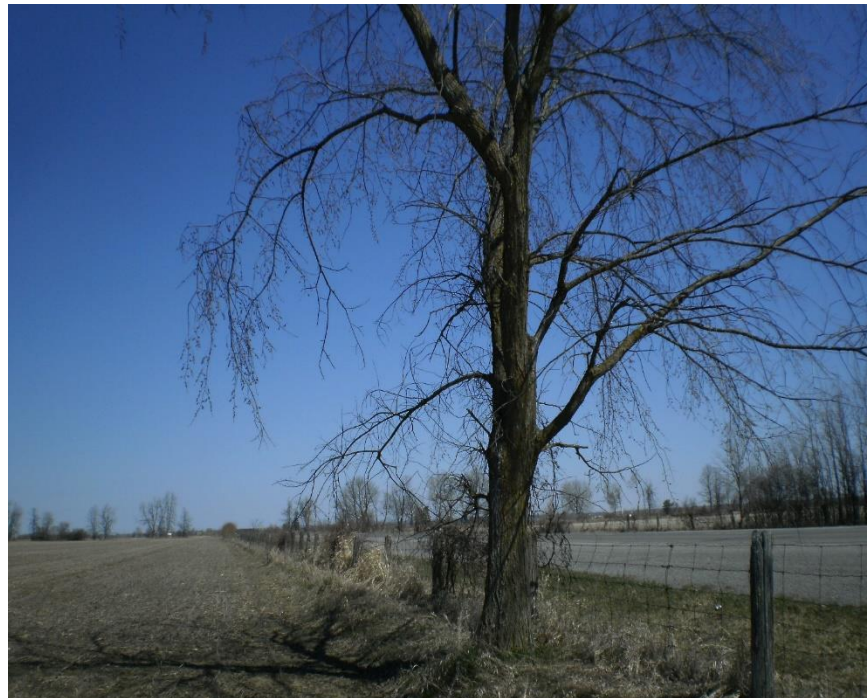
Photo 4 – White elm along the east site edge, west of Eagleson Road. View looking northeast

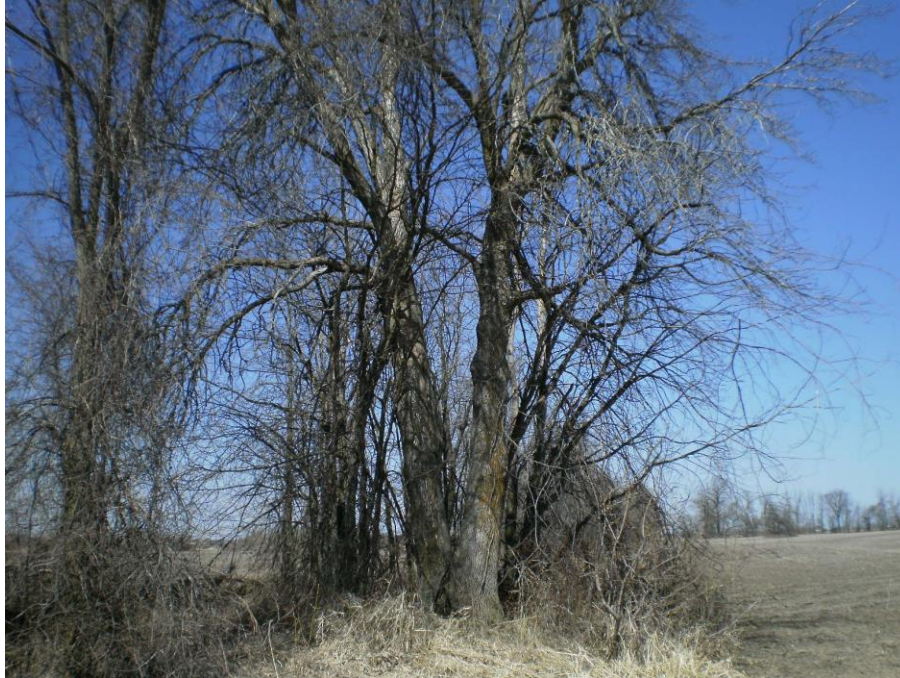
Scattered deciduous trees are also in a north-south orientation between the two main cultivated fields. The largest of these trees are mature white ash up to 58cm dbh near the north site boundary (Photo 5). These ash appear to be in poor condition with extensive emerald ash borer damage on the trunks. To the south of the white ash, white elm up to 25cm dbh also appear to be in poor condition, with a couple of the elm stems appearing healthier. Additional green ash and Manitoba maple up to 25cm and 15cm dbh respectively are also present in this area. Further south, a 40cm dbh Manitoba maple had major trunk and lower branch damage.

Photo 5 – Larger white ash with extensive emerald ash borer damage in the central portion of the north site edge. View looking north

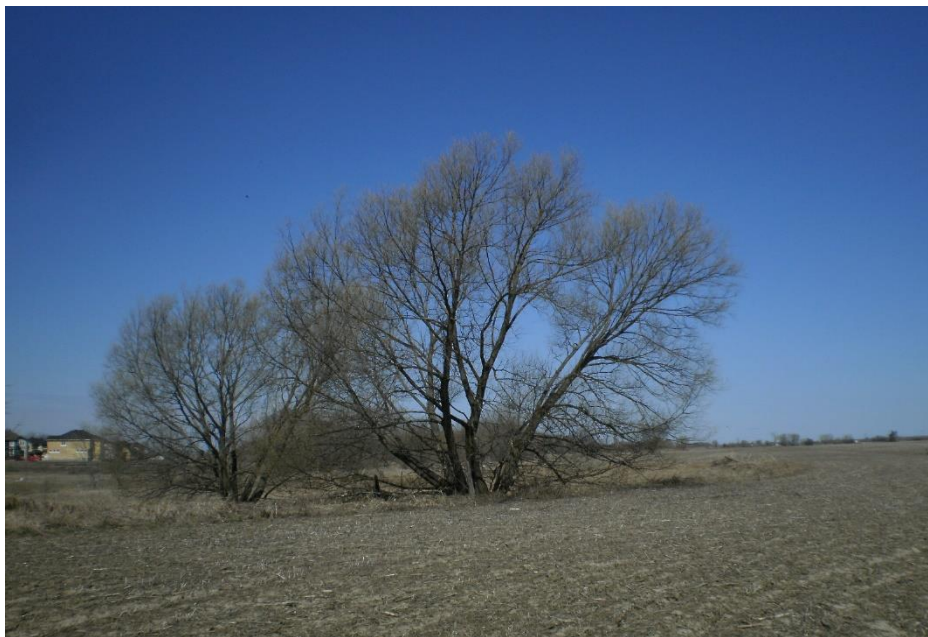
Manitoba maple and white elm up to 18cm and 25cm dbh are along the southeast edge of the site. Many of the Manitoba maple had damaged lower branches. A small area of cultural meadow in the southwest corner of the site included a couple of mature coppice crack willow with individual stems up to 55cm dbh (Photo 6). Manitoba maple and bur oak up to 25cm dbh and smaller white ash, green ash, and white elm are also in this area. There is a noticeable drop in the elevation west of the cultural meadow, and the site, towards the Flowing Creek Municipal Drain.

Photo 6 – Crack willow adjacent to the cultivated fields in the southwest corner of the site. View looking northwest

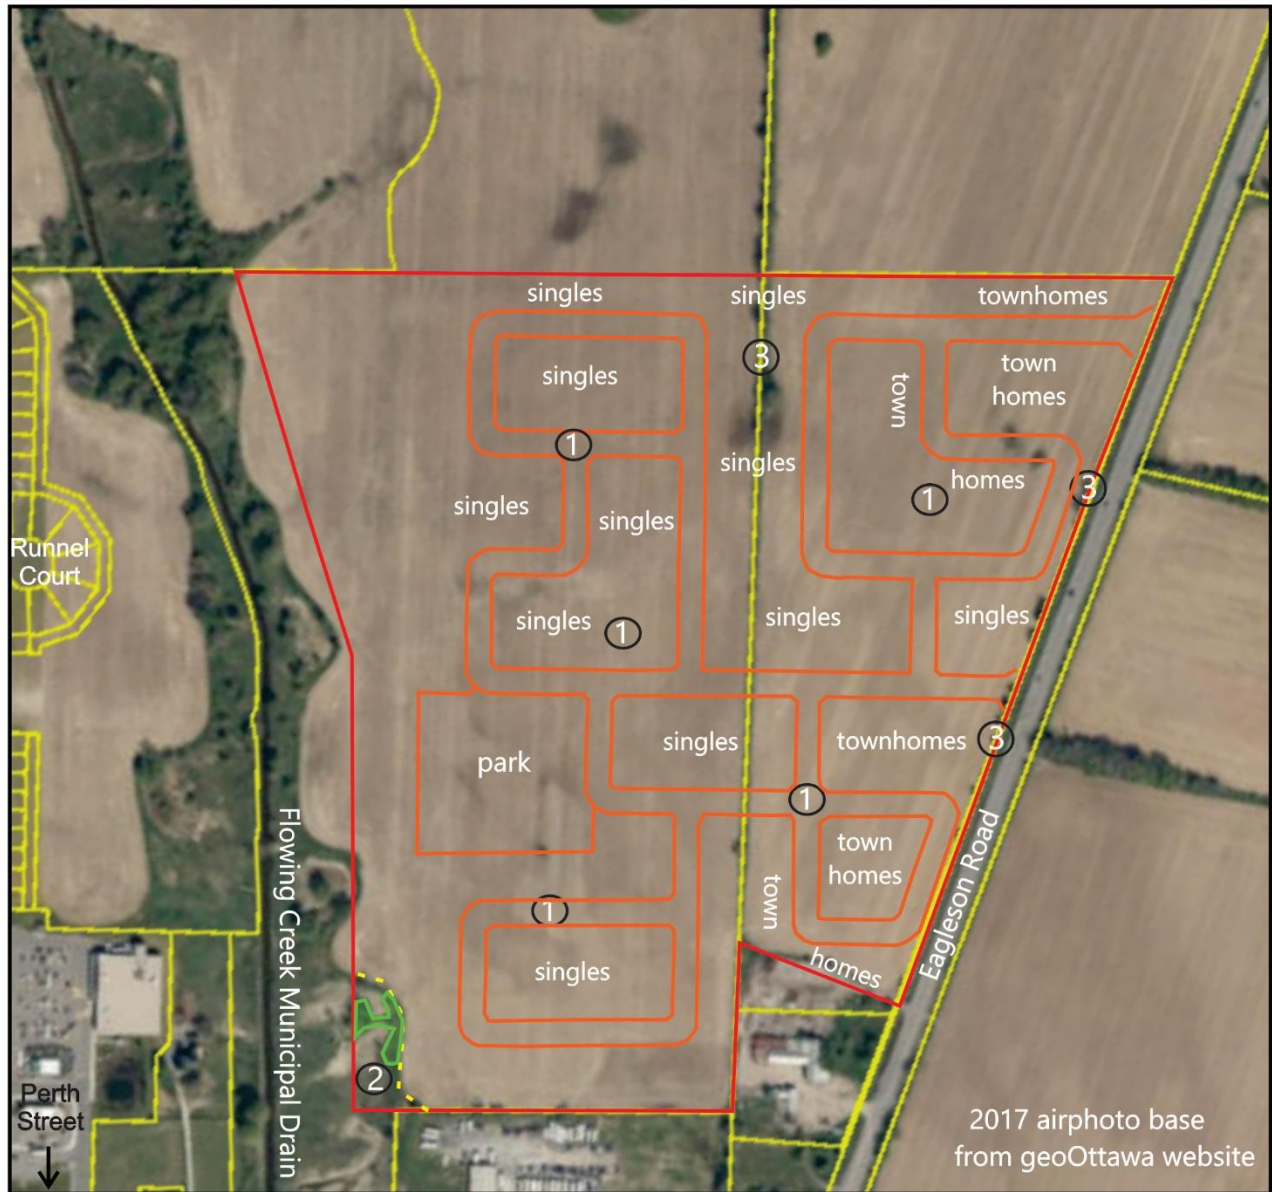
FILE: 20 - 01	Map 2	April 29, 2020
PROPOSED CONSERVED VEGETATION Creekside Phase 2 Richmond, City of Ottawa		
Prepared for:		Cardel Homes
Prepared by:		  Muncaster Environmental Planning Inc.

Due to the density of residential development and associated required urban servicing and grading, no tree retention is anticipated within the footprint of development. As shown on Map 2, some trees will be retained within a cultural meadow in the southwest corner of the site, west of the proposed residences.

2. Any trees to be retained are to be protected with sturdy temporary fencing at least 1.2 metres in height installed from the tree trunk a distance of ten times the retained tree's diameter where possible. Signs, notices, or posters are not to be attached to any tree. No grading, heavy machinery traffic, stockpiling of material, machinery maintenance and refueling, or other activities that may cause soil compaction are to occur within the critical root zones of the trees to be retained and protected. The root system, trunk, or branches of the trees to be retained are to be protected and not damaged. If any roots of trees to be retained are exposed during site alterations, the roots shall be immediately reburied with soil or covered with filter cloth, burlap, or woodchips and kept moist until the roots can be buried permanently. A covering of plastic should be used to retain moisture during an extended period when watering may not be possible. Any roots that must be cut are to be cut cleanly to facilitate healing and as far from the tree as possible. A qualified arborist is to prune prior to construction any branches from retained trees on or adjacent to the site that may be damaged during construction. Exhaust fumes from all equipment during construction will not be directed towards the canopies of retained trees.
