**Phase One  
Environmental Site Assessment  
Proposed Residential Development  
393 McArthur Avenue  
Ottawa, Ontario**

May 31, 2022  
Project: 64819.22

**Re: Phase One Environmental Site Assessment  
393 McArthur Street  
Ottawa, Ontario**

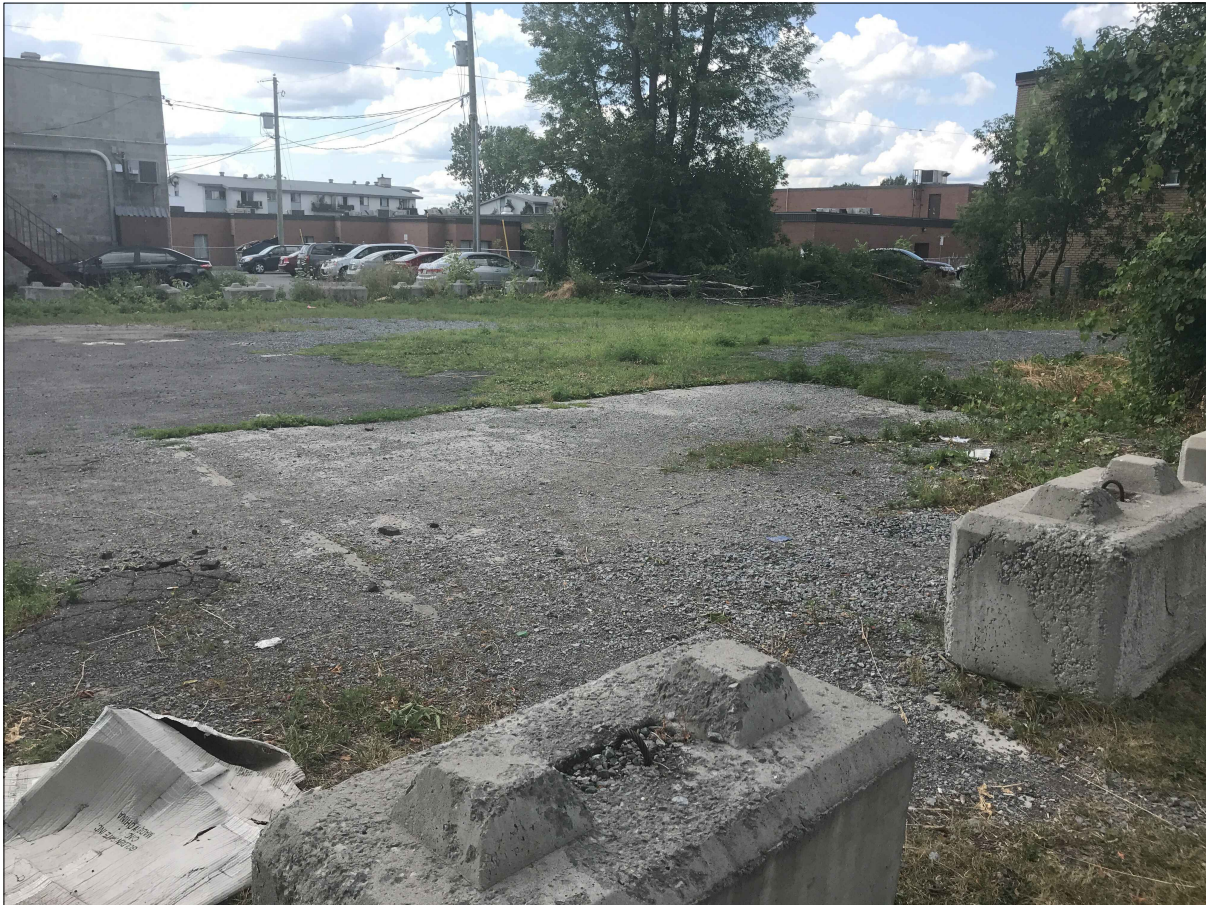
**FIGURE J1**

NORTHWEST VIEW OF SITE  
CONCRETE PAD, CONCRETE BLOCKS

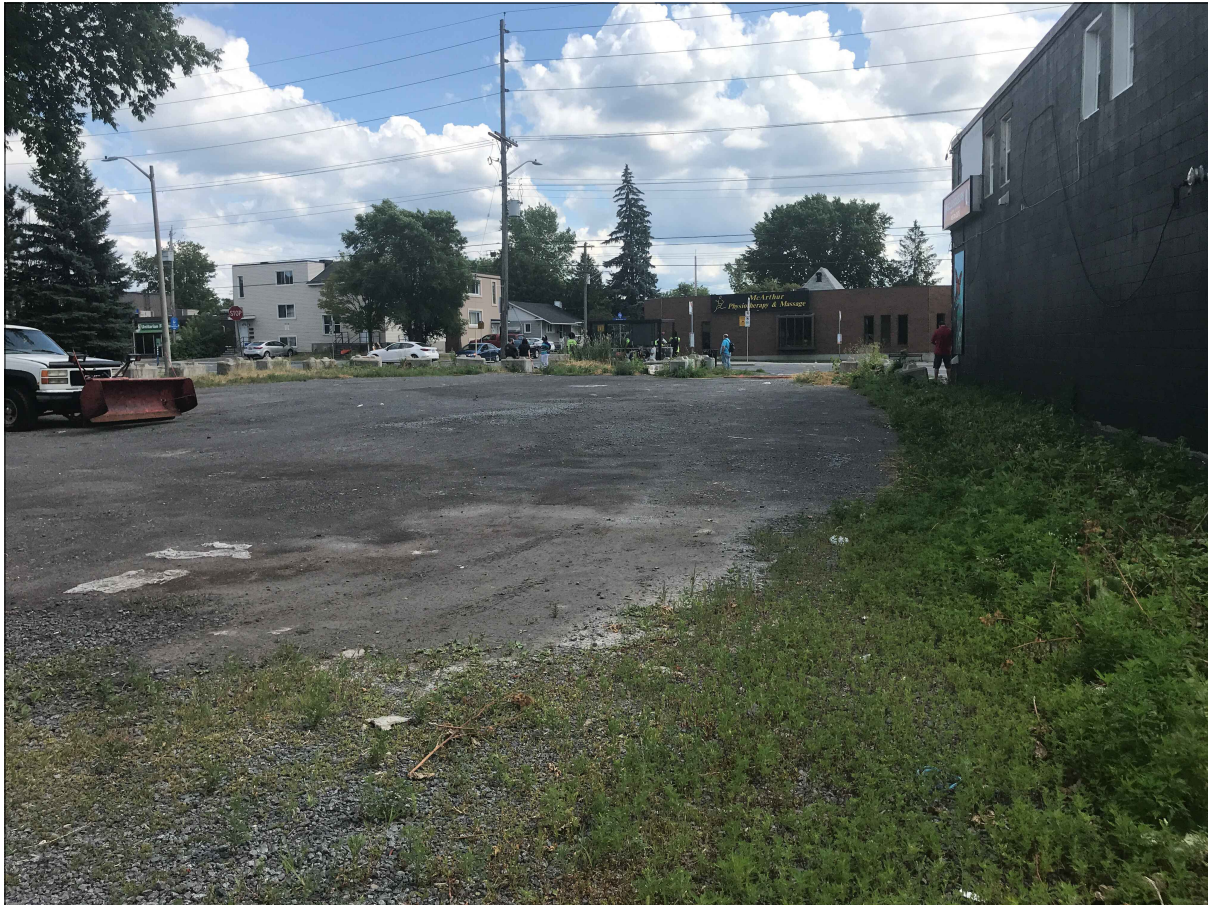
**FIGURE J2**

SOUTH VIEW OF SITE  
LOOKING TOWARDS MCARTHUR AVENUE

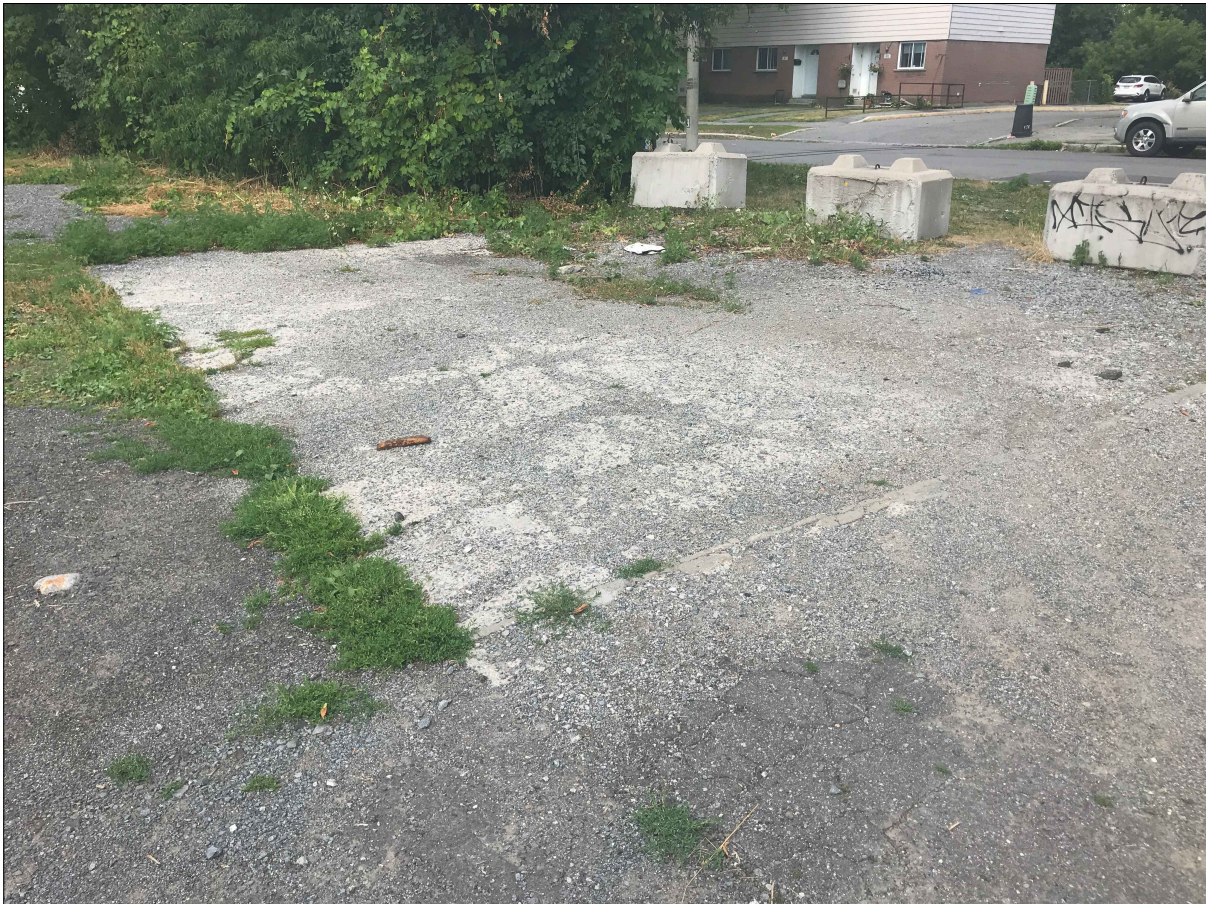
**FIGURE J3**

CONCRETE PAD

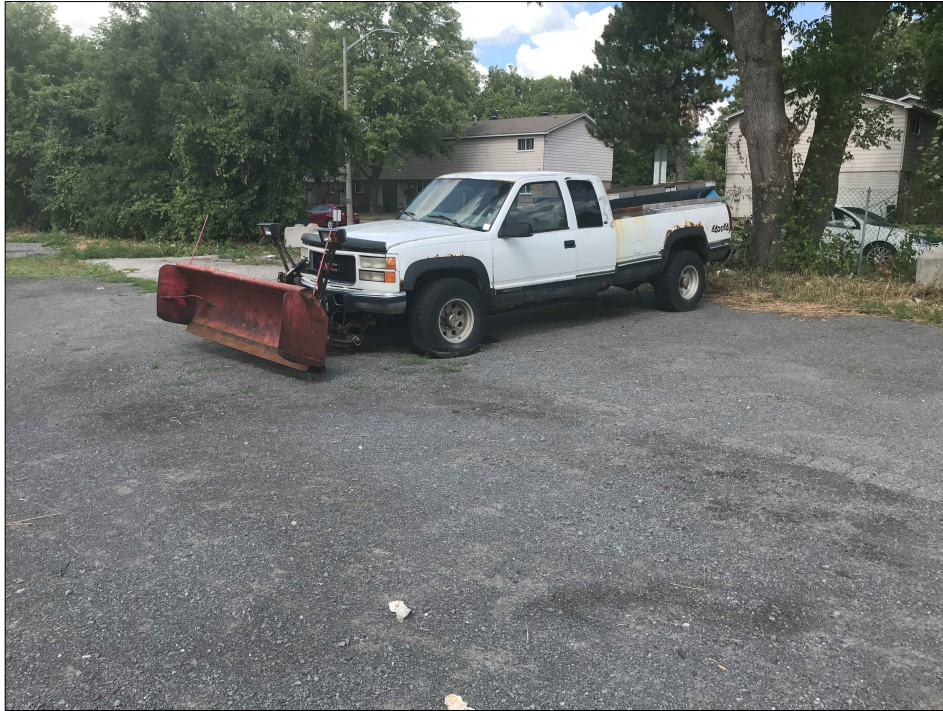
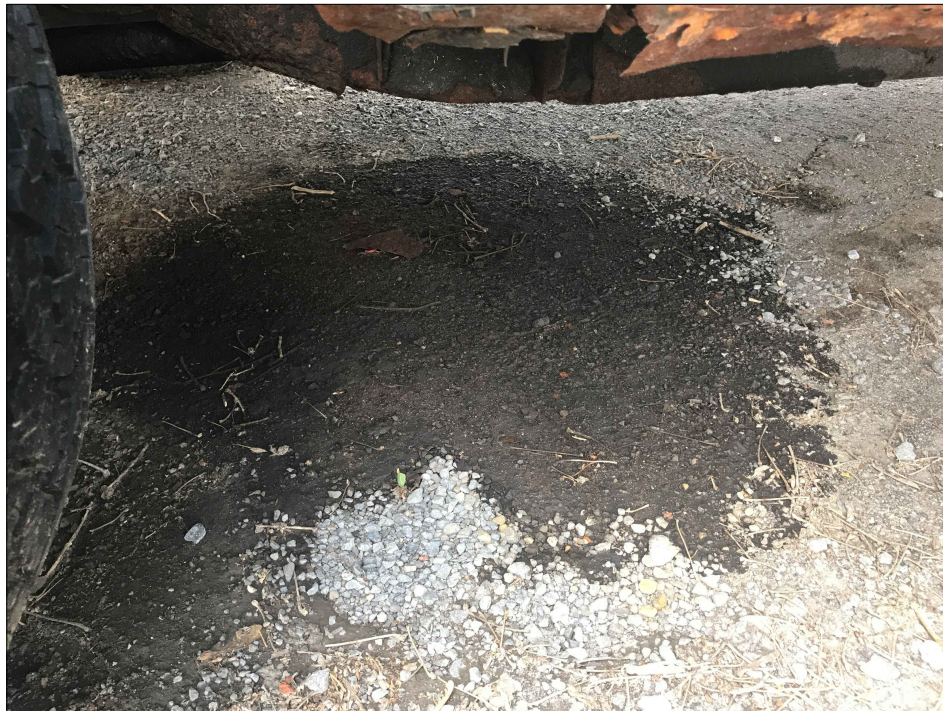
**FIGURE J4**

A white pick-up truck was identified during the 2019 site reconnaissance. The truck was located on the east side of the subject property, with staining and a hydrocarbon odour identified on the asphalt below the truck.

A white pick-up truck was located on the east side of the subject property, staining was identified on the asphalt below the truck and a hydrocarbon odour was identified.

PICK UP TRUCK, PARKED ON EAST SIDE OF PROPERTY

STAINED SOIL CAUSED BY TRUCK LEAKING

A Phase Two ESA was recommended to be completed for the subject property, to investigate soil and groundwater quality in the vicinity of the identified APECs and assist in the preparation of a remedial or risk management strategy for the development of the subject property, if required.

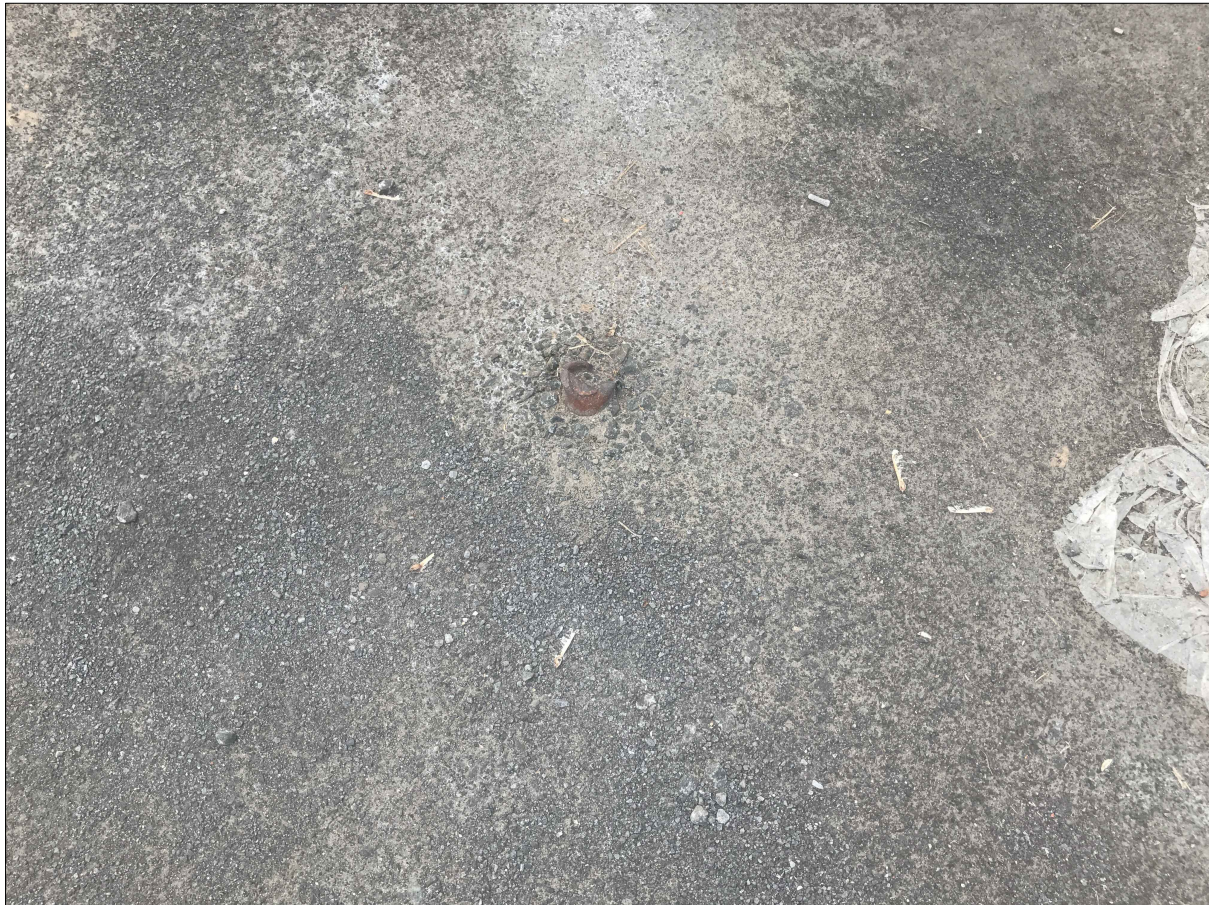
**FIGURE J5**

METAL STICKING UP FROM GROUND. CUT OFF

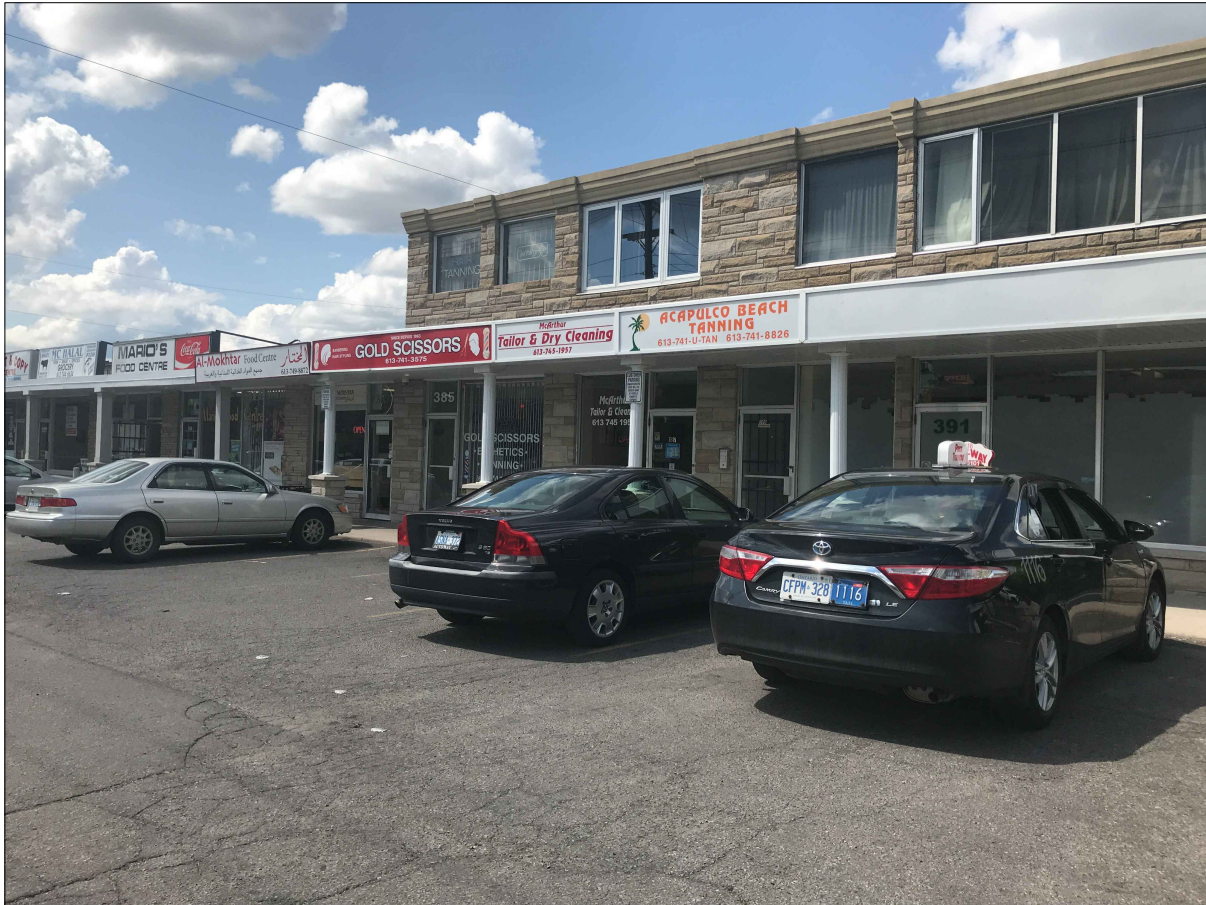
**FIGURE J6**

ADJACENT DRY CLEANING BUSINESS. POTENTIALLY CONTAMINATING BUSINESS WITHIN STUDY AREA. MCARTHUR TAILOR AND DRY CLEANING. 387 MCARTHUR AVENUE

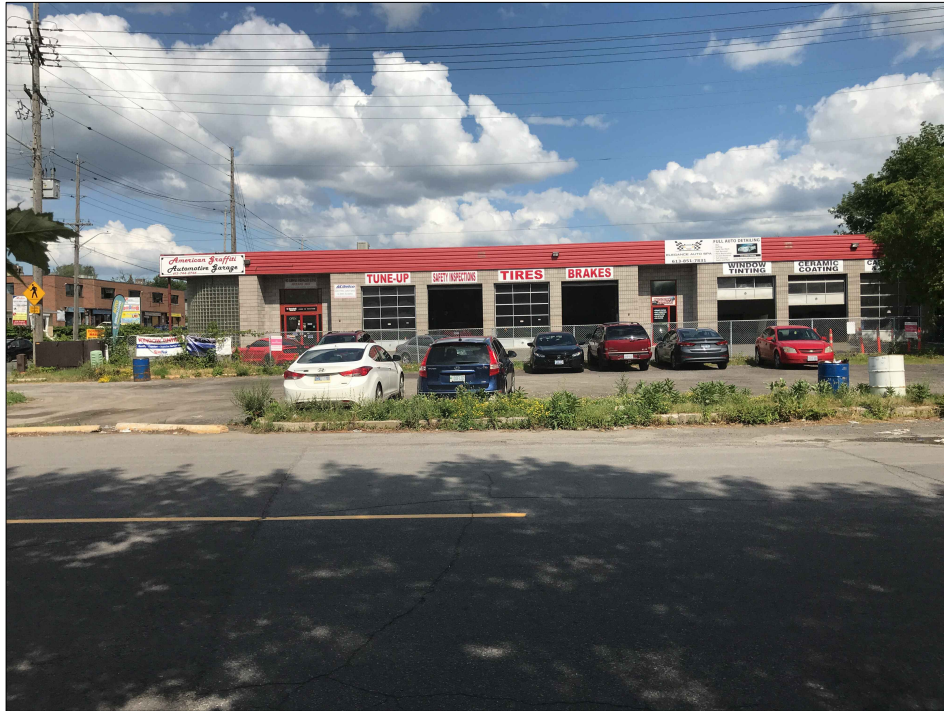
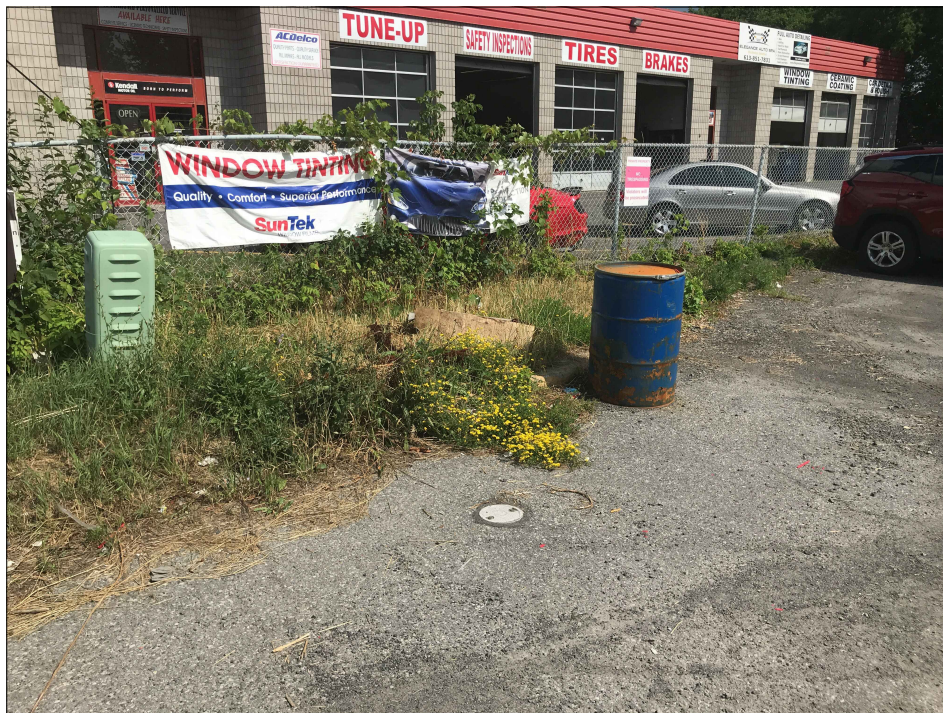
**FIGURE J7**

POTENTIALLY CONTAMINATING BUSINESS WITHIN THE STUDY AREA.  
 AMERICAN GRAFFITI AUTOMOTIVE. 416 MCARTHUR AVENUE. DRUM AND  
 MONITORING WELL IN FRONT OF BUSINESS

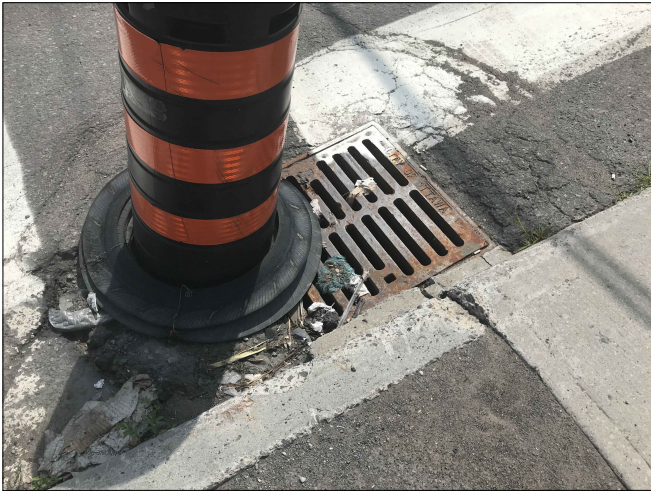
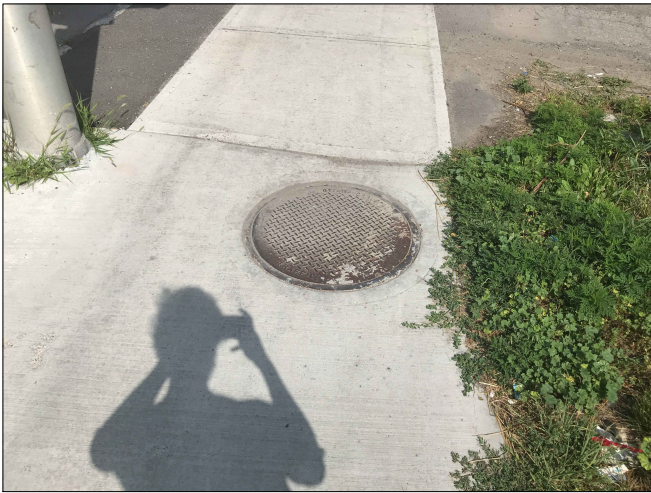
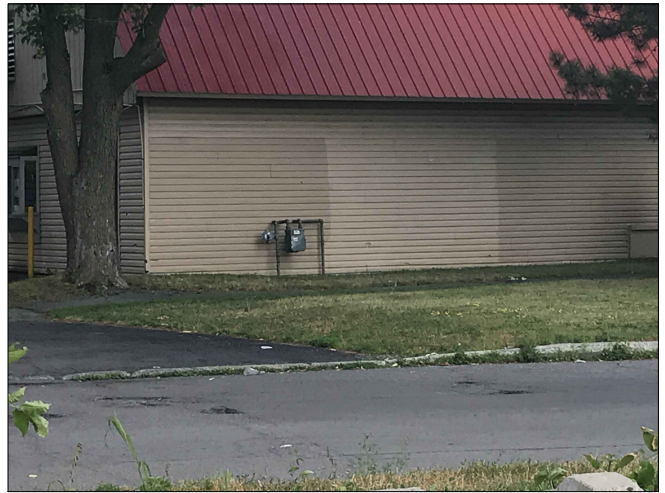
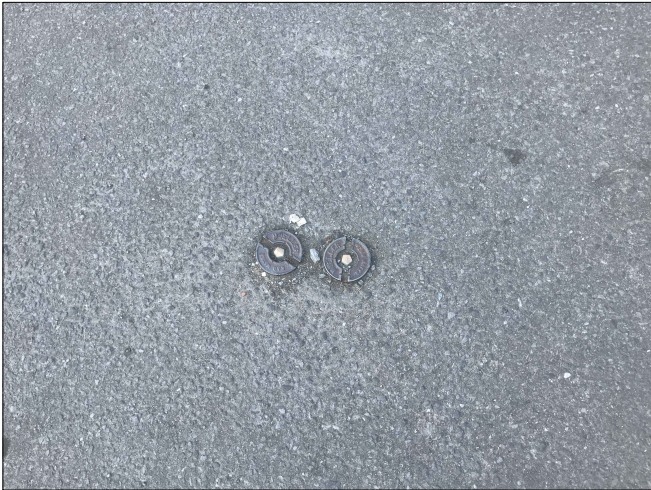
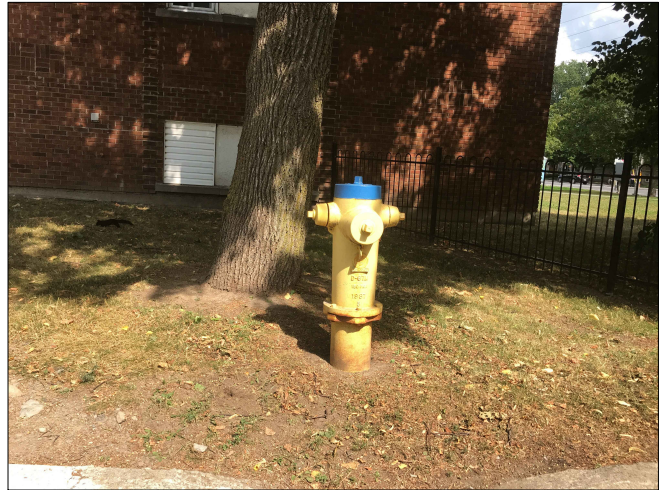
**FIGURE J8**

SEWER GRATES, ABOVE GROUND HYDRO LINES AND TRANSFORMER,  
NATURAL GAS METER, WATER MAINS, FIRE HYDRANTS, AND SEWER CAPS  
ALL LOCATED WITHIN THE SUBJECT AREA.

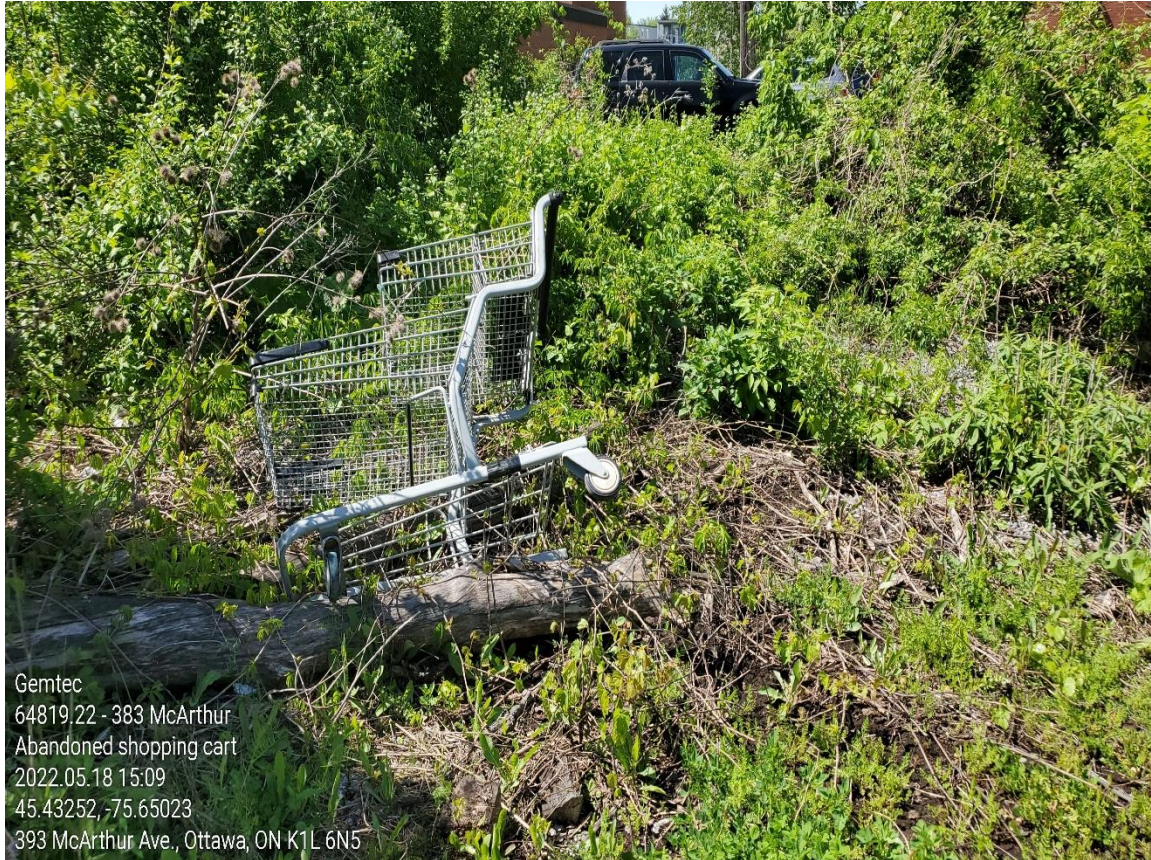
Project	PHASE ONE ESA 393 MCARTHUR AVENUE, OTTAWA, ON	Project No.	64819.22	<b>FIGURE J9</b>
---------	--	-------------	----------	------------------

ABANDONED SHOPPING CART ON THE  
 NORTH PORTION OF THE SUBJECT  
 PROPERTY

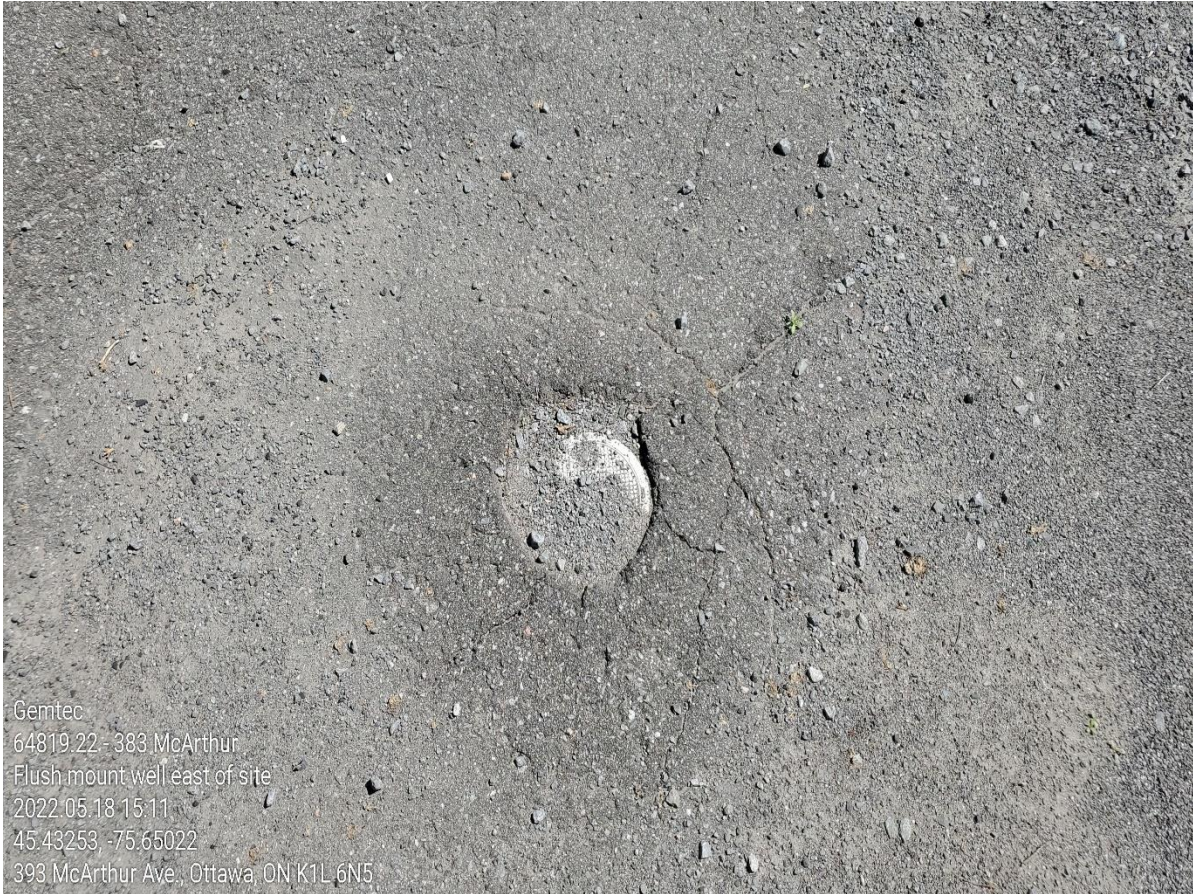
Project	PHASE ONE ESA 393 MCARTHUR AVENUE, OTTAWA, ON	Project No.	64819.22	<b>FIGURE J10</b>

- Intrusive investigations have are evident on the subject property in the form of at least three monitoring wells; two stick-up and one flush mount observed across the subject property from east to west.
- The north side of the subject property was filled with assorted litter and garbage, including numerous metal objects, the largest of which was an abandoned shopping cart.
- The truck identified as a PCA and as an APEC in the 2019 site reconnaissance was no longer on-site during the 2022 site reconnaissance.

MONITORING WELL ON THE EAST PORTION OF  
THE SUBJECT PROPERTY

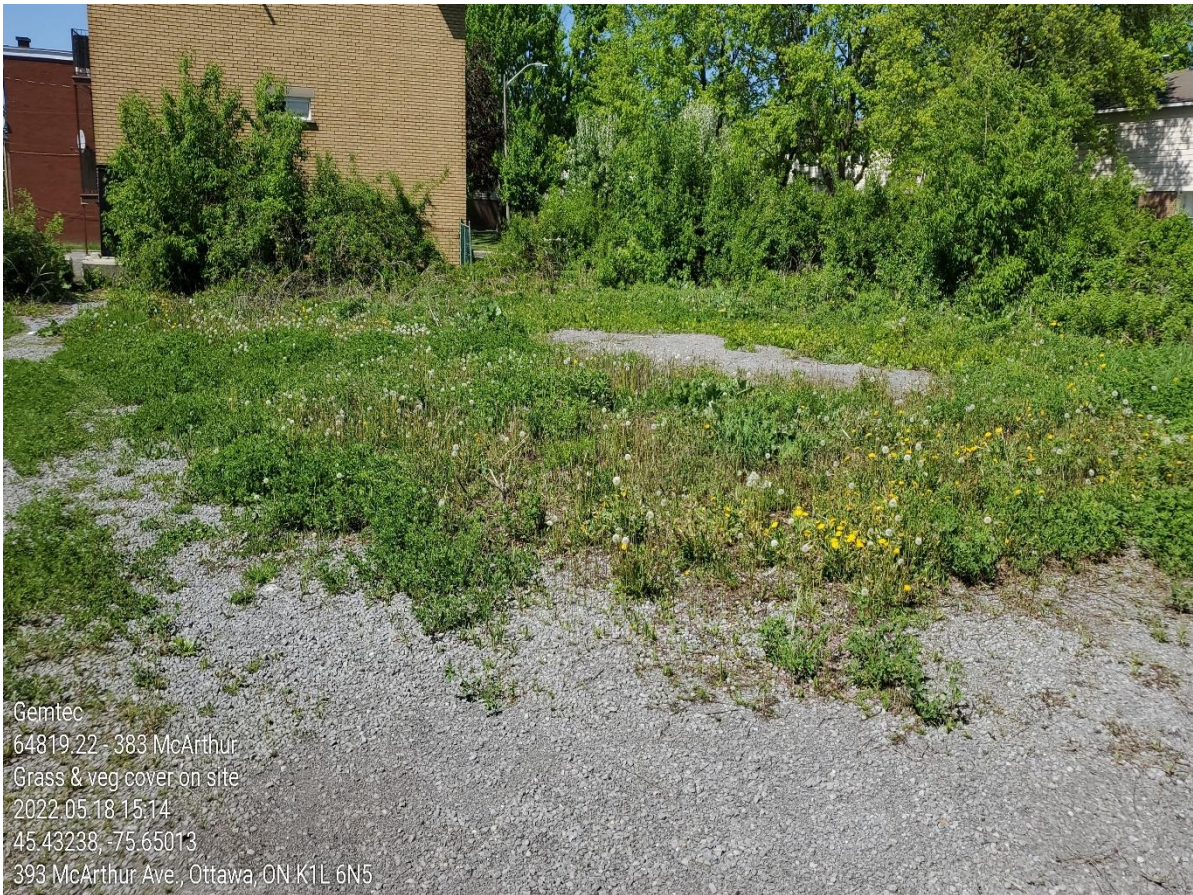
**FIGURE J11**

Gemtec  
 64819.22 - 383 McArthur  
 Grass & veg cover on site  
 2022-05-18 15:14  
 45.43238, -75.65013  
 393 McArthur Ave., Ottawa, ON K1L 6N5

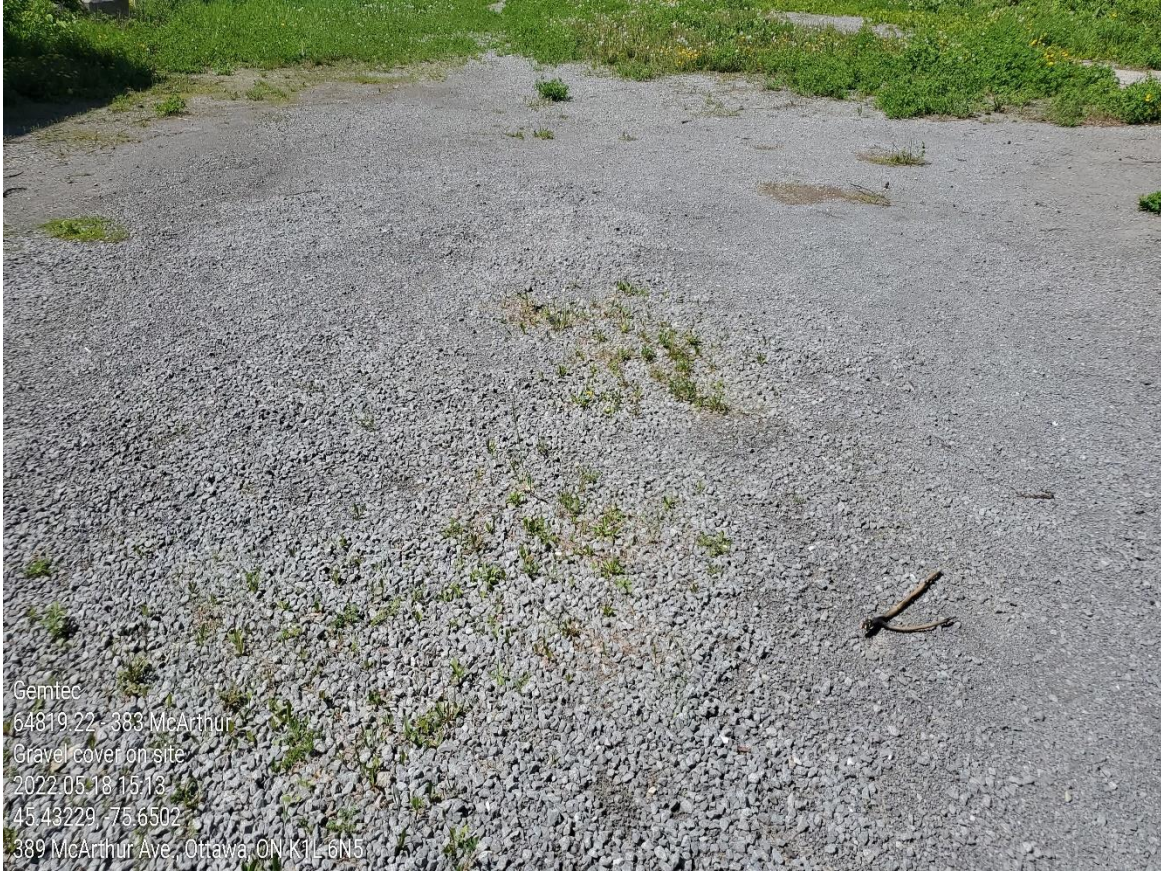
Project	PHASE ONE ESA 393 MCARTHUR AVENUE, OTTAWA, ON	Project No.	64819.22	<b>FIGURE J12</b>

GRAVEL COVERAGE ON THE SUBJECT  
 PROPERTY

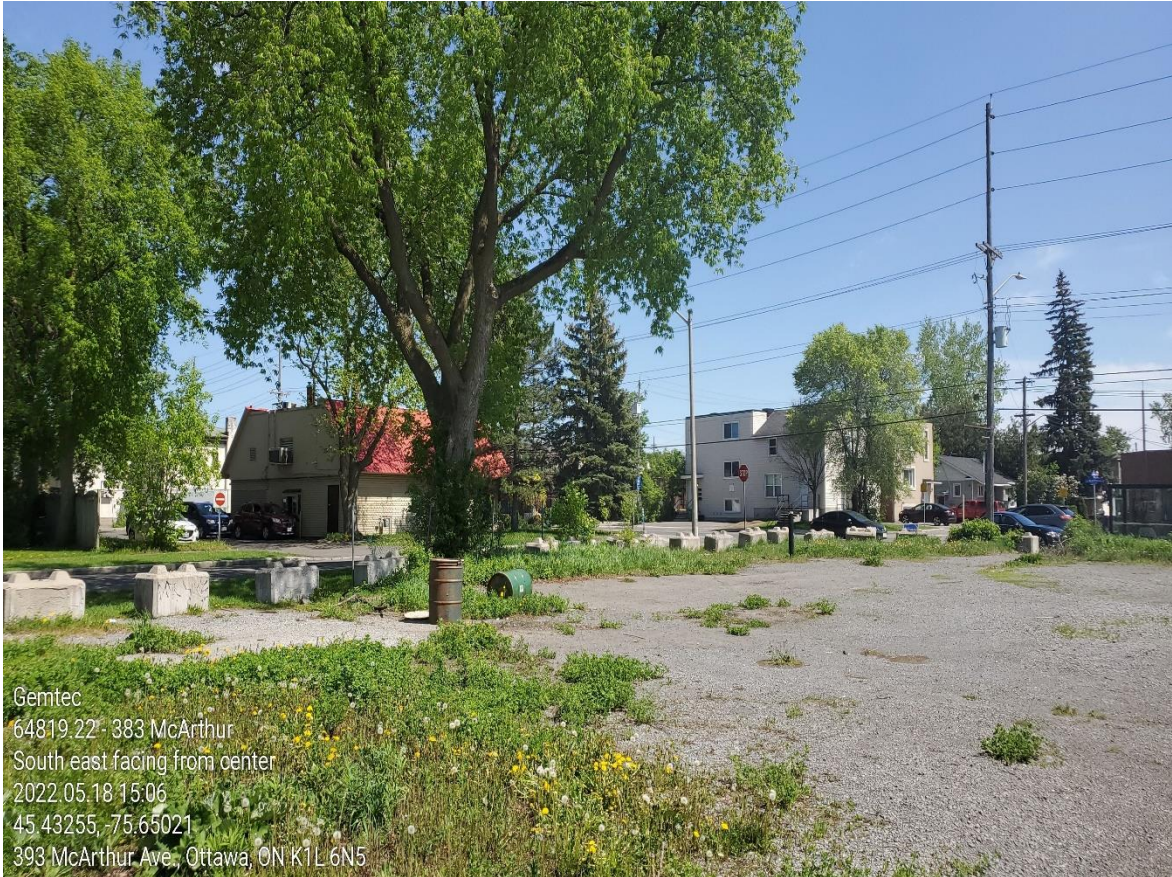
Gemtec  
 64819.22 - 383 McArthur  
 South east facing from center  
 2022.05.18 15:06  
 45.43255, -75.65021  
 393 McArthur Ave., Ottawa, ON K1L 6N5

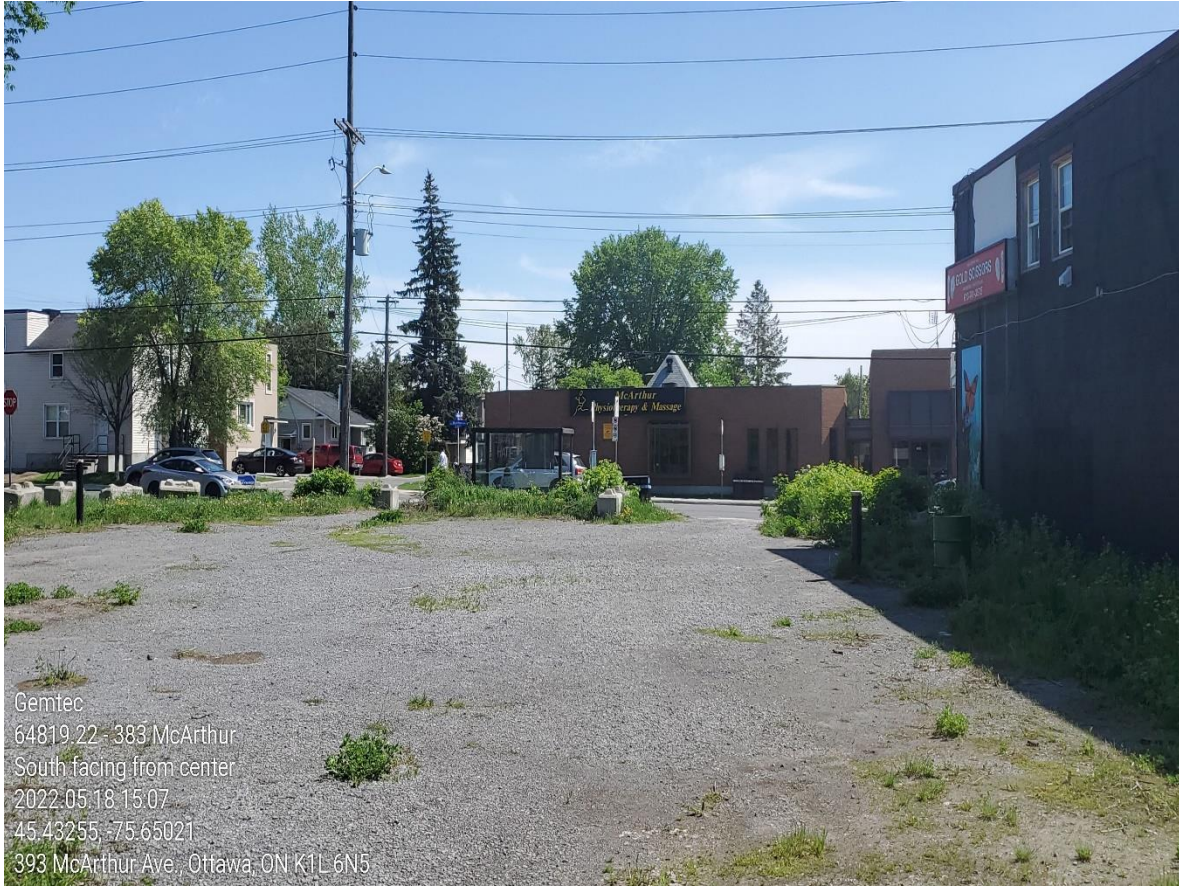
**FIGURE J13**

Gemtec  
 64819.22 - 383 McArthur  
 South facing from center  
 2022-05-18 15:07  
 45.43255 -75.65021  
 393 McArthur Ave., Ottawa, ON K1L 6N5
