Subject: **Phase I - Environmental Site Assessment**
1533 Goth Avenue
Ottawa, Ontario

Phase I - Environmental Site Assessment

1533 Goth Avenue
Ottawa, Ontario

Report: PE1975-1

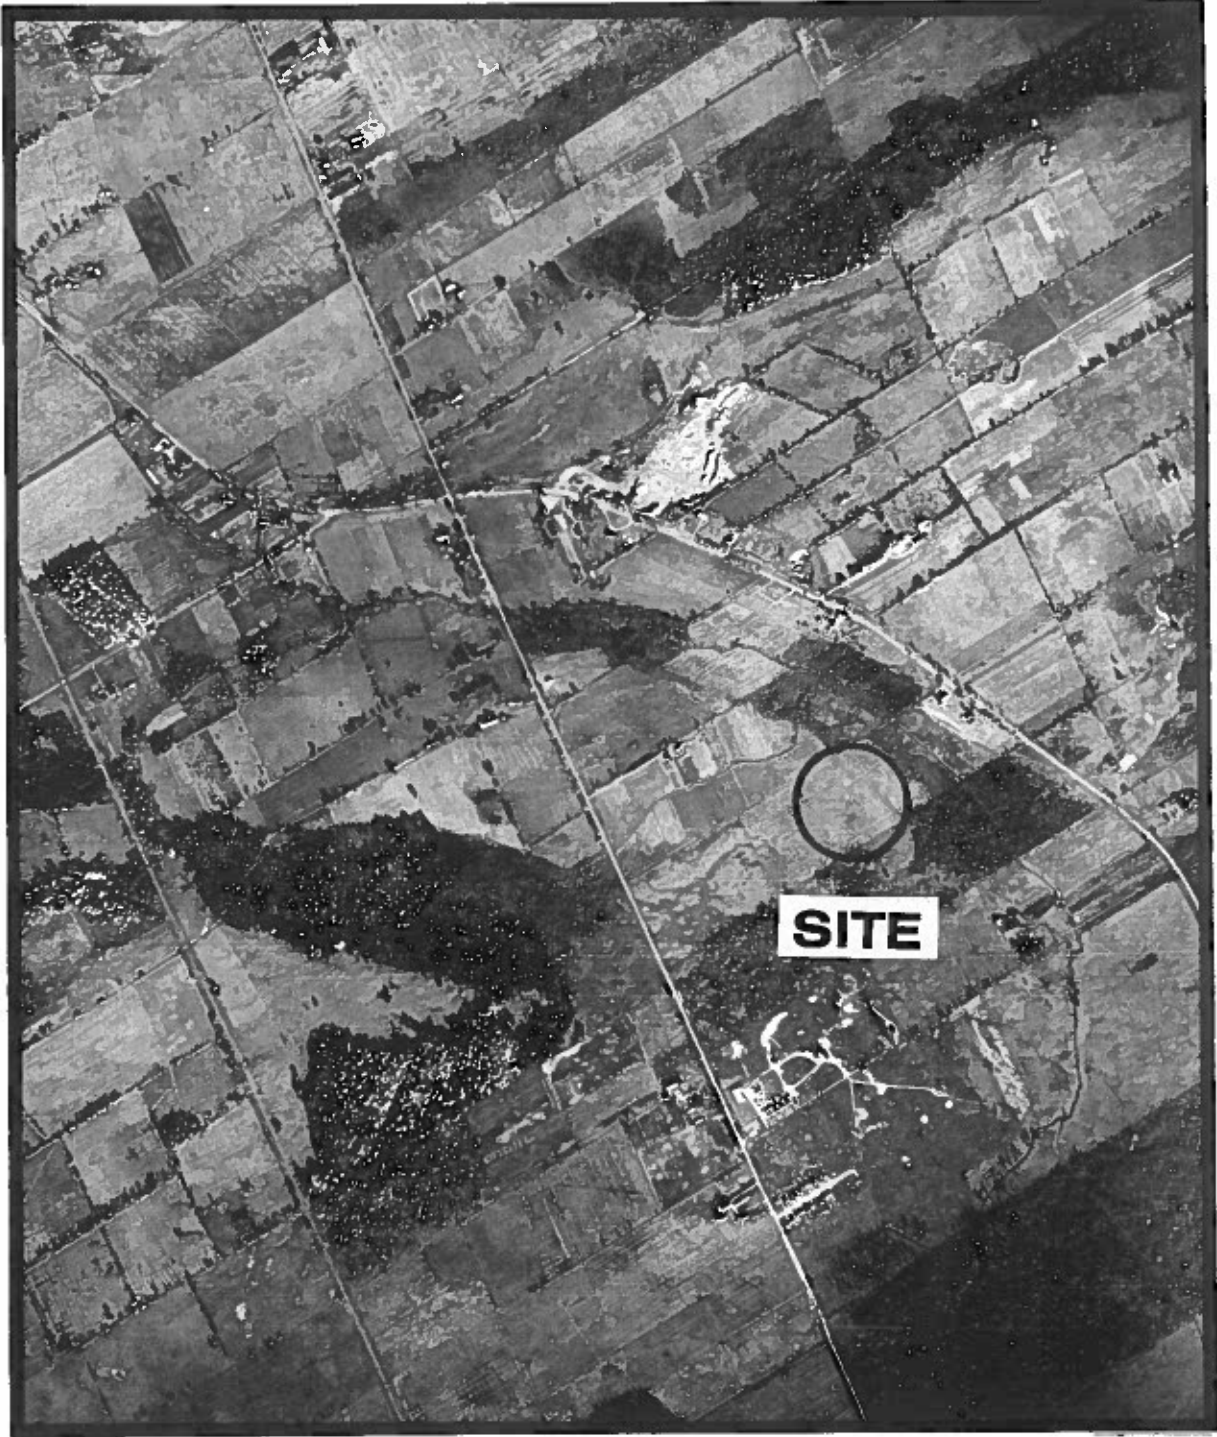
AERIAL PHOTOGRAPH
1945

- 1945 The subject site and neighbouring properties consist of vacant and/or agricultural land. What appears to be a former sand pit is located further to the west of the site. Bank Street is present, east of Sawmill Creek, further to the east of the site.

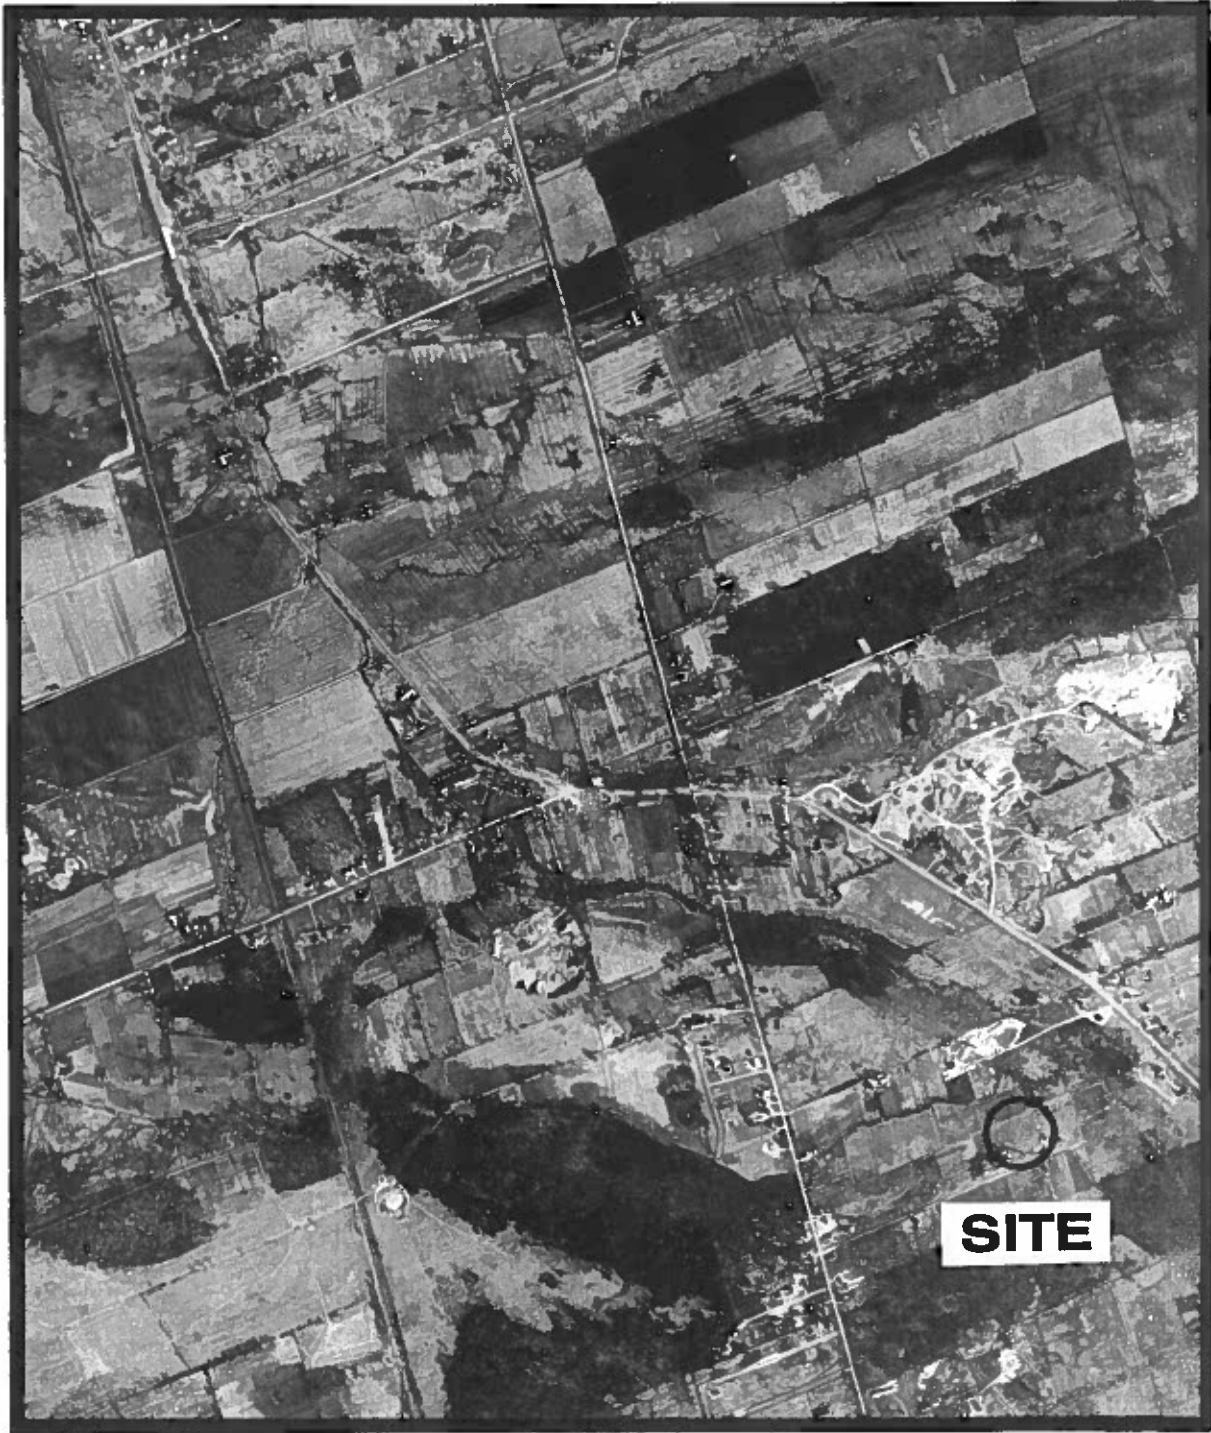
AERIAL PHOTOGRAPH
1952

- 1952 Goth Avenue appears to have been constructed south of the subject site. What appear to be residential dwellings are present on some of the neighbouring properties. A lumber mill is present further north of the site.

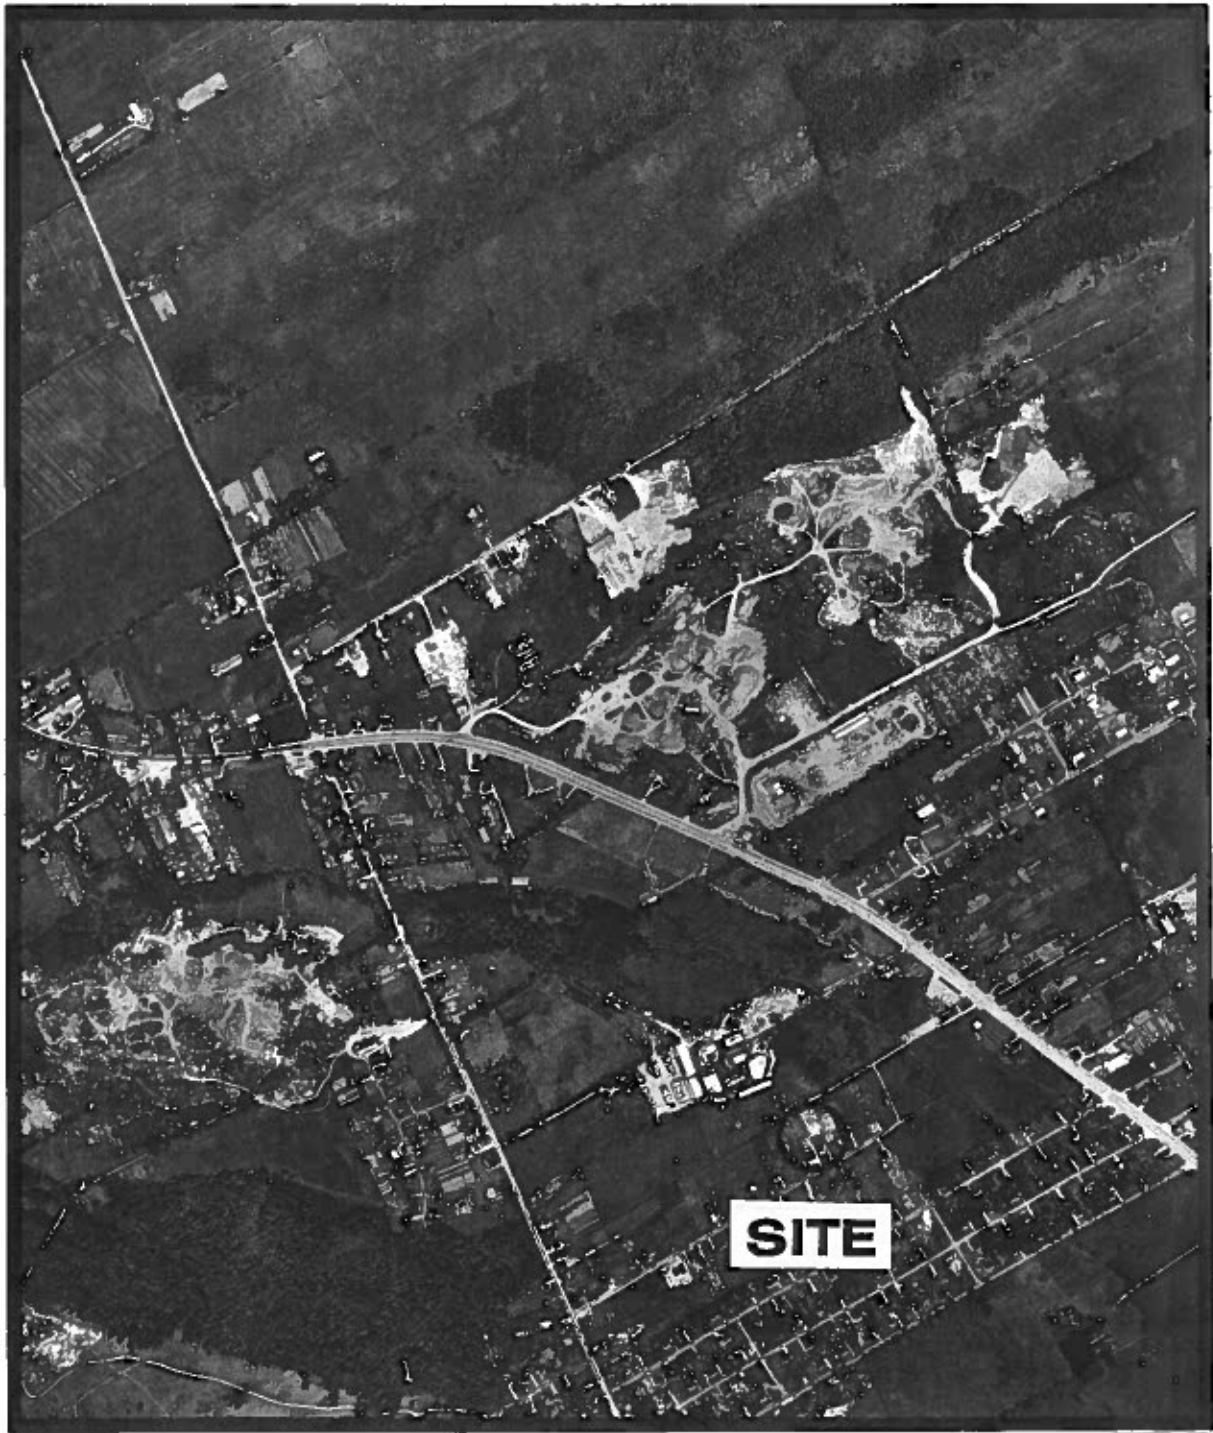
AERIAL PHOTOGRAPH
1962

- 1962 The site has been developed with what appears to be the present day residential dwelling. Increased residential development is apparent along Goth Avenue and further to the south of the site. The lumber mill to the north has expanded into a building material supply centre.

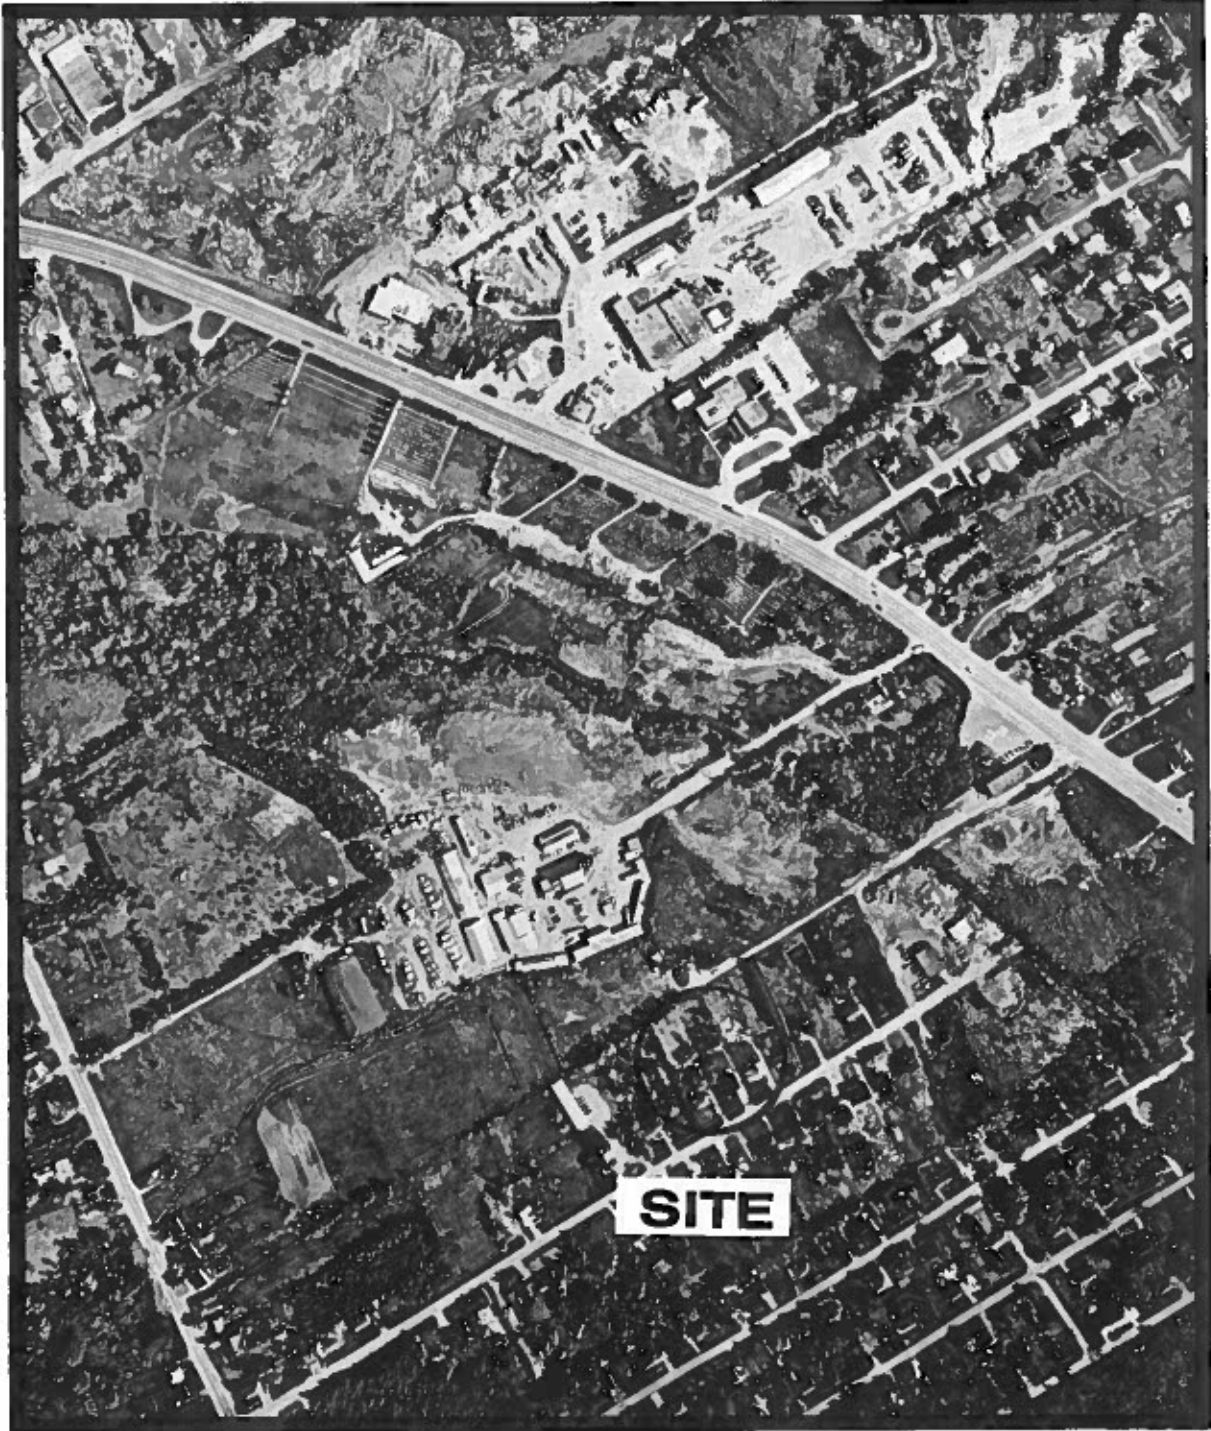
AERIAL PHOTOGRAPH
1973

- 1973 No significant changes have been made to the subject site or neighbouring properties. Several large fill piles are present on the building material supply centre property.

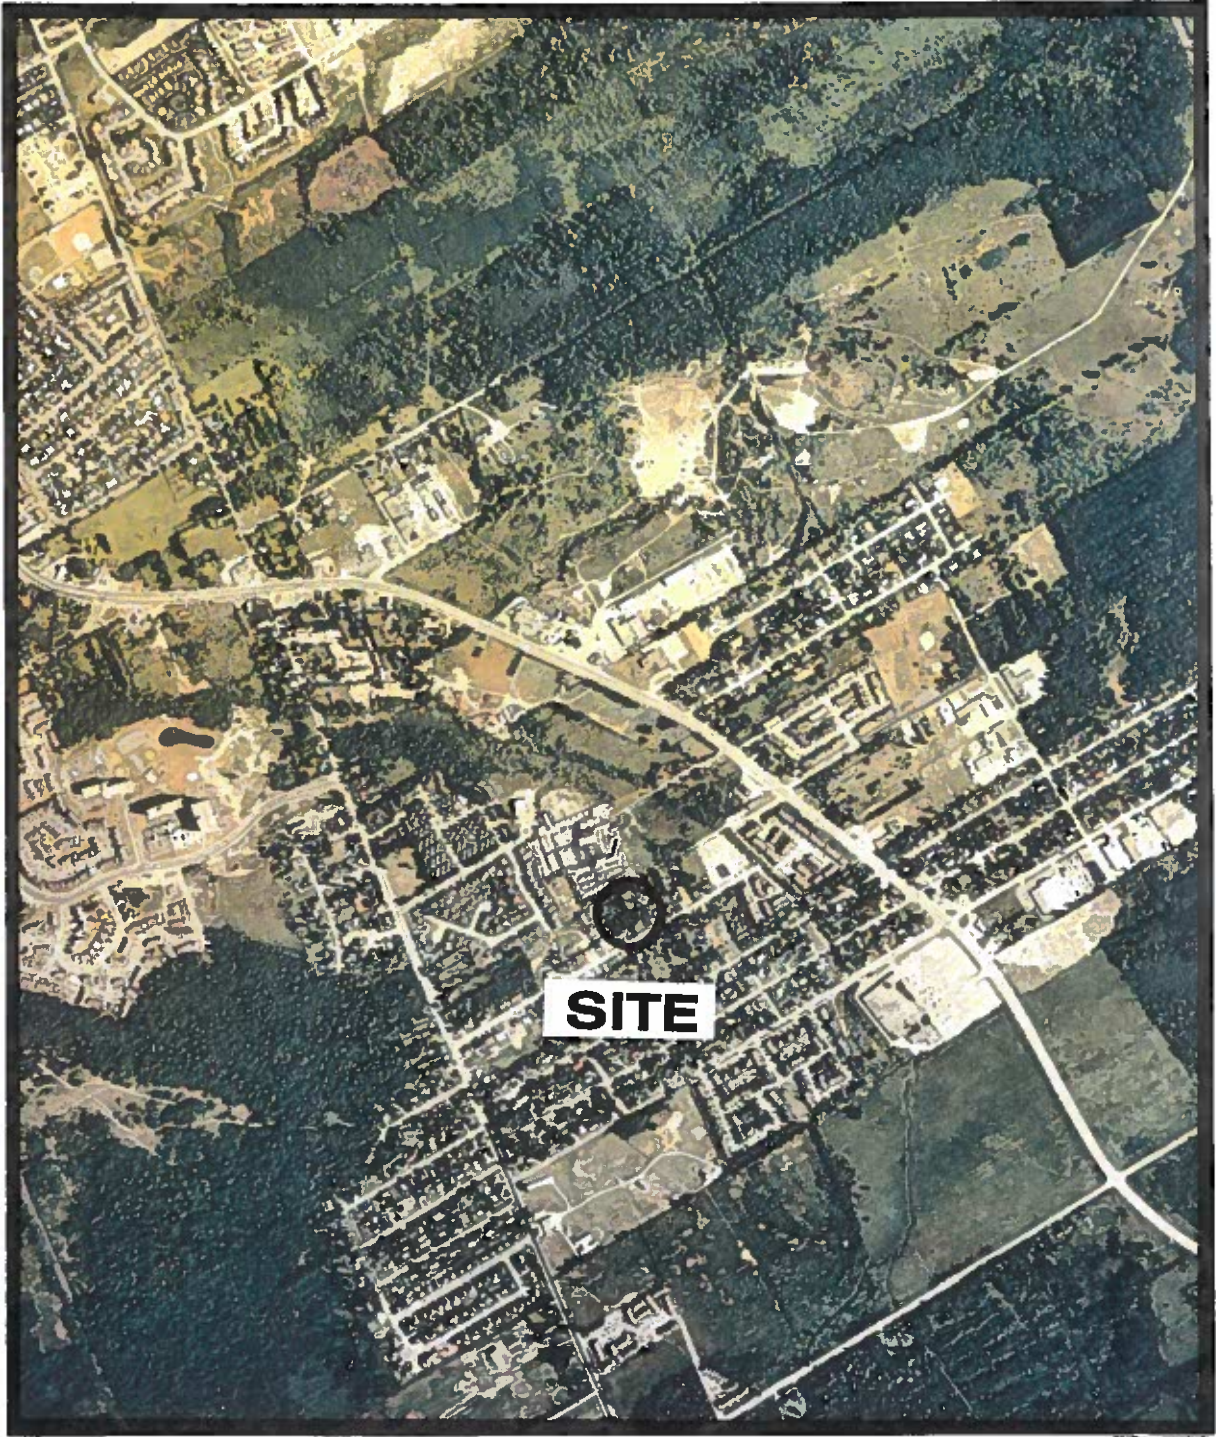
AERIAL PHOTOGRAPH
1983

- 1983 No significant changes have been made to the subject site or neighbouring properties.
- 1999 No significant changes were made to the subject site. The former lumber mill is no longer present north of the site. D'Aoust Avenue has been constructed further north of the site. Sawmill Creek Elementary school has been constructed north of D'Aoust Avenue.
