Geotechnical Investigation

Proposed Commercial Development Employment Lands – Riverside South

Ottawa, Ontario

Report PG4958-2 dated July 5, 2022

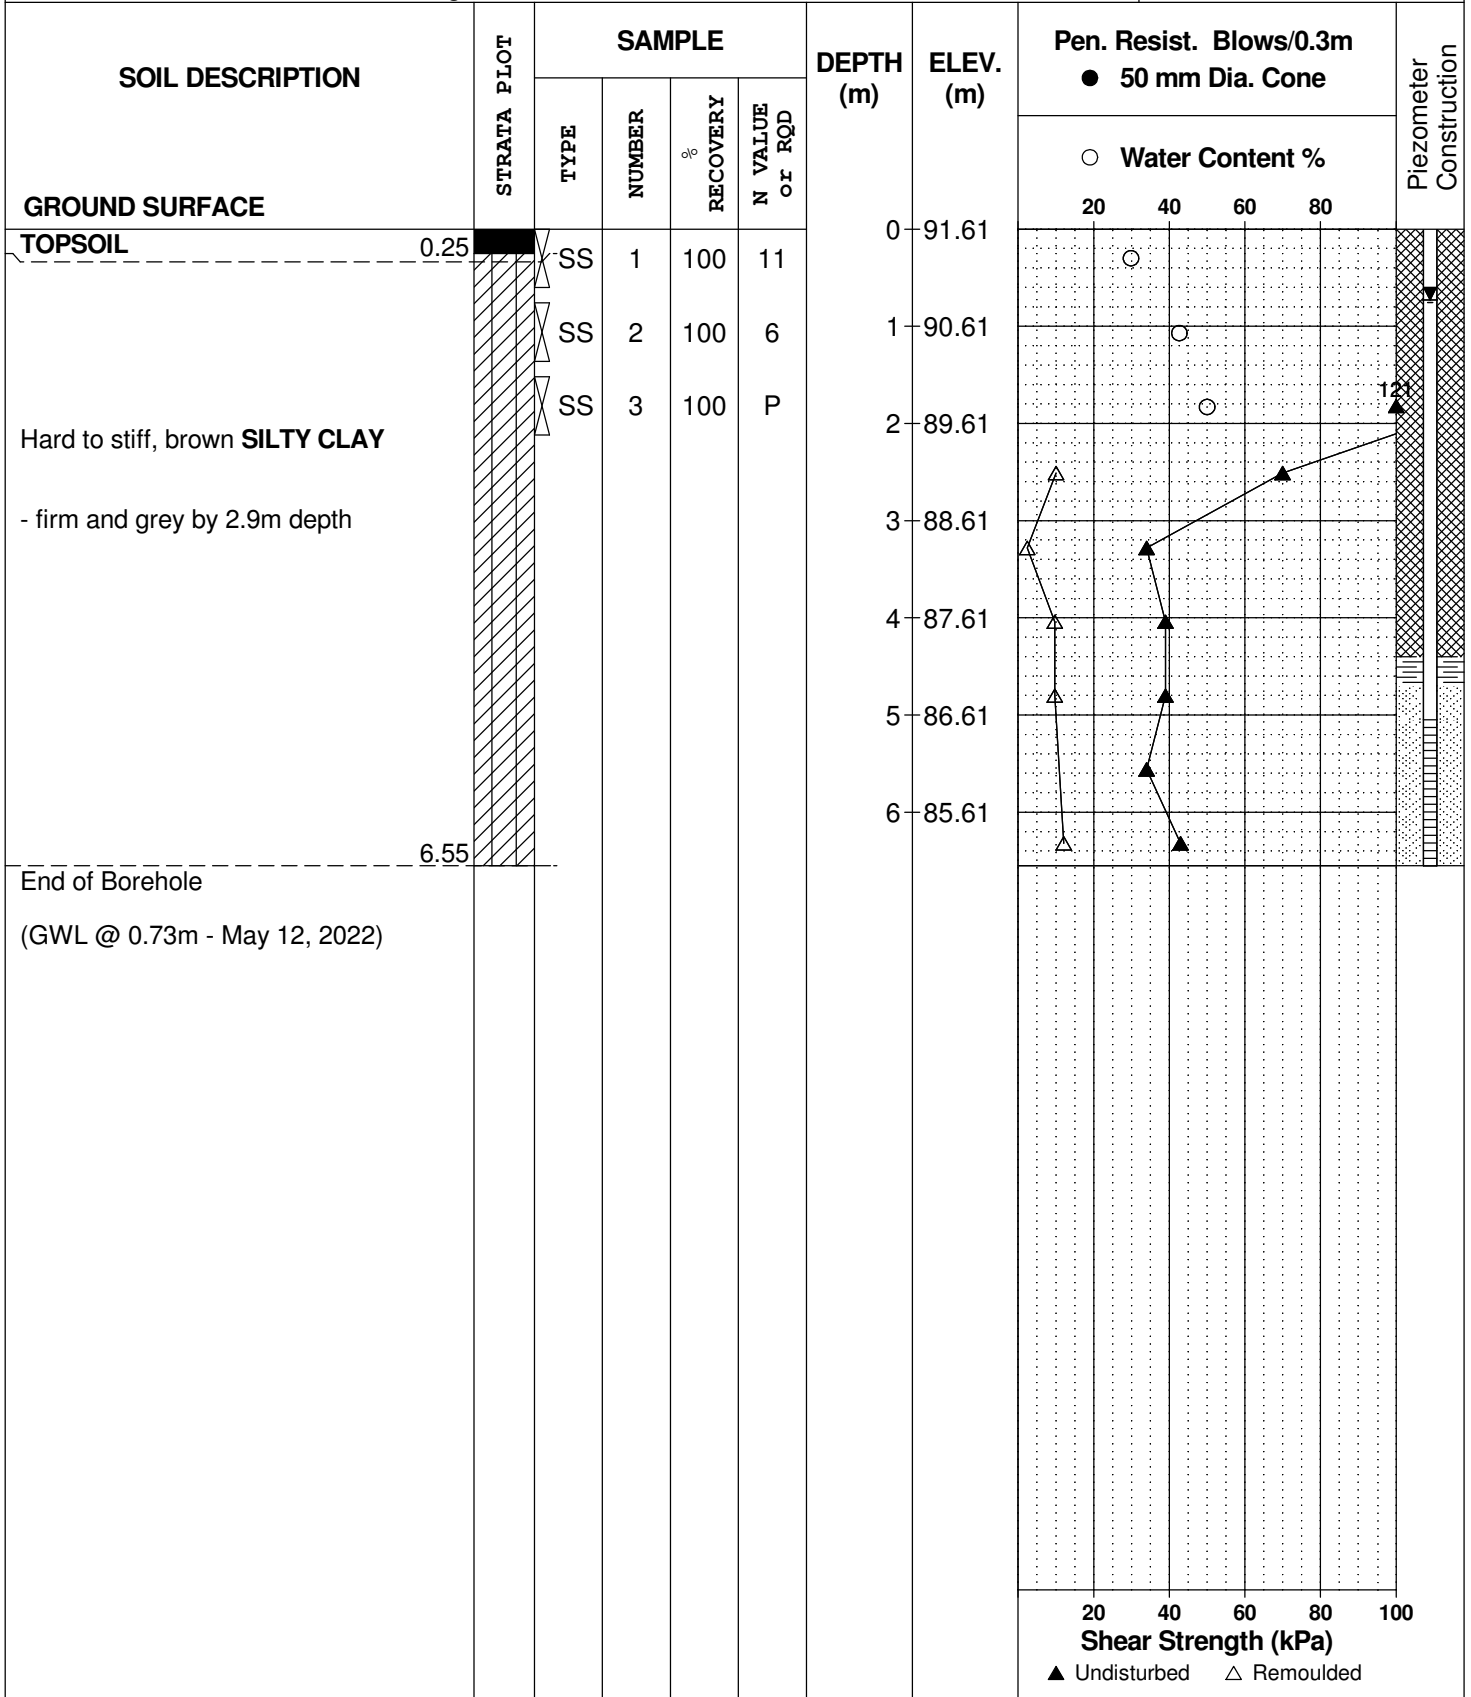
HOLE NO.
BH 1-22-EL

The subsurface conditions observed in the test holes were recorded in detail in the field. The soil profiles are logged on the Soil Profile and Test Data sheets in Appendix 1 of this report.
