# **Geotechnical Investigation**

## **Carp Airport Servicing and Residential Development – Phase 1**

Carp Road  
(Carp) Ottawa, Ontario

Report PG2450-2, Revision 1, dated January 16, 2023

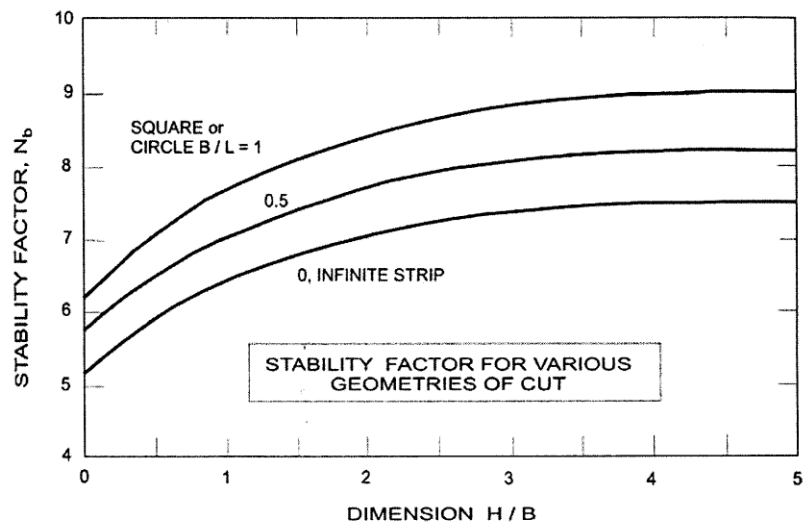
Figure 1 - Stability Factor for Various Geometries of Cut

In the case of soft to firm clays, **a factor of safety of 2 is recommended** for base stability.

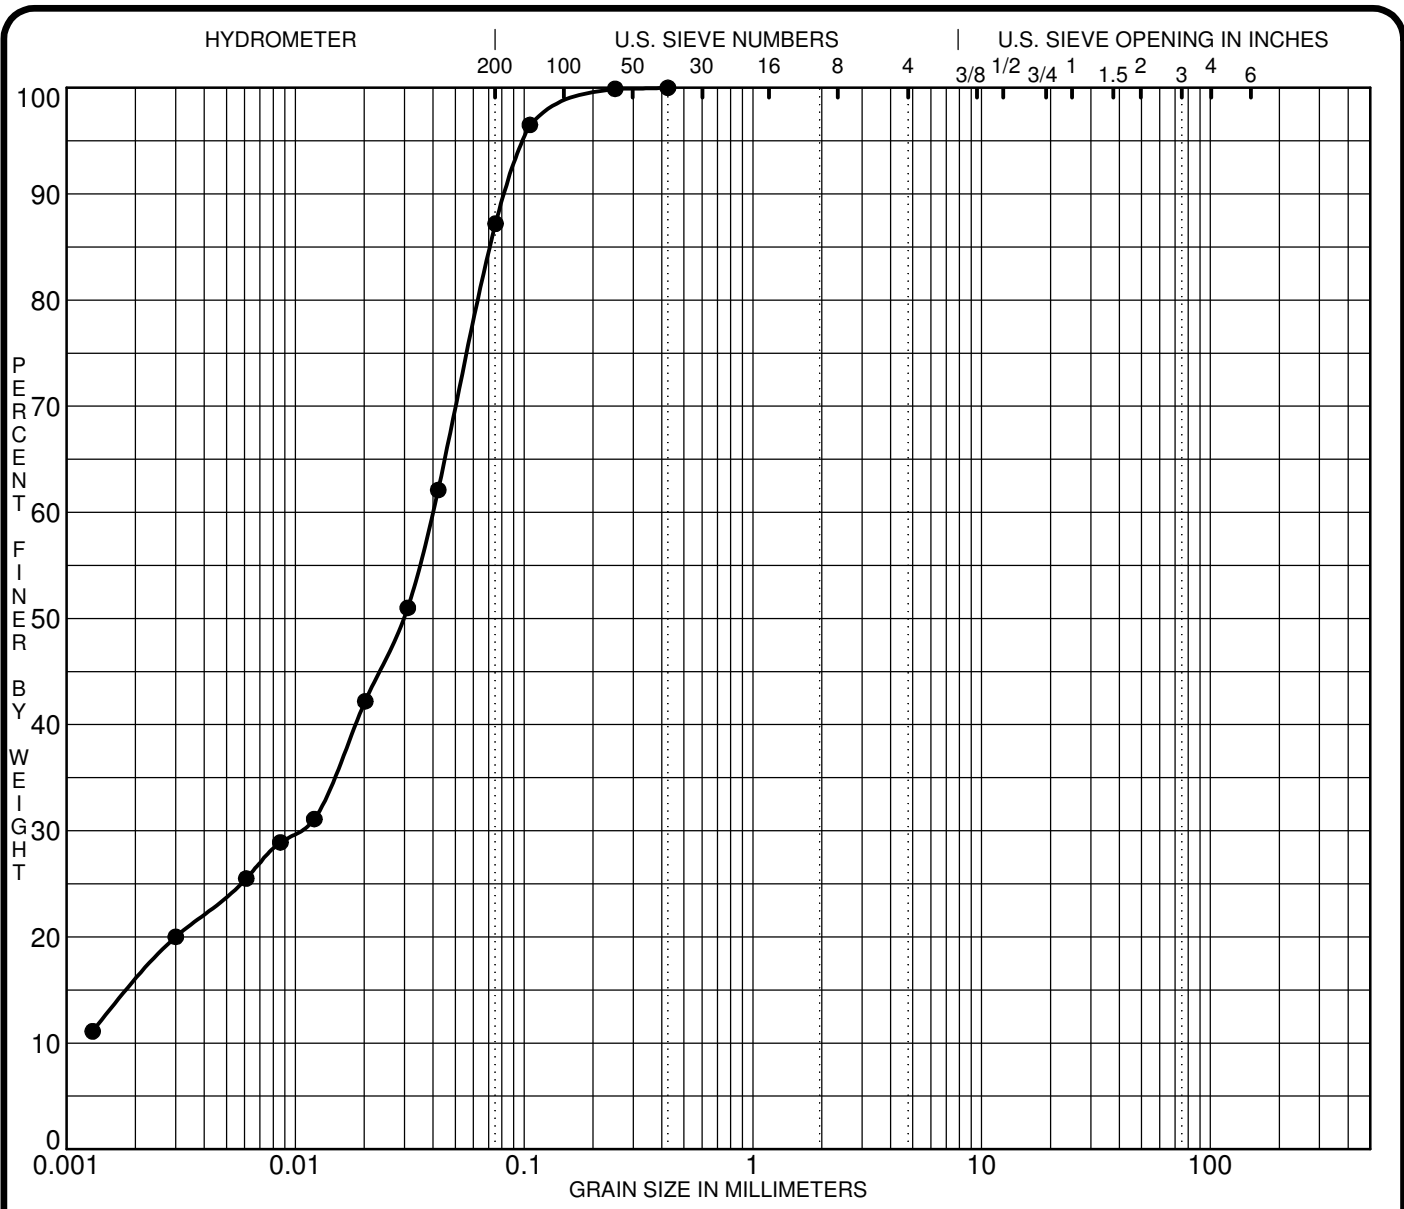
**GRAIN SIZE DISTRIBUTION**

Specimen Identification	Classification					MC%	LL	PL	PI	Cc	Cu
● TP 3-22 G4	<b>Silty Sand to Sandy Silt</b>					22.1					
☒											
▲											
★											
Specimen Identification	D100	D60	D30	D10	%Gravel	%Sand	%Silt	%Clay			
● TP 3-22 G4	0.43	0.04	0.010		0.0	12.8	71.7	15.5			
☒											
▲											
★

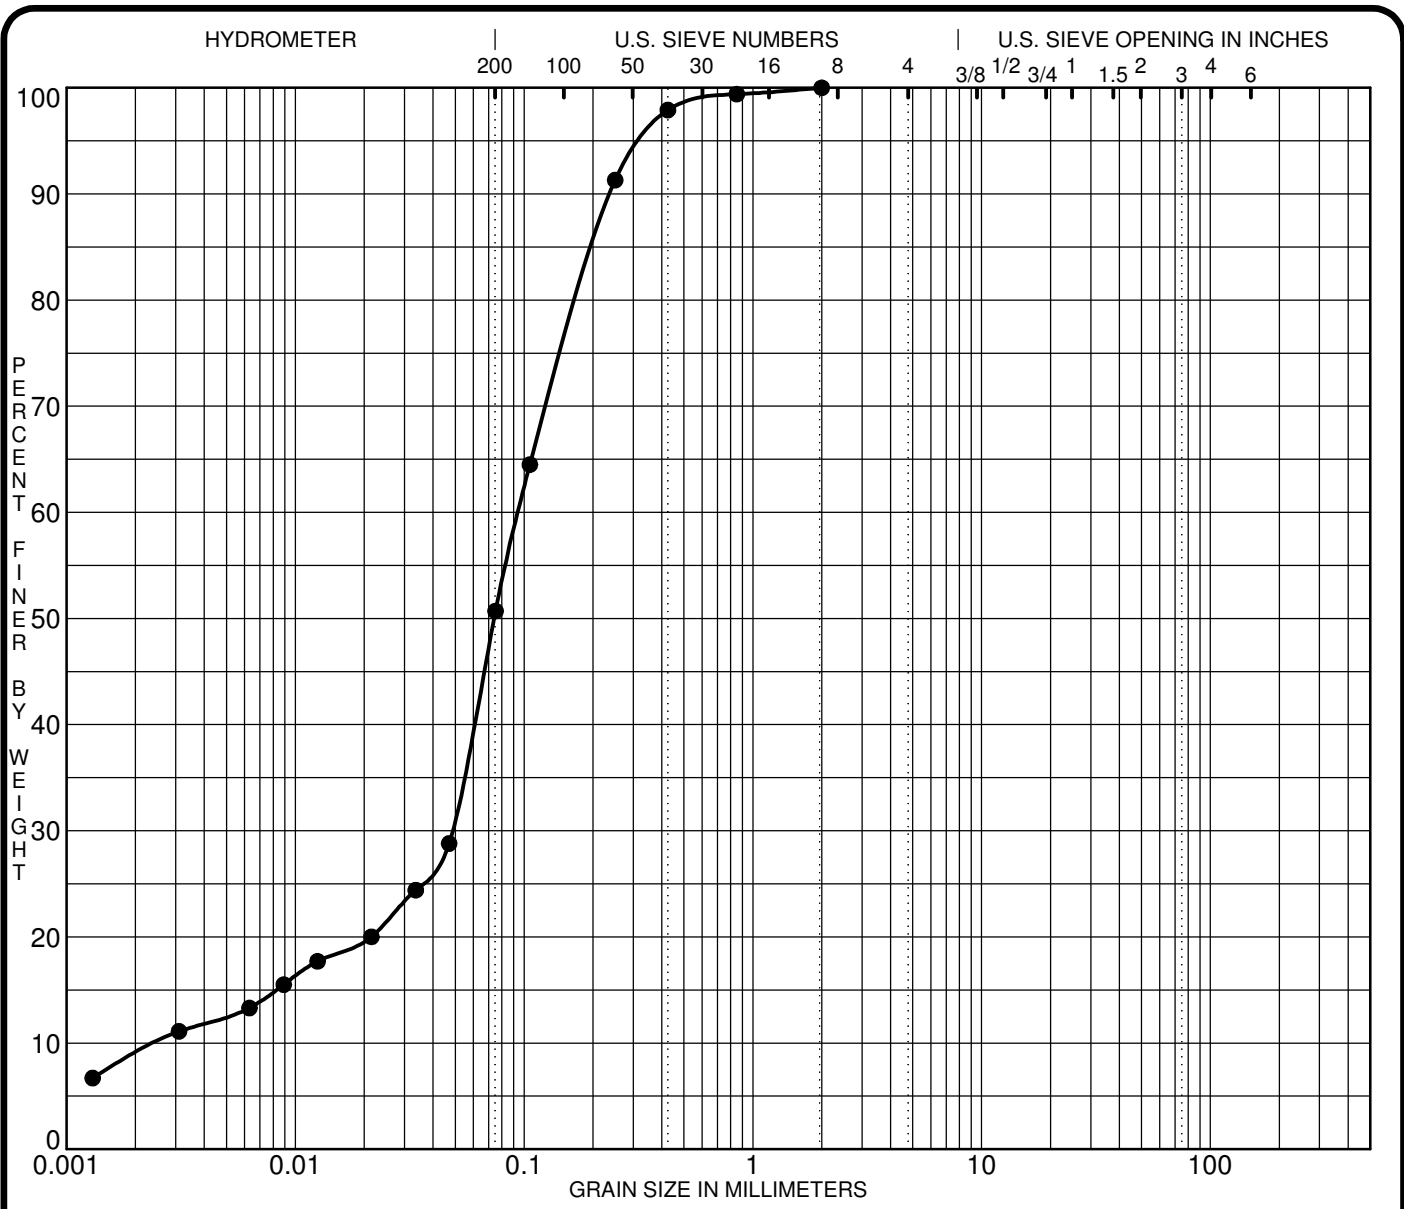
**GRAIN SIZE DISTRIBUTION**

Specimen Identification	Classification					MC%	LL	PL	PI	Cc	Cu
● TP 5-22 G5	<b>Silty Sand to Sandy Silt</b>					<b>22.2</b>				<b>9.84</b>	<b>38.0</b>
☒											
▲											
★											
Specimen Identification	D100	D60	D30	D10	%Gravel	%Sand	%Silt	%Clay			
● TP 5-22 G5	2.00	0.09	0.048	0.0025	0.0	49.3	41.2	9.5			
☒											
▲											
★

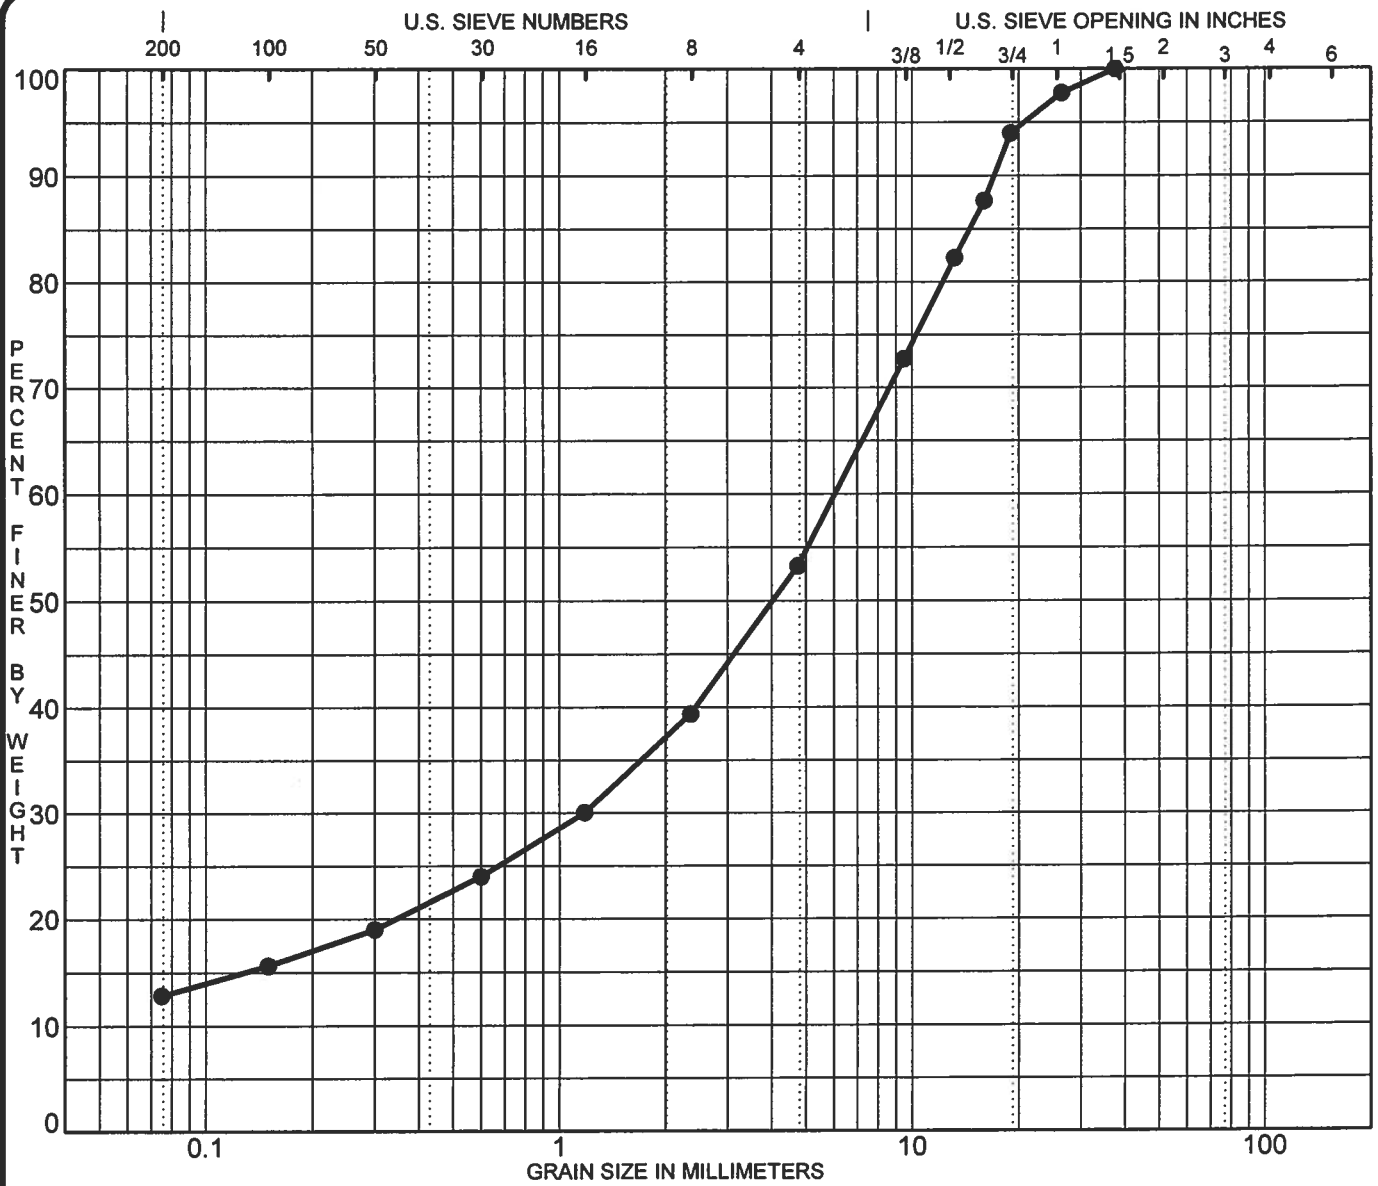
**GRAIN SIZE DISTRIBUTION**

Specimen Identification	Classification				MC%	LL	PL	PI	Cc	Cu
● BH 2-11 AU 1	Granular crushed stone with silty sand									
☒										
▲										
★	Based on ASTM D 2487									
Specimen Identification	D100	D60	D30	D10	%Gravel	%Sand	%Silt	%Clay		
● BH 2-11 AU 1	37.50	6.04	1.174		46.7	40.4	12.8			
☒										
▲										
★

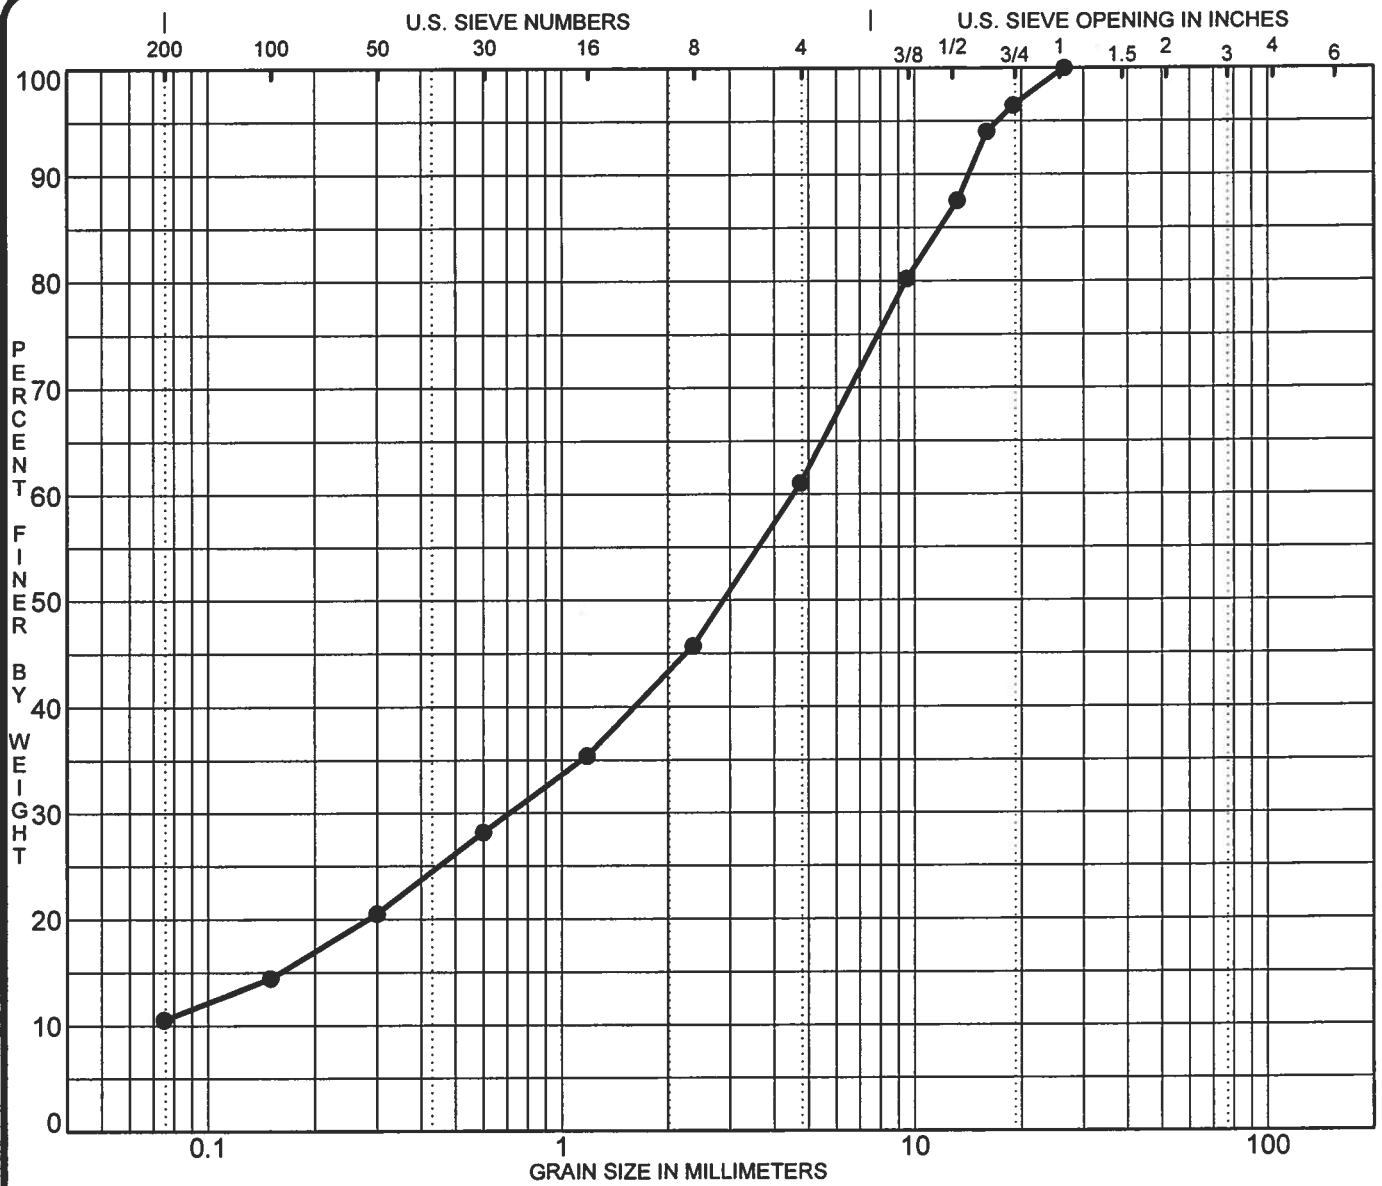
**GRAIN SIZE DISTRIBUTION**

Specimen Identification	Classification				MC%	LL	PL	PI	Cc	Cu
● BH26-11 AU 1	Silty sand with granular crushed stone								1.64	66.3
☒										
▲										
★	Based on ASTM D 2487									
Specimen Identification	D100	D60	D30	D10	%Gravel	%Sand	%Silt	%Clay		
● BH26-11 AU 1	26.50	4.53	0.712		39.0	50.5	10.5			
☒										
▲										
★

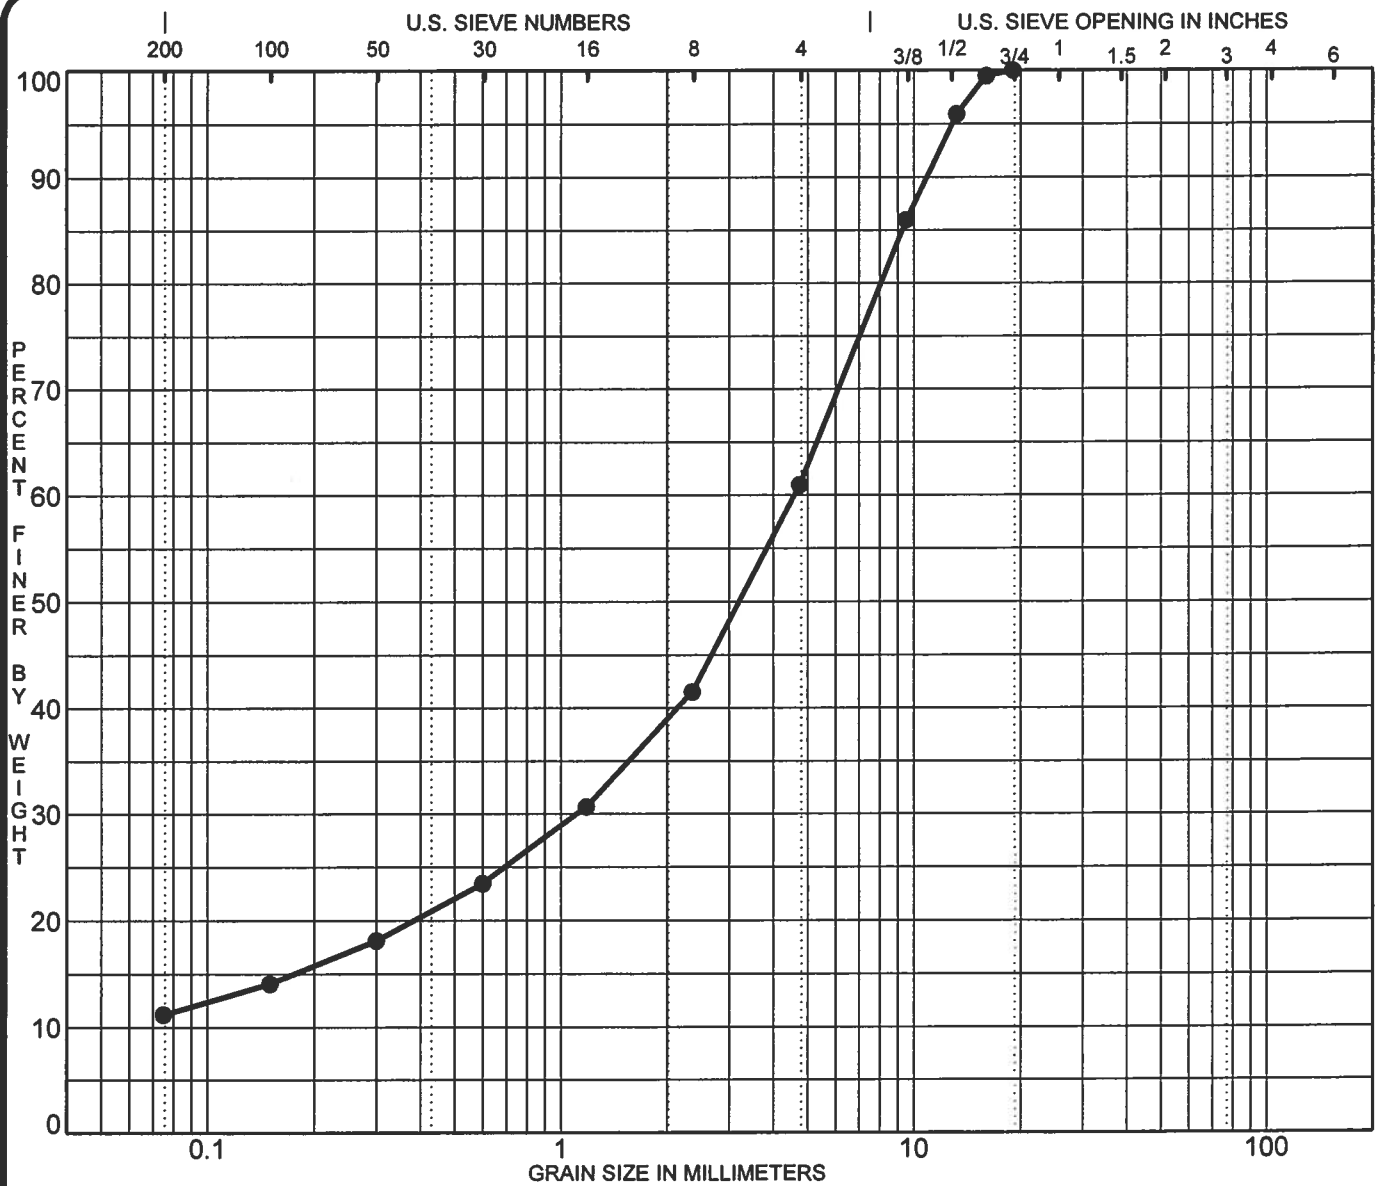
**GRAIN SIZE DISTRIBUTION**

Specimen Identification	Classification				MC%	LL	PL	PI	Cc	Cu
● BH37-11 AU 1	Silty sand with granular crushed stone								4.77	81.7
☒										
▲										
★	Based on ASTM D 2487									
Specimen Identification	D100	D60	D30	D10	%Gravel	%Sand	%Silt	%Clay		
● BH37-11 AU 1	19.00	4.59	1.108		39.0	49.8	11.2			
☒										
▲										
★

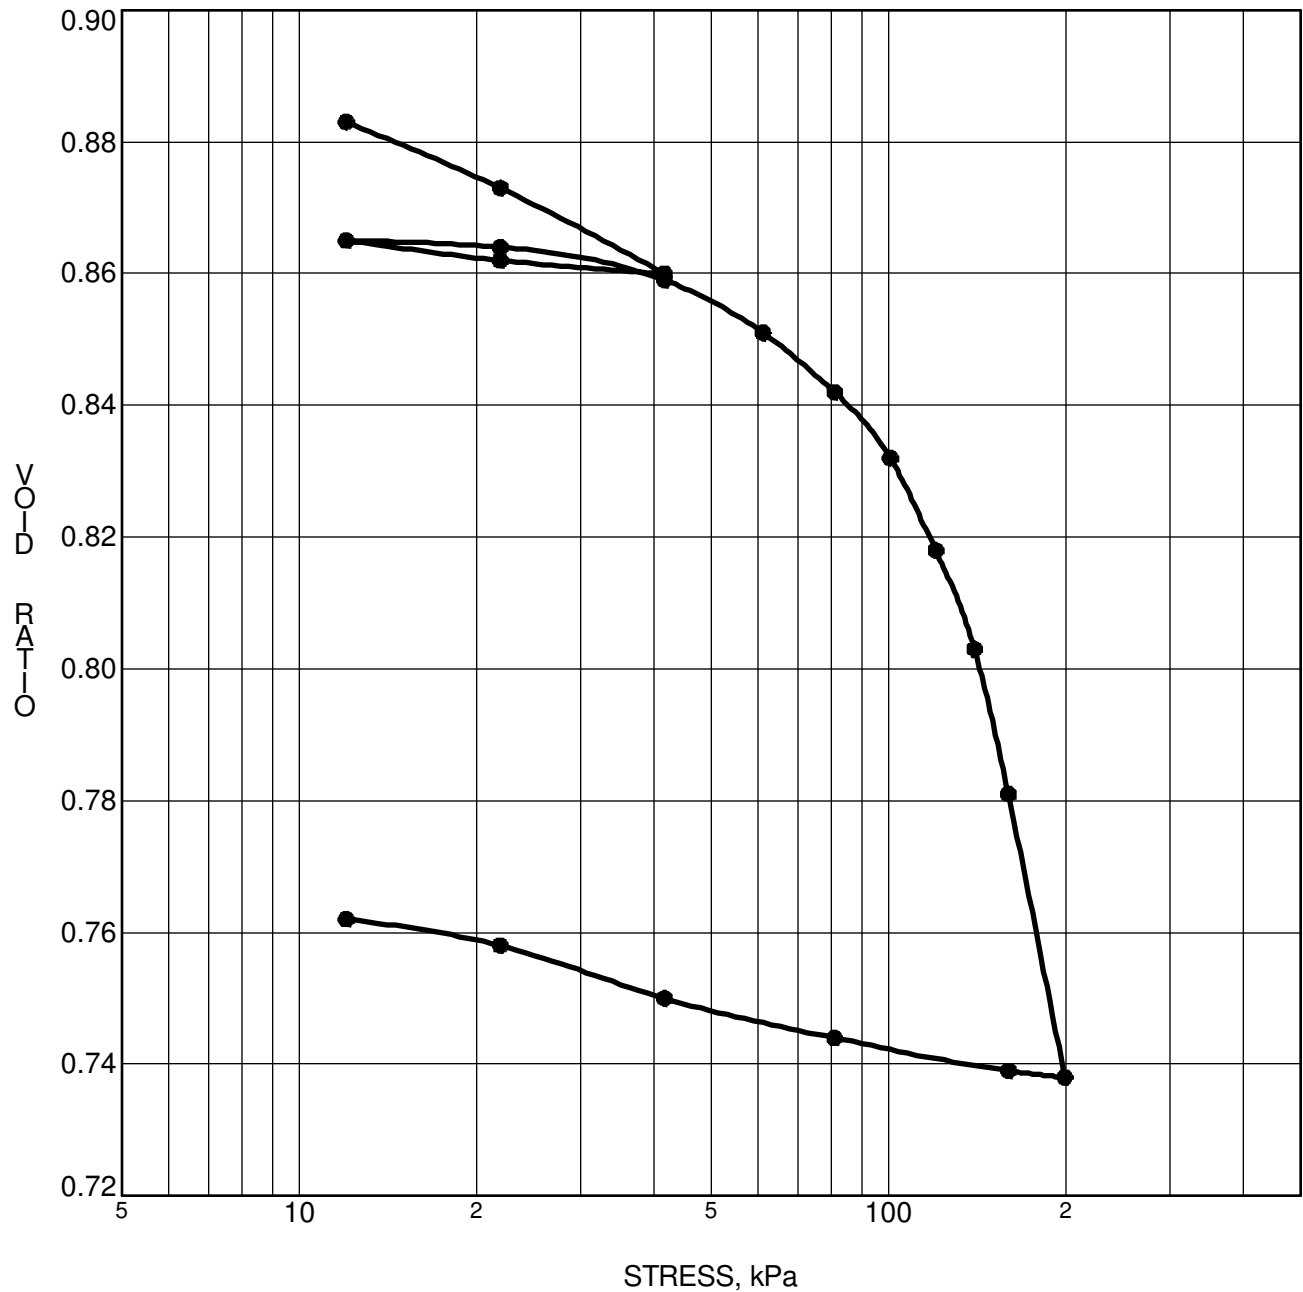
**CONSOLIDATION  
 TEST**

CONSOLIDATION TEST DATA SUMMARY					
Borehole No.	<b>BH41-13</b>	$p'_o$	<b>52 kPa</b>	$C_{cr}$	<b>0.011</b>
Sample No.	<b>TW 5</b>	$p'_c$	<b>112 kPa</b>	$C_c$	<b>0.412</b>
Sample Depth	<b>5.00 m</b>	OC Ratio	<b>2.2</b>	$W_o$	<b>32.6 %</b>
Sample Elev.	<b>111.13 m</b>	Void Ratio	<b>0.762</b>	Unit Wt.	<b>18.0 kN/m<sup>3</sup></b>

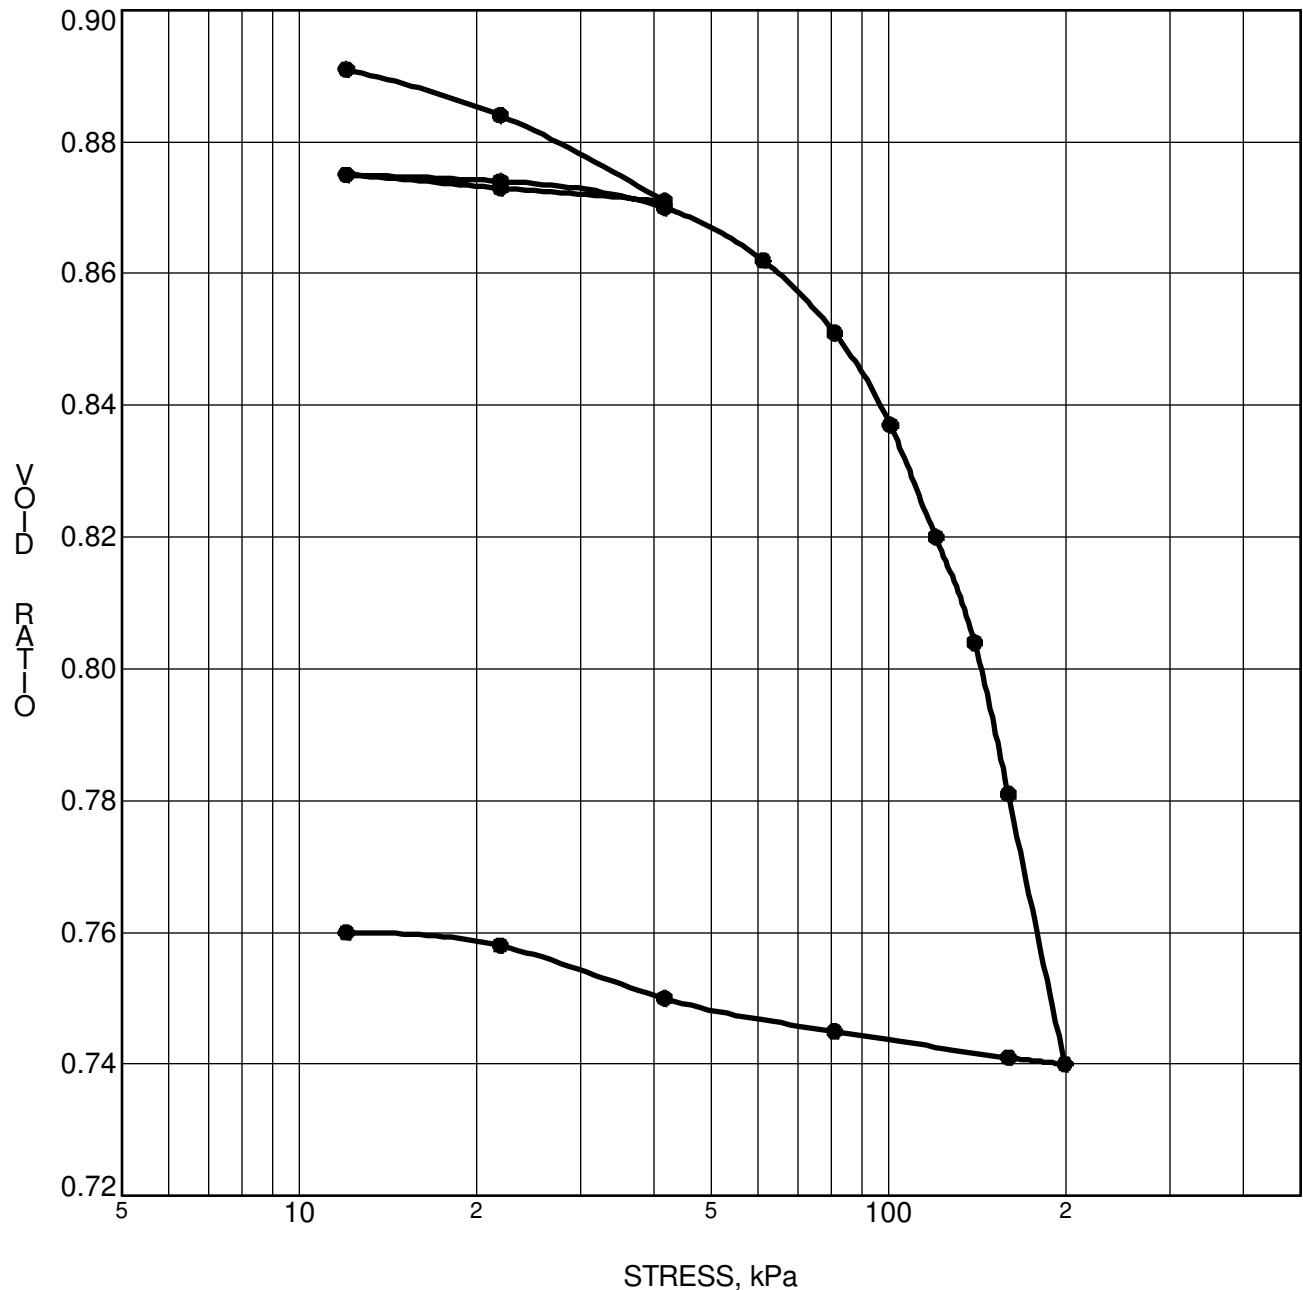
**CONSOLIDATION  
 TEST**

CONSOLIDATION TEST DATA SUMMARY					
Borehole No.	<b>BH42-13</b>	$p'_o$	<b>57 kPa</b>	$C_{cr}$	<b>0.009</b>
Sample No.	<b>TW 6</b>	$p'_c$	<b>97 kPa</b>	$C_c$	<b>0.370</b>
Sample Depth	<b>5.03 m</b>	OC Ratio	<b>1.7</b>	$W_o$	<b>32.9 %</b>
Sample Elev.	<b>109.92 m</b>	Void Ratio	<b>0.905</b>	Unit Wt.	<b>18.0 kN/m<sup>3</sup></b>

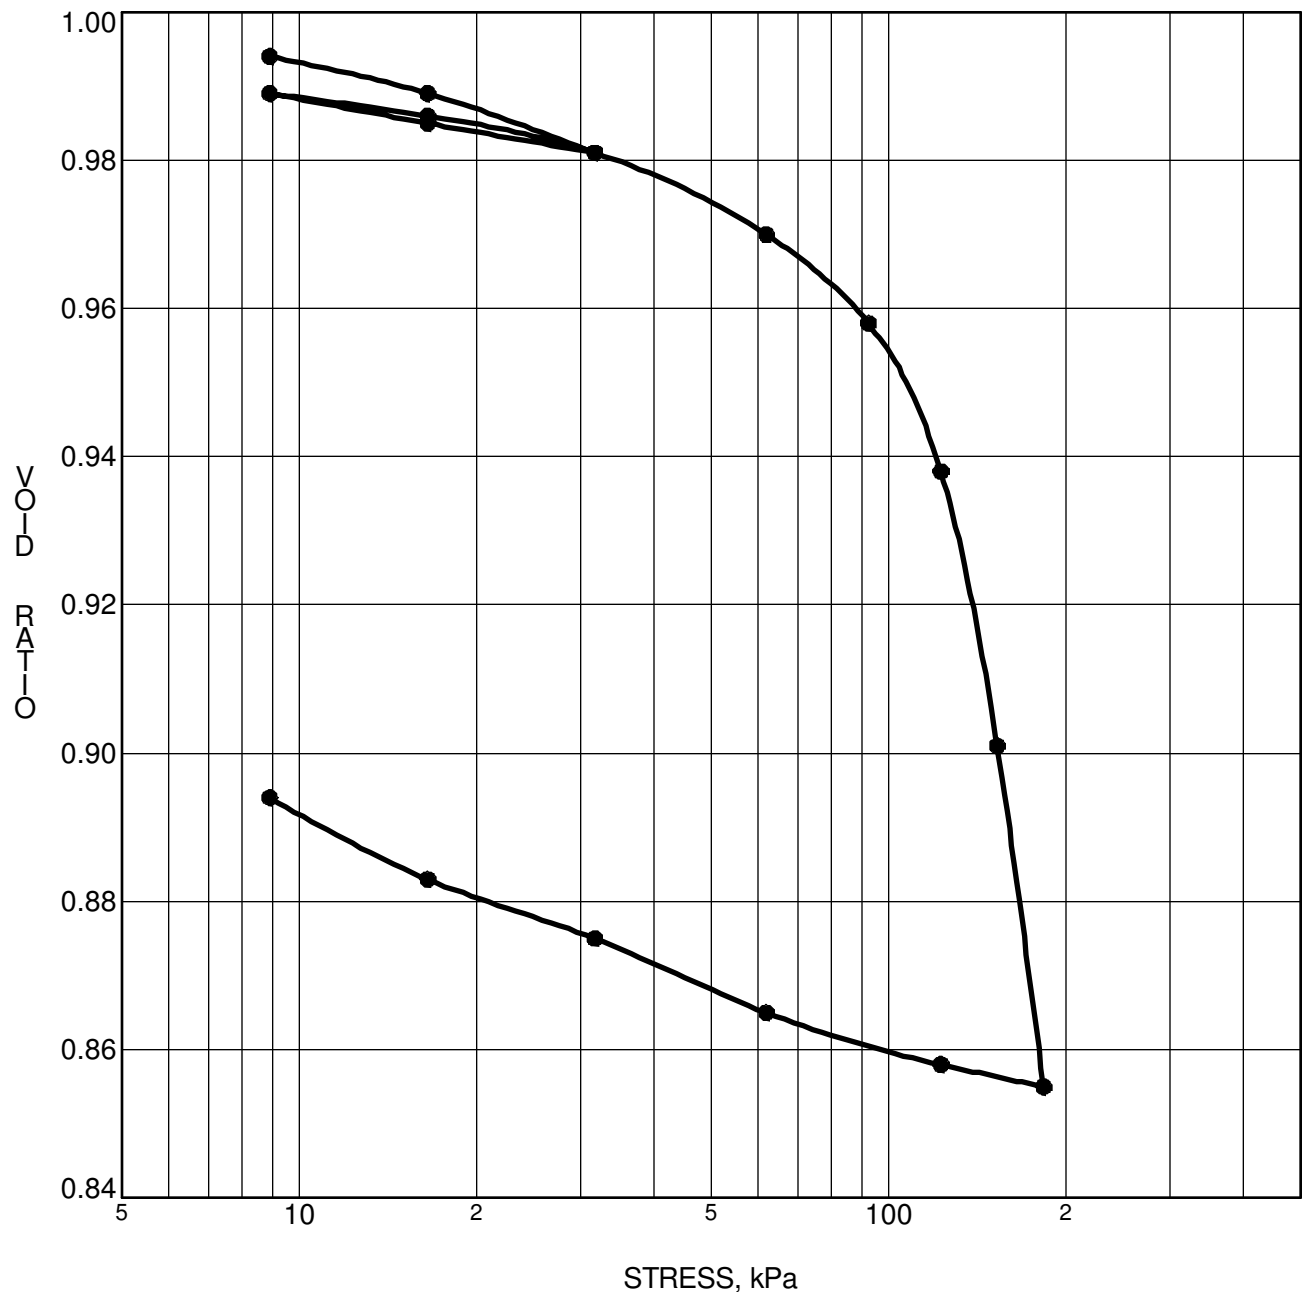
CONSOLIDATION TEST DATA SUMMARY					
Borehole No.	<b>BH43-13</b>	$p'_o$	<b>56 kPa</b>	$C_{cr}$	<b>0.016</b>
Sample No.	<b>TW 7</b>	$p'_c$	<b>104 kPa</b>	$C_c$	<b>0.390</b>
Sample Depth	<b>5.56 m</b>	OC Ratio	<b>1.9</b>	$W_o$	<b>36.4 %</b>
Sample Elev.	<b>111.24 m</b>	Void Ratio	<b>1.001</b>	Unit Wt.	<b>18.0 kN/m<sup>3</sup></b>

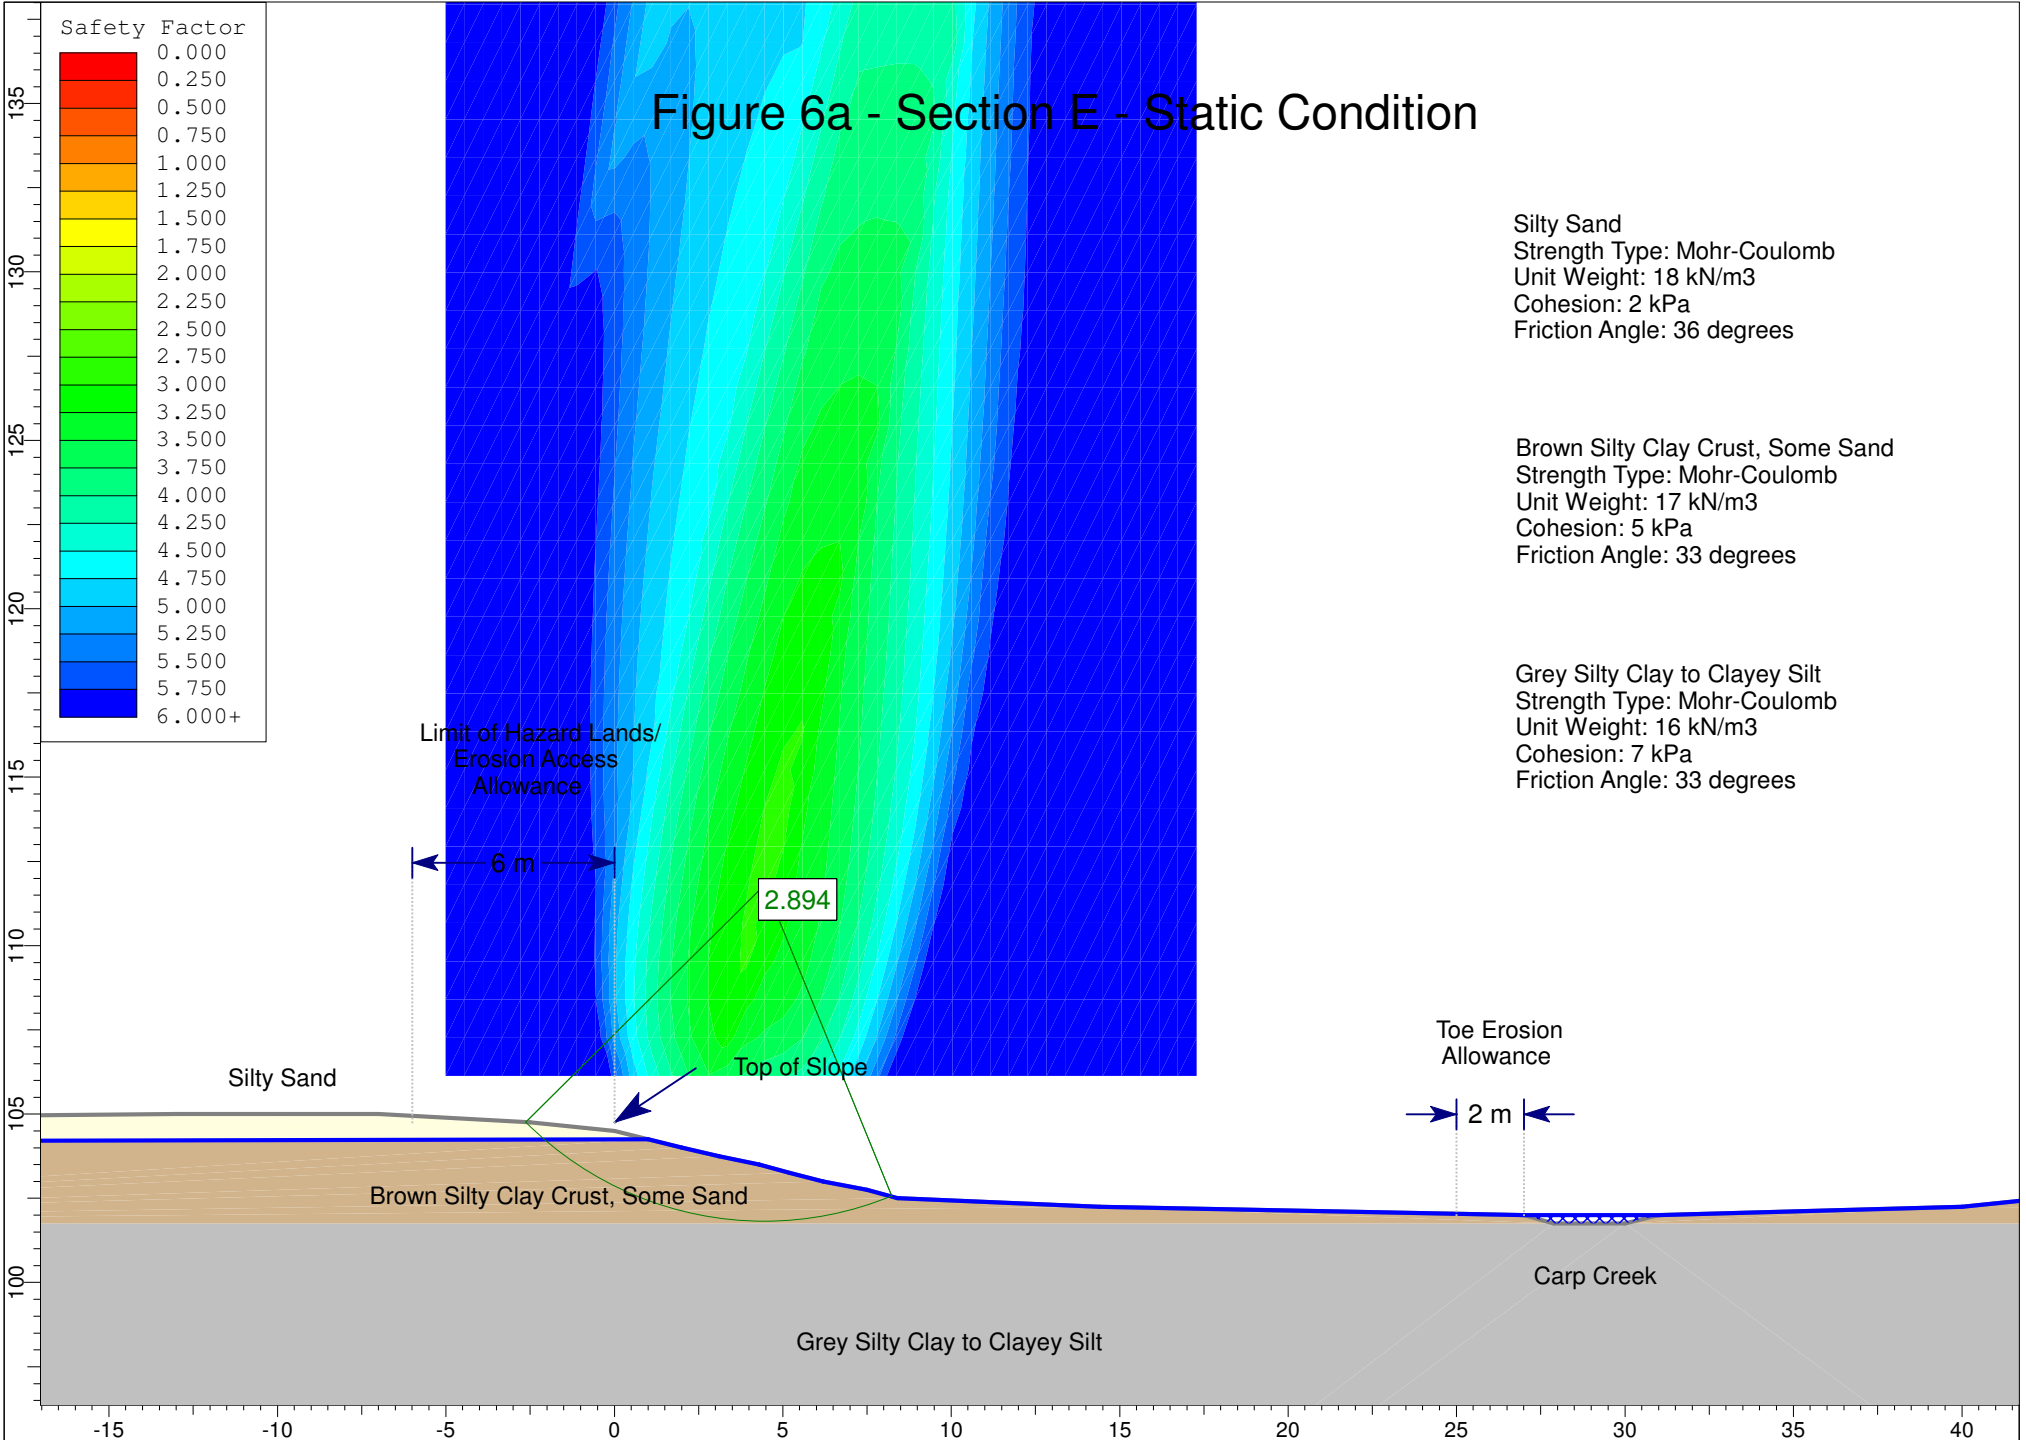
# Figure 6a - Section E - Static Condition

The results for the existing slope conditions at Section A, B, C, D, E and F are shown in Figure 2a, 3a, 4a, 5a, 6a and 7a attached to the report. The factor of safety was found to be greater than 1.5 under static conditions.

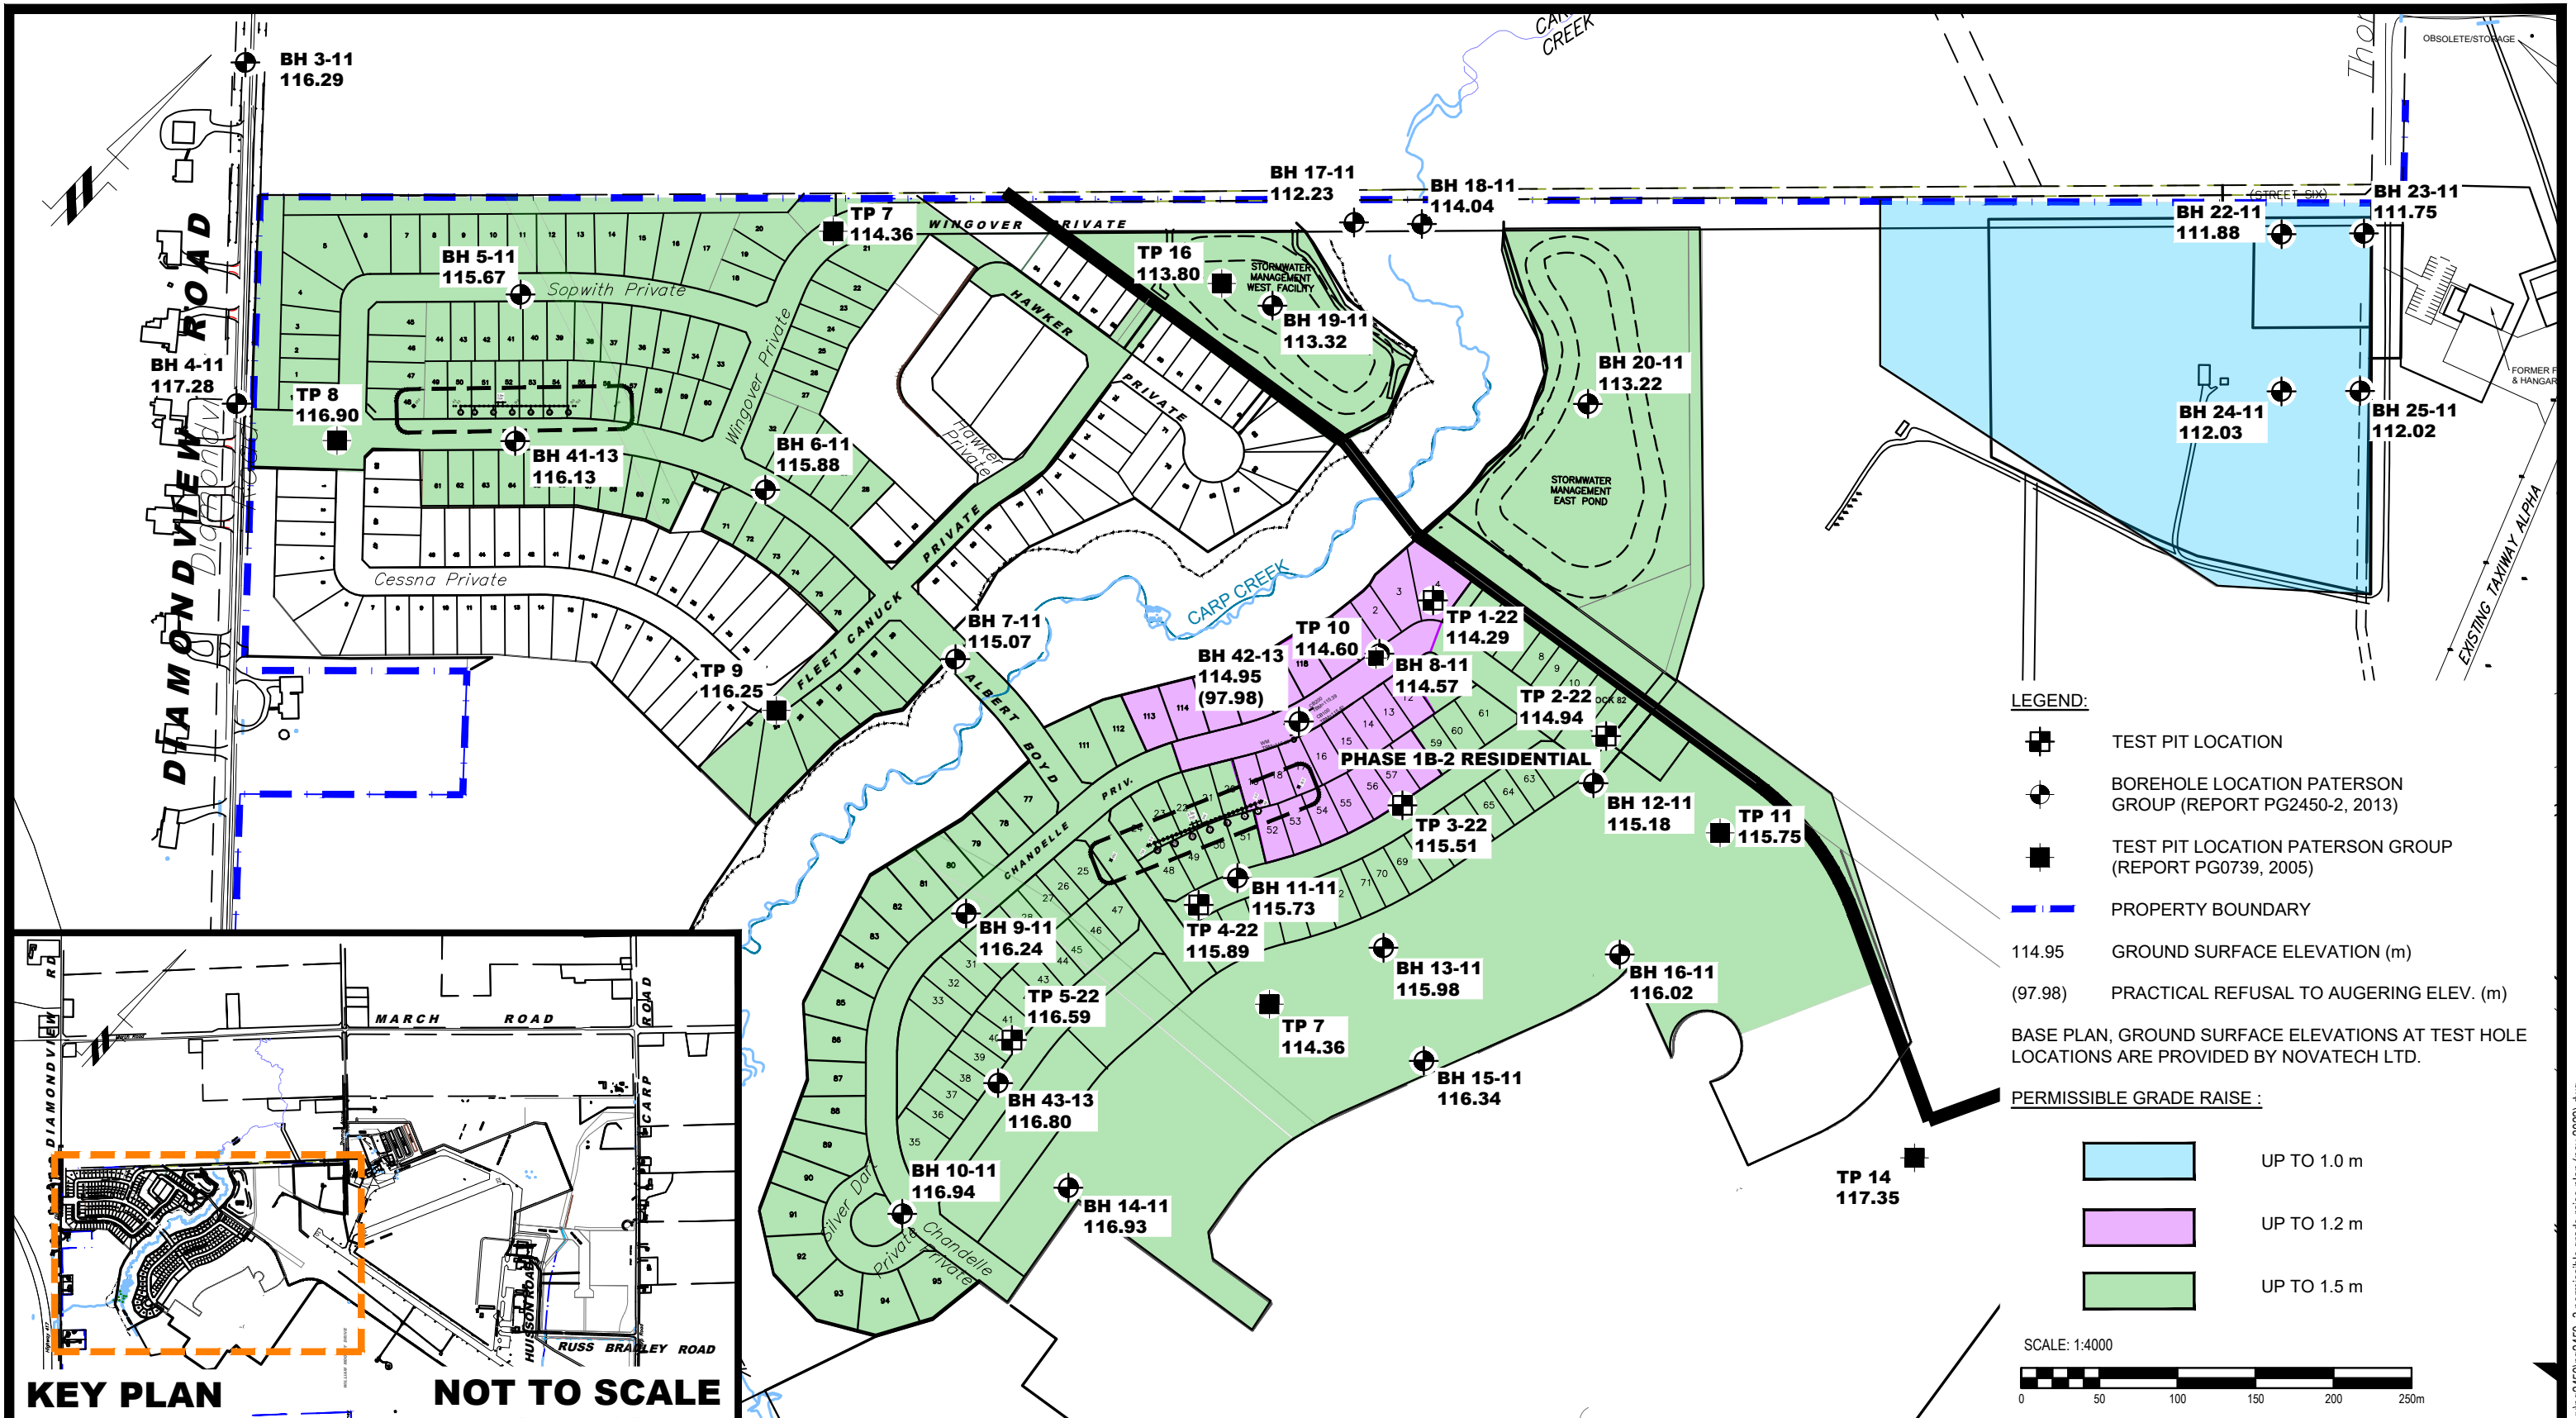
Scale:	1:4000	Date:	07/2013
Drawn by:	GK	Report No.:	PG2450-2
Checked by:	KP	Dwg. No.:	<b>PG2450-3</b>
Approved by:	DJG	Revision No.:	2

The recommended permissible grade raise areas ranging from **1 to 1.5 m** are defined in Drawing PG2450-3 - Permissible Grade Raise Plan in Appendix 2.
