# **Geotechnical Investigation**

## **Carp Airport Servicing and Residential Development – Phase 1**

Carp Road  
(Carp) Ottawa, Ontario

Report PG2450-2, Revision 1, dated January 16, 2023

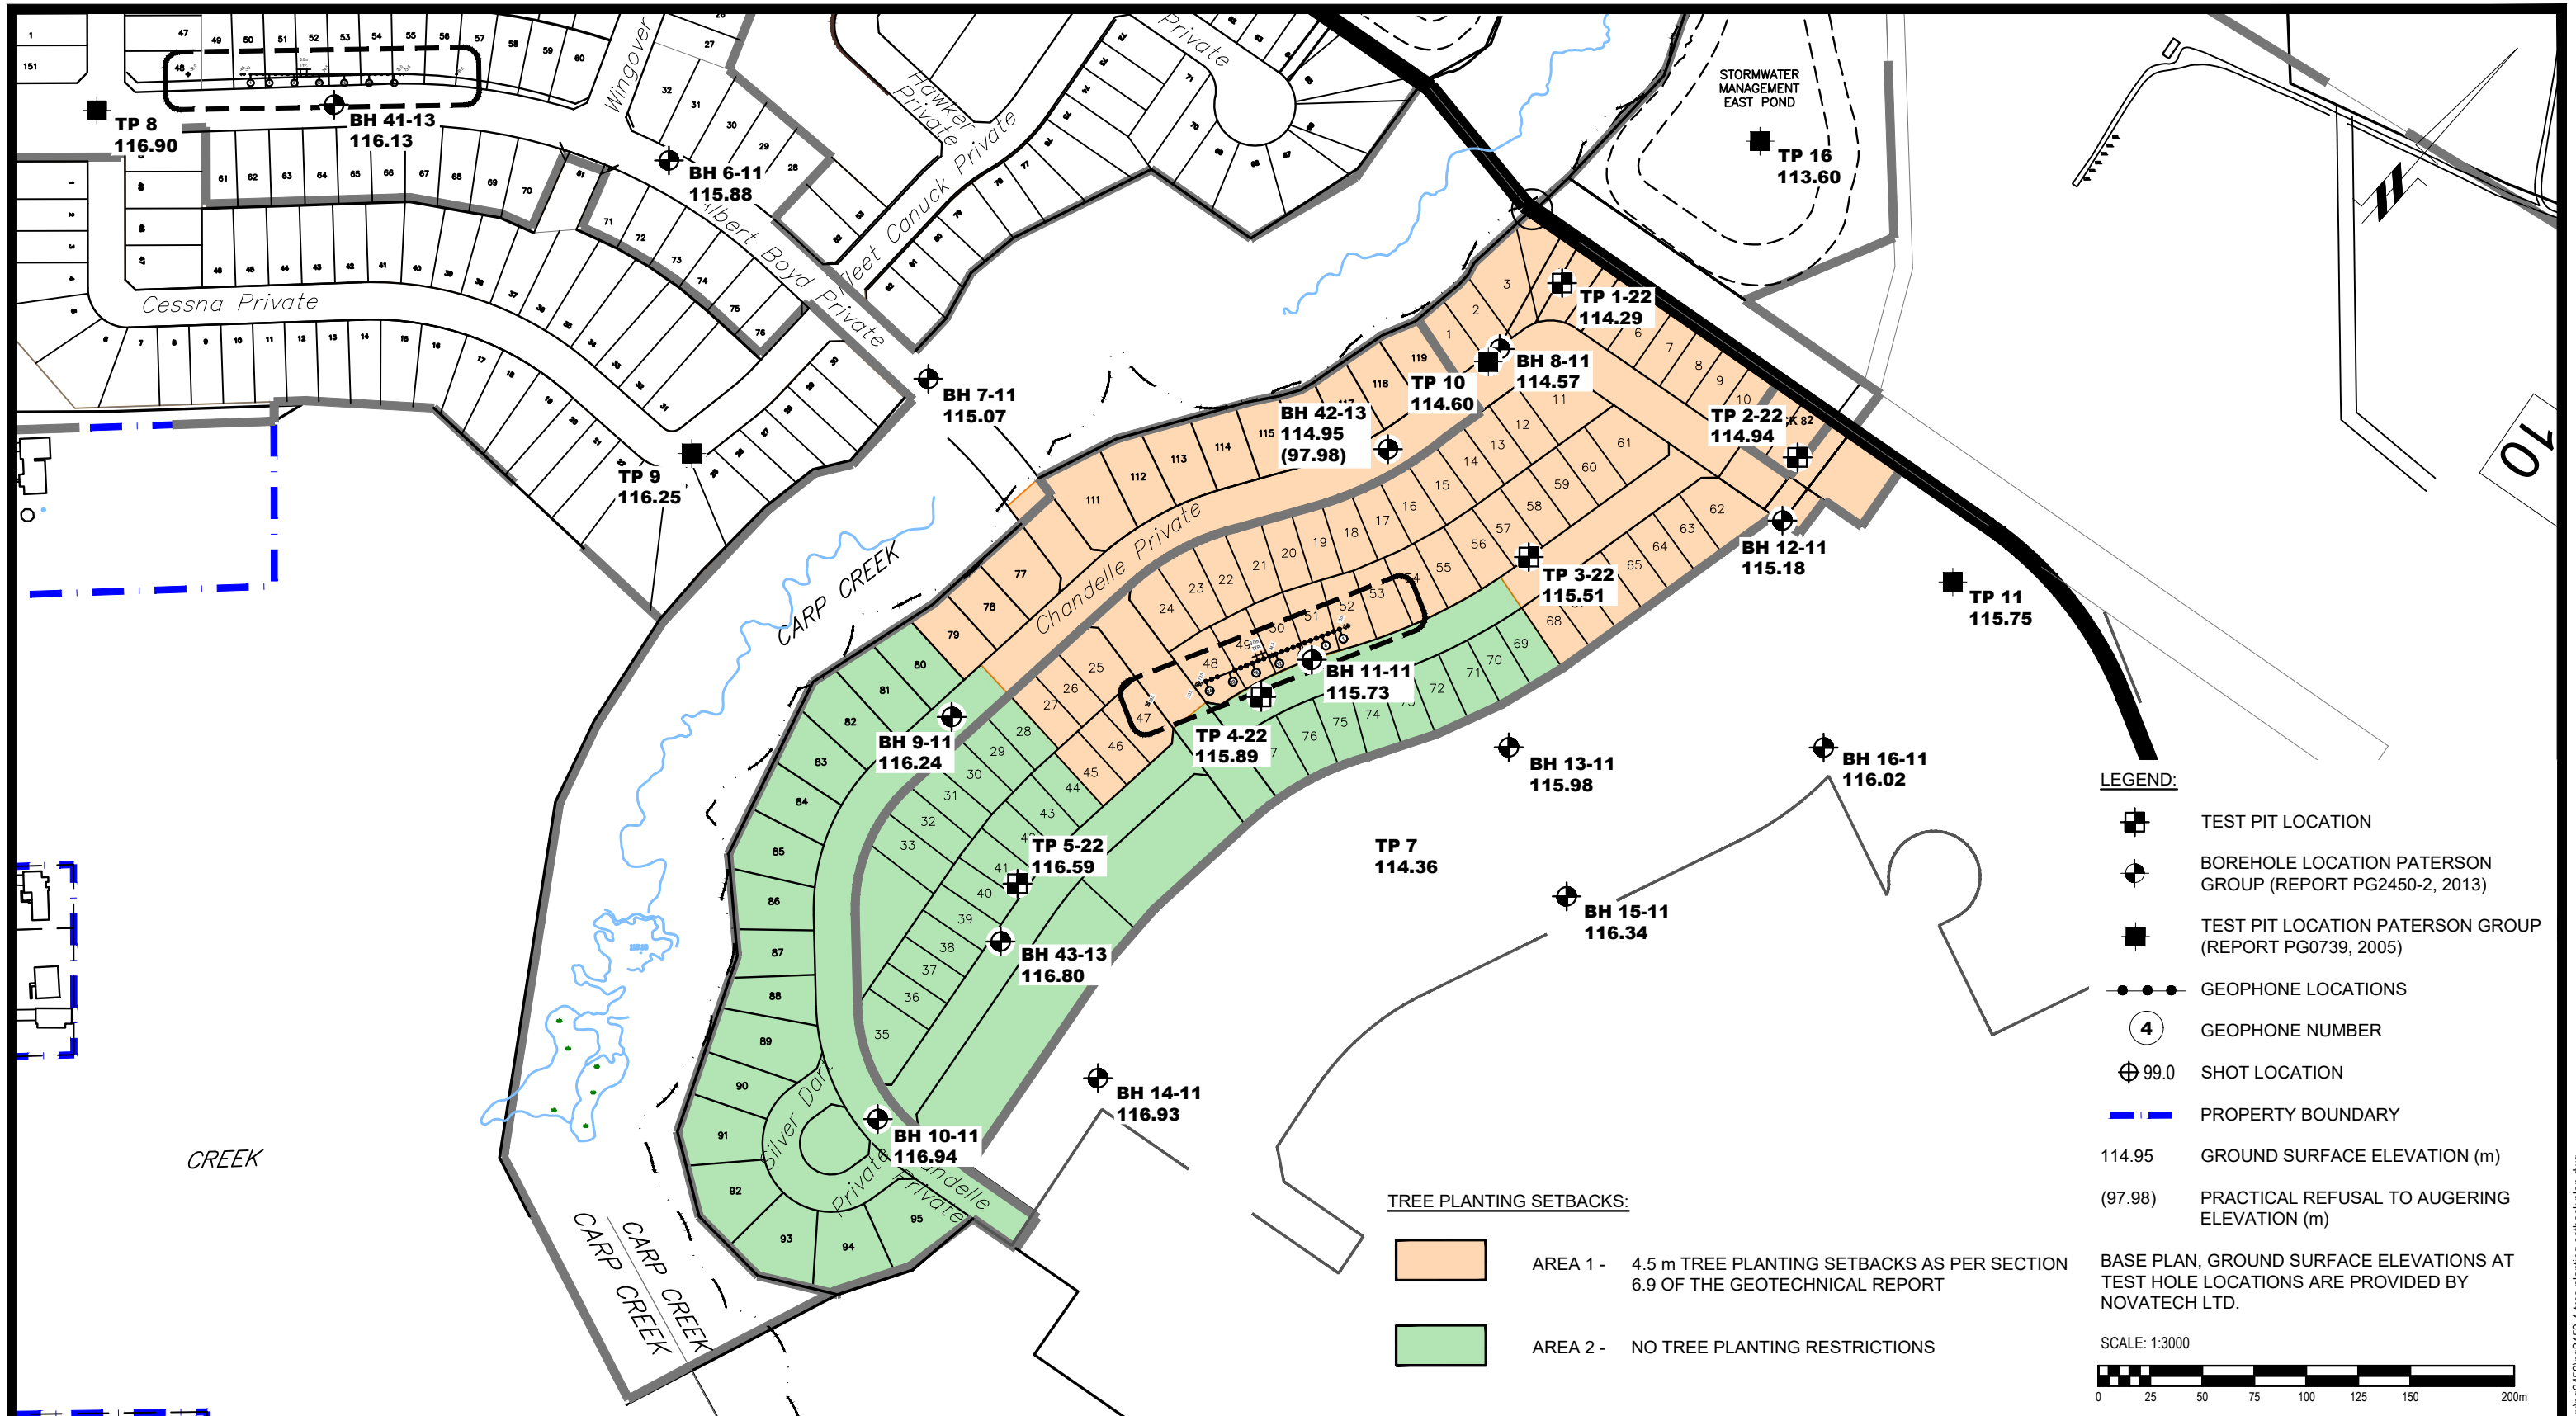
- TREE PLANTING SETBACKS:**
- AREA 1 - 4.5 m TREE PLANTING SETBACKS AS PER SECTION 6.9 OF THE GEOTECHNICAL REPORT
  - AREA 2 - NO TREE PLANTING RESTRICTIONS
