## **Geotechnical Investigation - Slope Stability Assessment**

2164 Old Prescott Road,  
Ottawa, ON

Prepared for:  
Justice Construction

Prepared by:  
Stantec Consulting Ltd.  
1331 Clyde Avenue  
Ottawa, ON K2C 3G4

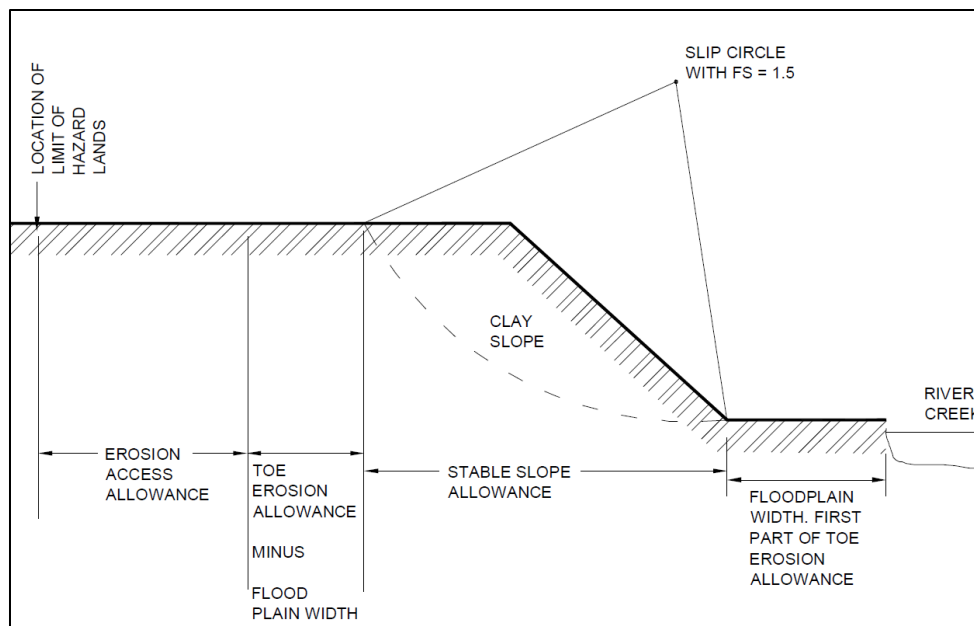
**Figure from the City of Ottawa Slope Stability Guidelines displaying the location of the Limit of Hazard Lands**

The Limit of Hazard Land is the land that is at risk of being impacted by geologic processes that results in the loss of land. For slopes, the Limit of Hazard land is the summation of the following three allowances or set-back distances:

Is the set-back distance beyond the crest of the slope for which there is an acceptable factor of safety against a slope failure occurring. For permanent structures of valuable

Is a set-back distance which provides room for equipment to access the slope to carry out any future repairs or stabilization treatments. The Access Allowance is typically specified as a 6 m set-back measured away from the Erosion Allowance.

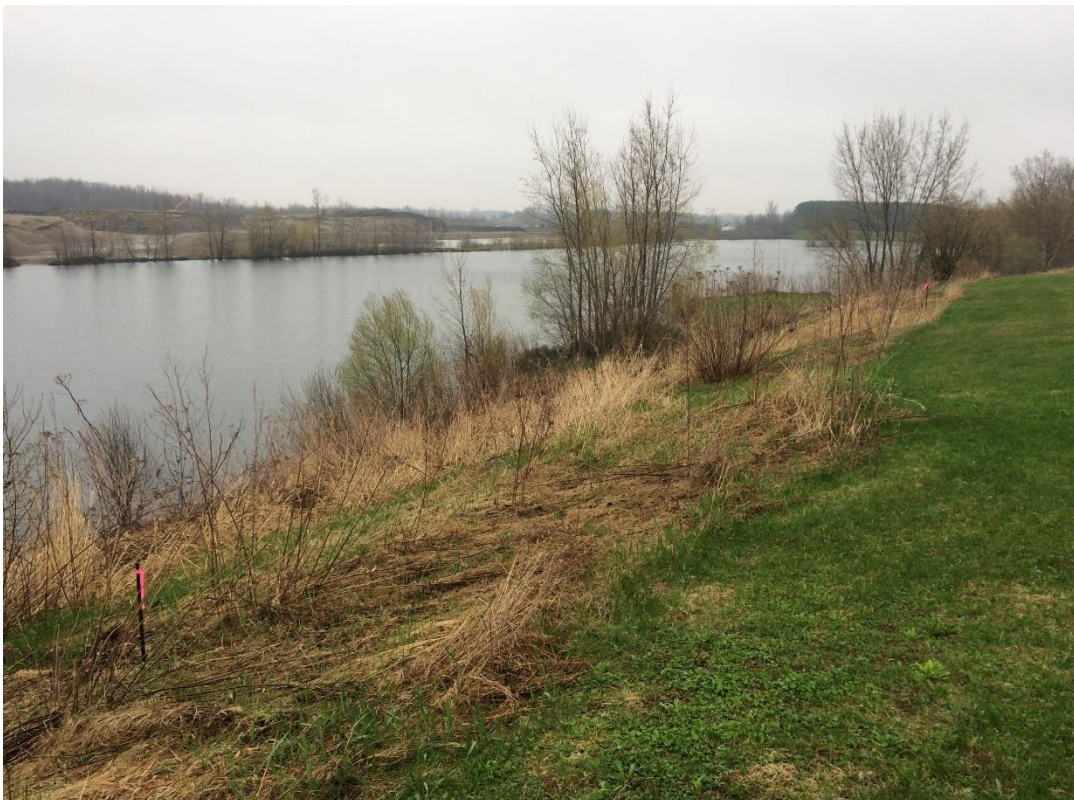
**Photo No. 1: Looking east from footprint of office**

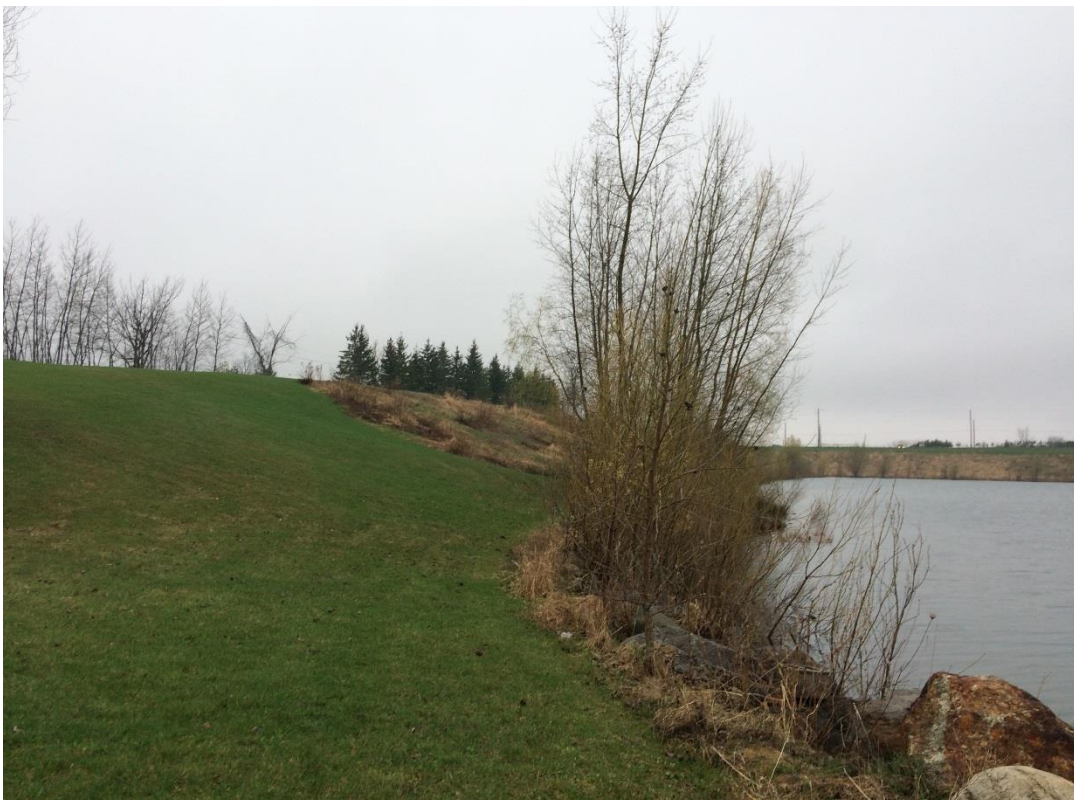
**Photo No. 2: Looking south-west from BH18-3**

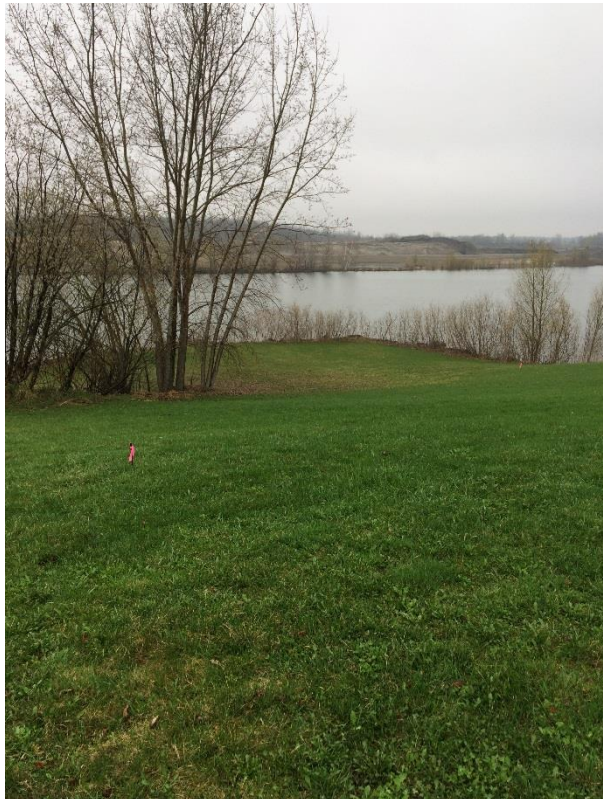
**Photo No. 3: Looking north from footprint of residence**

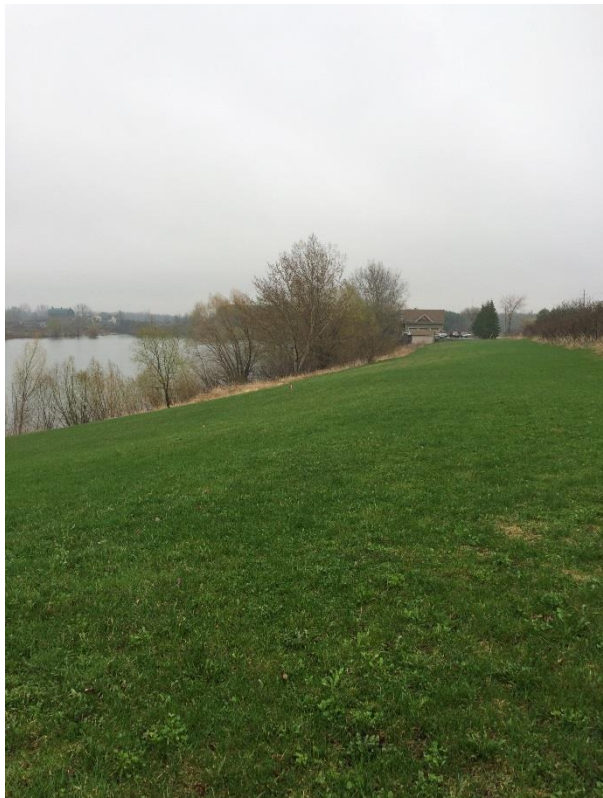
**Photo No. 4: Looking east from footprint of residence**

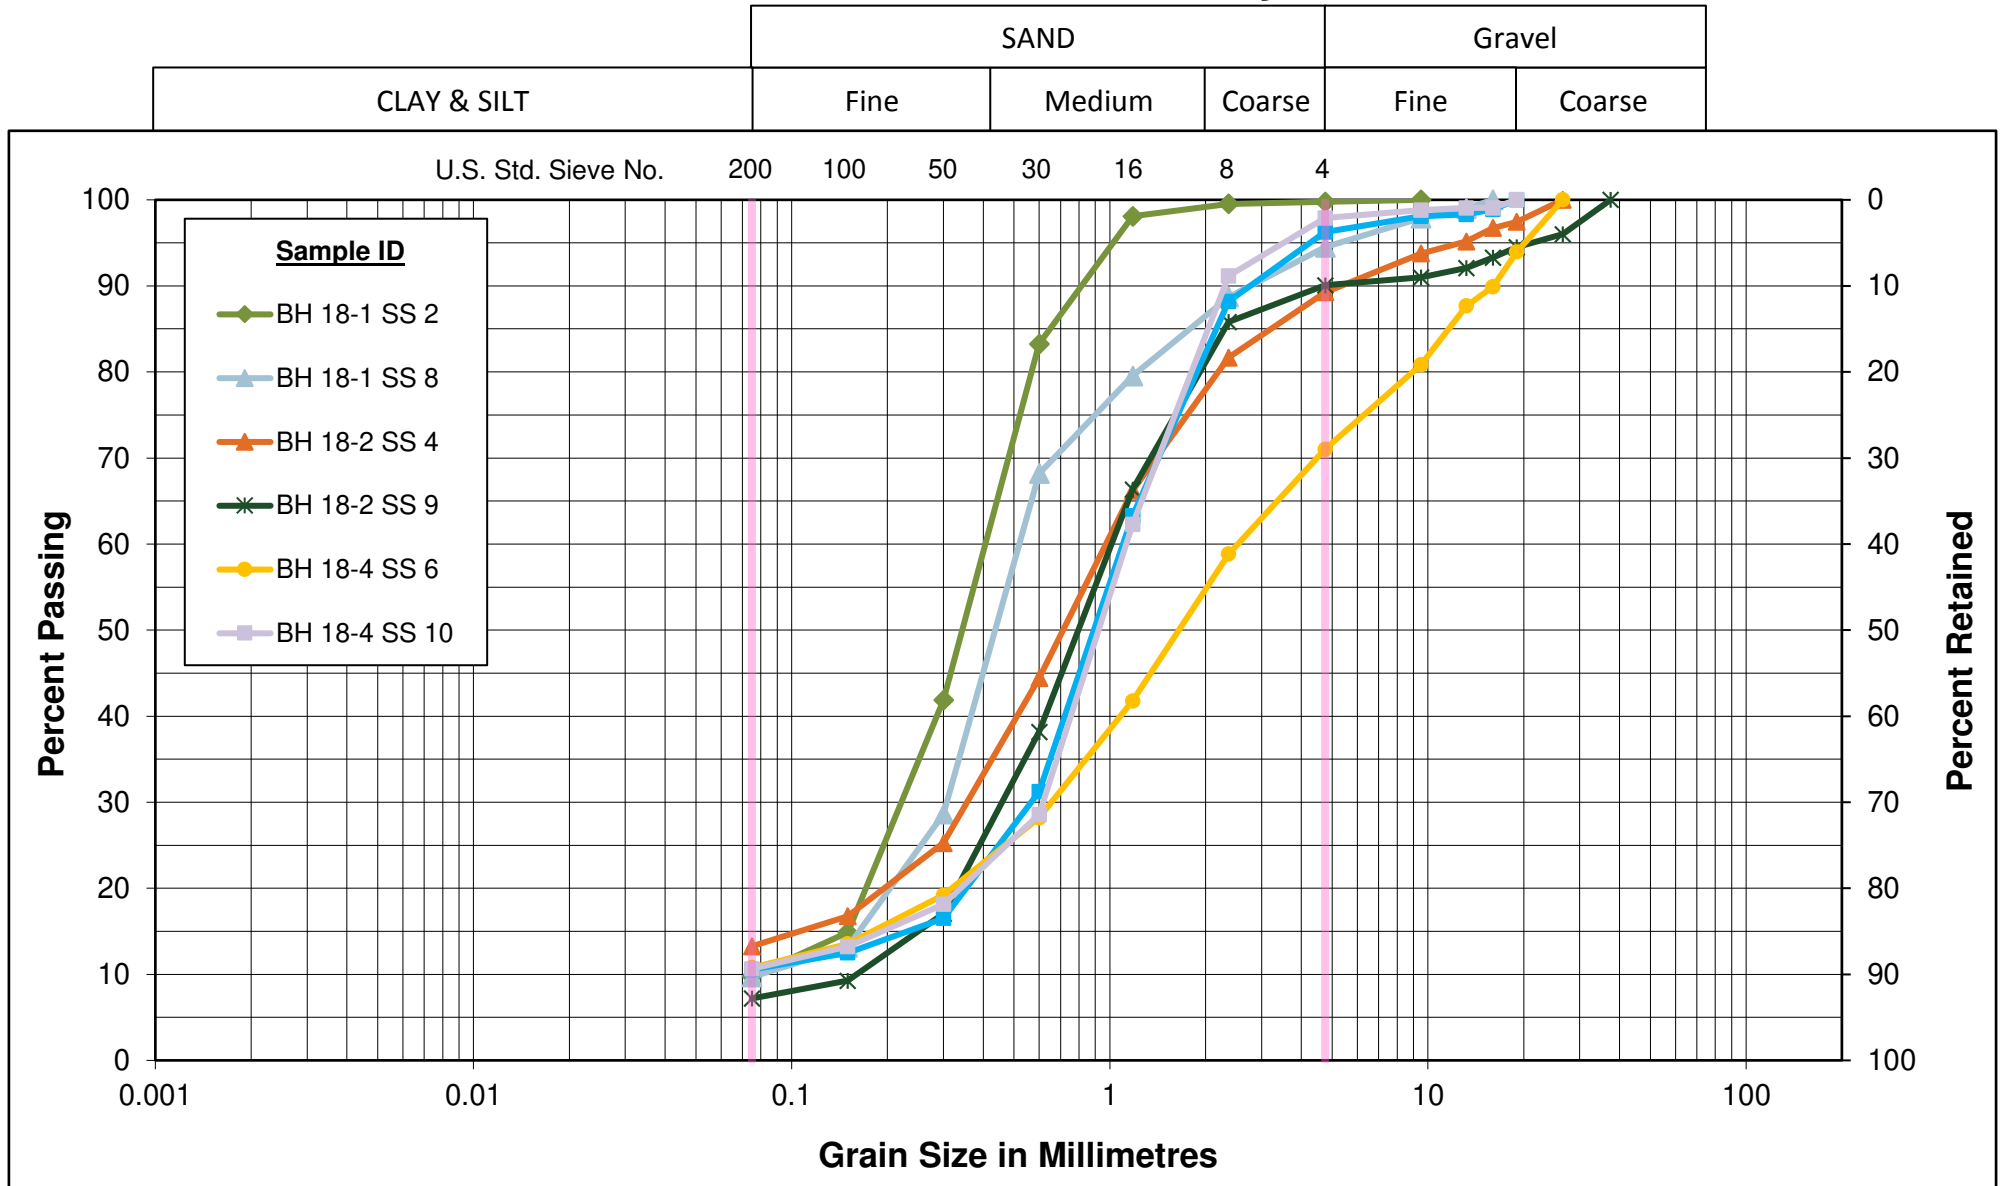
## GRAIN SIZE DISTRIBUTION

Silty SAND (SM), Poorly Graded SAND with Silt (SP-SM), Well Graded Sand with Silt and Gravel (SW-SM)

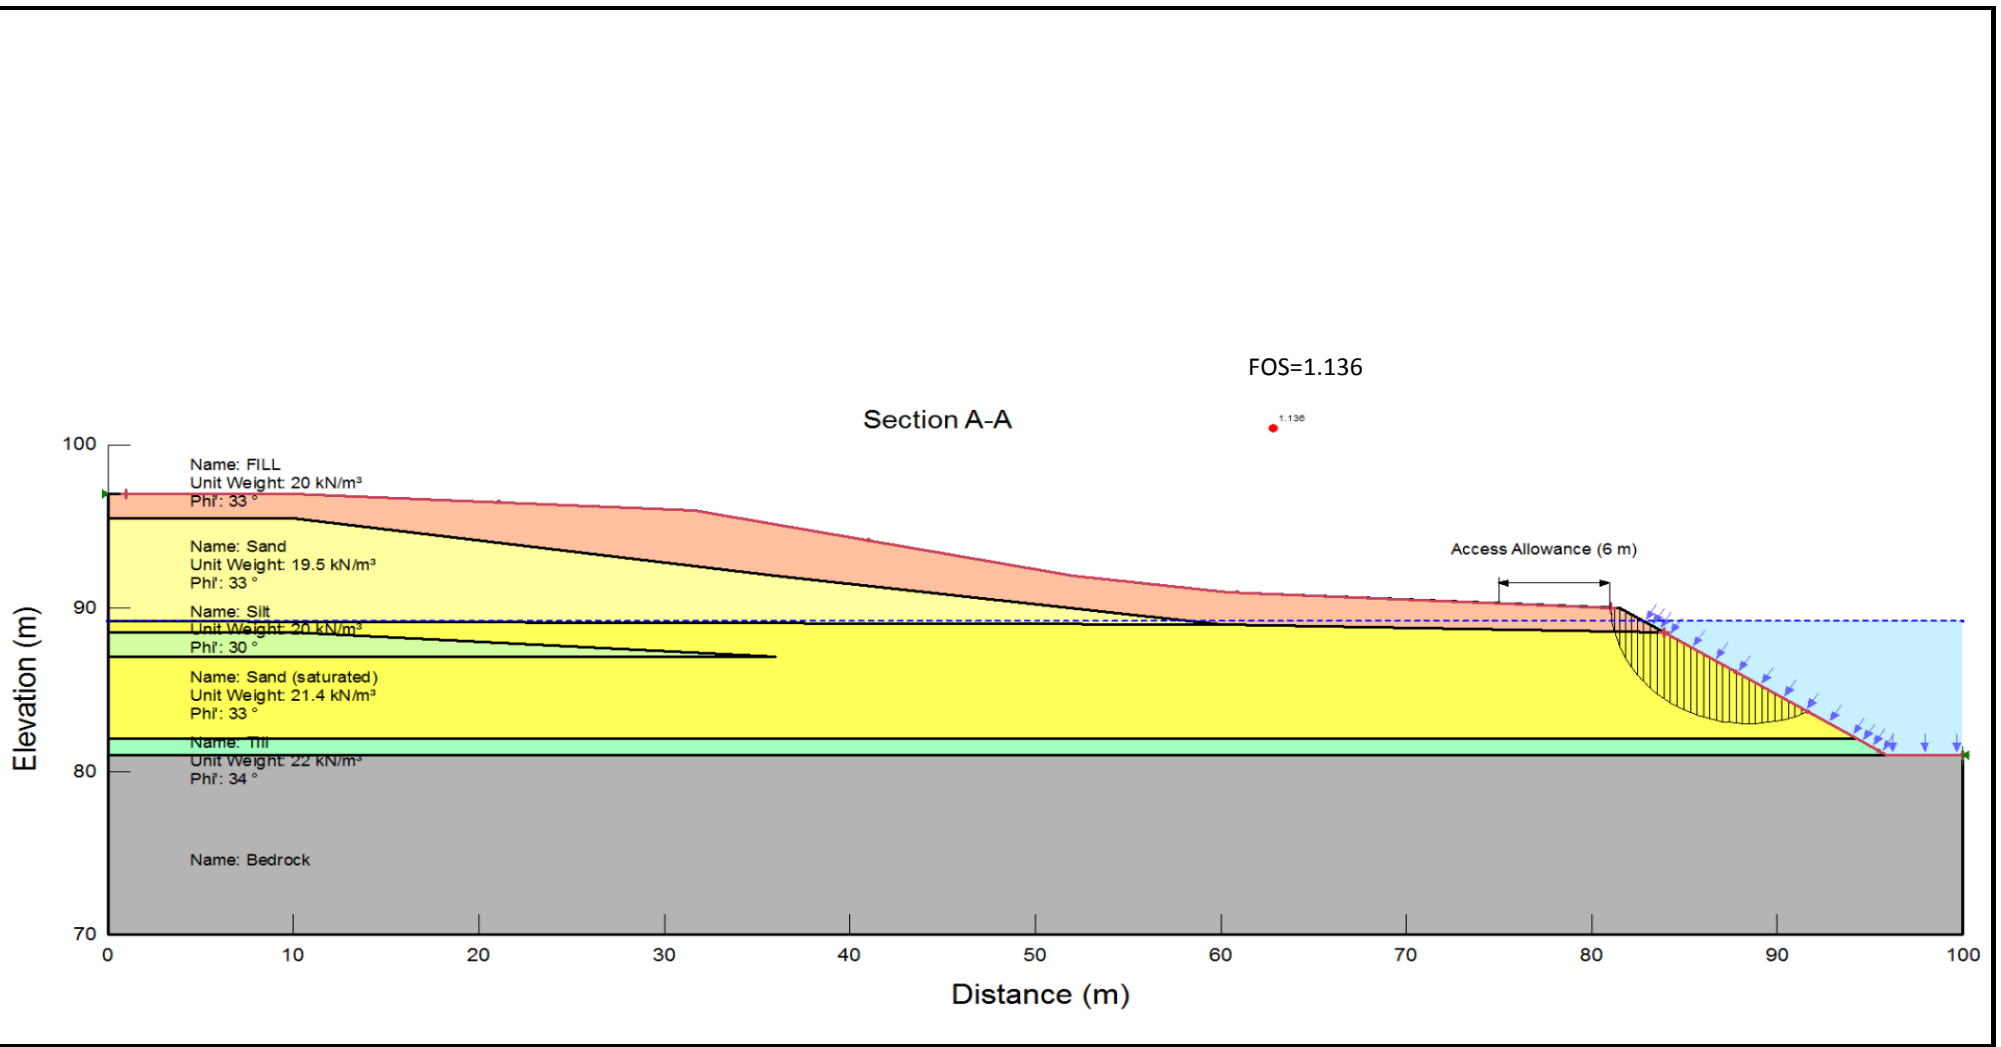
Figure E2

**Seismic Slope Stability Analysis (A-A)**  
 2164 Old Prescott Road, Ottawa, ON

Section	Groundwater Condition	Approximate Side Slope	Static Factor of Safety		Seismic Factor of Safety		Conclusion
			Value	Figure	Value	Figure	
A-A	Existing	5.1H: 1V	1.484	E1	1.136	E2	Unstable
B-B	Existing	2.9H: 1V	1.549	E3	1.044	E4	Unstable

The results of the analysis indicate that the existing slopes at A-A and B-B are unstable. The figures presented in Appendix E show the slip circle with the required factor of safety of 1.5 for static conditions and 1.1 for seismic conditions.
