JBPA Developments Inc.

**Phase I Environmental Site Assessment Rev 2
12-24 Hawthorne Avenue
Ottawa, Ontario**

CM3 Project SDC1007

February 7, 2023 (Revision 2)

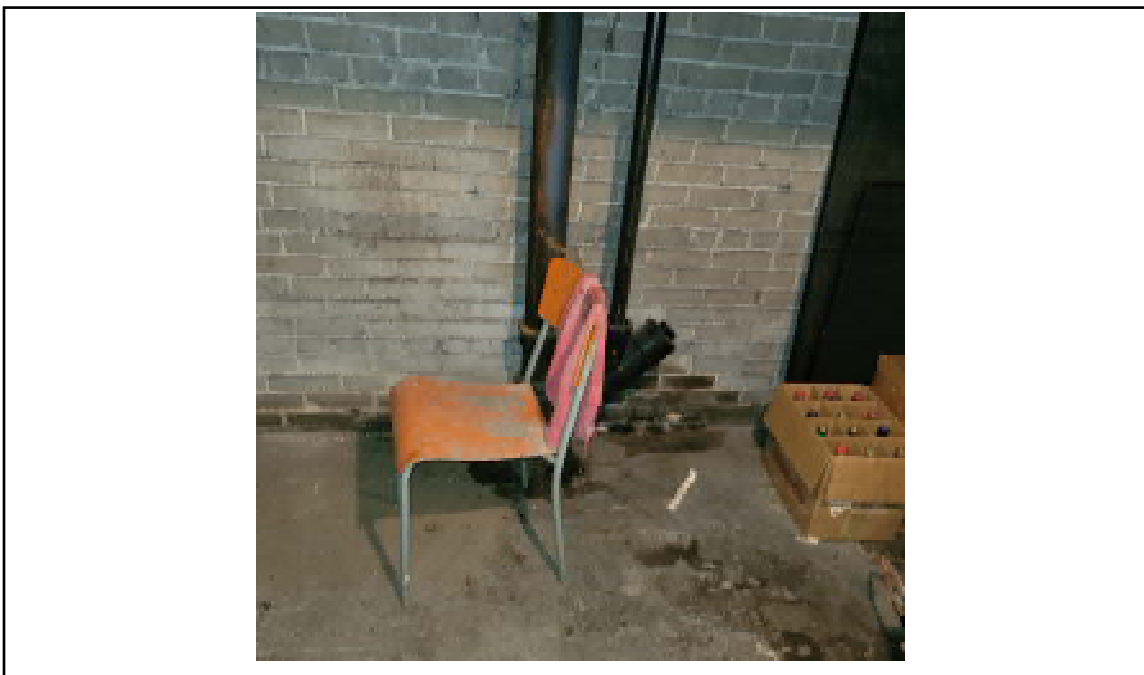
Photograph 12: Main sanitary drain for 12 and 14 Hawthorne next to the brick dividing wall for 12/14 Hawthorne in basement of 12 Hawthorne.
