2510 St. Laurent Blvd – Tree Conservation Report

Claridge Homes

Prepared for Claridge Homes
by Arcadis | IBI Group

January 30, 2024

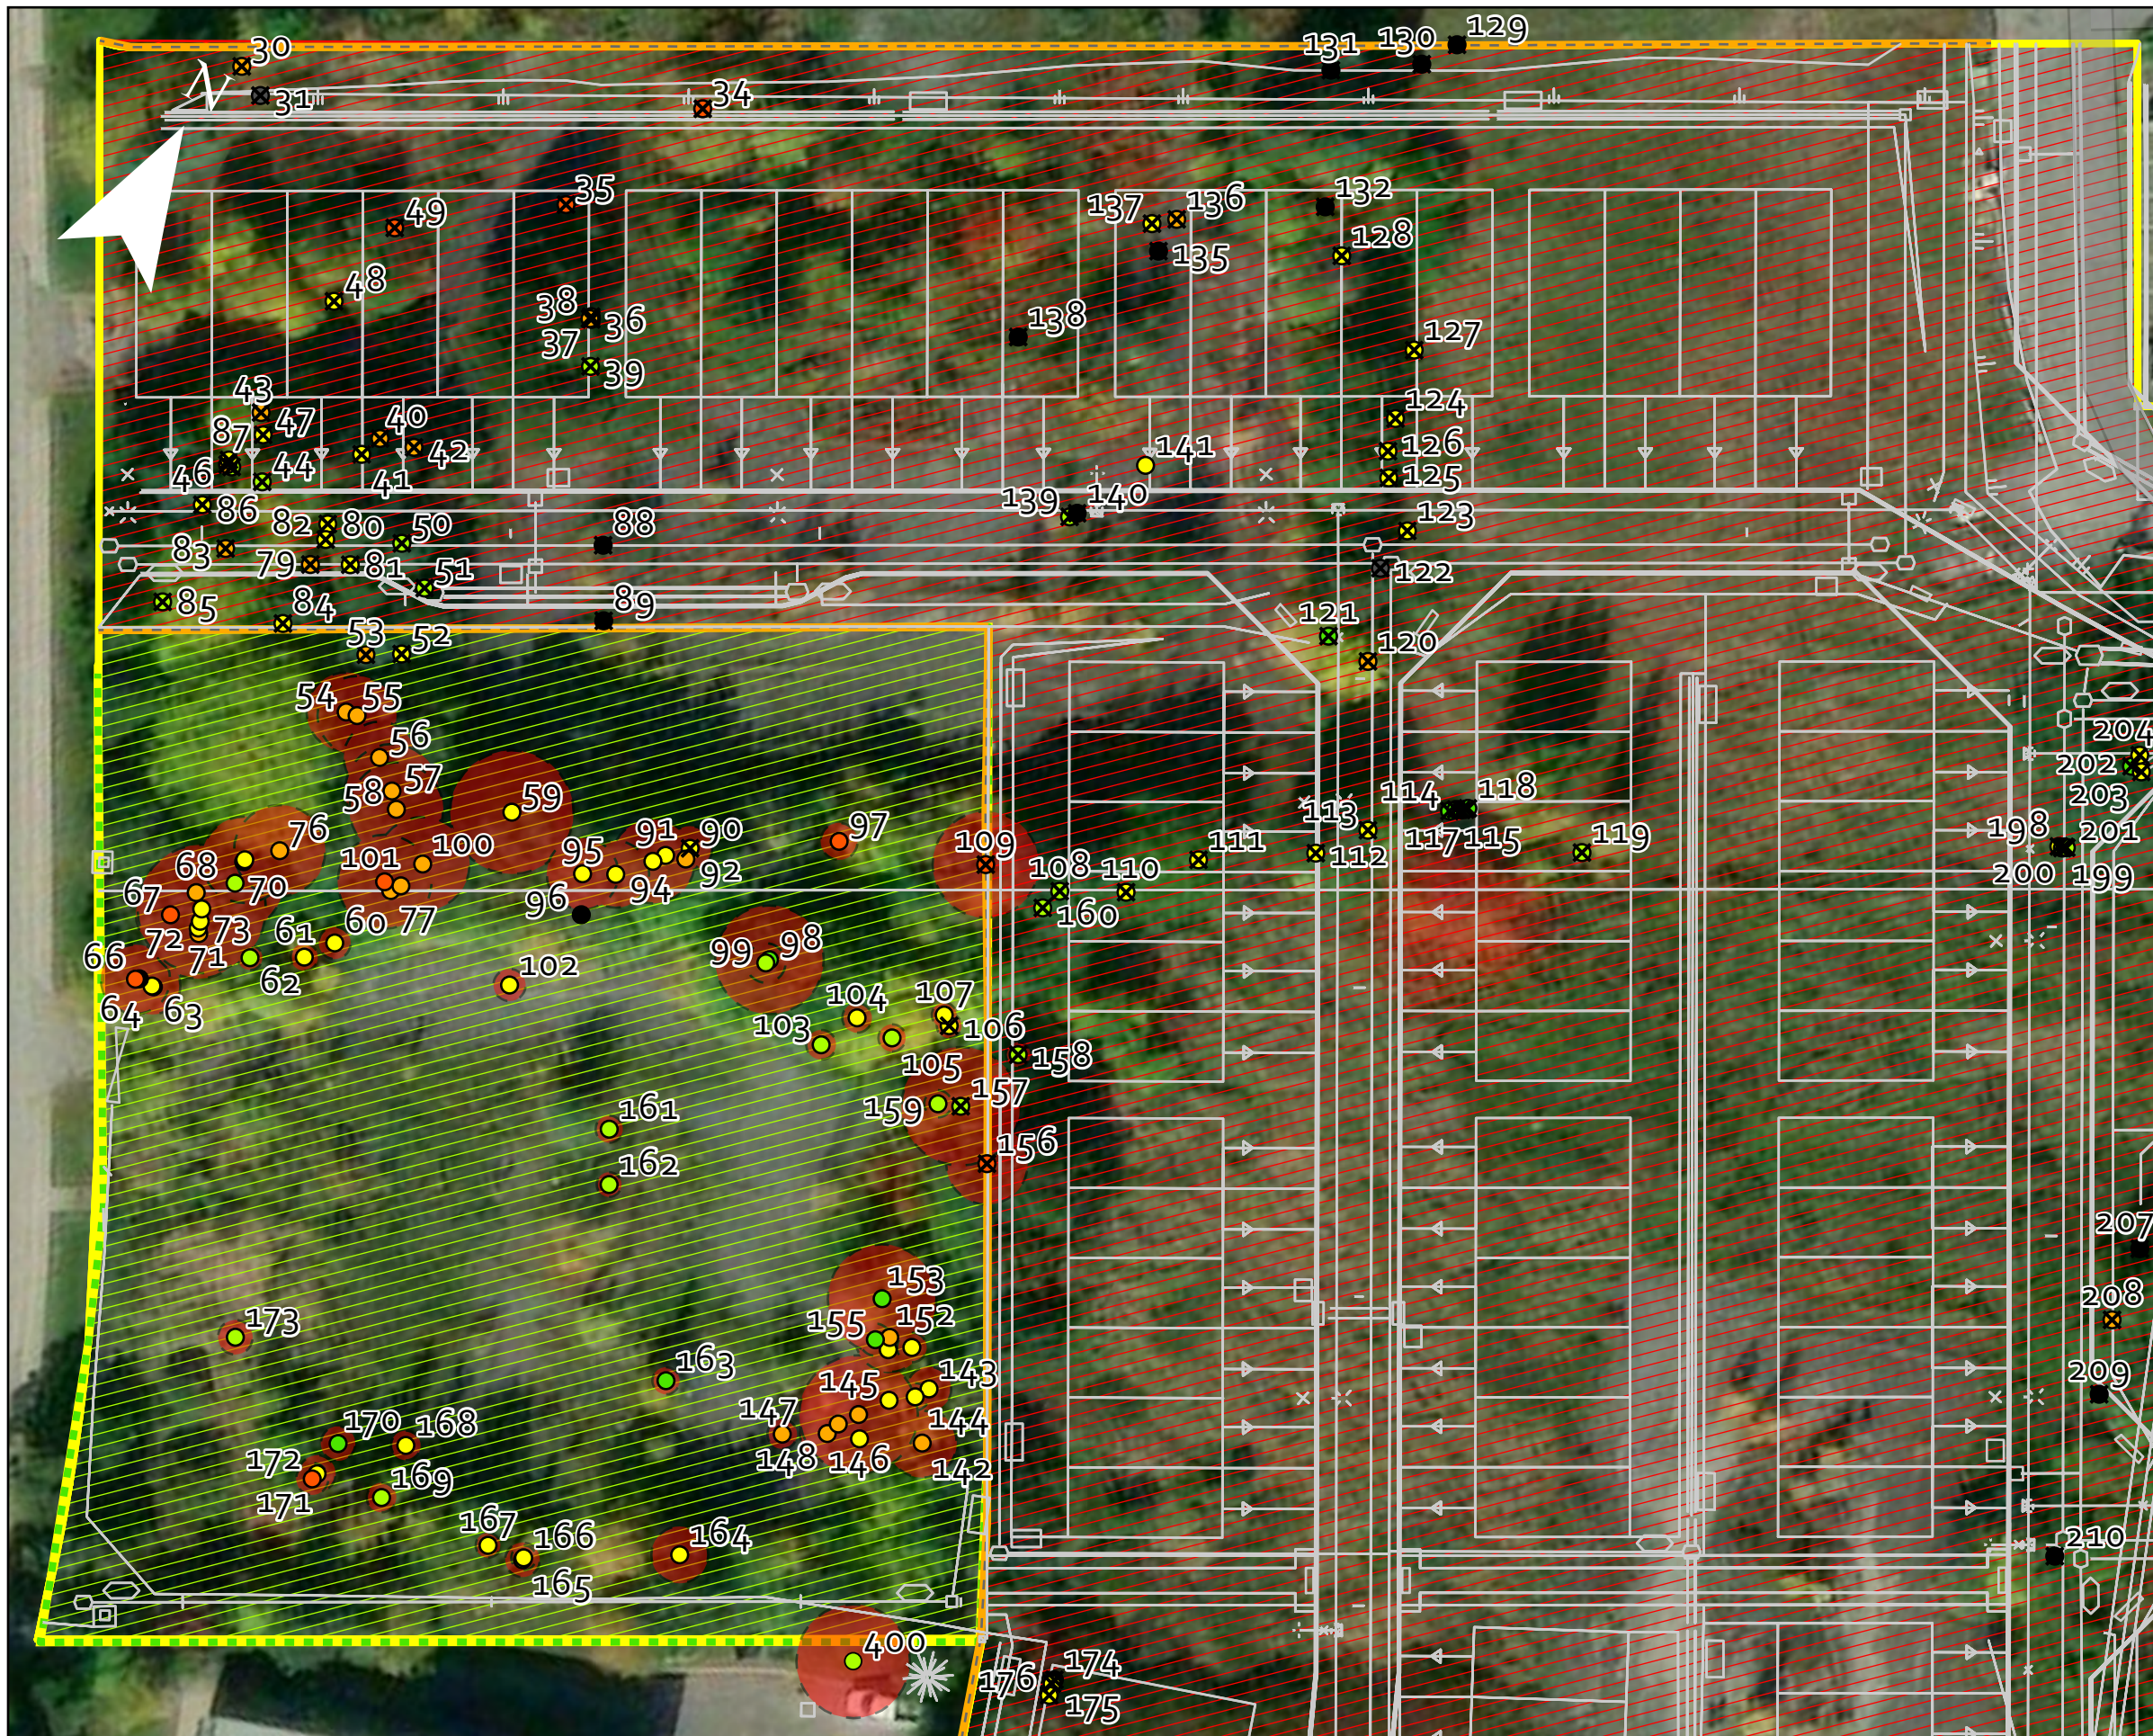
Figure: 3.1

- X Tree Removal
- Site Plan (Jan 11, 2024)
- Tree Protection Fencing
- Park Boundary
- Subject Property
- Potential to be Retained
- Trees to be Removed
- Critical Root Zone (CRZ)

Title:
2510 St. Laurent Blvd:
Tree Protection and Removals:
Area-A

To protect trees in properties adjacent to the Subject Property orange snow fence should be installed to serve as tree protection fencing along the perimeter of the construction footprint (**Figures 3.1-3.3**). Additionally, to ensure that no harm is caused to breeding birds, tree removal and vegetation clearing should be avoided during the migratory bird season (April 15 – August 15) as specified by The City of Ottawa's Environmental Impact Study Guidelines.

- Tree Protection Fencing shall be installed as per the mapping in **Figures 3.1-3.3** of the TCR to protect the CRZ of the trees to be retained.
 - Tree protection fencing must be at least 1.2m in height, and constructed of rigid or framed materials (e.g. moduloc - steel, plywood hoarding, or snow fence on a 2"x4" wood frame) with posts 2.4m apart, such that the fence location cannot be altered. All supports and bracing must be placed outside of the CRZ, and installation must minimise damage to existing roots, as per the City of Ottawa Tree Protection Specification (**Appendix C**).

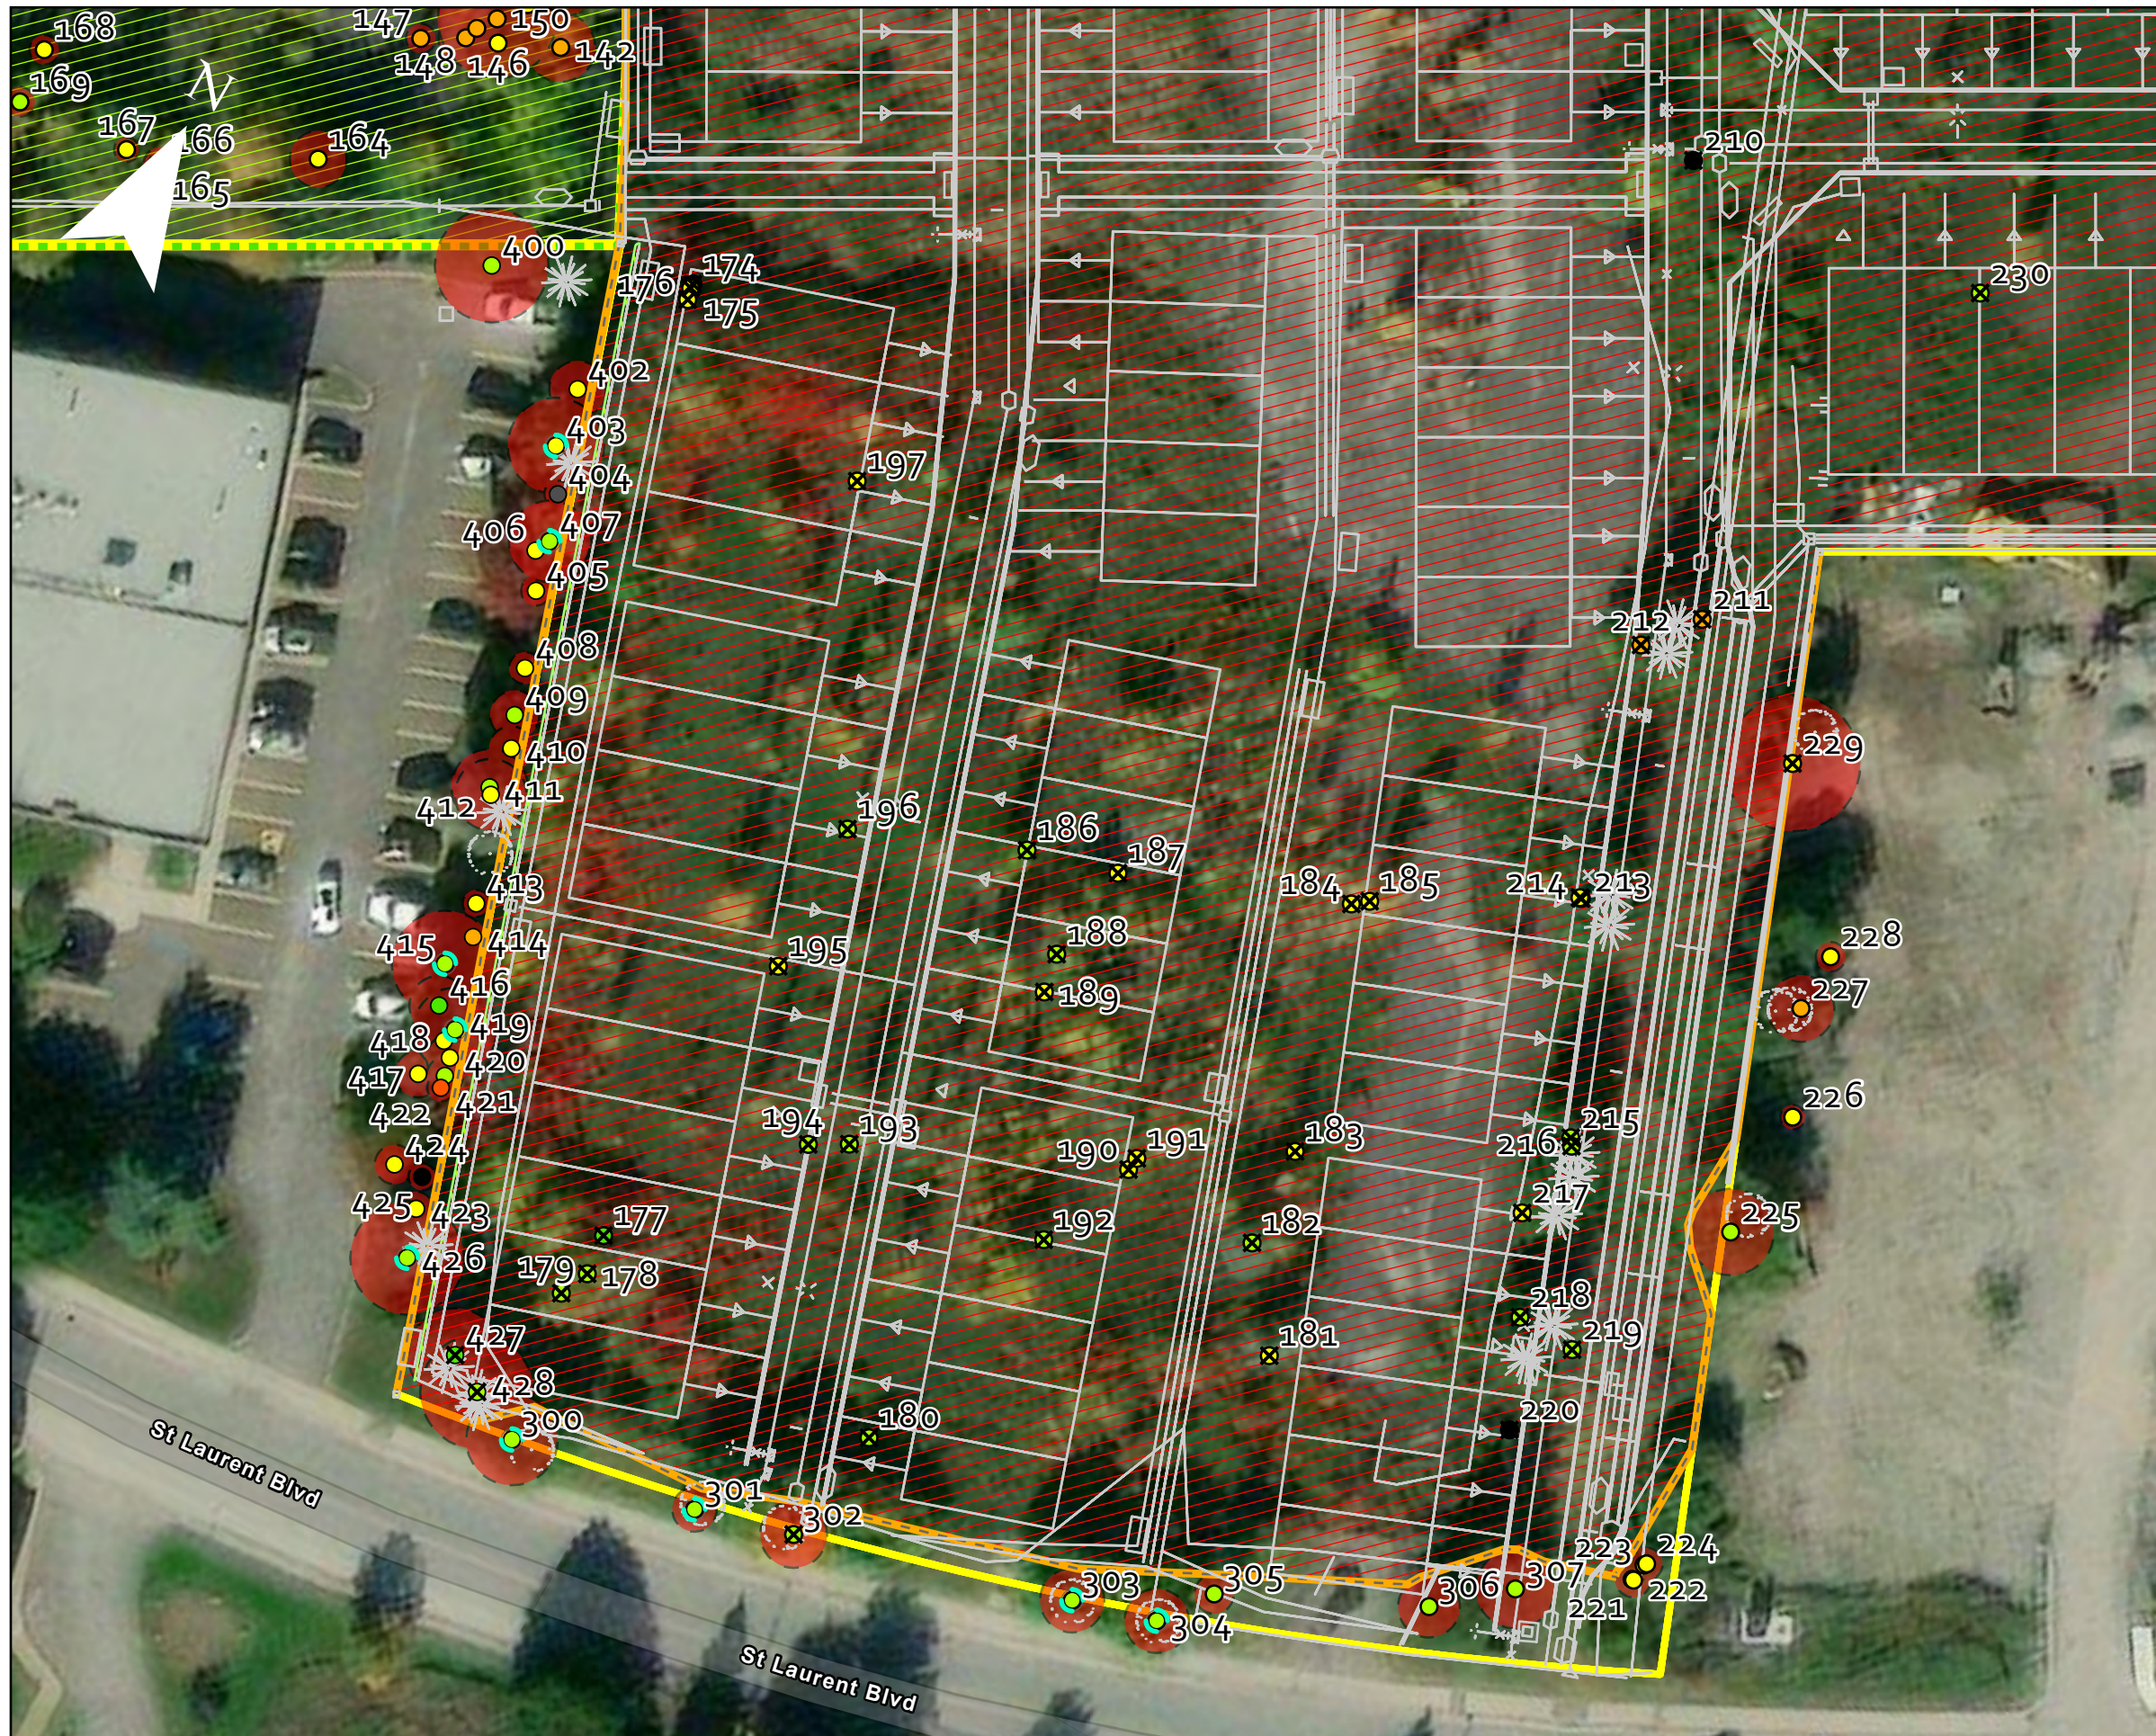
- Tree Removal
- Trees to Monitor
- Site Plan (Jan 11, 2024)
- Tree Protection Fencing
- Park Boundary
- Subject Property
- Potential to be Retained
- Trees to be Removed
- Critical Root Zone (CRZ)
- Western Drain Clear Stone Surround (0.3m)
