Phase Two Environmental Site Assessment 266 and 268 Carruthers Avenue, Ottawa, Ontario

Phase Two Environmental Site Assessment

OTT-22009213-C0

EXP Services Inc.

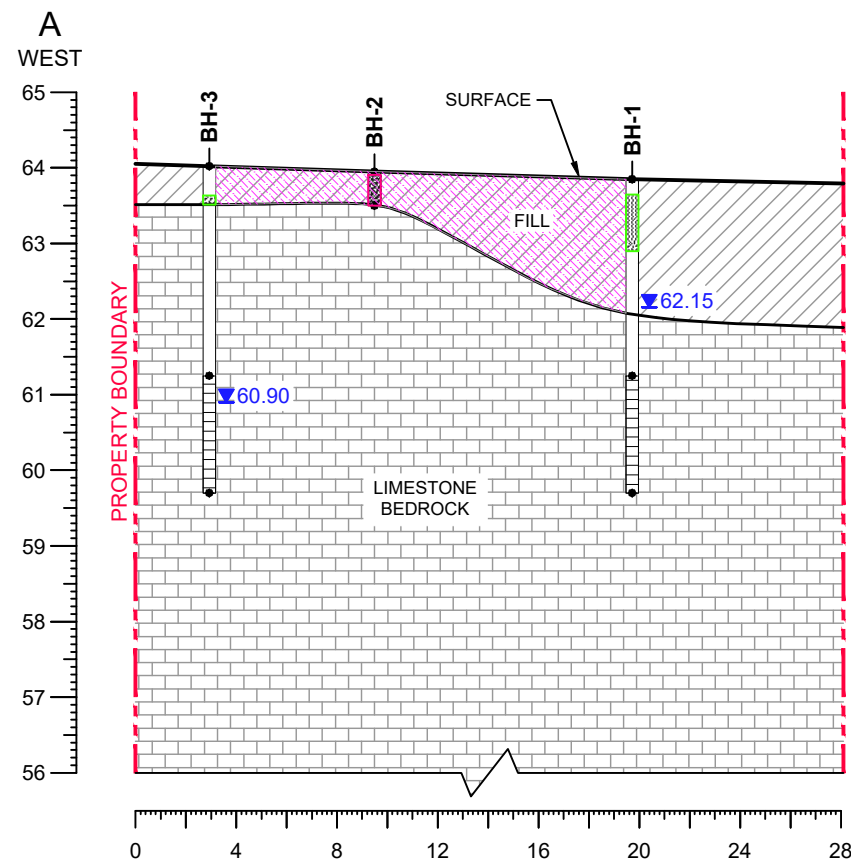
CROSS SECTION A-A'

The general stratigraphy at the Phase Two property, as observed in the boreholes, consisted of fill overlying grey limestone bedrock at depth of 0.4 m to 1.6 m bgs. A brief description of the soil stratigraphy at the Phase Two property, in order of depth, is summarized in the following sections.

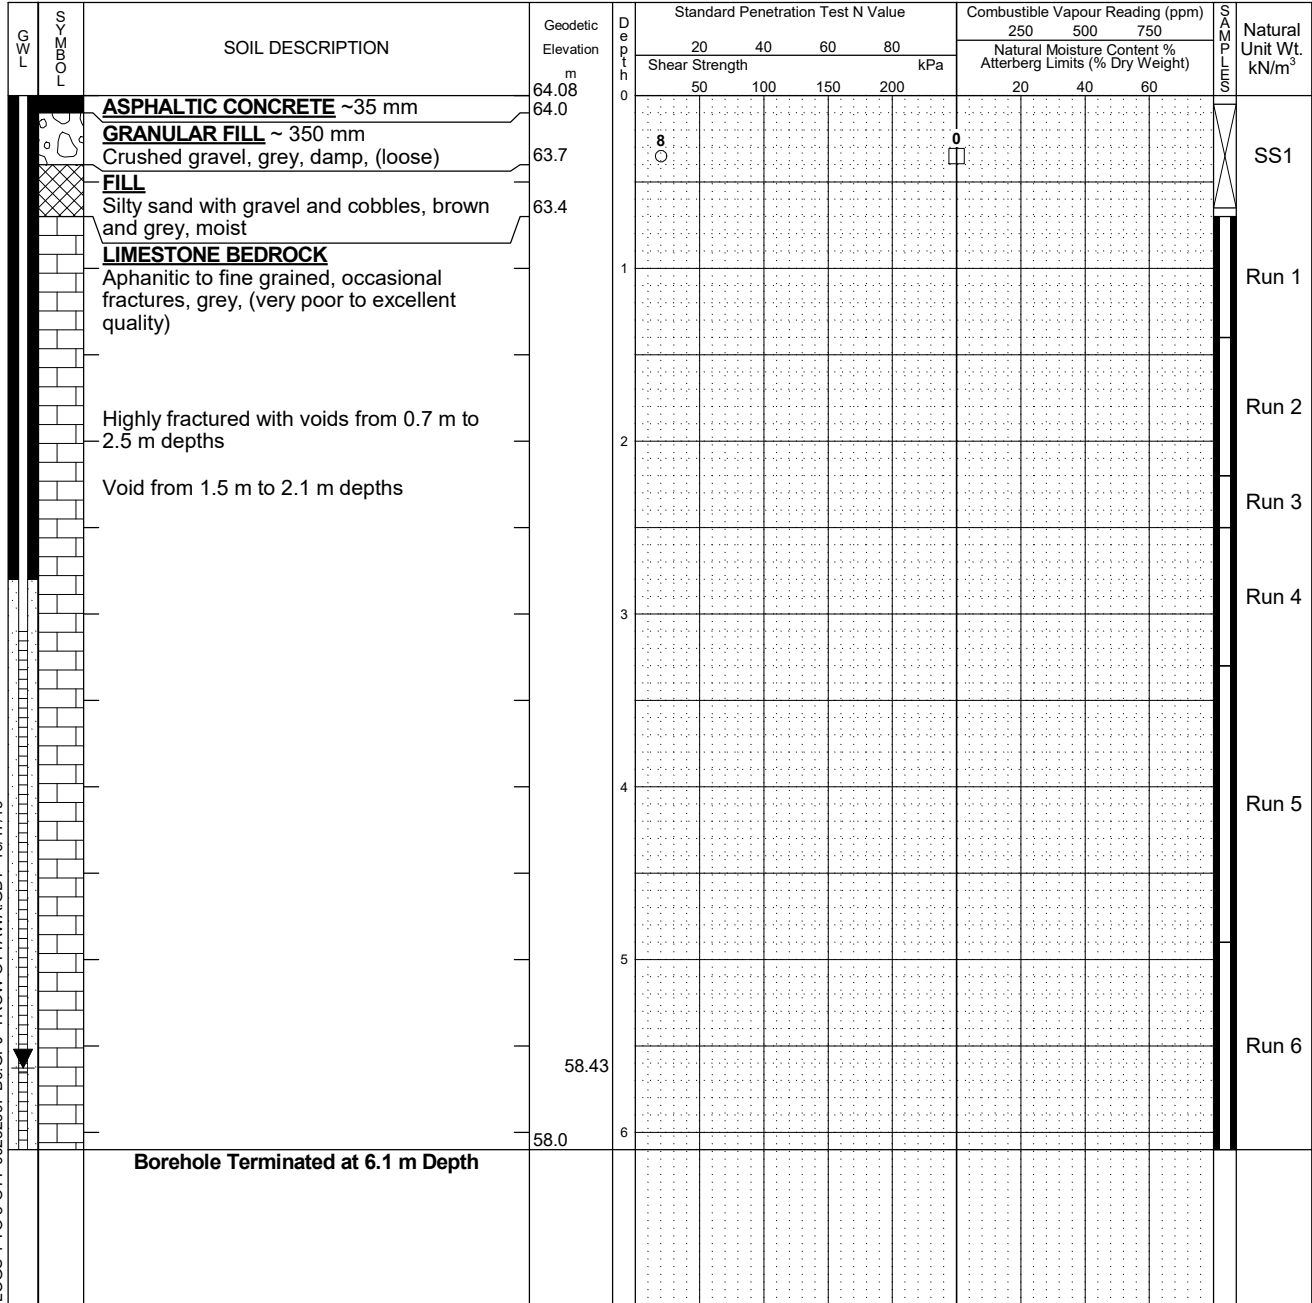
LOG OF BOREHOLE BOREHOLE LOGS 1 TO 8 OTT-00252997-B0.GPJ TROW/OTTAWA.GDT 10/17/19

EXP staff continuously monitored the drilling activities to log the stratigraphy observed from the recovered samples, to record the depth of the samples, and to record total depths of borings. Field observations are documented on the borehole logs provided in Appendix D.
