Geotechnical Investigation

Proposed Residential Development

Cardinal Creek Village South
Old Montreal Road
Ottawa, Ontario

Report PG5201-1 Revision 7 dated October 17, 2024

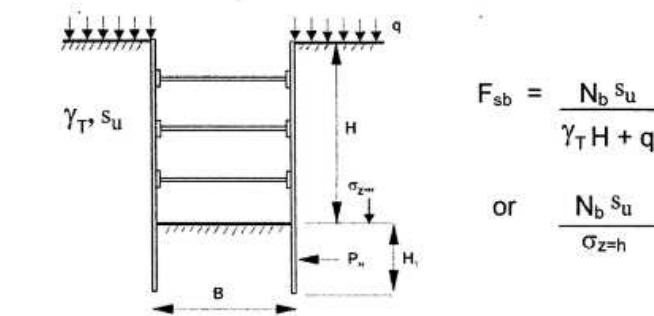
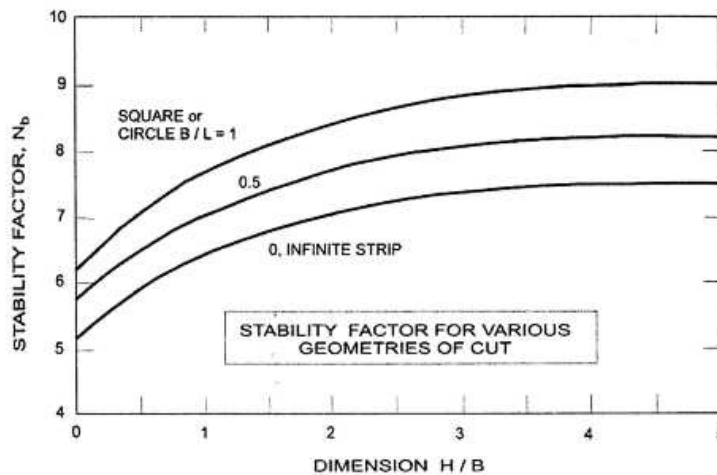
Figure 1 – Stability Factors for Various Cut Geometries

s_u - undrained shear strength of the soil below the base level.

σ_z - total overburden and surcharge pressures at the bottom of the excavation.

In the case of soft to firm clays, a factor of safety of 2 is recommended for base stability.

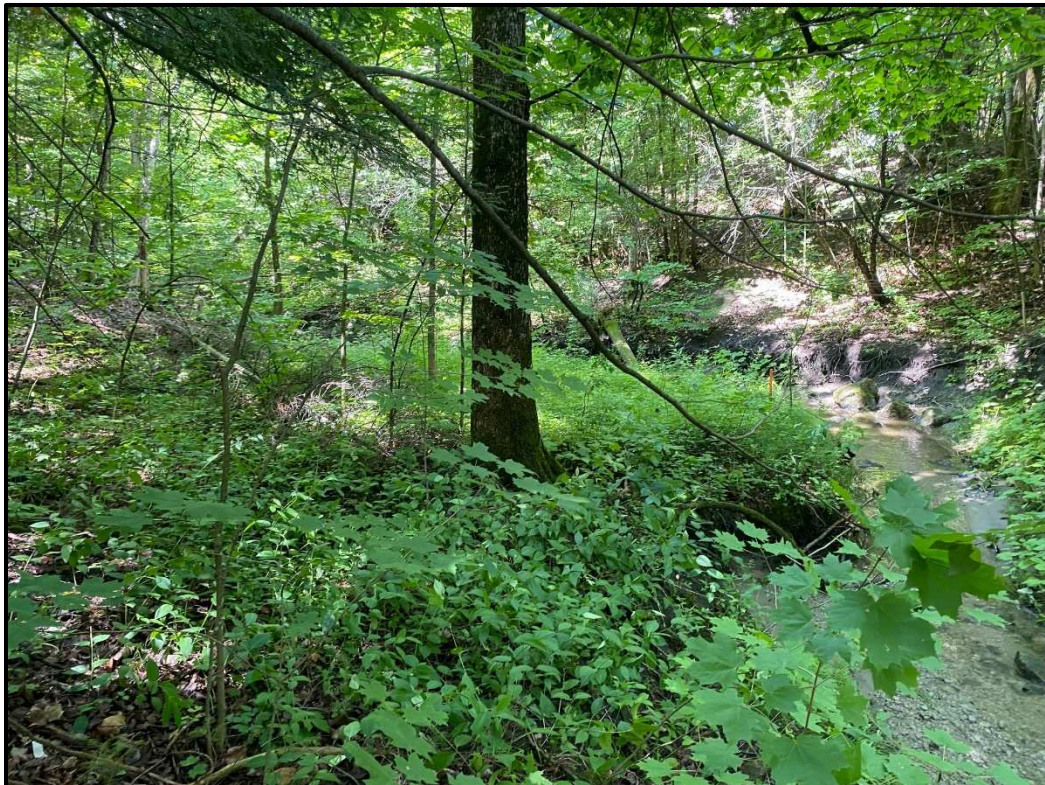
Photo 26: Photo taken on July 19, 2023 of the north slope face, looking west (downstream) near Section F.

Follow-up site visits have been completed to review the slope conditions along the tributary ravine slopes to confirm that our original Limit of Hazard Lands recommendations are still applicable for the subject slopes. Photographs from our site visits are presented in Appendix 2.

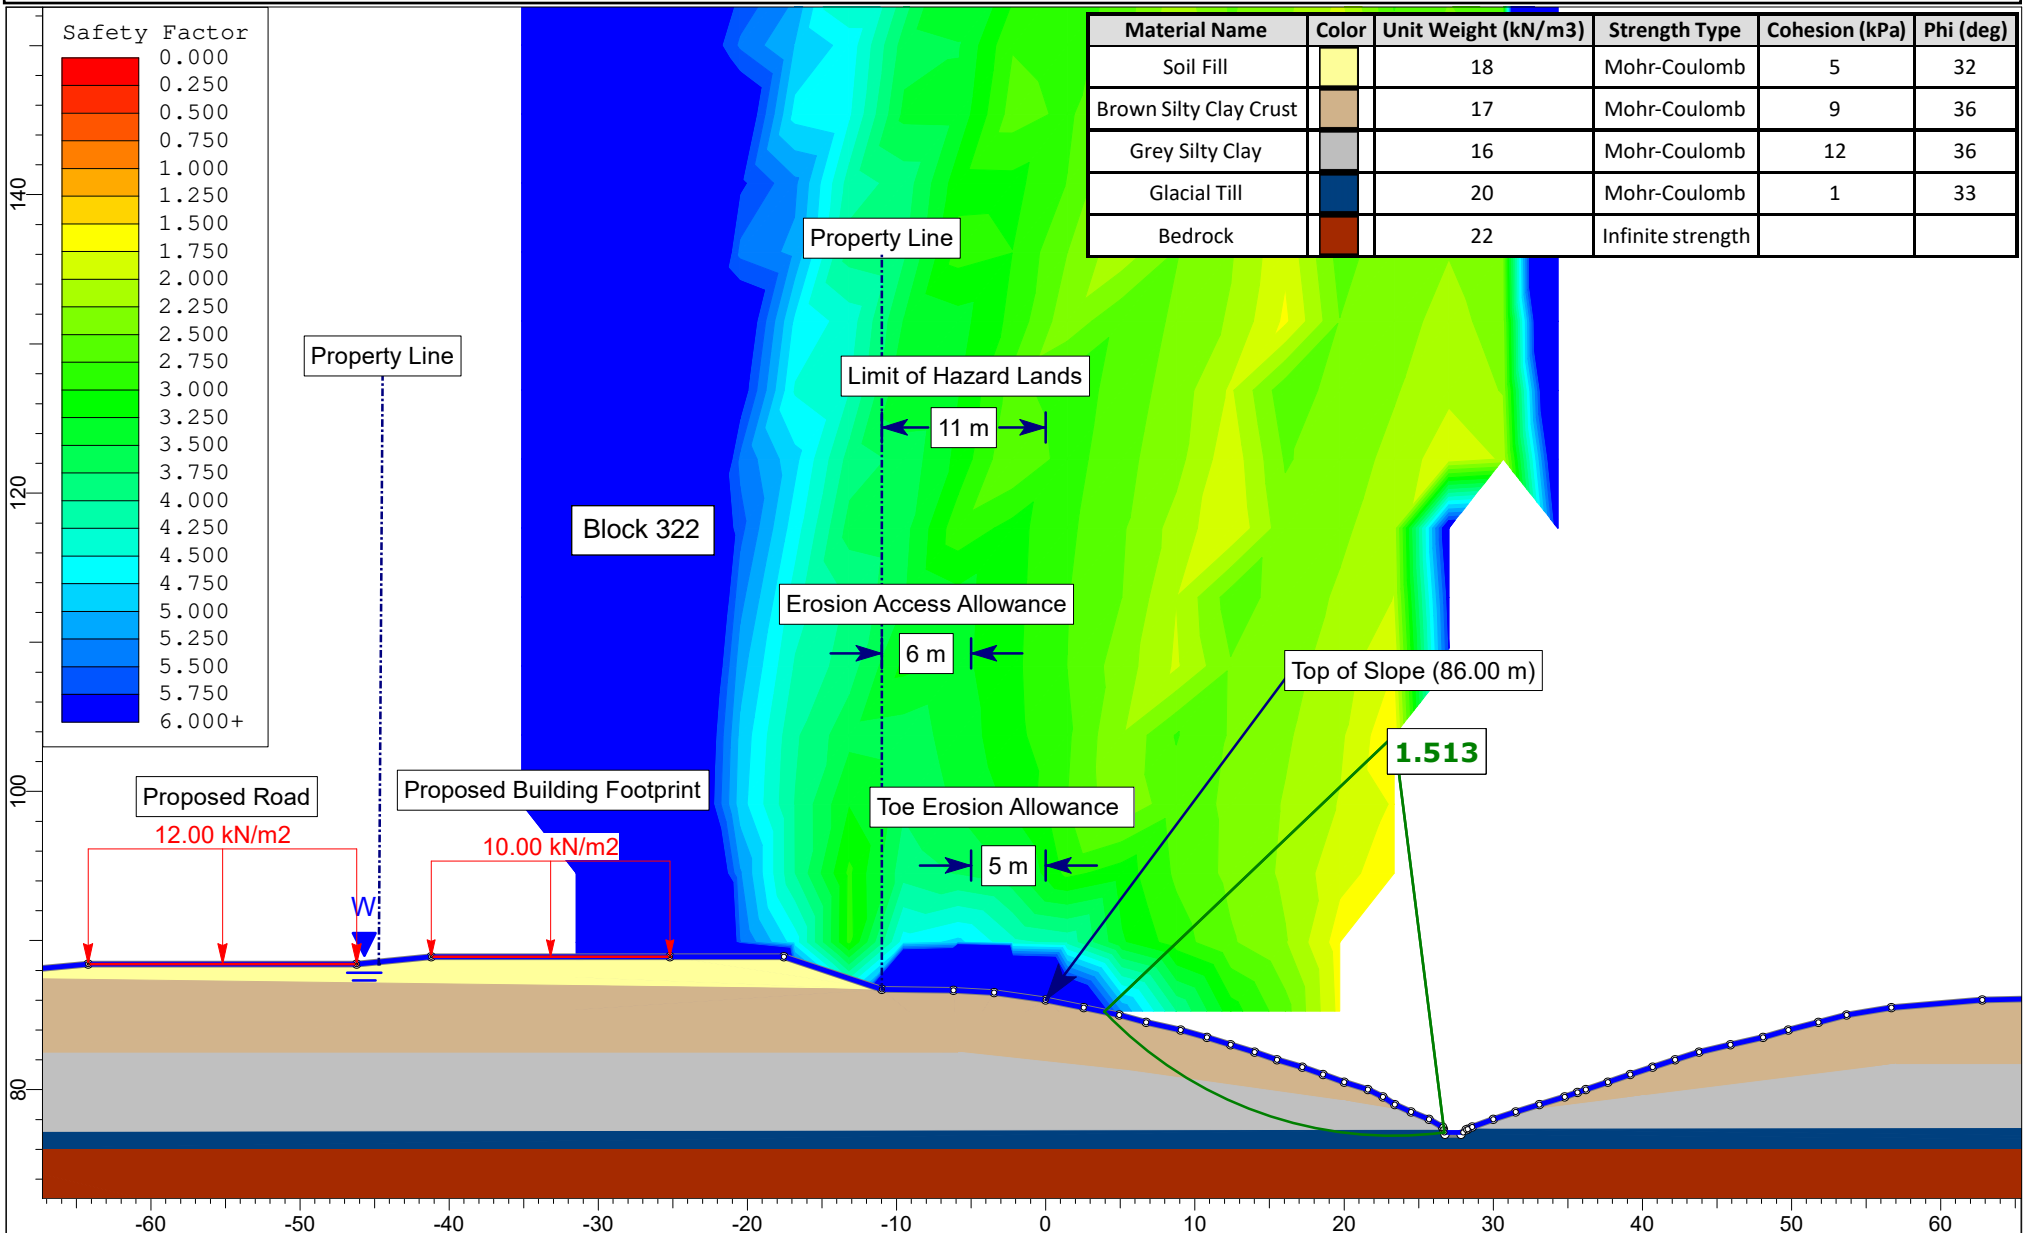
Figure 7C - Section G - Proposed Static Conditions

Project PG5201 - Proposed Residential Development - Cardinal Creek Village South Old Montreal Road, Ottawa, Ontario	
	Cross Section G	Scenario Static - Proposed Condition
	Drawn By EA	Company Tamarack Homes
	Date 8/18/2023	File Name Geotechnical Investigation

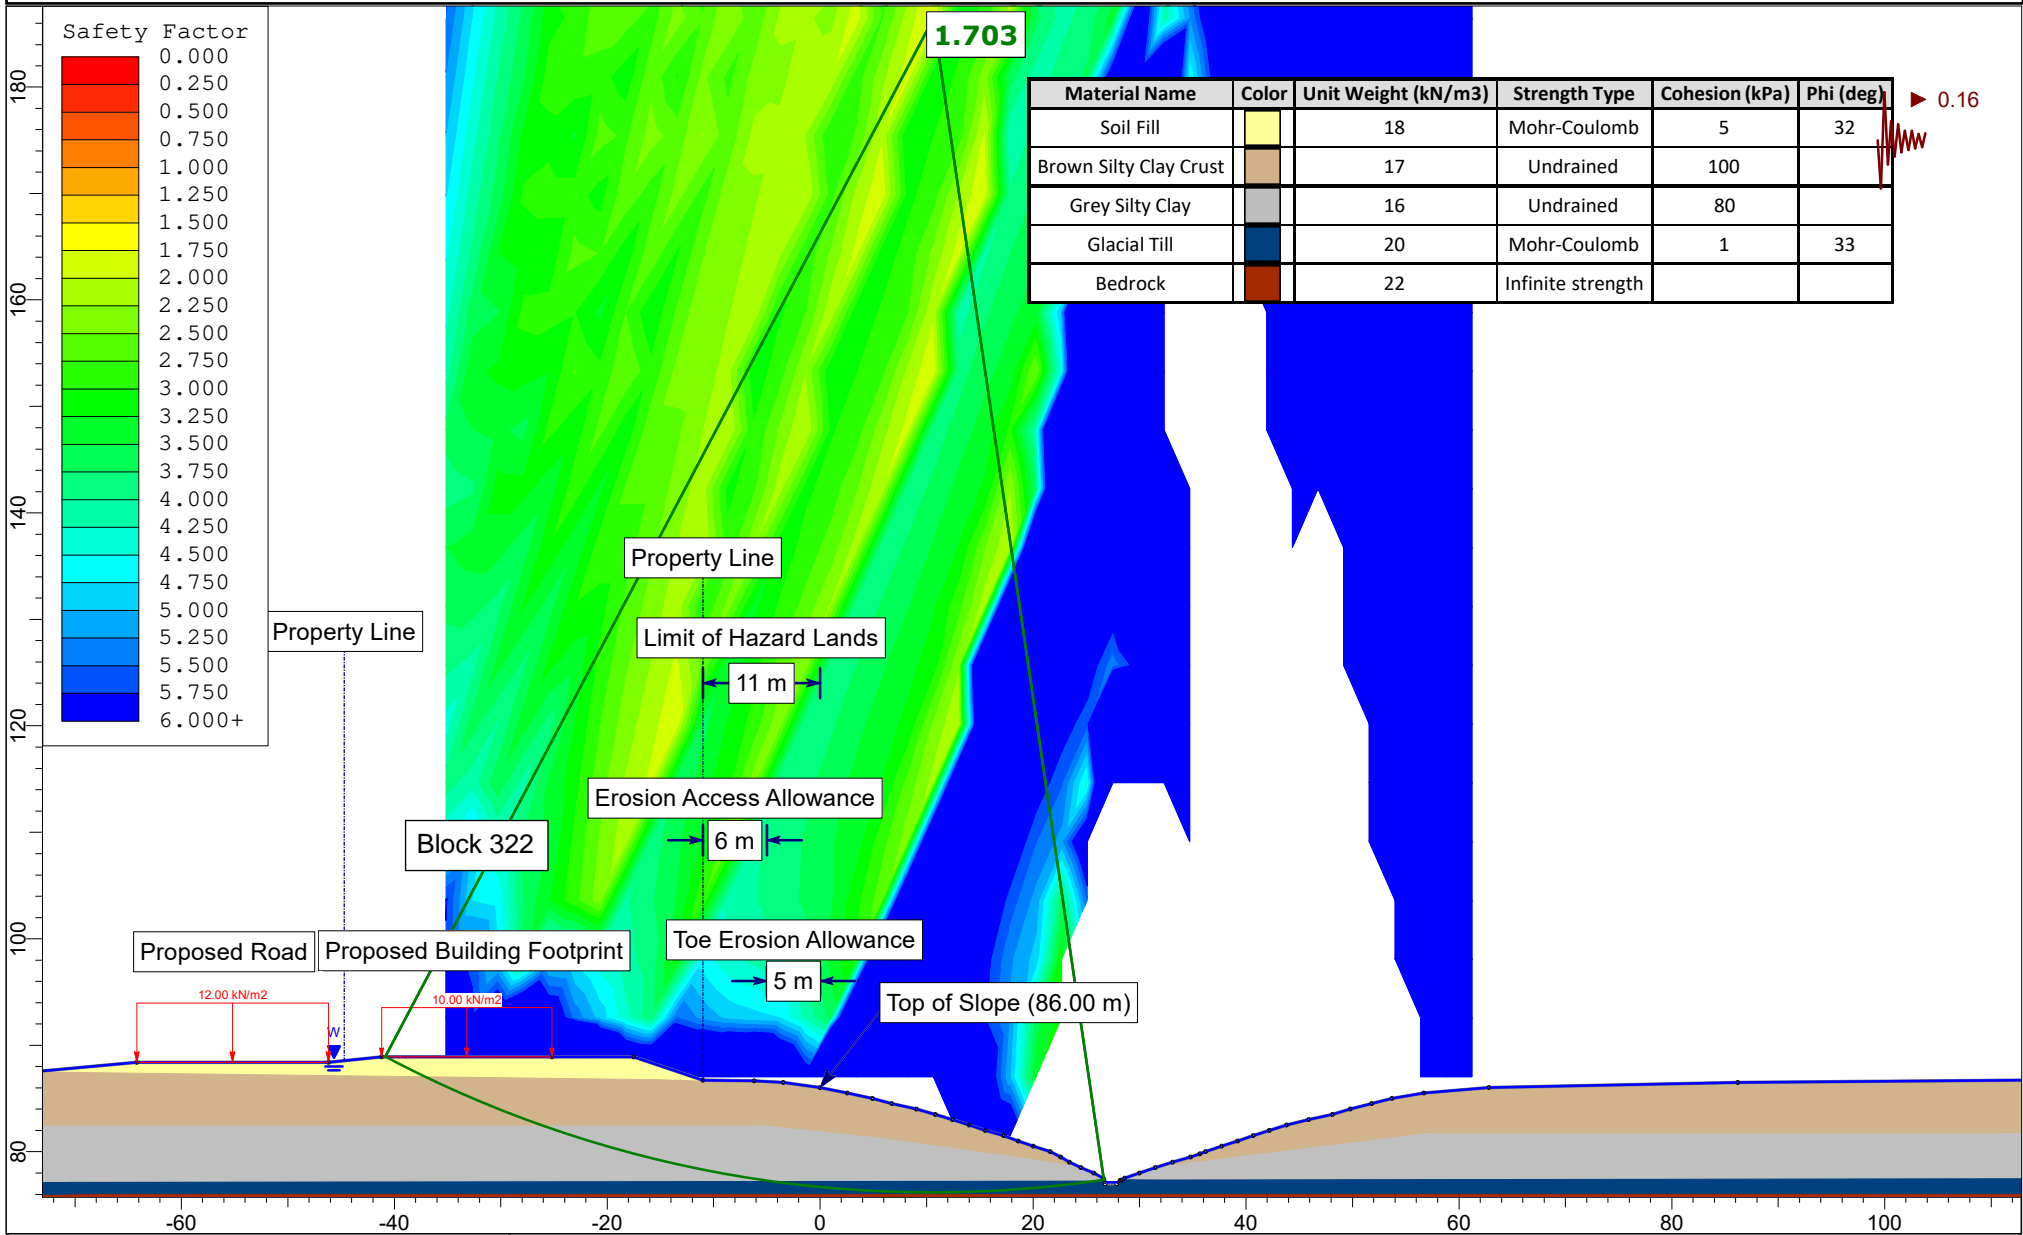
Figure 7D - Section G - Proposed Seismic Conditions

Project PG5201 - Proposed Residential Development - Cardinal Creek Village South Old Montreal Road, Ottawa, Ontario	
	Cross Section G	Scenario Seismic - Proposed Condition
	Drawn By EA	Company Tamarack Homes
	Date 8/18/2023	File Name Geotechnical Investigation

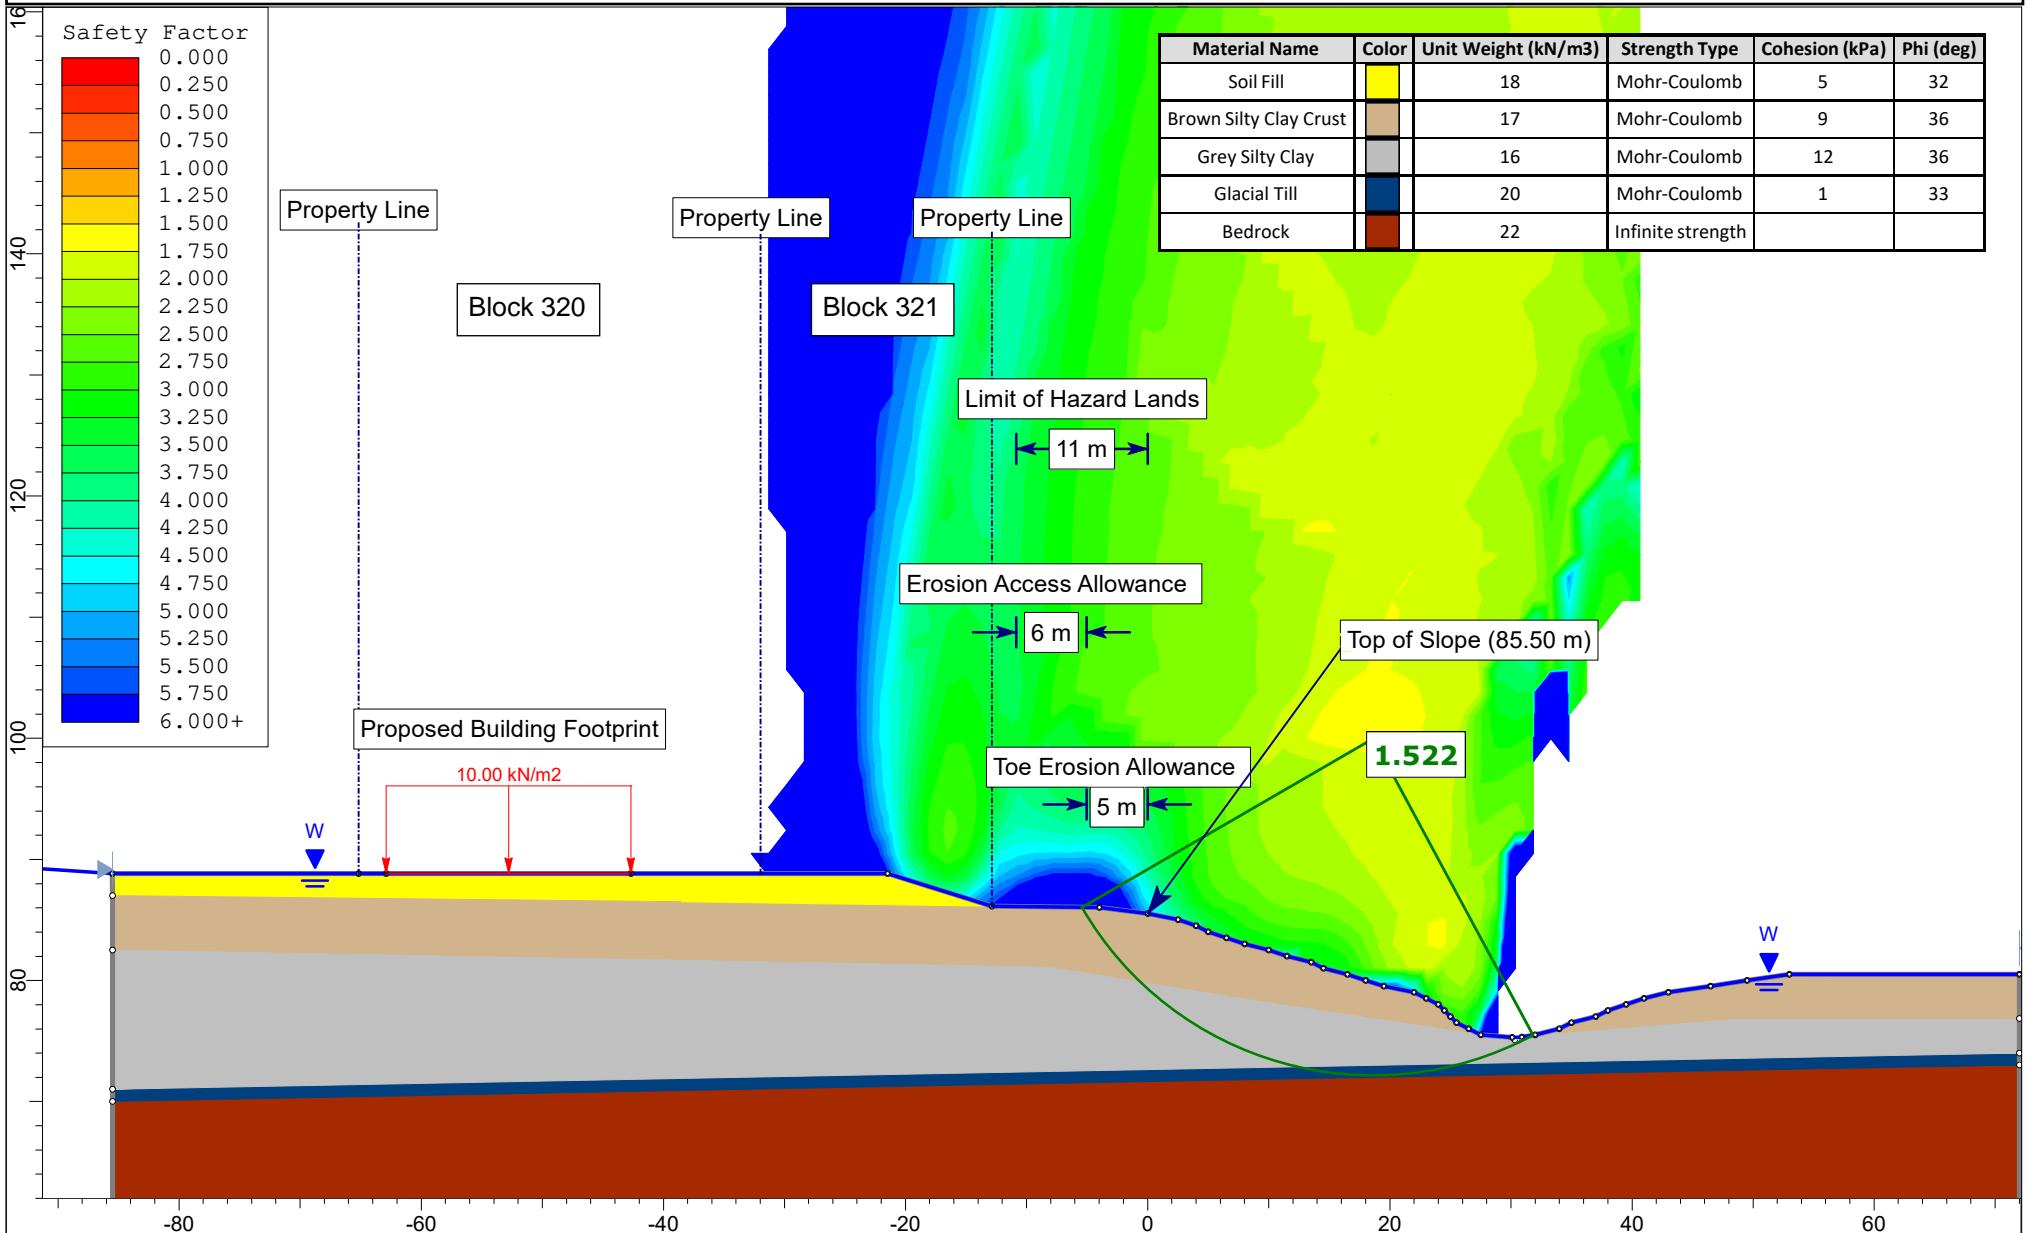
Figure 29C - Section CC - Proposed Static Conditions

Project PG5201 - Proposed Residential Development - Cardinal Creek Village South Old Montreal Road, Ottawa, Ontario	
	Cross Section CC	Scenario Static - Proposed Condition
	Drawn By EA	Company Tamarack Homes
	Date 8/15/2023	File Name Geotechnical Investigation

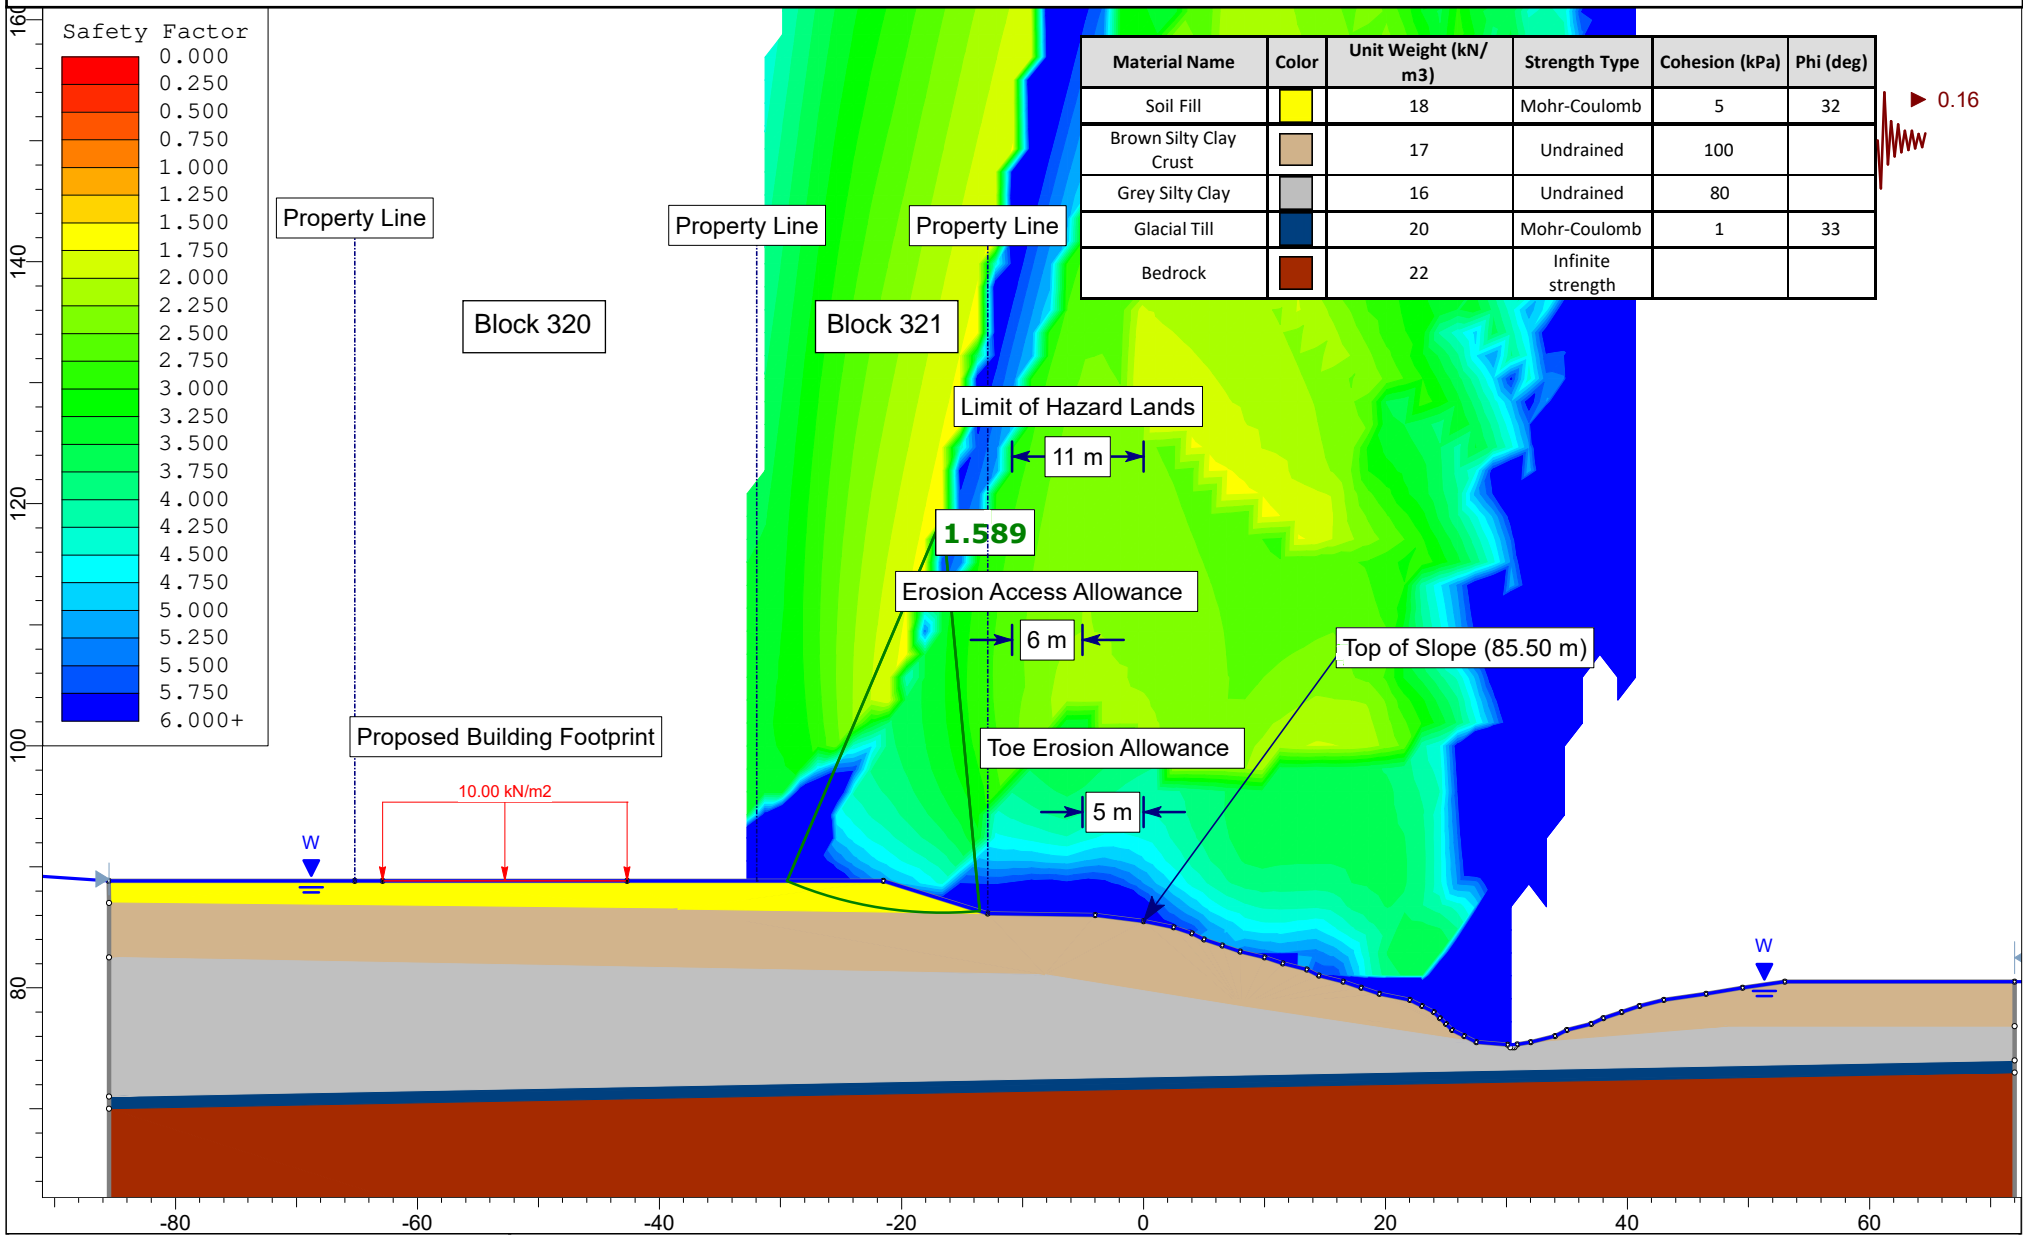
Figure 29D - Section CC - Proposed Seismic Conditions

<i>Project</i> PG5201 - Proposed Residential Development - Cardinal Creek Village South Old Montreal Road, Ottawa, Ontario	
	<i>Cross Section</i> CC	<i>Scenario</i> Seismic - Proposed Condition
	<i>Drawn By</i> EA	<i>Company</i> Tamarack Homes
	<i>Date</i> 8/15/2023	<i>File Name</i> Geotechnical Investigation

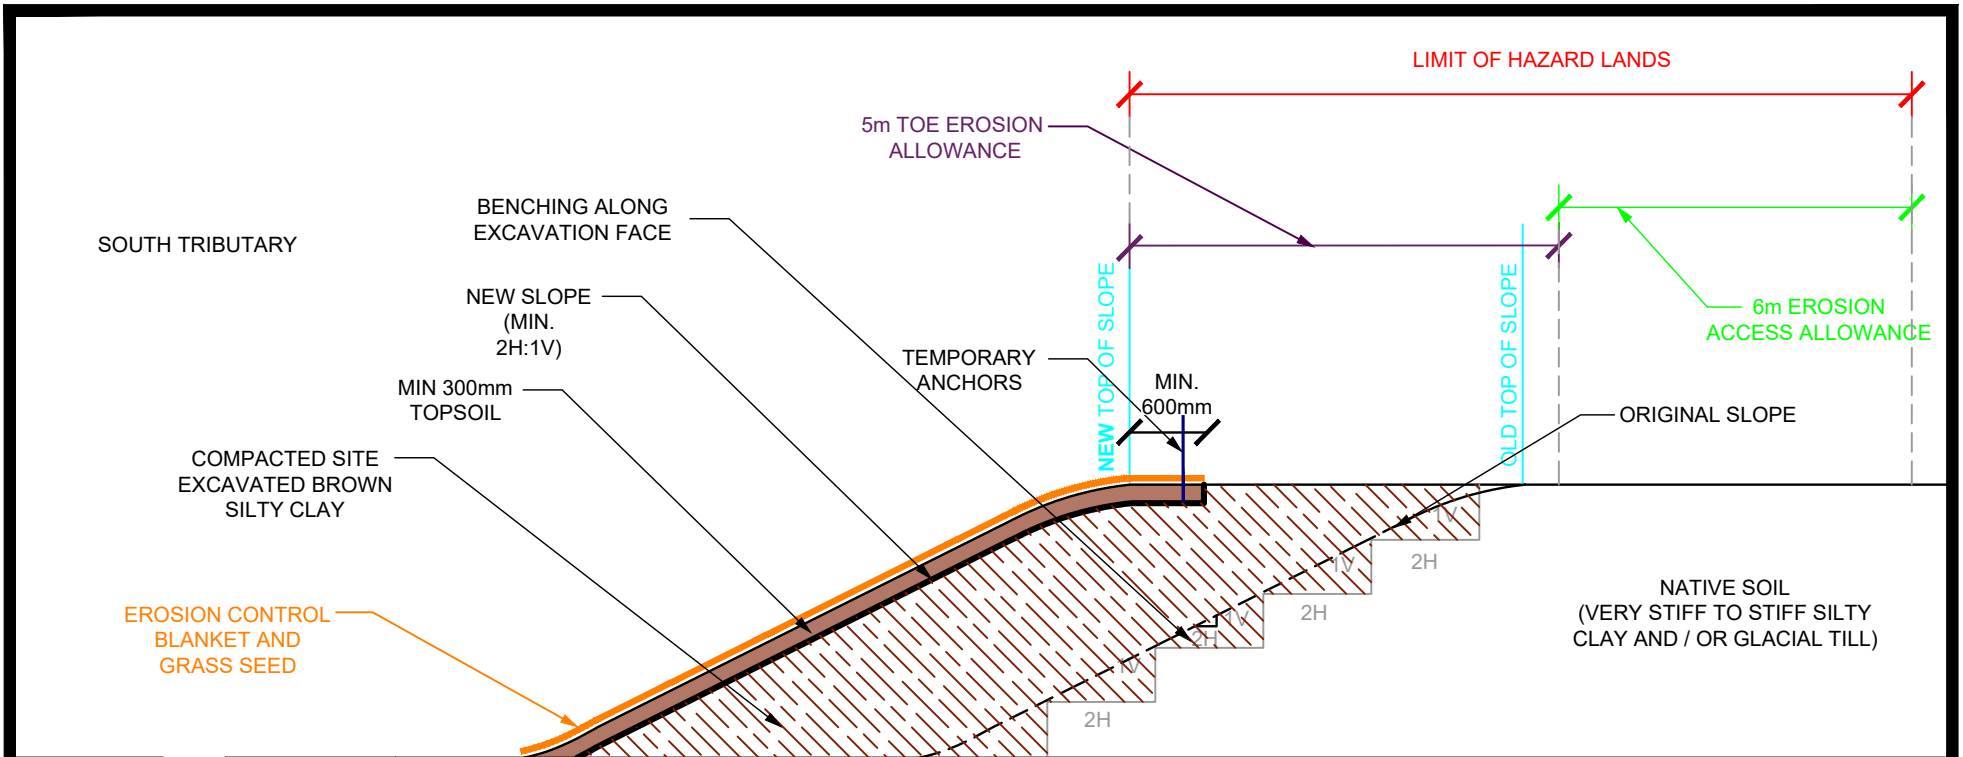
- SITE EXCAVATED MATERIAL SUCH AS WORKABLE, BROWN SILTY SAND OR ANY APPROVED SITE EXCAVATED MATERIAL, FREE OF DELETERIOUS FILL SUCH AS ORGANICS OR CONSTRUCTION DEBRIS, CAN BE USED AS BACKFILL MATERIAL TO IN-FILL CURRENT SLOPE AND EXTEND THE SLOPE FACE TO MATCH THE EXISTING ADJACENT SLOPES.

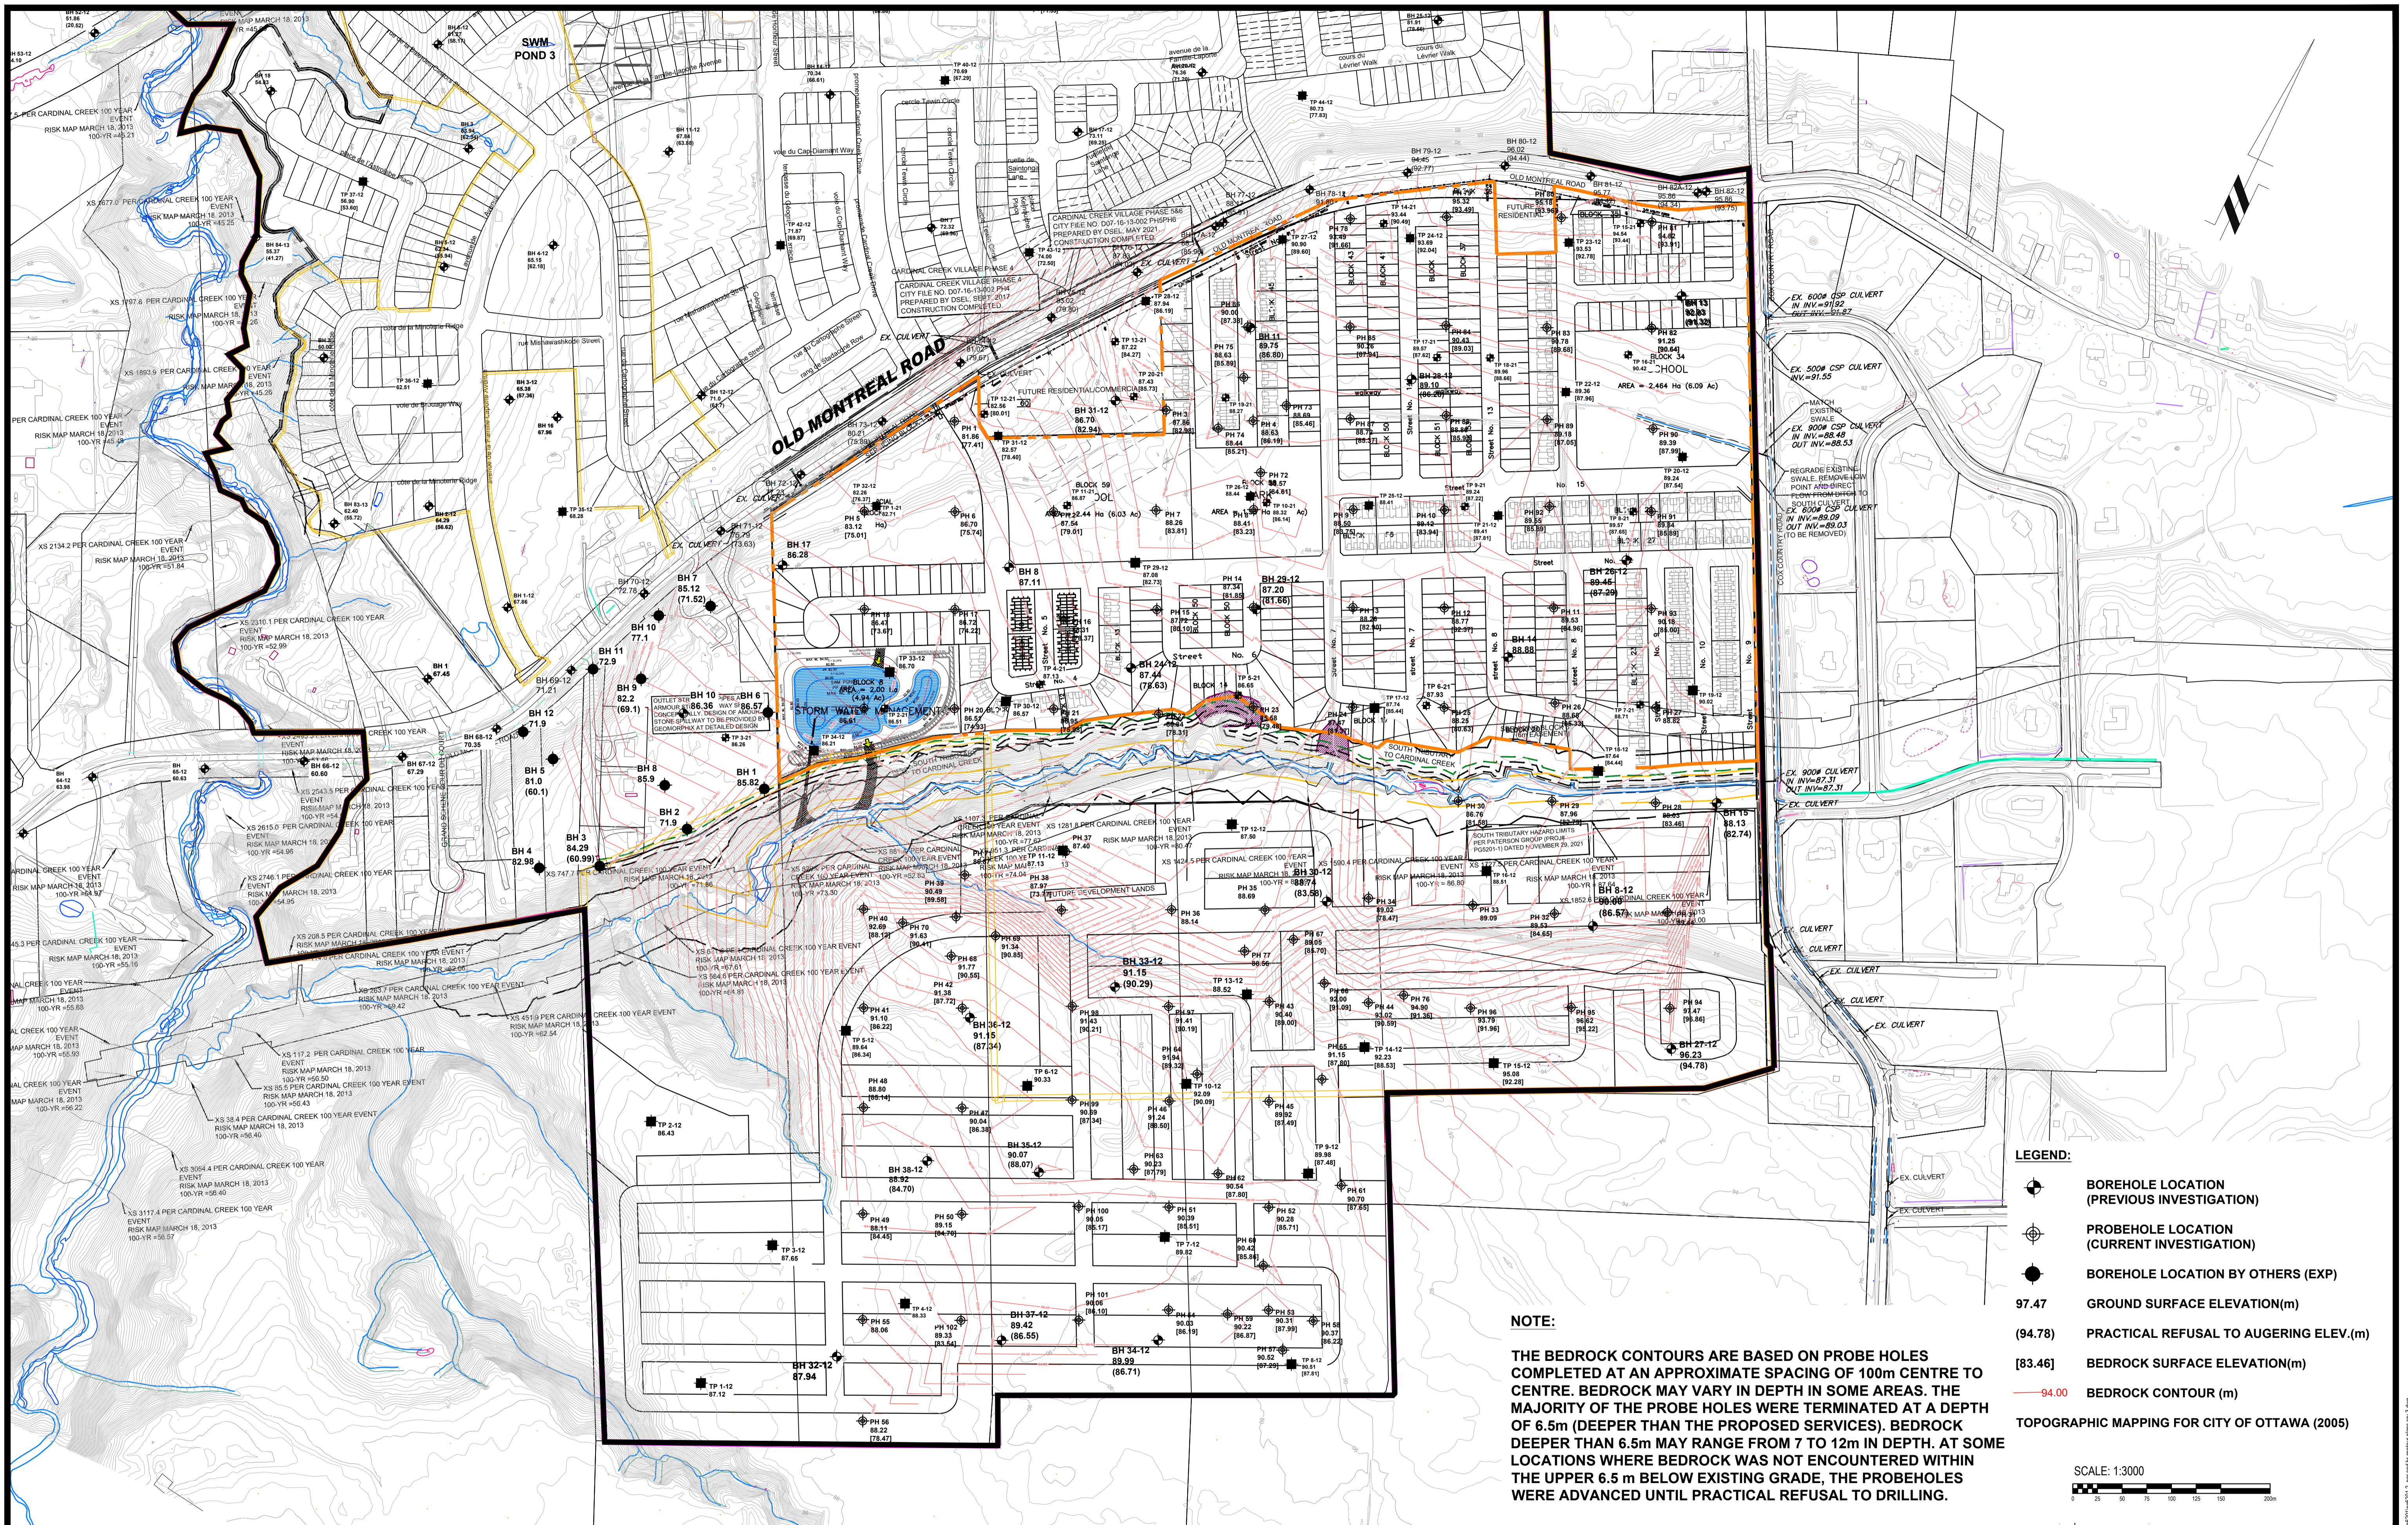
Stamp: _____	Scale: 1:3000	Report No.: PG5201-1
Drawn by: RCG	Checked by: FA	Drawing No.: _____
Approved by: FA	Date: 03/2020	PG5201-1
		Revision No.: 3
