Geotechnical Investigation

Proposed Residential Development
Cardinal Creek Village South
Old Montreal Road
Ottawa, Ontario

Report: PG5201-1
Revision 5

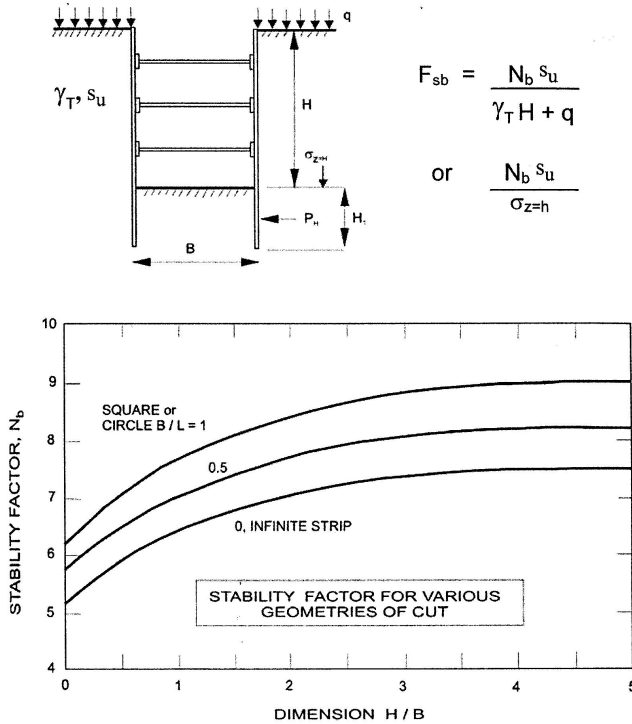
Figure 1 - Stability Factor for Various Geometries of Cut

The base of supported excavations can fail by three (3) general modes:

- Shear failure within the ground caused by inadequate resistance to loads imposed by grade difference inside and outside of the excavation,
- Piping from water seepage through granular soils, and
- Heave of layered soils due to water pressures confined by intervening low permeability soils.

Shear failure of excavation bases is typically rare in granular soils if adequate lateral support is provided. Inadequate dewatering can cause instability in excavations made through granular or layered soils. The potential for base heave in cohesive soils should be determined for stability of flexible retaining systems.

s_u - undrained shear strength of the soil below the base level

σ_z - total overburden and surcharge pressures at the bottom of the excavation

In the case of soft to firm clays, a factor of safety of 2 is recommended for base stability.

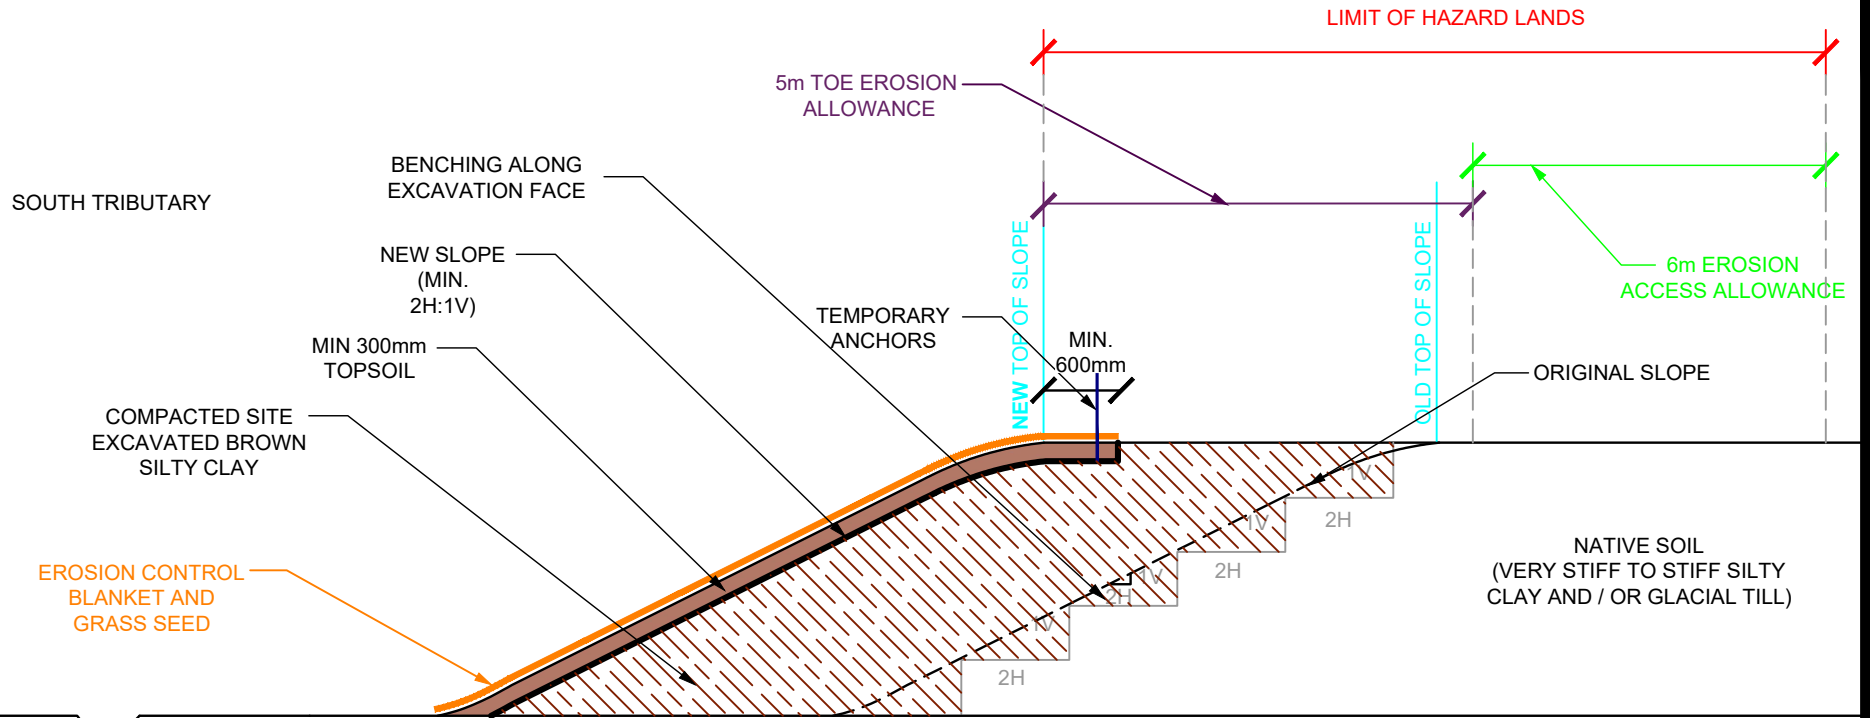
Drawing No.: **FIG. 42**

NOTES:

- SITE EXCAVATED MATERIAL SUCH AS WORKABLE, BROWN SILTY SAND OR ANY APPROVED SITE EXCAVATED MATERIAL, FREE OF DELETERIOUS FILL SUCH AS ORGANICS OR CONSTRUCTION DEBRIS, CAN BE USED AS BACKFILL MATERIAL TO IN-FILL CURRENT SLOPE AND EXTEND THE SLOPE FACE TO MATCH THE EXISTING ADJACENT SLOPES.

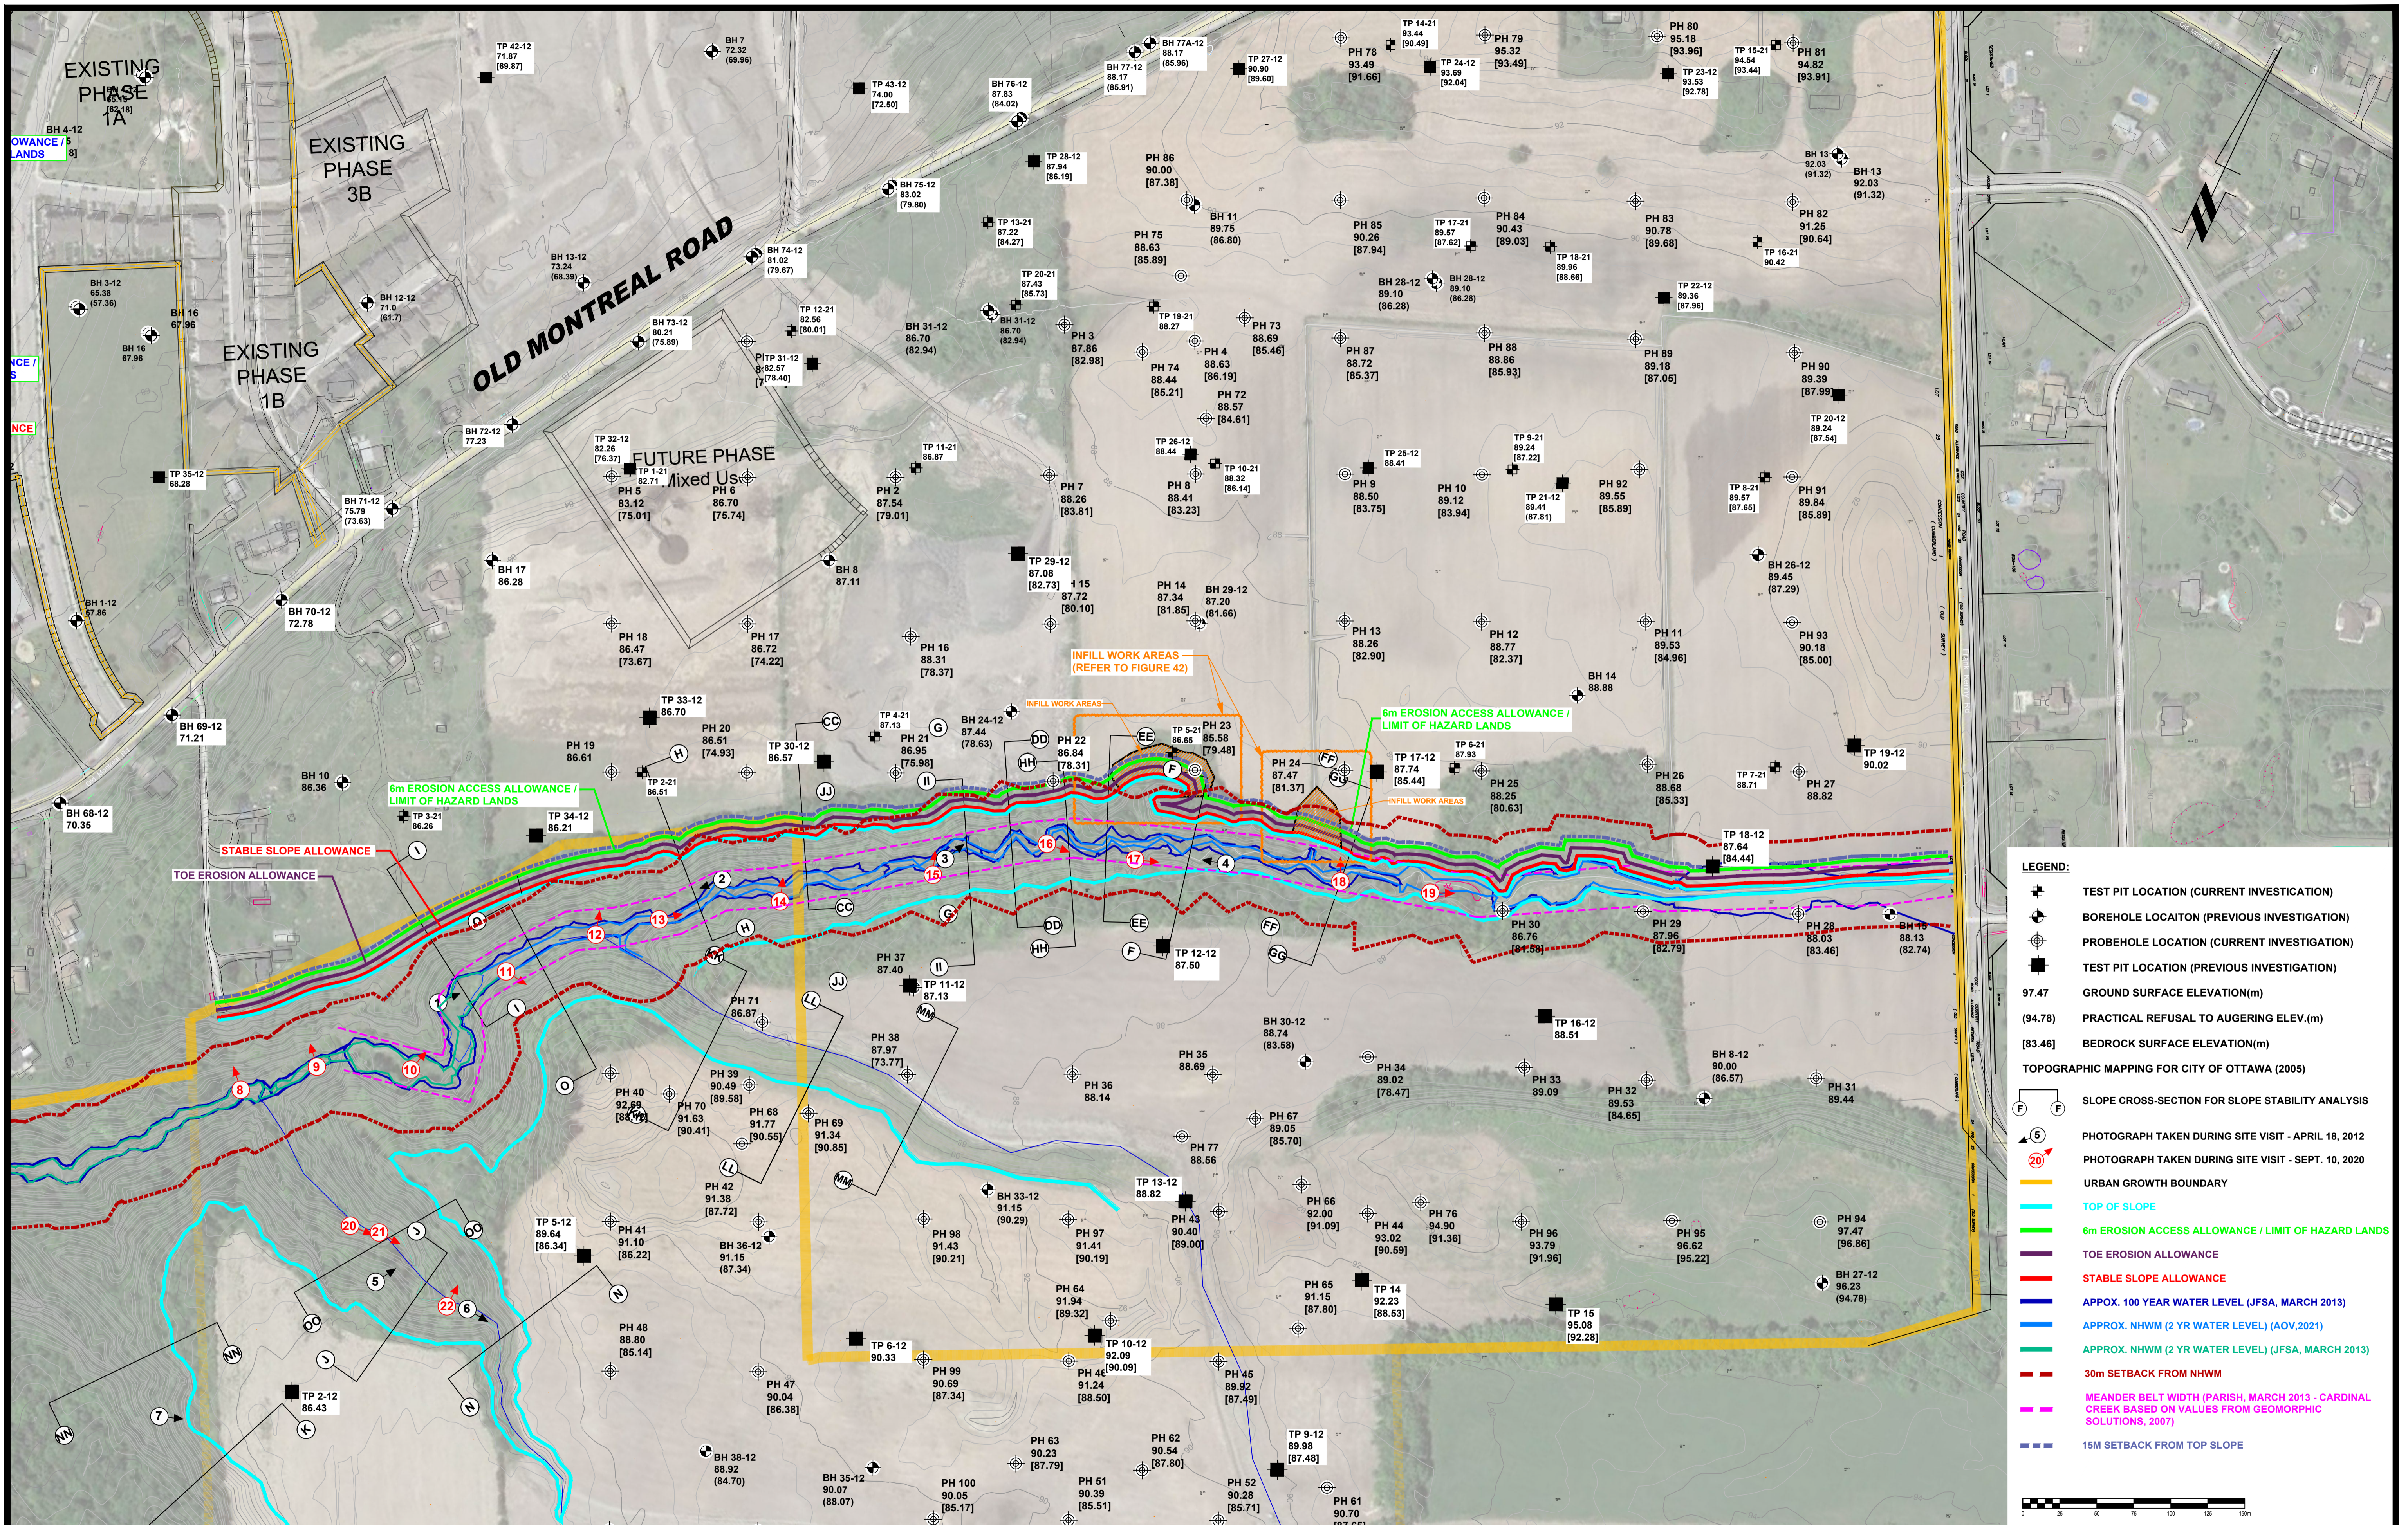
DRAWING PG5201-2 - TEST HOLE LOCATION PLAN

- LEGEND:**
- ⊕ TEST PIT LOCATION (CURRENT INVESTIGATION)
 - ⊕ BOREHOLE LOCATION (PREVIOUS INVESTIGATION)
 - ⊕ PROBEHOLE LOCATION (CURRENT INVESTIGATION)
 - ⊕ TEST PIT LOCATION (PREVIOUS INVESTIGATION)

- 97.47 GROUND SURFACE ELEVATION(m)
 - (94.78) PRACTICAL REFUSAL TO AUGERING ELEV.(m)
 - [83.46] BEDROCK SURFACE ELEVATION(m)
 - TOPOGRAPHIC MAPPING FOR CITY OF OTTAWA (2005)

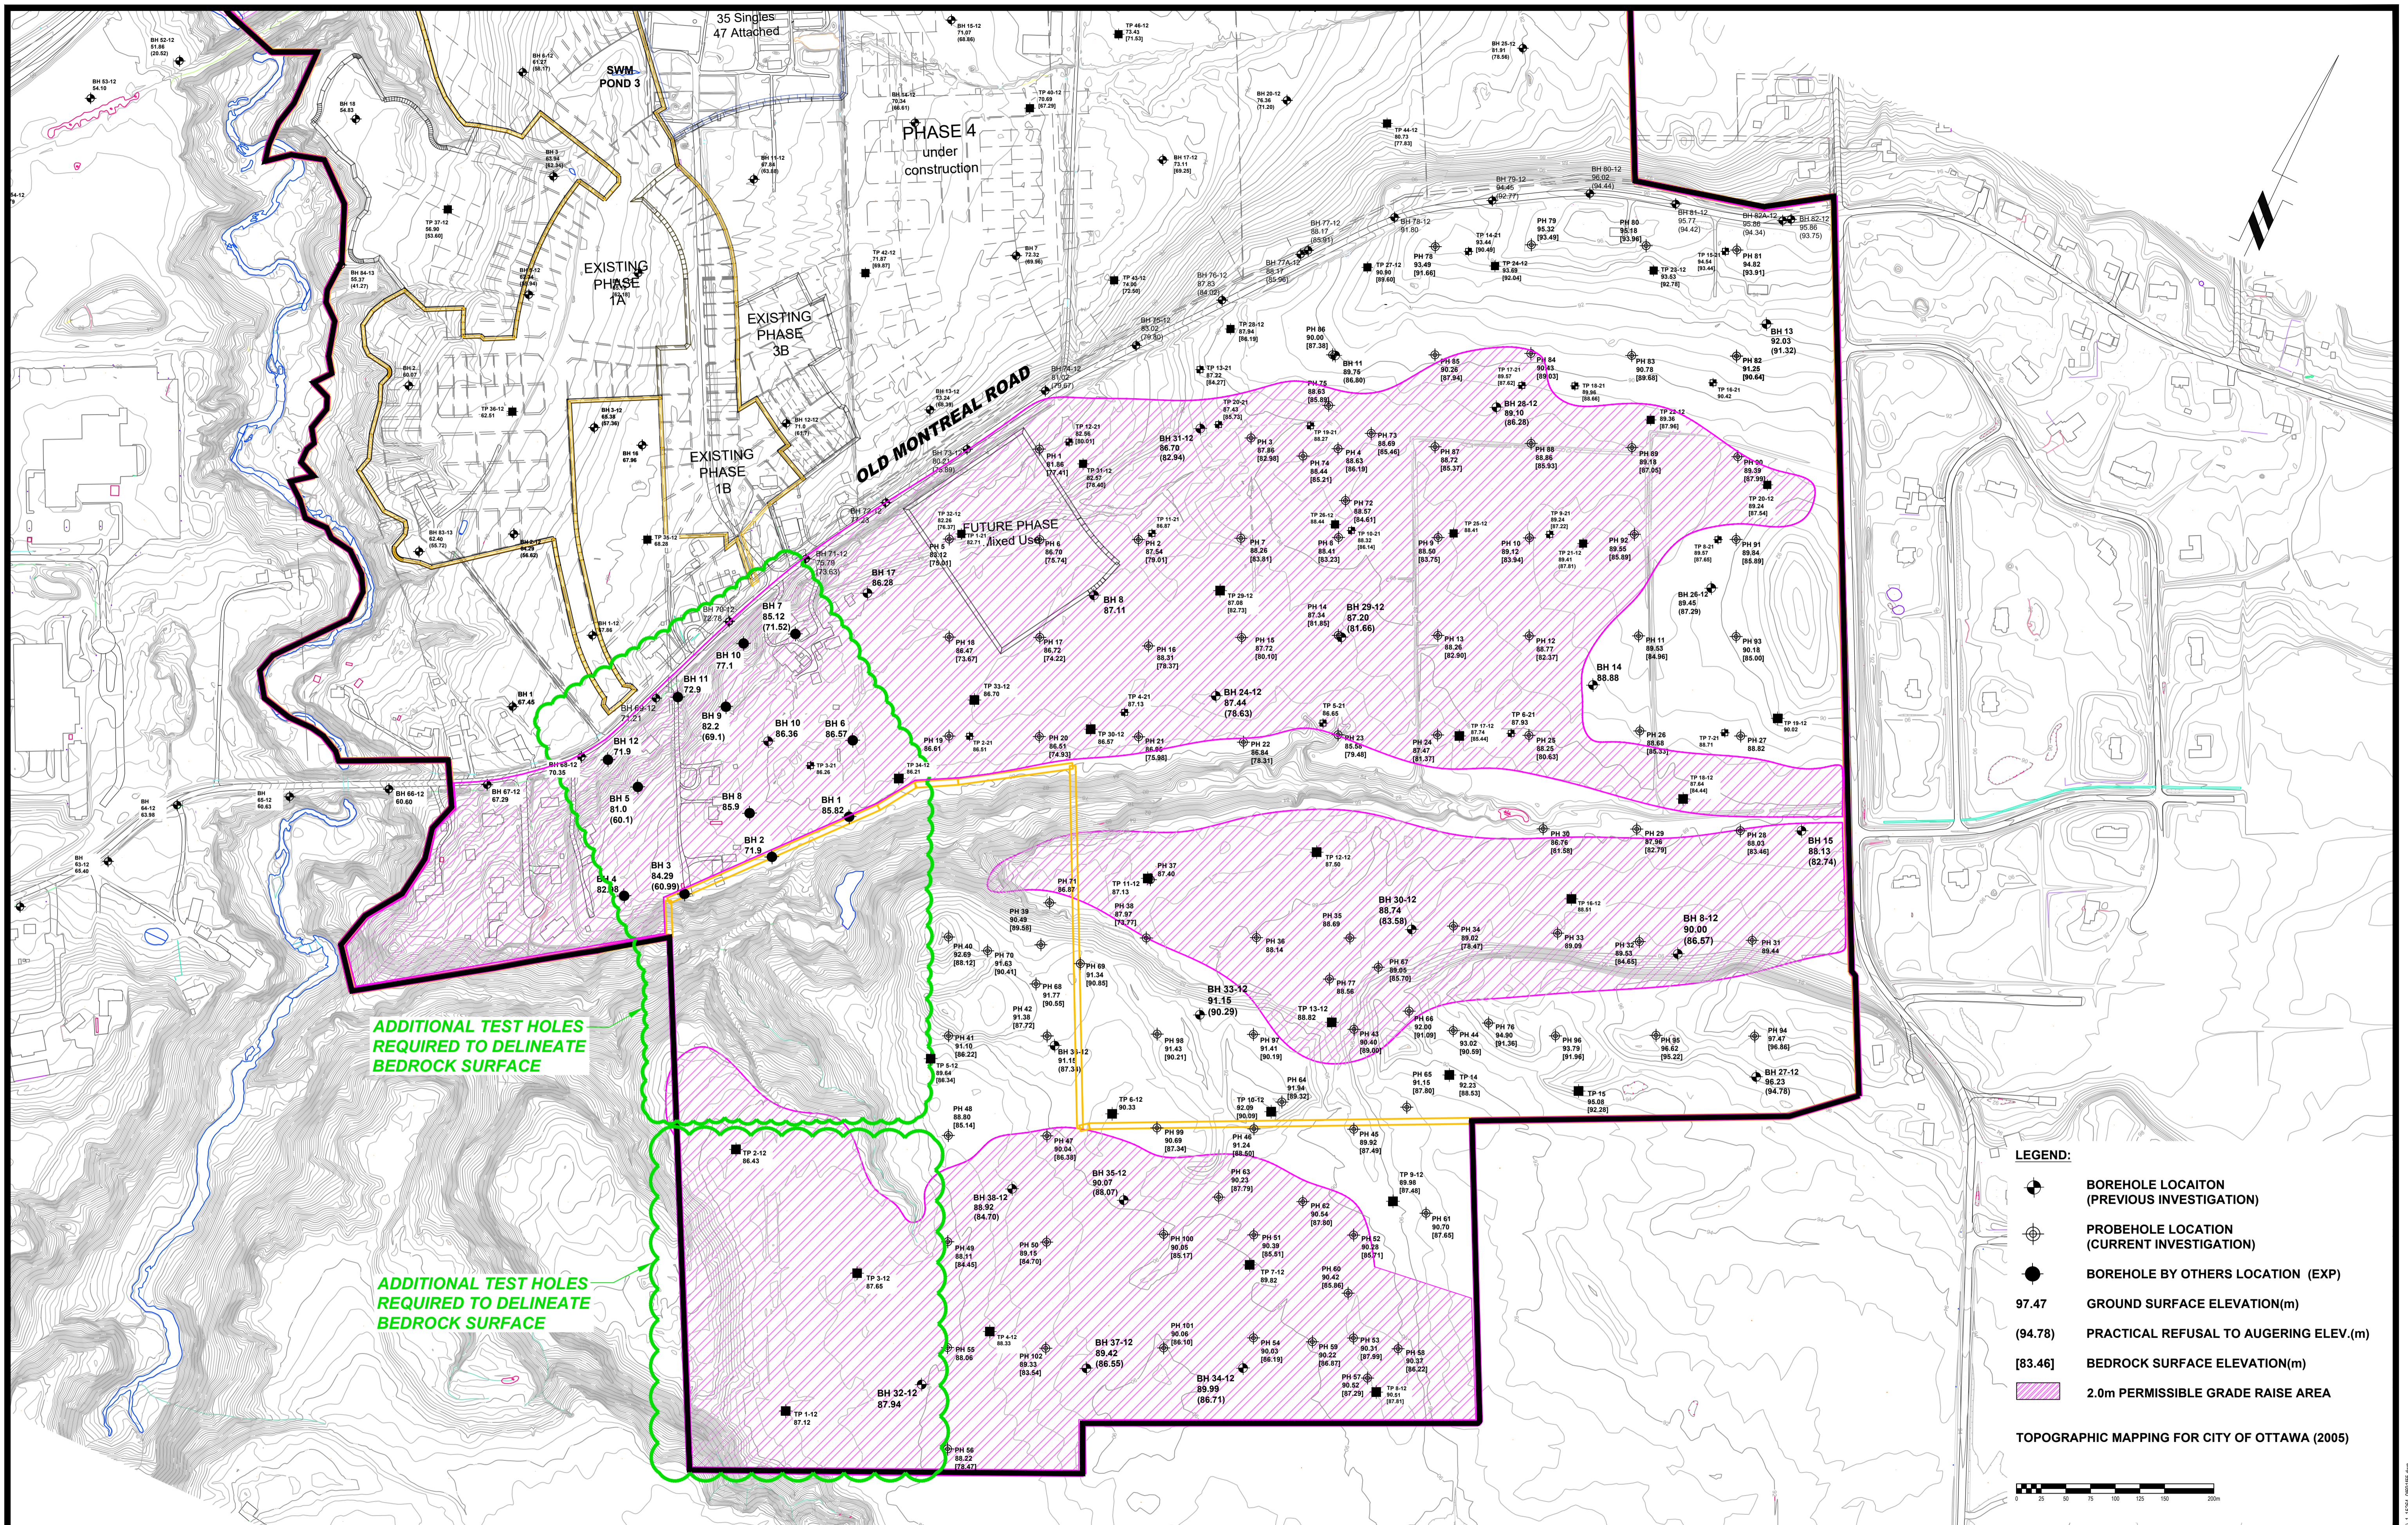
DRAWING PG5201 - 3 - PERMISSIBLE GRADE RAISE RESTRICTION AREAS

Based on our soil information for the subject site, a 2 m permissible grade raise restriction is recommended for areas where the silty clay deposit is located below design footing level. The permissible grade areas are shown on Drawing PG5201-3 - Permissible Grade Raise Restriction Area, in Appendix 2.
