**ENVIRONMENTAL IMPACT STATEMENT  
and  
TREE CONSERVATION REPORT**

**PROPOSED RESIDENTIAL DEVELOPMENT  
CARDINAL CREEK VILLAGE PHASE  
OLD MONTREAL ROAD to SOUTH TRIBUTARY  
CITY of OTTAWA**

**Tamarack Homes**

**by *Muncaster Environmental Planning Inc.***

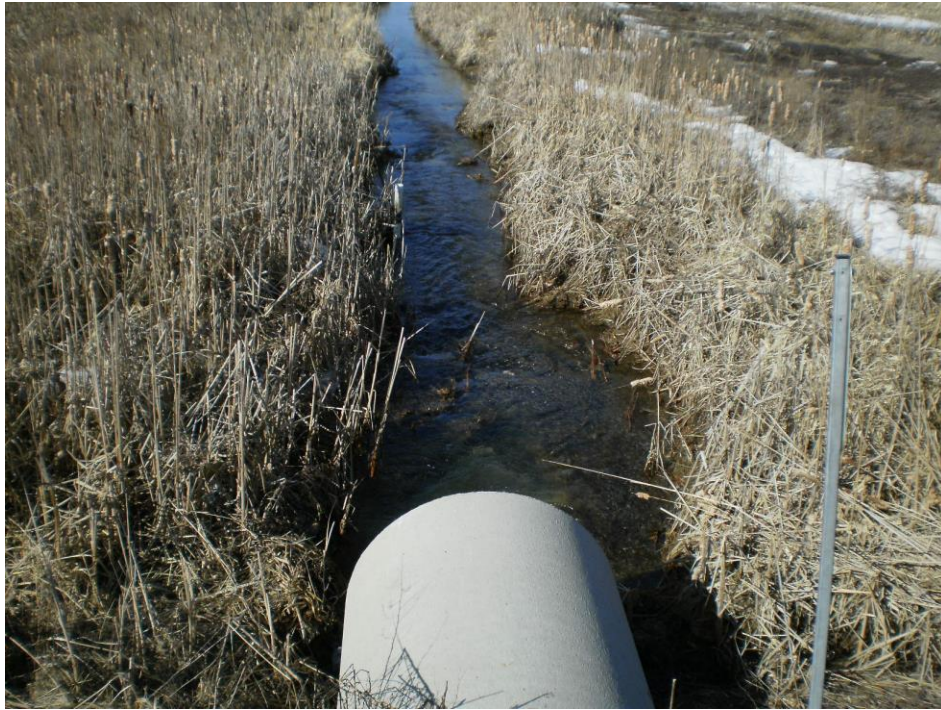
*Photo 1 - South tributary looking west from culvert under Cox Country Road  
(March 17<sup>th</sup>, 2020)*

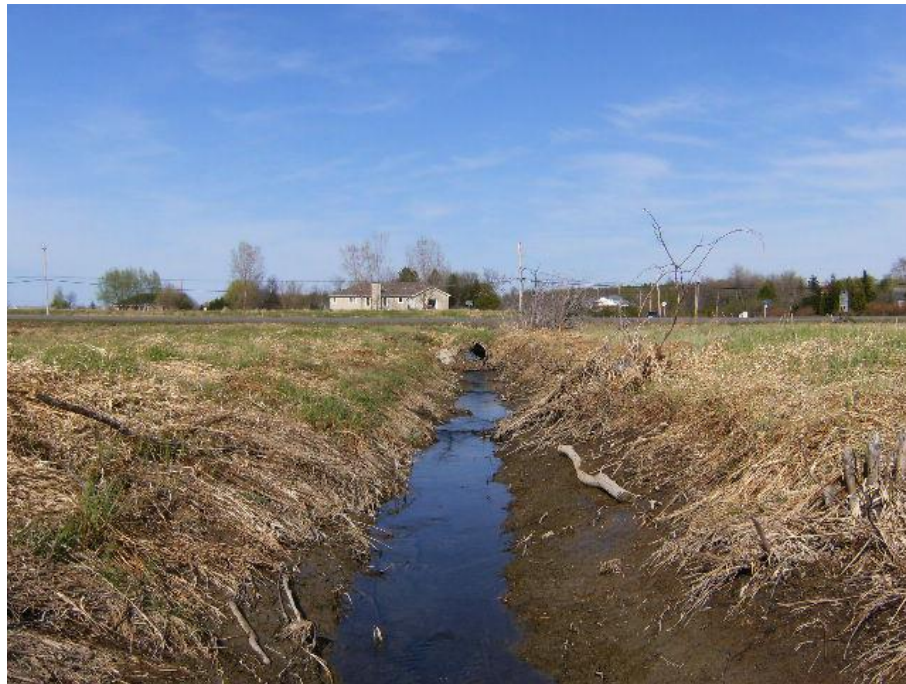
*Photo 2 – The South Tributary looking upstream, east, to Cox Country Road (May 4<sup>th</sup>, 2009)*

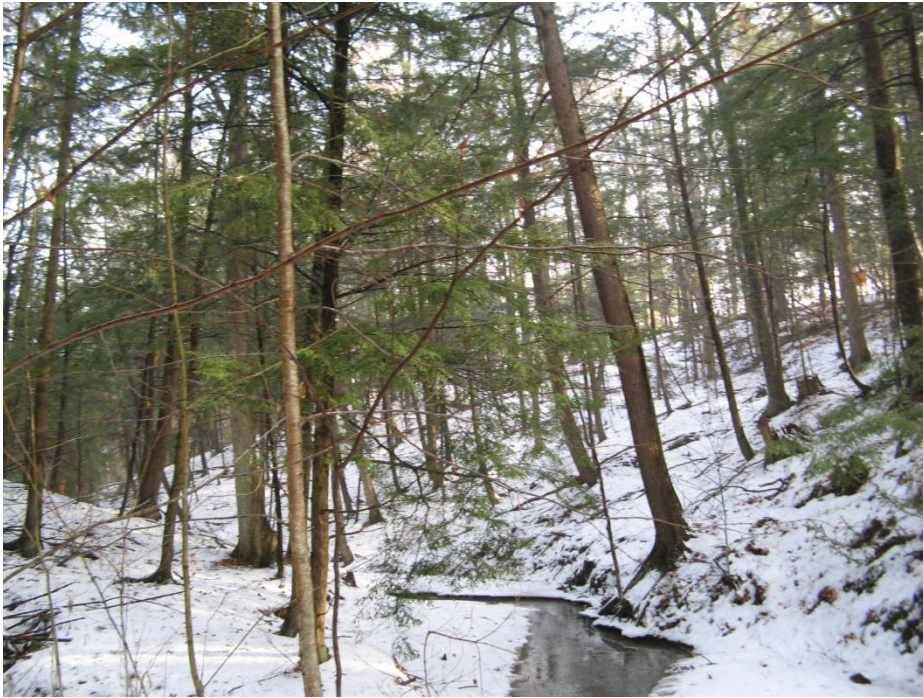
*Photo 3 – South tributary within the deciduous forest south of the lands proposed for development. View looking east (December 16<sup>th</sup>, 2020)*

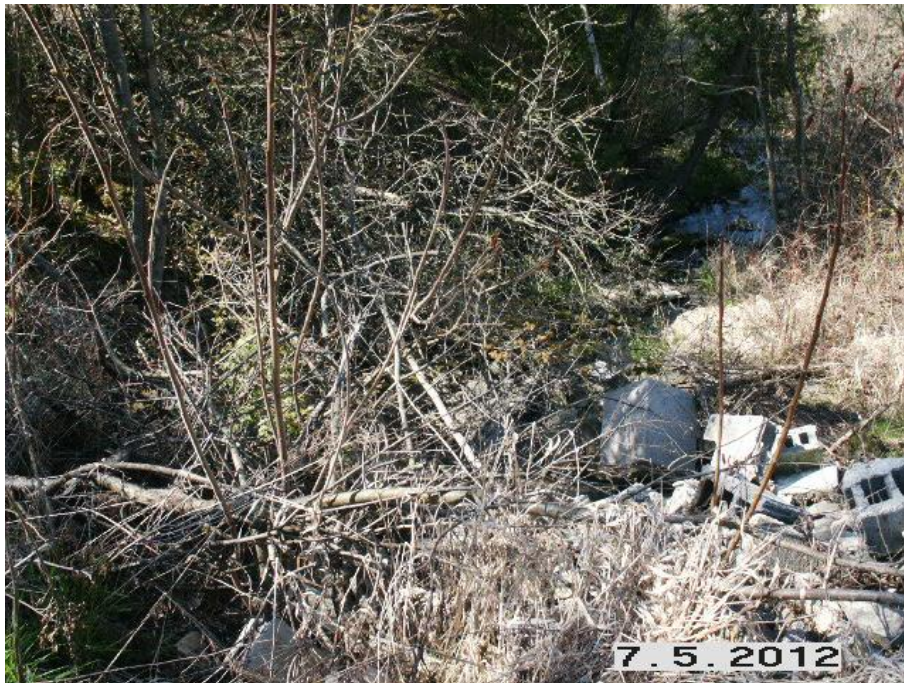
To the west of the site, culverts in poor condition and debris associated with an access lane create a barrier to fish movement between Cardinal Creek and the site (Photo 4). Also in this area PECG (2013) noted that the gradient of the South Tributary flattened out and much of the stream flow was interpreted to be lost to subsurface flow in thick sediments in this area, with an associated loss of defined channel.

*Photo 4 – Culverts and other debris impact the connectivity of the south tributary downstream (west) of the site. View looking west*

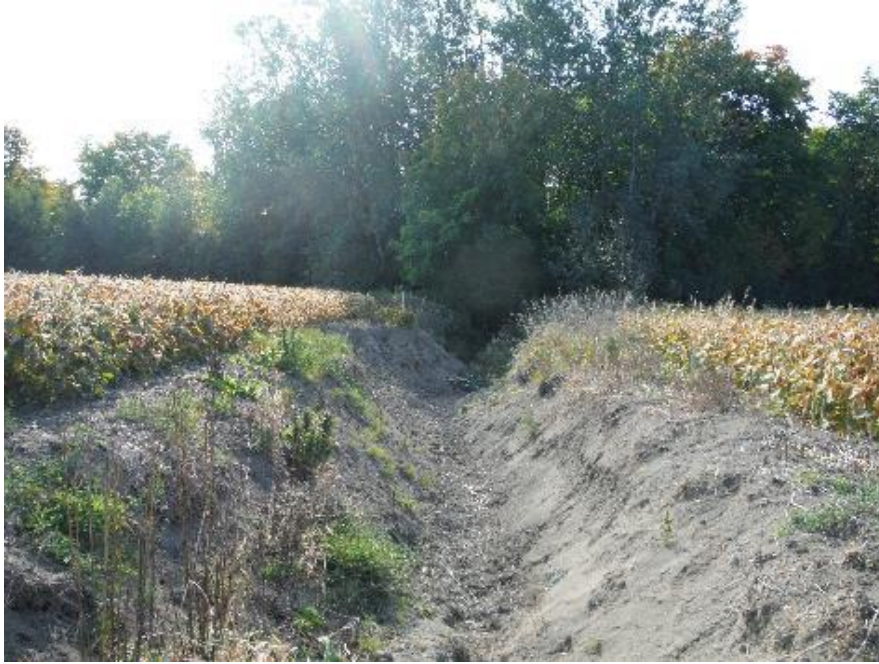
*Photo 5 - North Channel, approaching the forested corridor along the South Tributary.  
View looking south (September 21, 2020)*

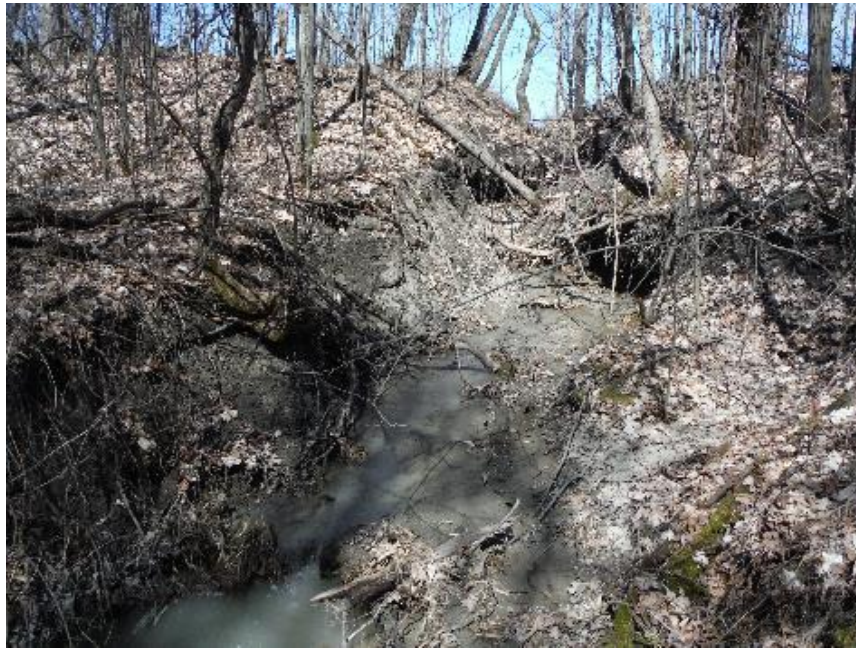
*Photo 6 - Downstream portion of the North Channel showing the physical barrier within the  
South Tributary corridor. View looking north (April 6, 2020)*

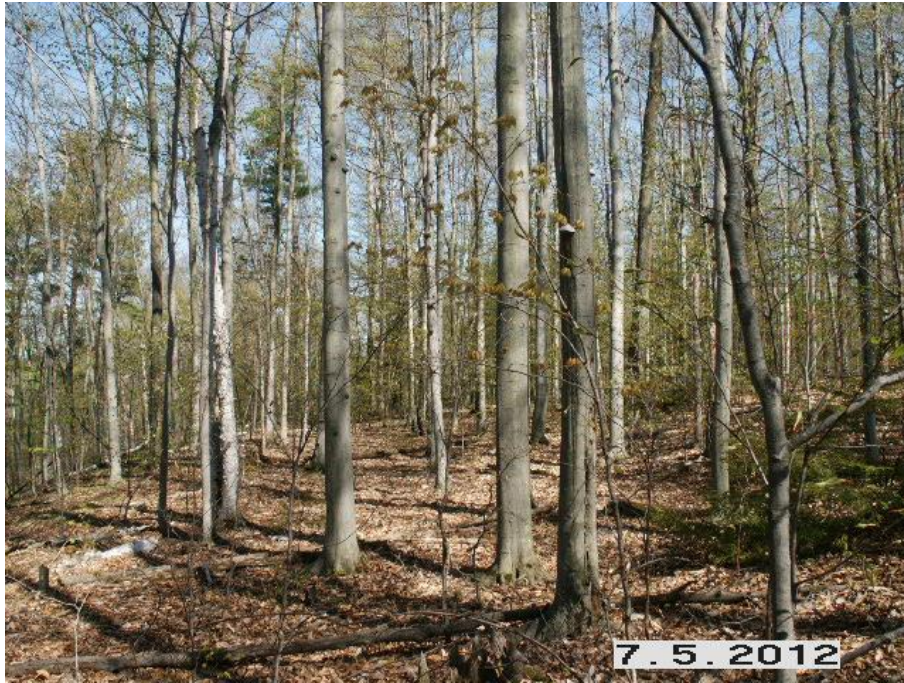
Sugar maple, bur oak, white ash, American beech, eastern hemlock, basswood, white cedar, large-toothed aspen, and red maple are common in the forests along the slopes of the South Tributary corridor, to the south of the proposed development area, with white birch, white spruce, black cherry, white ash, green ash and ironwood also present (Photos 7 and 8). Yellow birch is found near the base of the slopes in the vicinity of the South Tributary channel. There are several mature bur oak, sugar maple, American beech, and eastern hemlock trees. In the west portion of the site, the deciduous forest extends onto the tablelands for approximately 15 meters. Smaller trees are along the outer edge of the tableland portion as described below, with the maximum size generally in the 30cm – 40cm dbh range.

*Photo 7 – South side of deciduous forest along south tributary corridor*

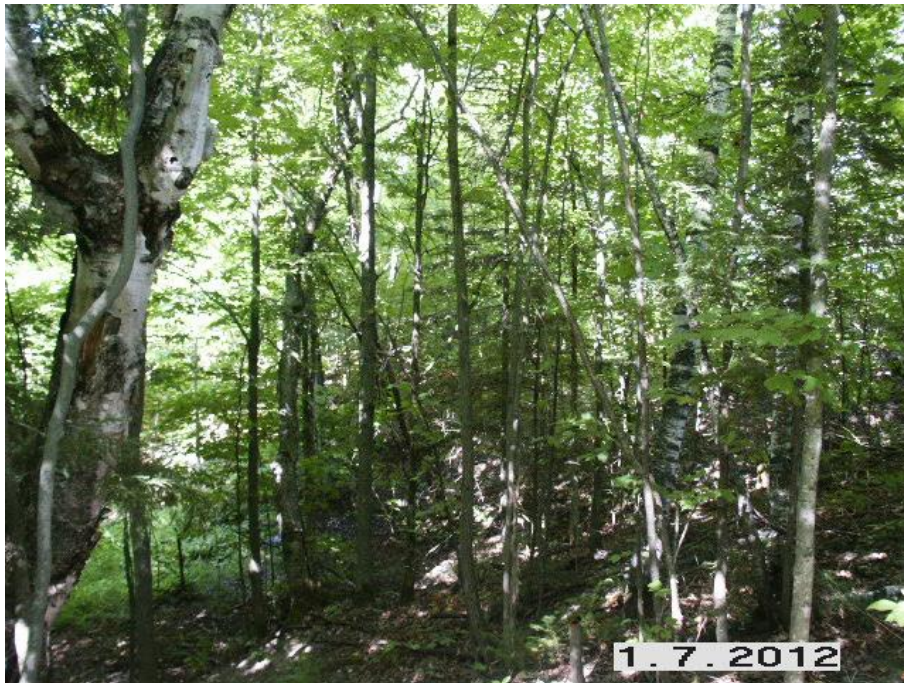
The forest conditions along the north edge of the maple forest, closest to the proposed site disturbances, are generally dominated by trembling aspen, white ash, green ash, white elm, and bur oak, with the largest of the trees white ash up to 40cm dbh (Photo 9). Common buckthorn and tartarian honeysuckle shrubs are common along the outer forest edges. The maple trees become dominant beginning in the range of ten metres into the forest cover.

*Photo 8 – Deciduous forest on the north slope of south tributary corridor*

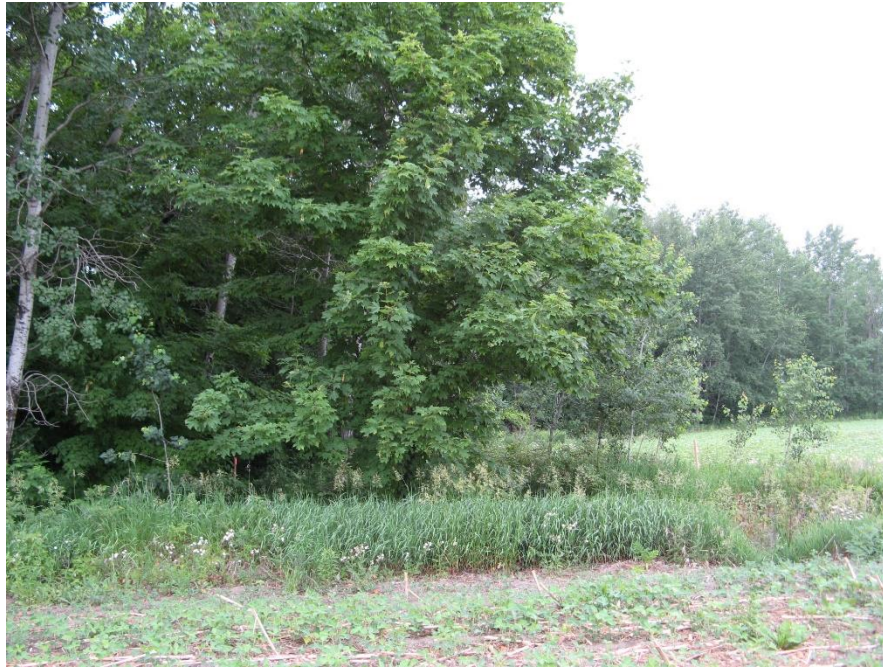
*Photo 9 – Trees along the north edge of the South Tributary forest are smaller. View looking west (June 28<sup>th</sup>, 2020)*

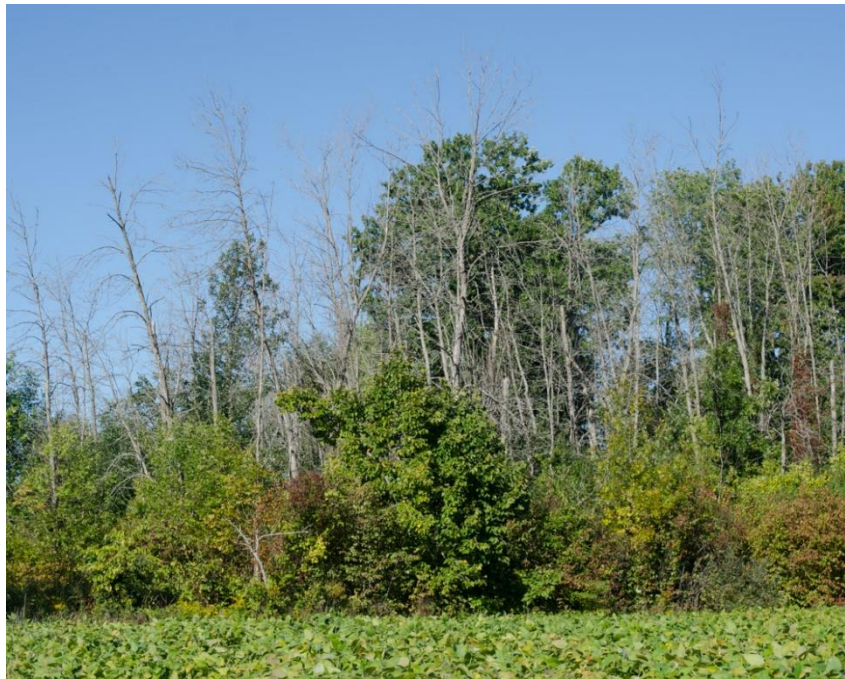
In 2012 an upland ash forest north of the South Tributary in the southeast portion of the site was included in the Natural Heritage System for the Cardinal Creek Area, as well as the Subwatershed Study (AECOM, 2014). Surveys in 2020 and 2021 indicate that the condition of the ash trees have declined dramatically since these observations, with impacts of emerald ash borer extensive (Photos 10, 11, 13, and 16). In addition to the dominant white ash in poor

*Photo 10 - Ash deciduous forest to the north of the South Tributary in the southeast portion of the site. View looking west to the east portion of the forest (September 12<sup>th</sup>, 2020)*

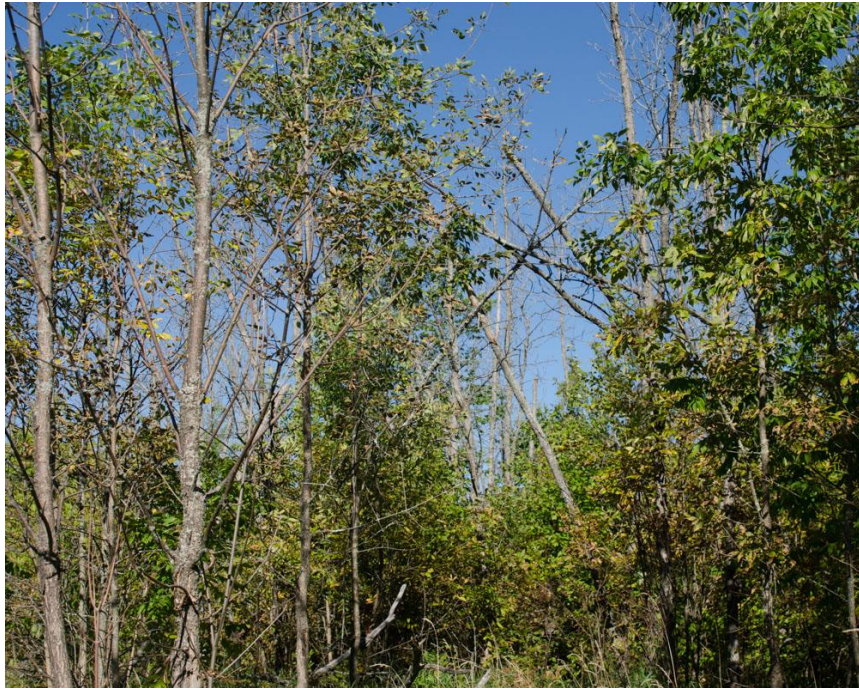
*Photo 11 – Tree condition along the west edge of the ash deciduous forest.  
View looking east (September 12<sup>th</sup>, 2020)*

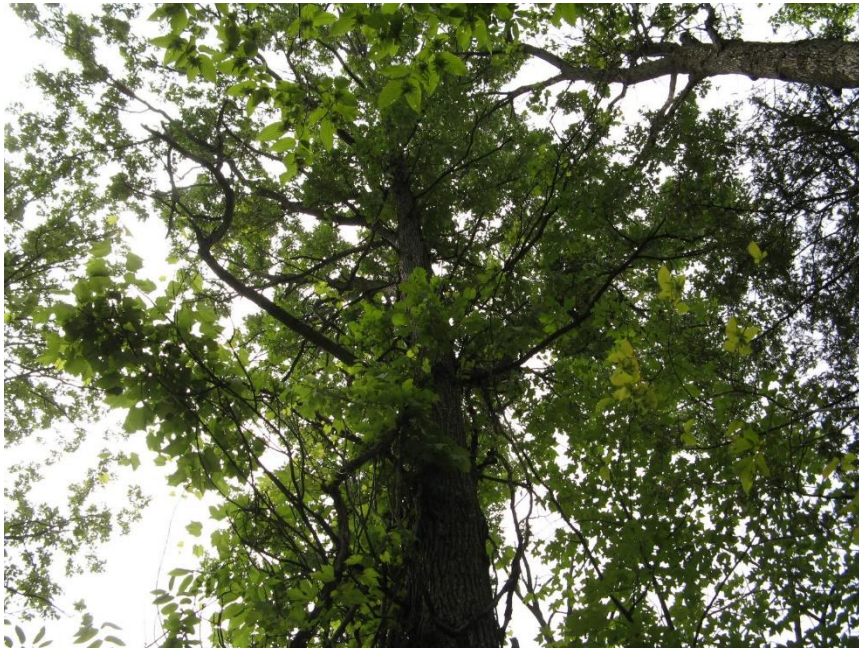
*Photo 12 - Bitternut hickory in apparently good condition in the central portion of the ash  
deciduous forest (June 22<sup>nd</sup>, 2021)*

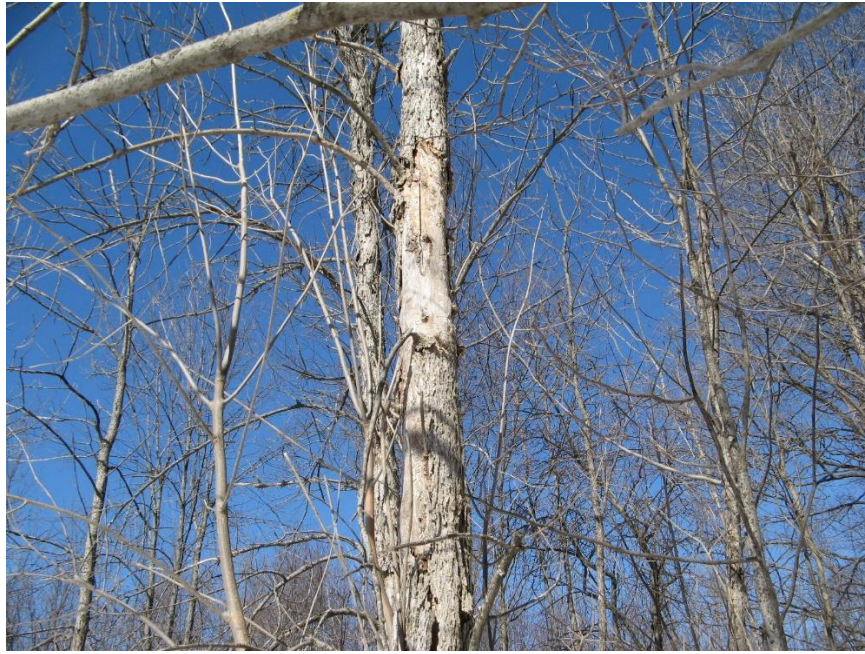
*Photo 13 - Impact of emerald ash borer is extensive in the ash deciduous forest (March 20<sup>th</sup>, 2021)*

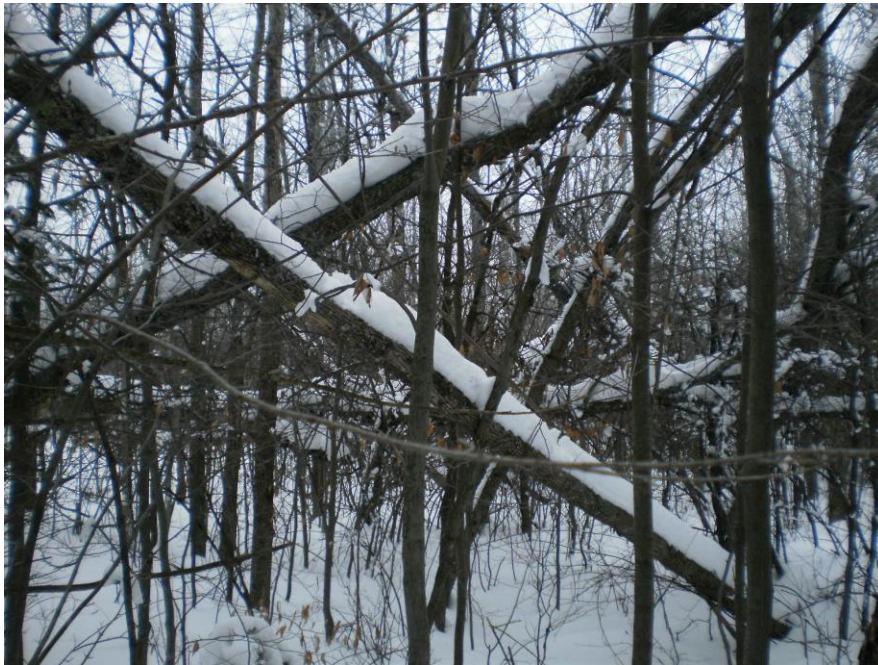
*Photo 14 - Windthrow is extensive in the ash deciduous forest. View looking south in the north-central portion of the ash deciduous forest (February 11<sup>th</sup>, 2020)*

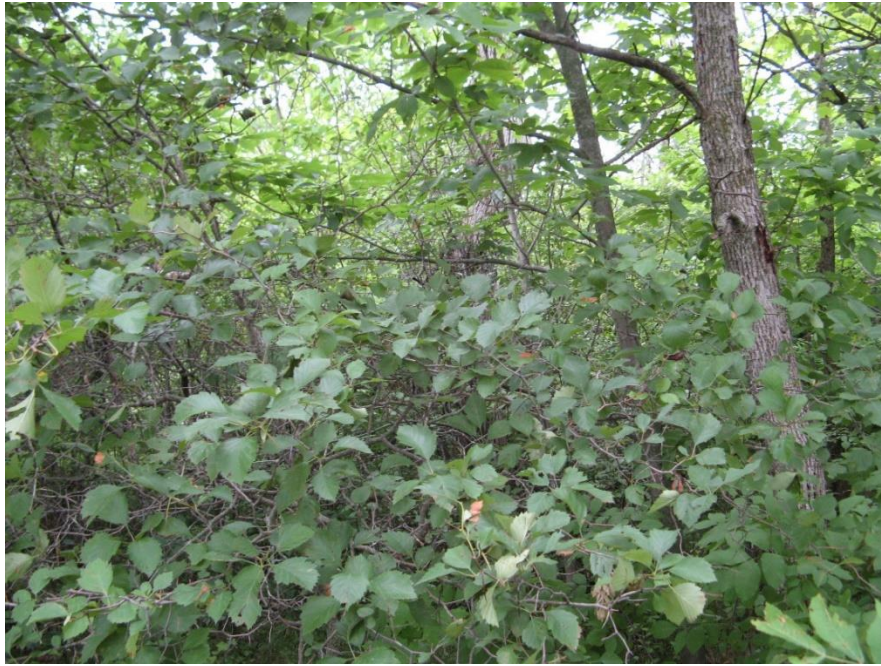
The understory of the ash deciduous forest is very thick (Photo 15), with regenerating stems of ash and buckthorn shrubs abundant, along with extensive hawthorn shrubs around the periphery. Other regenerating stems include basswood, balsam fir, maple, Manitoba maple, poplar, bitternut hickory, ironwood, white spruce, and bur oak. In addition to the common hawthorn, red raspberry, beaked hazel, common buckthorn, glossy buckthorn, red-osier dogwood, and prickly ash shrubs are present. Pennsylvania sedge, June meadow grass, common strawberry, small enchanter's nightshade, common burdock, heart-leaved aster, calico aster, early goldenrod, Canada goldenrod, thicket creeper, wild grape, white avens, blue violet, yellow violet, purple flowering raspberry, and poison ivy (dominant in areas) indicate past disturbances in the forest with lady fern, ostrich fern, white snakeroot, Canada mayflower, white baneberry, starflower, sweet cicely, and false Solomon's seal also present.

*Photo 15 - Understory is very thick in the ash deciduous forest in the southeast portion of the site  
View looking south (June 28<sup>th</sup>, 2020)*

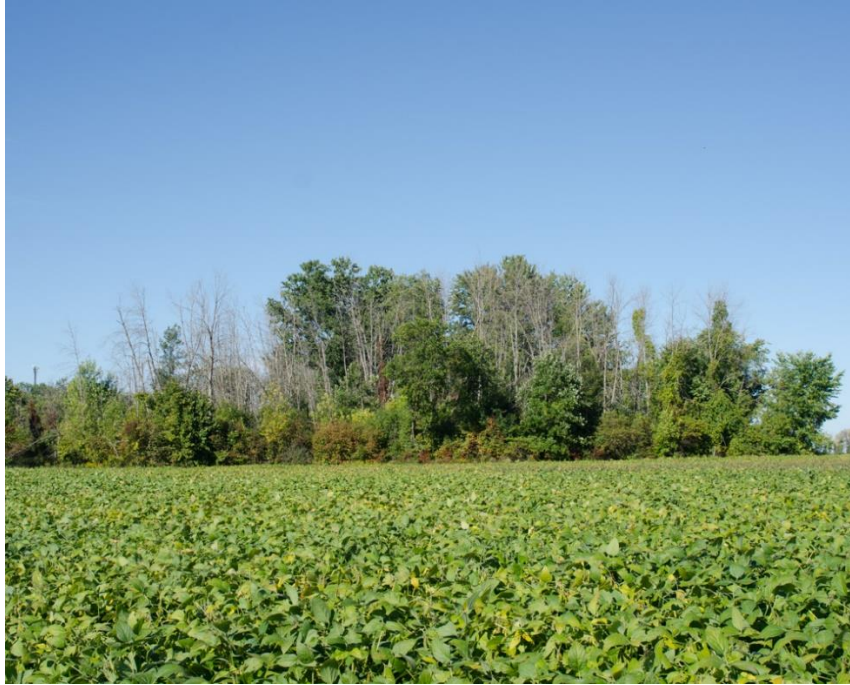
Agricultural fields dominate much of the site. These fields were predominately planted in soybeans in 2020 and 2021 (Photos 16, 17, and 20). Since 2014 portions of the west fields have been used for stockpiling of coarse material.

*Photo 16 – Cultivated field in the southeast portion of the site west of Cox Country Road. View looking west to ash deciduous forest north of the South Tributary (September 12<sup>th</sup>, 2020)*

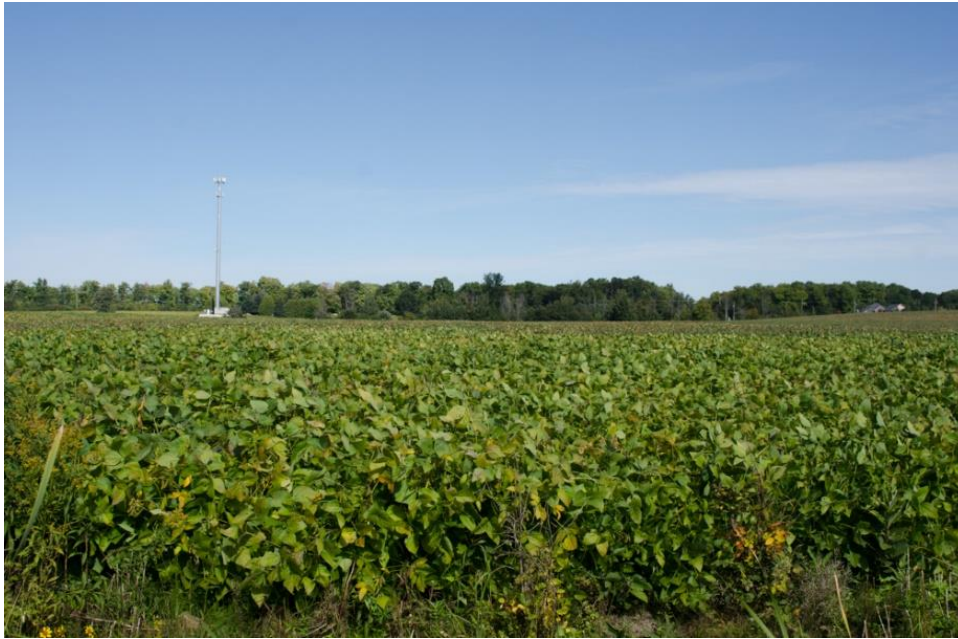
*Photo 17 – Cultivated soybean field in the east portion of the site.  
View looking north to Old Montreal Road and forest off-site to the north of Old Montreal Road  
(September 12<sup>th</sup>, 2020)*

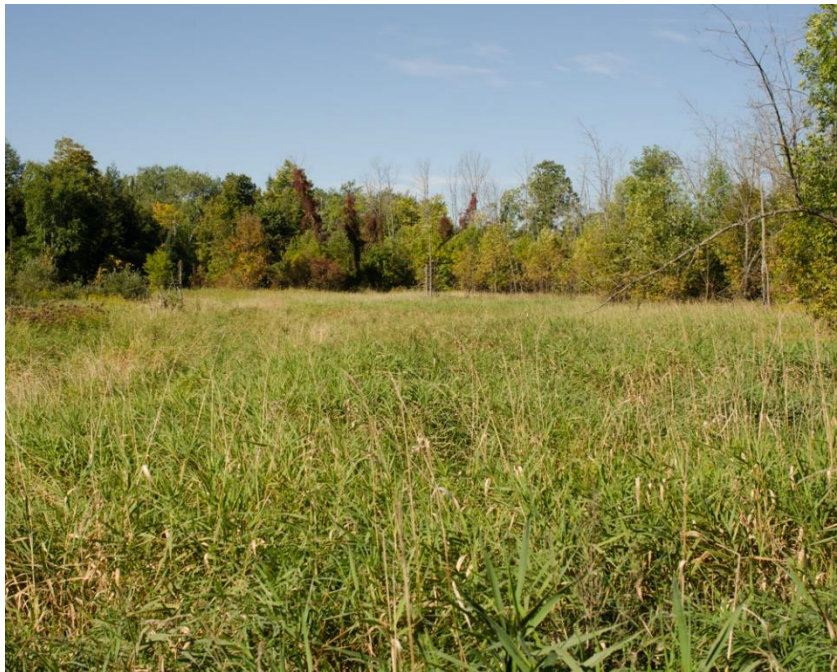
Once considered a meadow marsh in association with the former beaver dam (MMM, 2007), the open area to the north of the South Tributary approximately 300 west of Cox County Road has dried out and is now considered a cultural meadow on the north side of the South Tributary (Photo 18). The facultative reed canary grass is very dominant with Canada thistle, Canada goldenrod, field sow-thistle, flat-topped aster, red raspberry, wild parsnip, and white snakeroot also present, along with regenerating ash stems. Soil moisture sampling completed by BCH Consulting Inc. on September 22<sup>nd</sup>, 2020 identified this area as upland rather than wetland habitat with respect to soil conditions. The moisture regime within the reed canary grass meadow averaged moderately moist, which under the Ontario Wetland Evaluation System would not be considered wetlands. In combination with a scattering of upland vegetation amongst the very dominant facultative reed canary grass it is concluded that this meadow area represents upland rather than wetland habitat.

*Photo 18 - Meadow vegetation dominated by reed canary grass to the north of the South  
Tributary in the southeast portion of the site. View looking west (September 12<sup>th</sup>, 2020)*

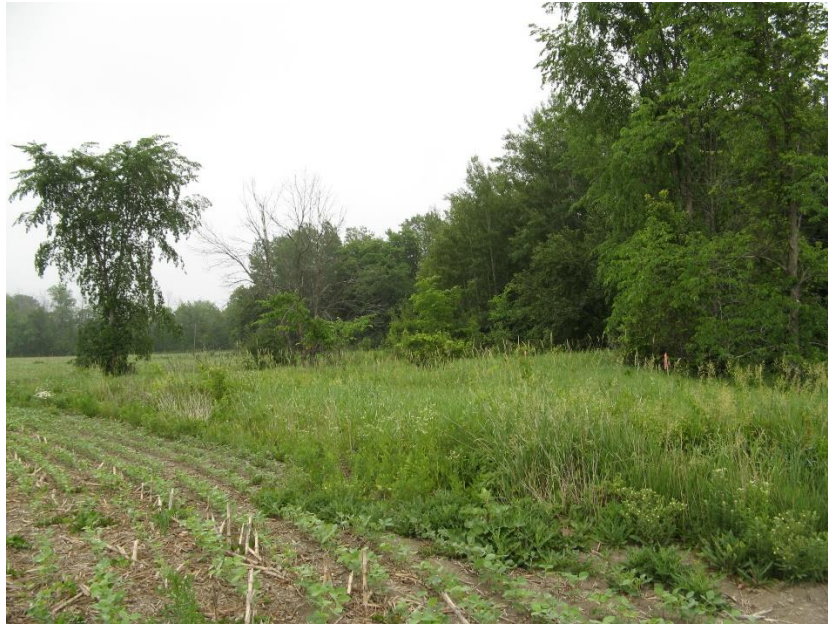
Areas of cultural meadows are also adjacent to the cultivated fields (Photo 19). Typical ground flora in these areas include Philadelphia fleabane, ox-eye daisy, bird's-foot trefoil, orchard grass,

*Photo 19 - Strip of cultural meadow between forest to the north of the top of slope to the right (south) and soybean field to the left (north). This location is a proposed infill work area for geotechnical purposes. View looking southeast (June 28<sup>th</sup>, 2020)*

As the headwater drainage feature assessment completed by Bowfin (2021) did not include a management recommendation of protection or conservation for the agricultural channels leading to the South Tributary, Paterson (2021) have recommended infilling the side slopes of the channels in two locations to the north of the top-of-slope and upland maple forest, shown as *infill work areas* on Drawing PG5201-2 of Paterson (2021). Tree removal in these areas is limited and will include a few white elm and trembling aspens up to 30cm dbh and smaller sugar maple (Photo 19). Regenerating poplar stem and red raspberry shrubs are also common in the proposed infill work areas. This infilling will result in a modification to the top of slope in these two areas and the fifteen metre top of slope setback in Paterson (2021) and this report has been modified to reflect the top of slope following the infilling.

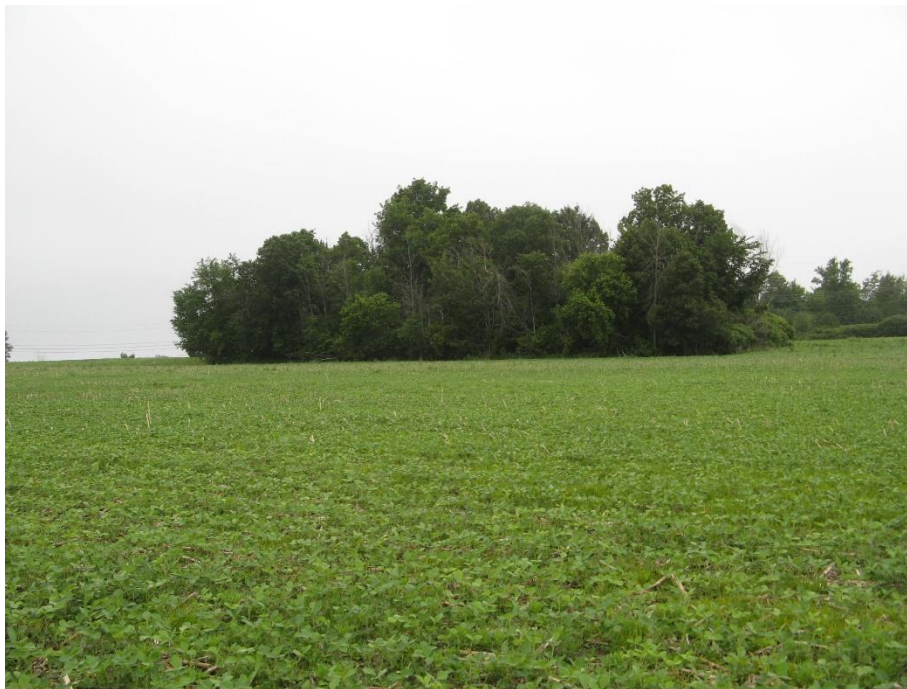
White elm, bur oak, sugar maple, basswood, red maple, Manitoba maple, and white ash are the common tree species in the small areas of cultural woodlands in the north portion of the site (Photos 20 and 21). Many of the elm and ash are dead or had very little leaf-out. Windthrow is extensive in many areas. Basswood and sugar maple in apparently good condition are up to 40cm dbh.

*Photo 20 - Cultivated field in the north-central portion of the site and cultural woodland further to the north. View looking north (June 28<sup>th</sup>, 2020)*

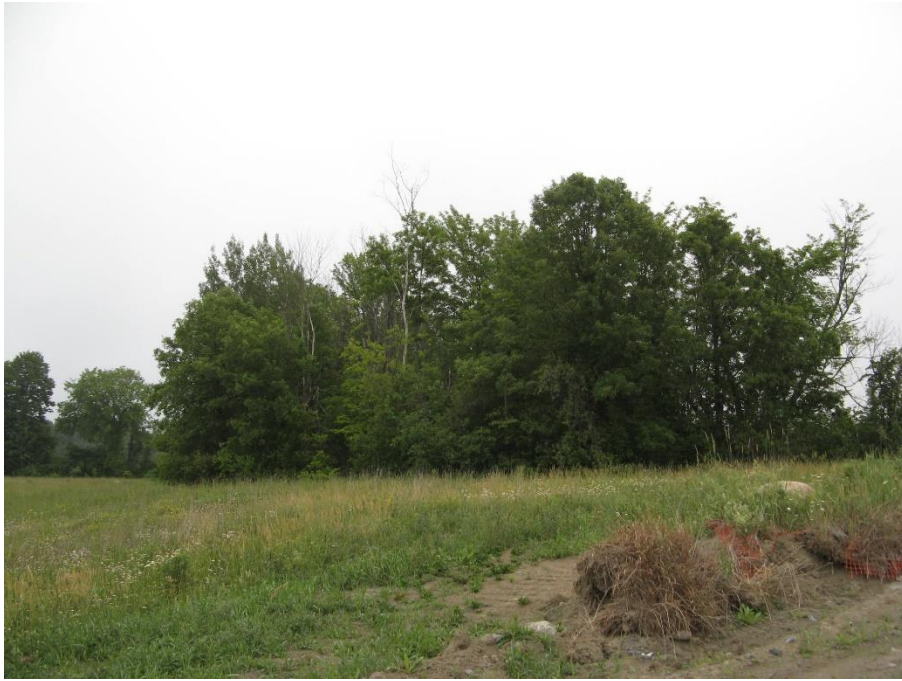
*Photo 21 – Cultural woodlot in the northwest portion of the site.  
View looking southwest (June 28<sup>th</sup>, 2020)*

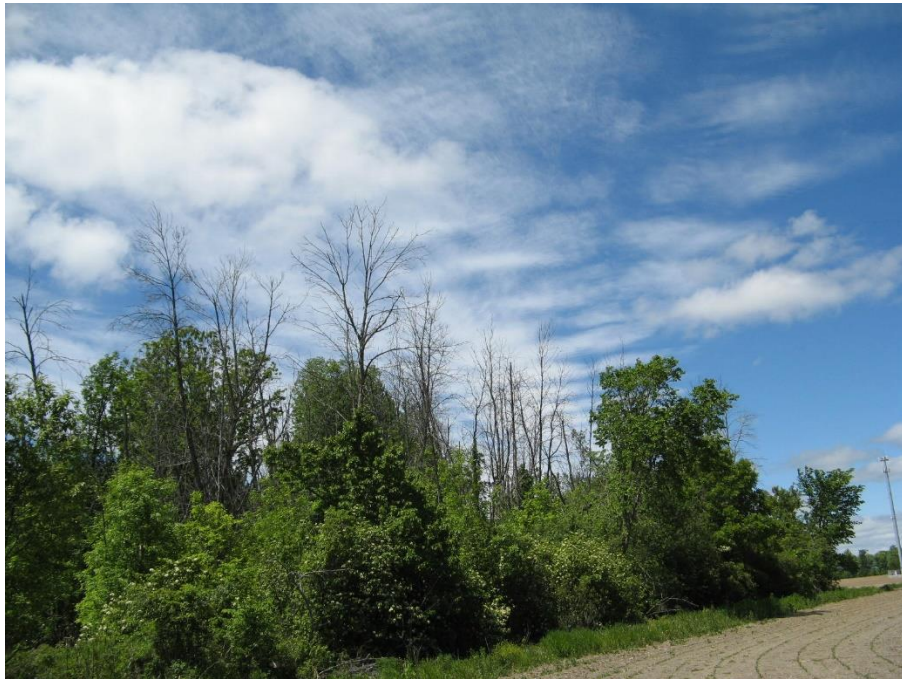
Intermittent deciduous hedgerows are scattered along the south side of Old Montreal Road and between some of the agricultural fields (Photo 22). Trembling aspen, crack willow, basswood, white elm, bur oak, sugar maple, white ash, and Manitoba maple are common tree species in the deciduous hedgerows. Larger trees include coppice basswoods on the south side of Old Montreal Road adjacent to the northwest and northeast portions of the site with individual trunks up to 70cm dbh, white elms in the 50cm dbh range adjacent to the north-central site boundary, and a 90cm dbh bur oak (Photo 24) along the south portion of the west site edge. A coppice Manitoba maple, with individual stems up to 40cm dbh adjacent to the northeast corner of the site has major trunk damage and has been extensively pruned. Many of the aspens have fungus and trunk damage, while reduced leaf-out and trunk damage are common on the elms and ash, though some of the white elm seemed to be in better condition (Photo 23).

*Photo 22 - Deciduous hedgerow in the northeast portion of the site. View looking northeast  
(May 27<sup>th</sup>, 2020)*

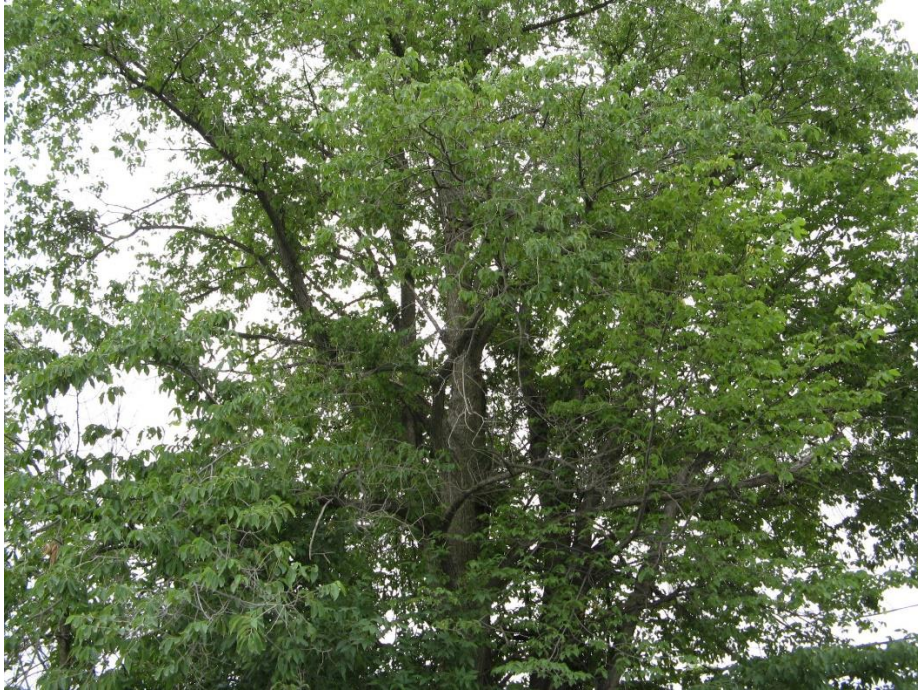
*Photo 23 – White elm with good leaf-out along the south side of Old Montreal Road adjacent to the north-central portion of the site. View looking southeast (June 28<sup>th</sup>, 2020)*

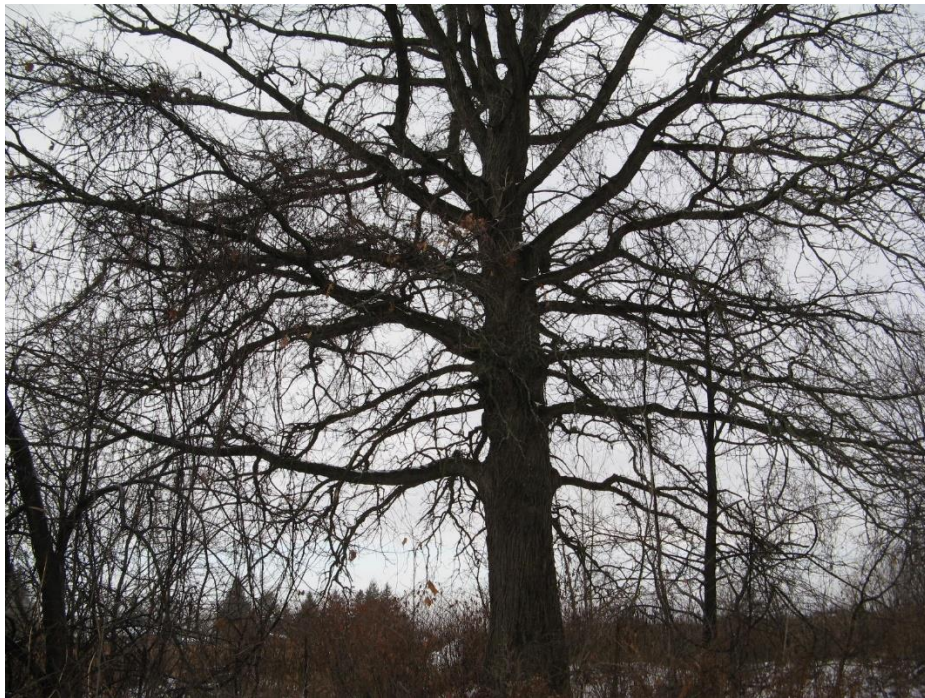
*Photo 24 – Mature bur oak along the south portion of the west site boundary. View looking west (December 16<sup>th</sup>, 2021)*

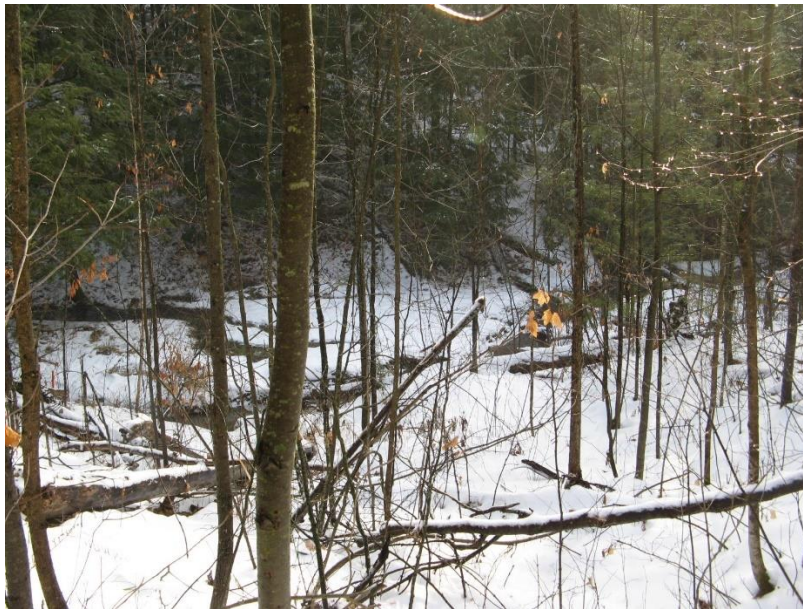
*Photo 25 – Location of outfall (west) spillway approaching the South Tributary.  
View looking southwest (December 16, 2021)*

The South Tributary will not be directly impacted by the proposed development, with mitigation measures described below to reinstate the spillways. PECG (2013) recommended a thirty metre buffer around the middle and lower reaches of the South Tributary to protect the local seepage contribution. This will be attained with the 15 metre top of valley slope setback. In addition, the existing agricultural drainage to the South Tributary will be maintained through the proposed stormwater management practices. PECG (2013) also noted that the granular bedding associated with buried services will have a much higher permeability than the existing marine clay or till. This would result in an increase in infiltration and groundwater recharge where the new services are placed on bedrock. Perforated pipes placed in rear yards on top of fractured Bobcaygeon Formation bedrock will greatly increase the infiltration and recharge potential of these areas.

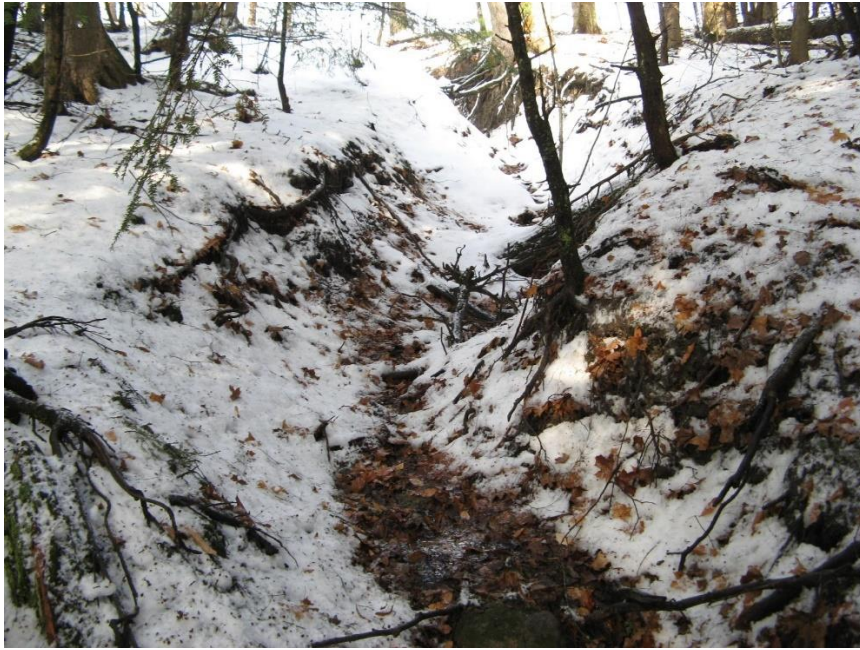
*Photo 26 – Location of emergency spillway looking north towards top of valley slope from north of the South Tributary (December 16, 2021)*
