Phase I Environmental Site Assessment 230 and 232 Lisgar Street Ottawa, Ontario

Prepared for 230 Lisgar Street Inc.

Report: PE5905-1 November 11, 2022

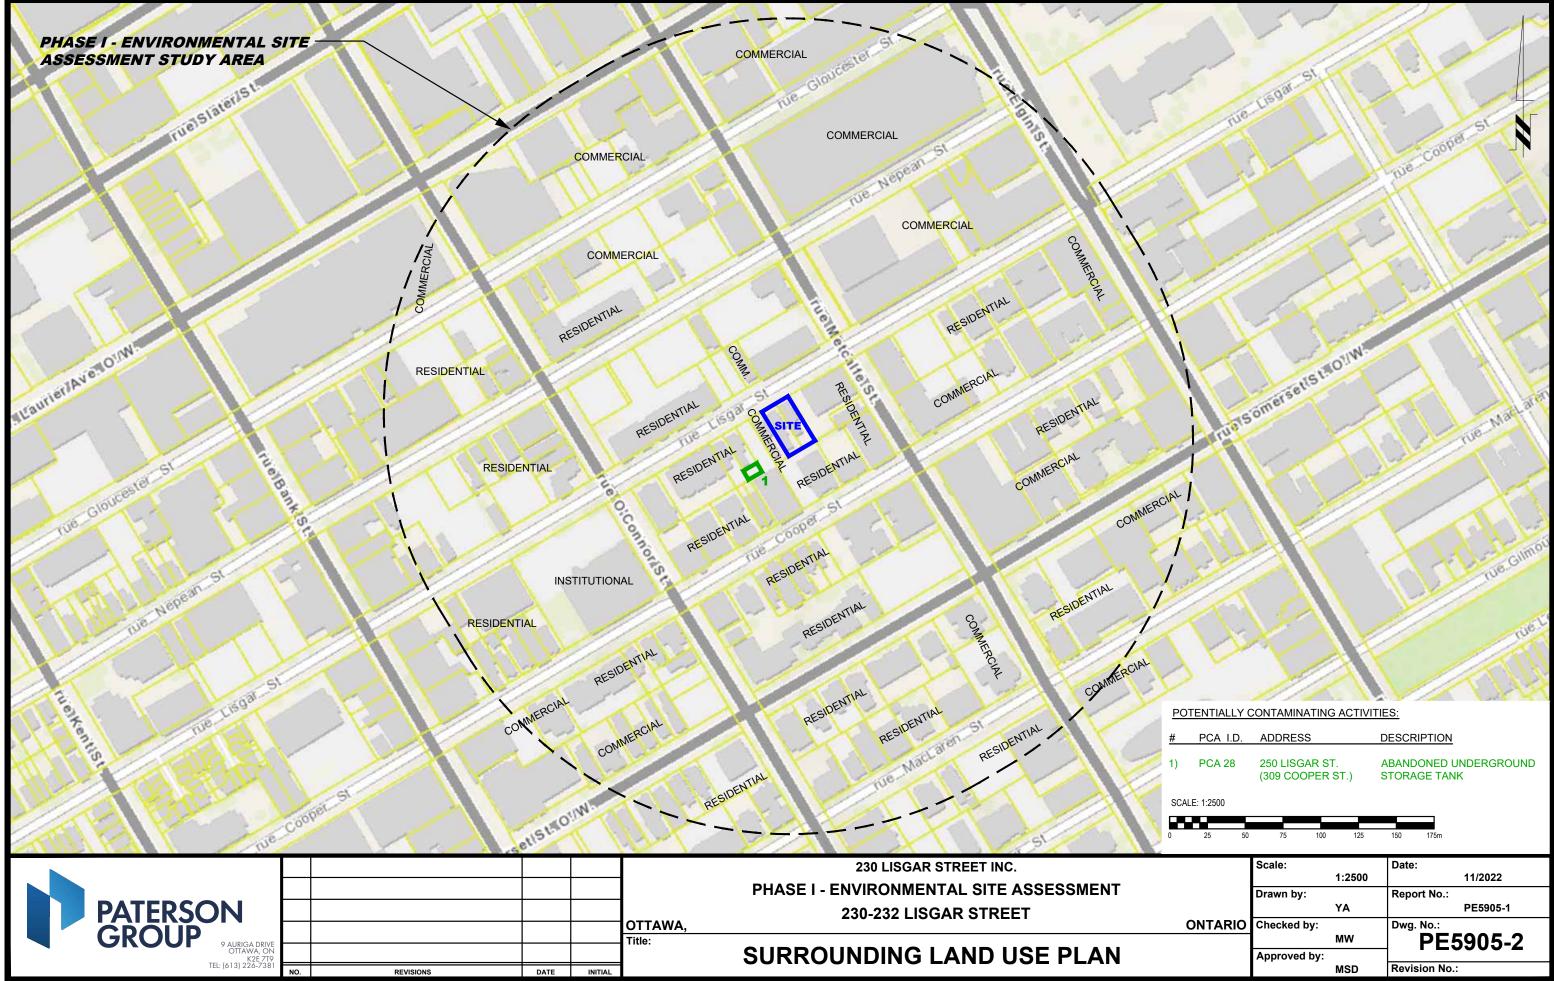
DRAWING PE5905-2 – SURROUNDING LAND USE PLAN

POTENTIALLY CONTAMINATING ACTIVITIES:										
<u>#</u>	PCA I.D.	ADDRESS		DESCRIPTION						
1)	PCA 28	250 LISGAR ST. (309 COOPER ST.)		ABANDONED UNDERGROUND STORAGE TANK						
SCALE: 1:2500										
	25 50	75 100	125	150 175m						
U	25 50	75 100	125	150 175m						
		Scale:	1:2500	Date:	11/2022					
		Drawn by:		Report No.:	-					
			YA		PE5905-1					
C	NTARIO	Checked by:		Dwg. No.:						
		MW		↓ PE5	905-2

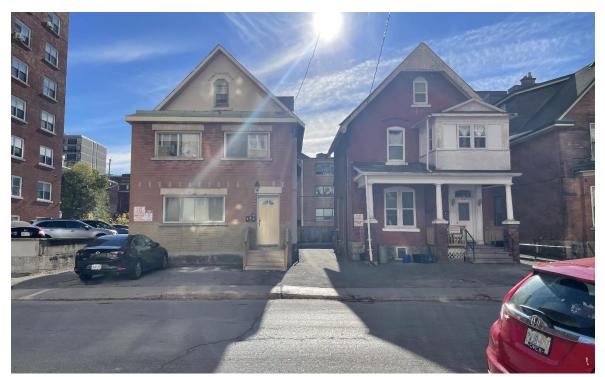
Photograph 1: View of the northern side of the Phase I Property, fronting Lisgar Street.

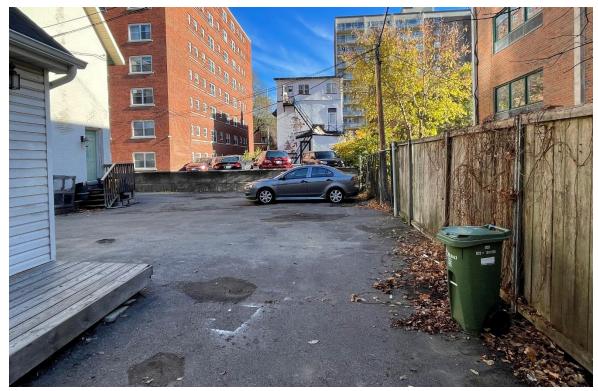
Photograph 2: View of the southern side of the of the Phase I Property, looking north.

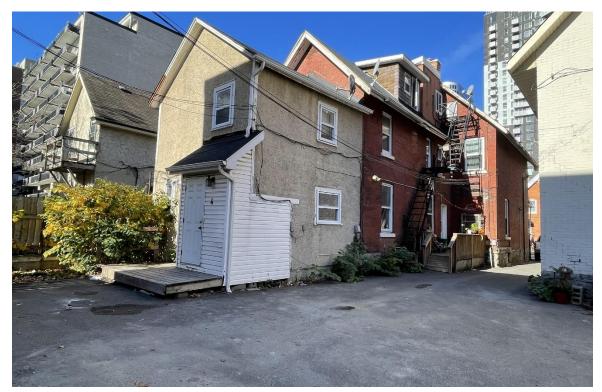
232 Lisgar Street is occupied by a 2-storey, multi-tenant residence with a basement level. The present-day residence was constructed circa 1888 with a limestone foundation with large areas covered in exterior parging. The exterior façade of the building is finished in brick, while the rear extension is finished in a mixed aggregate stucco and vinyl siding with a sloped shingle style roof.

Photograph 3: View of the 232 Lisgar Street, looking northwest.

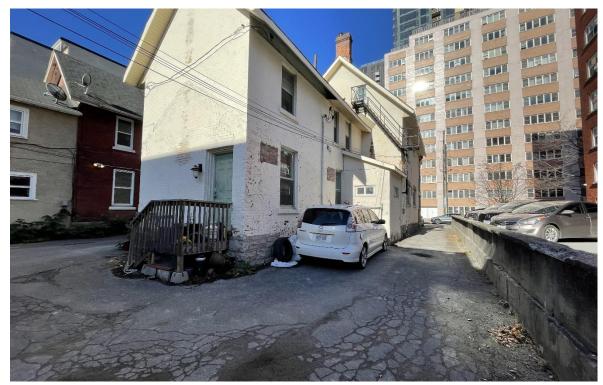
230 Lisgar Street is occupied by a 2-storey, multi-tenant residence with a basement level. The present-day residence was constructed circa 1888 with a limestone foundation with large areas covered in exterior parging. The exterior façade of the building is finished in brick with a sloped shingle style roof.

Photograph 4: View of the 230 Lisgar Street, looking northwest
