FLUVIAL GEOMORPHIC AND EROSION HAZARD ASSESSMENT
STINSON LANDS
OTTAWA, ONTARIO

Prepared for:
NOVATECH ENGINEERING AND CONSULTANTS LTD.

Prepared by:
MATRIX SOLUTIONS INC., A MONTROSE ENVIRONMENTAL COMPANY

Version 1.0
April 2024
Guelph, Ontario

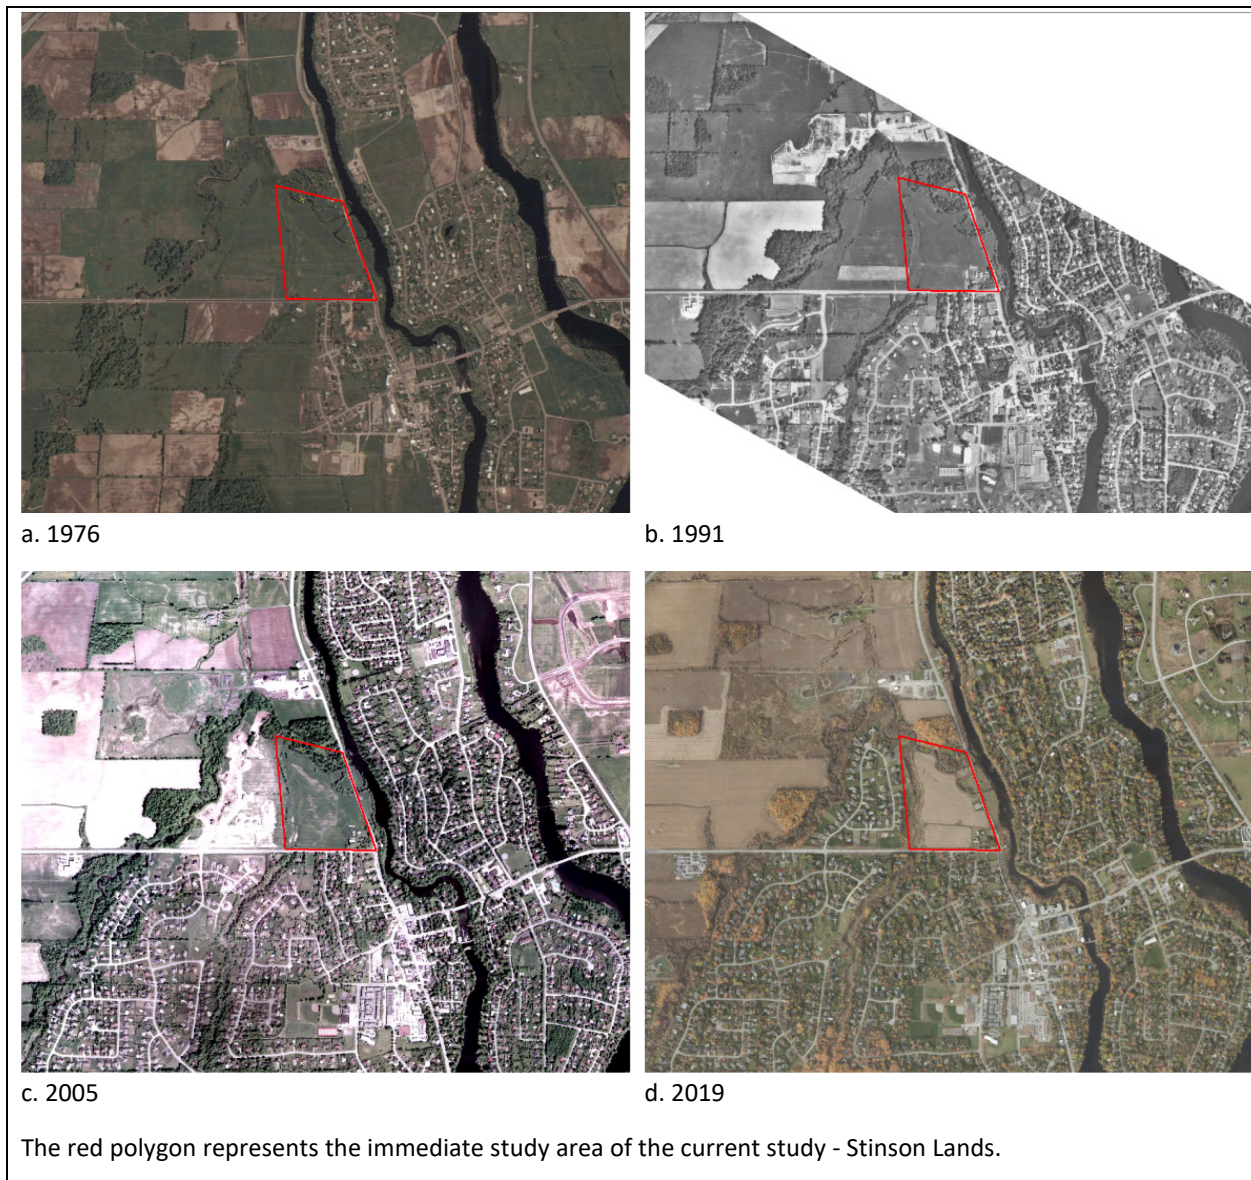
FIGURE 3 Historic Land Use and Development Expansion Around the Stinson Lands Study Site

In 1954, land use surrounding the study area consisted of vacant open land, agricultural fields, and wood lots. Mud Creek exhibited a sinuous planform with well-established meanders, some woody vegetation along the northern valley slope, and a wide floodplain bound by valley walls. However, it is apparent that some channelization likely happened prior to 1954 as the planform straightens on approach to the Rideau River. As a result, there is a cutoff feature (oxbow) in the floodplain to the south of the main channel. This cutoff was not visible in 1954 but can be seen in the remainder of the available air photographs and has been confirmed through field surveys. The Wilson-Cowan Drain was also sinuous, set within a small

valley with a well-defined, narrow floodplain but with sparse woody vegetation. Aerial photographs from 1976 reveal that no major changes had occurred to the area surrounding Mud Creek or the Wilson-Cowan Drain immediately upstream of Stinson Lands. By 1991, significant urbanization had occurred south of the study site, with the town of Manotick bordering the Stinson Lands and multiple developments encroaching on Mud Creek to the north and south; however, there is no indication of the creek being modified. Air photographs from 2002 show minimal adjustment in the planform of each creek, as it maintains well-vegetated riparian areas in most of the surrounding area. Construction of a subdivision along the west side of the Wilson-Cowan Drain began in 2005, set back from the valley top. This development area is visible in the 2015 photograph; however, limited development expansion was evident in 2019, and planform adjustment revealed little to no change.

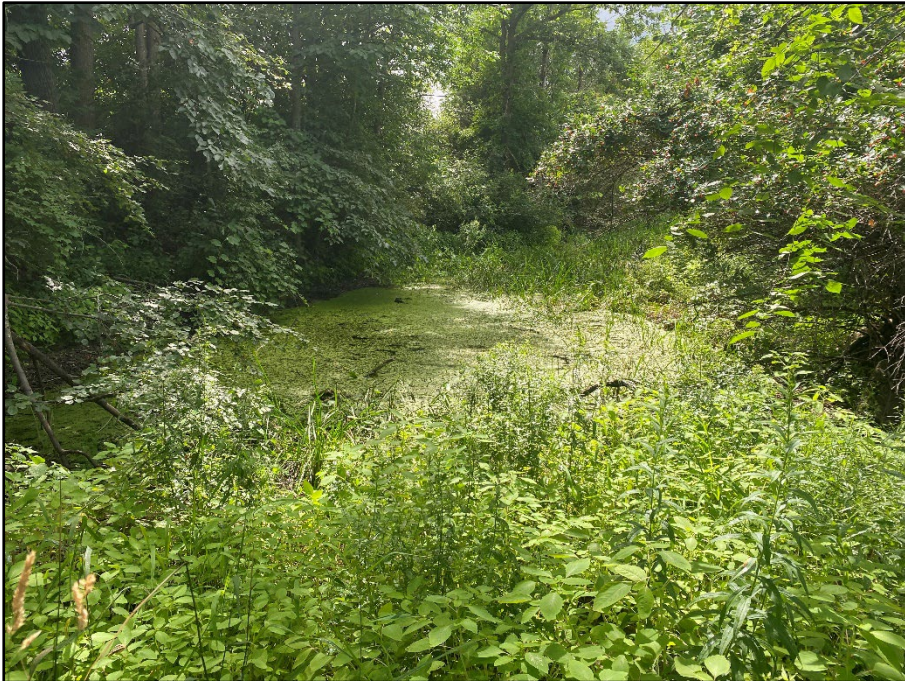
13. Oxbow Feature – Facing downstream, the depression maintained standing water at the time of the site visit, with saturated and unconsolidated soil underneath

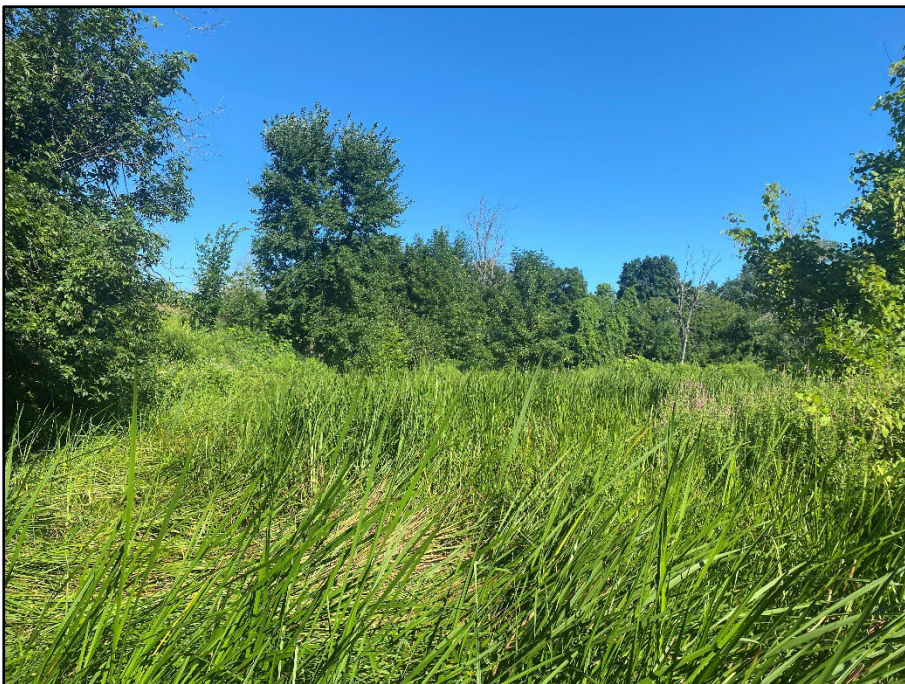
14. Oxbow Feature– Facing downstream, between the define banks, the feature is heavily grasses but maintains water

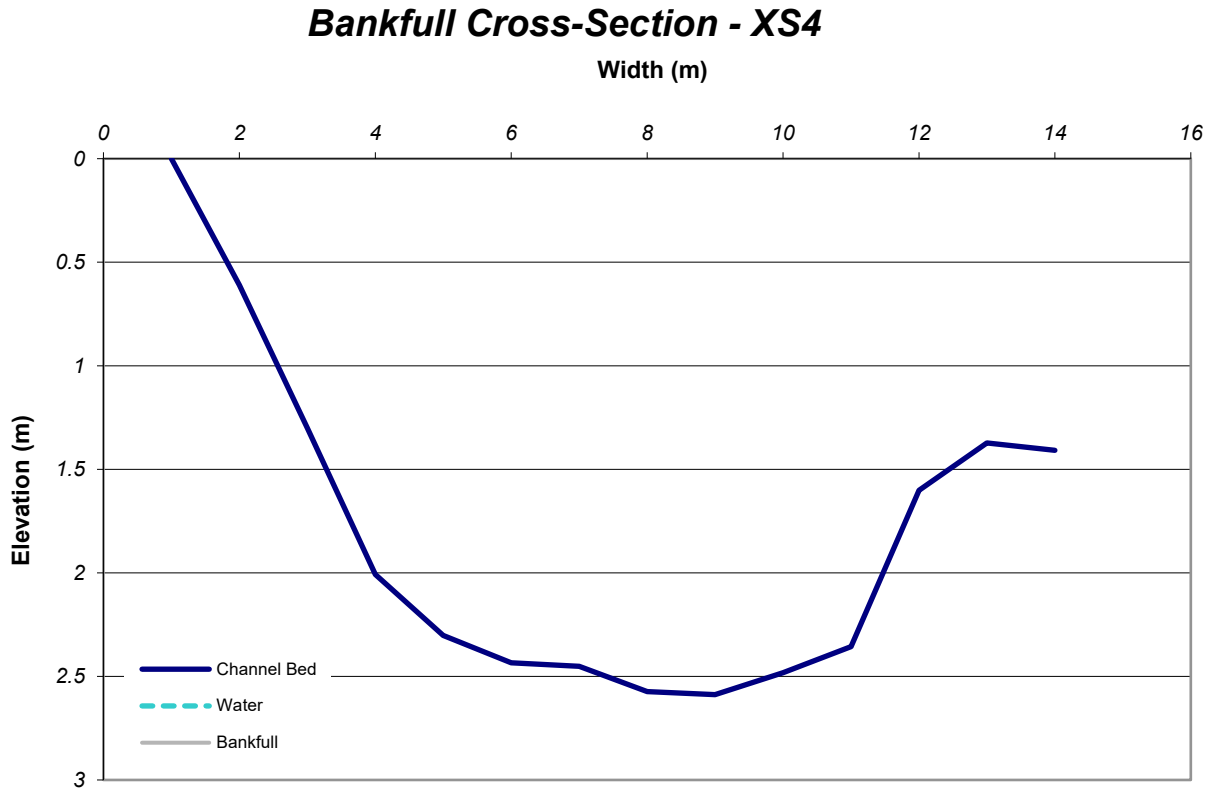
FIGURE B5 Cross-section profile at XS4 from tops of slope, right to left facing downstream

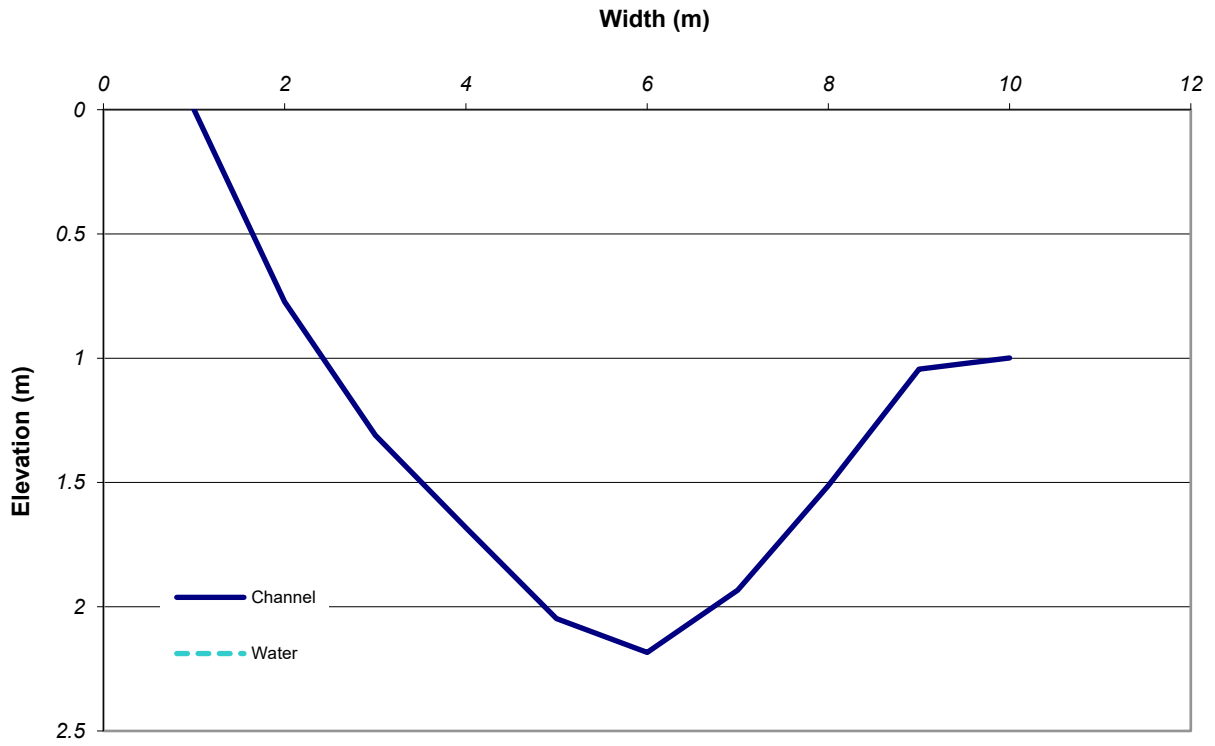
Bankfull Cross-section - Site 5

FIGURE B6 Cross-section profile at XS5 from tops of slope, right to left facing downstream
