15 August 2022

Subject: 4386 Rideau Drive, Manotick – Headwater Drainage Features Review and Assessment

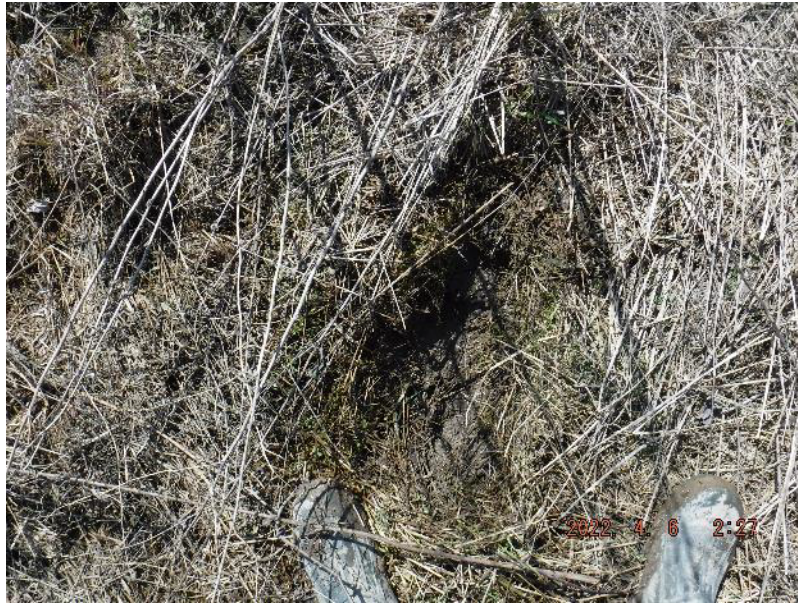
Photo 2: After moving vegetation aside, the lack of water was confirmed (April 5, 2022)

Based on the above, the No Management Recommendation option is the best fit and no further assessment of this headwater feature is required.

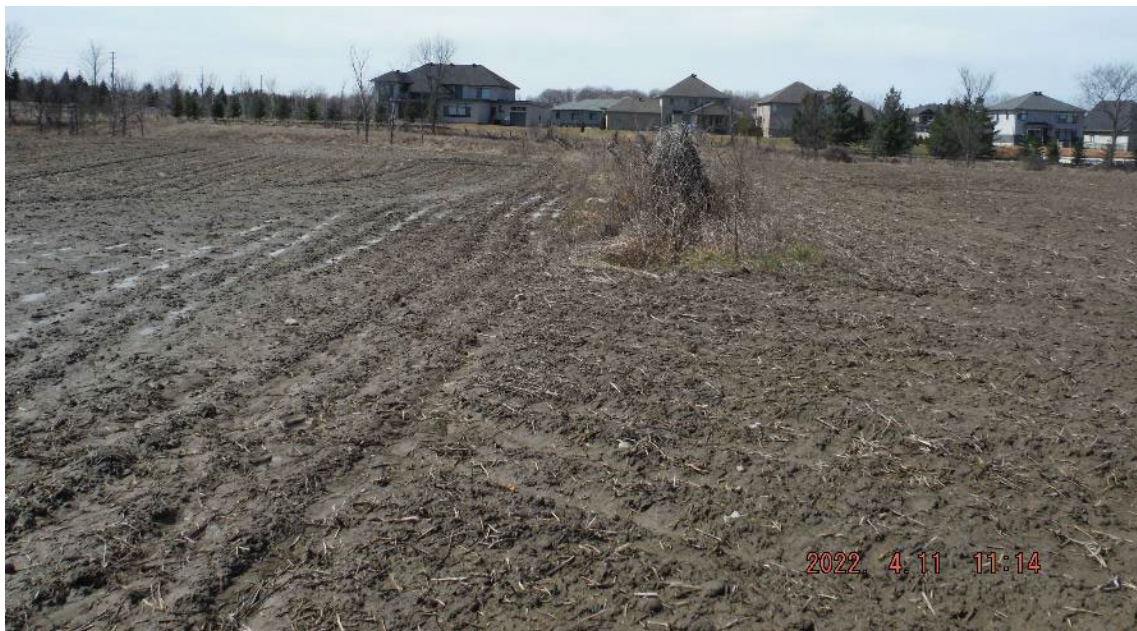
Photo 3: Section that was ploughed (looking downstream towards Wilson Cowan M. D.) (April 11, 2022)
