Phase One Environmental Site Assessment 178 Nepean Street and 219 Bank Street, Ottawa, Ontario

Smart Living Properties

OTT-22010865-A0

2022-07-13

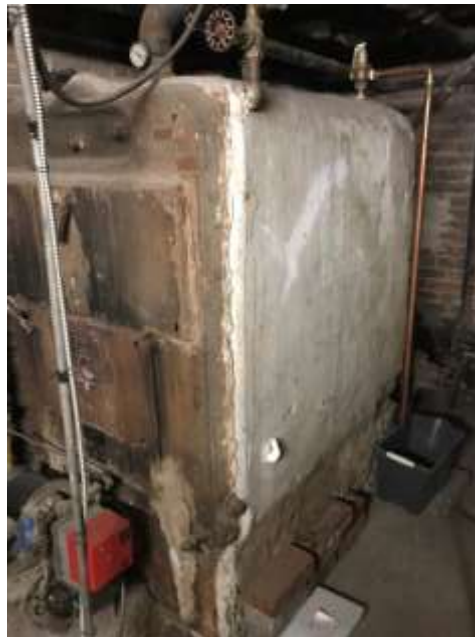
Photograph No. 7

View of the boiler with suspected asbestos insulation in poor condition at 178 Nepean Street.

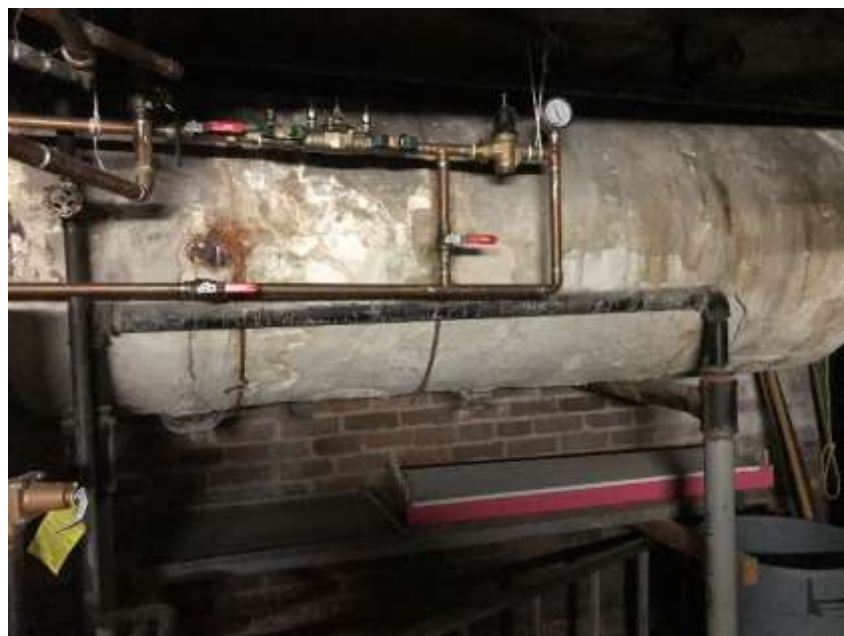
Photograph No. 8

View of the expansion tank with suspected asbestos insulation in poor condition at 178 Nepean Street.

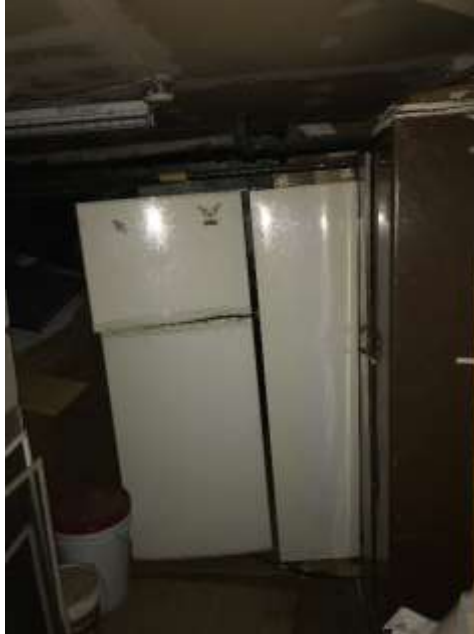
Photograph No. 9

View of the unused refrigerators stored in basement at 173 Nepean Street.

Maintenance of refrigerant containing equipment should continue to be completed by a licensed refrigeration contractor. The equipment should only be repaired, removed, or serviced by an appropriately licensed contractor.

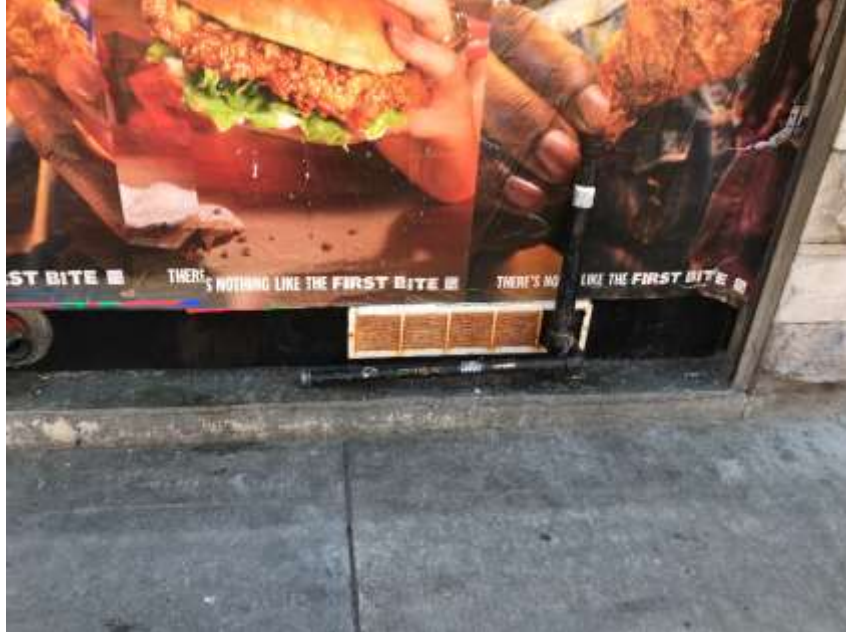
Photograph No. 11

An above ground storage tank (AST) was observed in the basement of 219 Bank Street (**PCA 23**). Vent/fill pipes were present at the southwest corner of the building. The AST was installed in 2005 and appeared to be in good condition. A wood floor was present beneath the AST. No staining was observed on the wood.

View of the vent/fill pipes at 219 Bank Street.

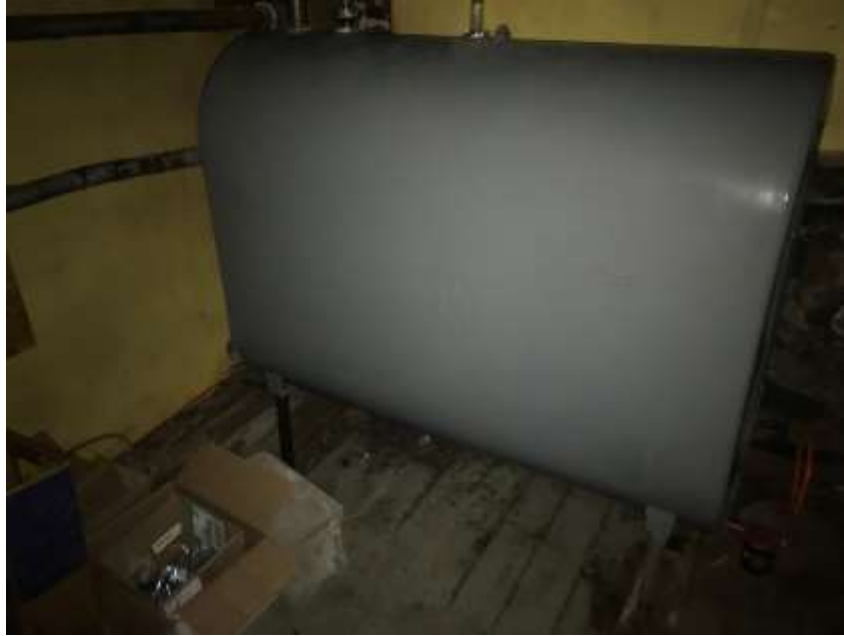
Photograph No. 13

View of the AST in the basement at 219 Bank Street.

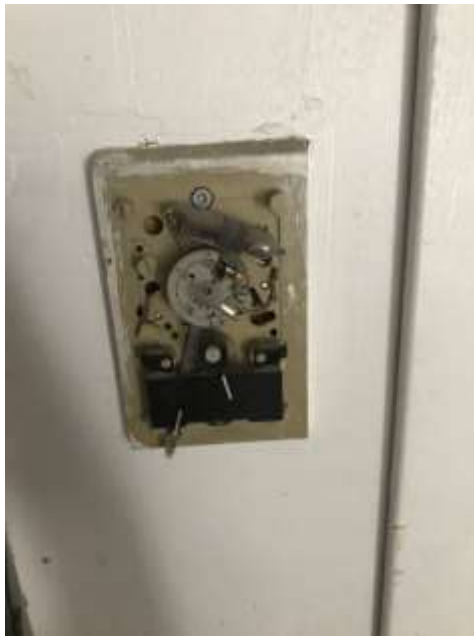
Photograph No. 14

The interior painted surfaces observed during EXP's site visit were in good condition. One mercury-containing thermostat was observed on the second floor of the building at 219 Bank Street.

View of a mercury containing thermostat at 219 Bank Street.
