FINAL REPORT

Phase One Environmental Assessment

Proposed Development at Riverside Drive and Hunt Club Road, Ottawa Ontario

Golder Associates Ltd.

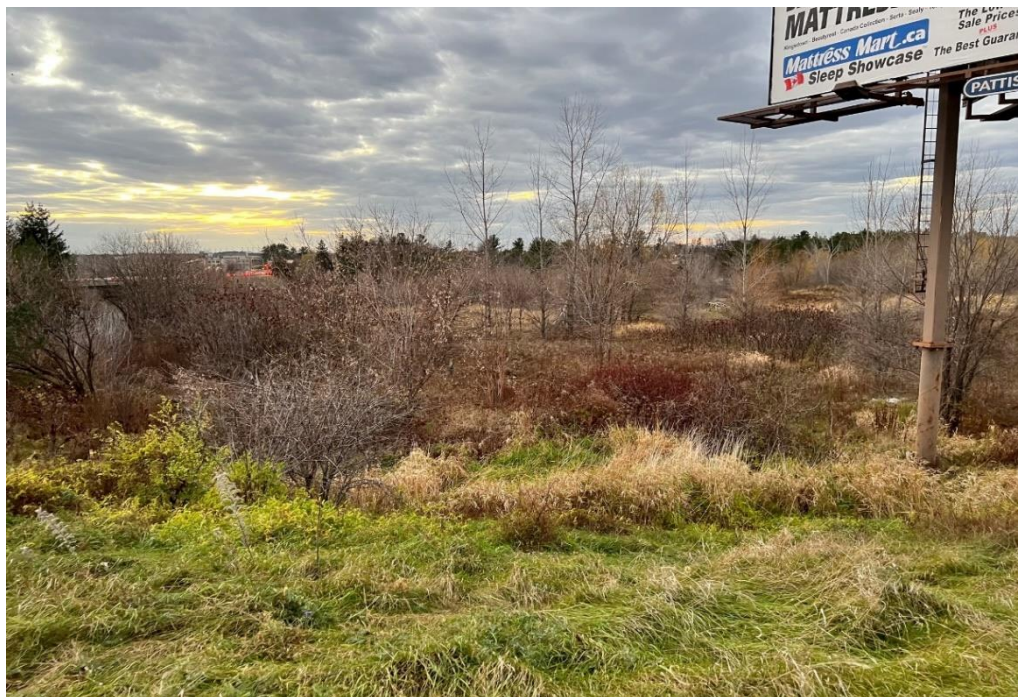
Photo 4: Looking West at the Site from the Eastern portion of the Site.

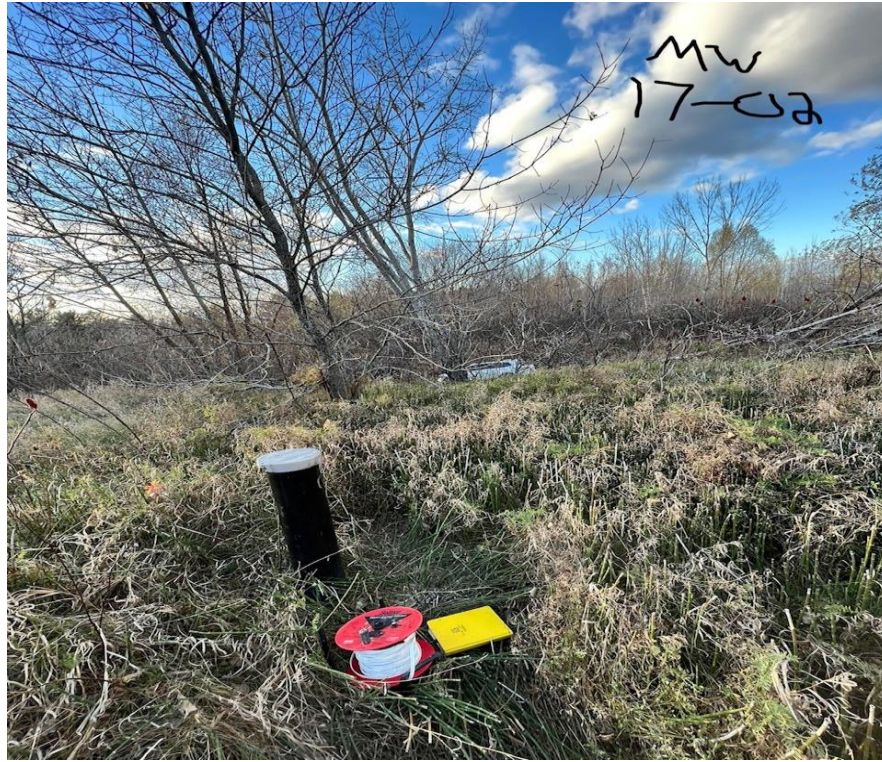
Photo 5: Monitoring well located on the southern portion of the Site near the western Site boundary.

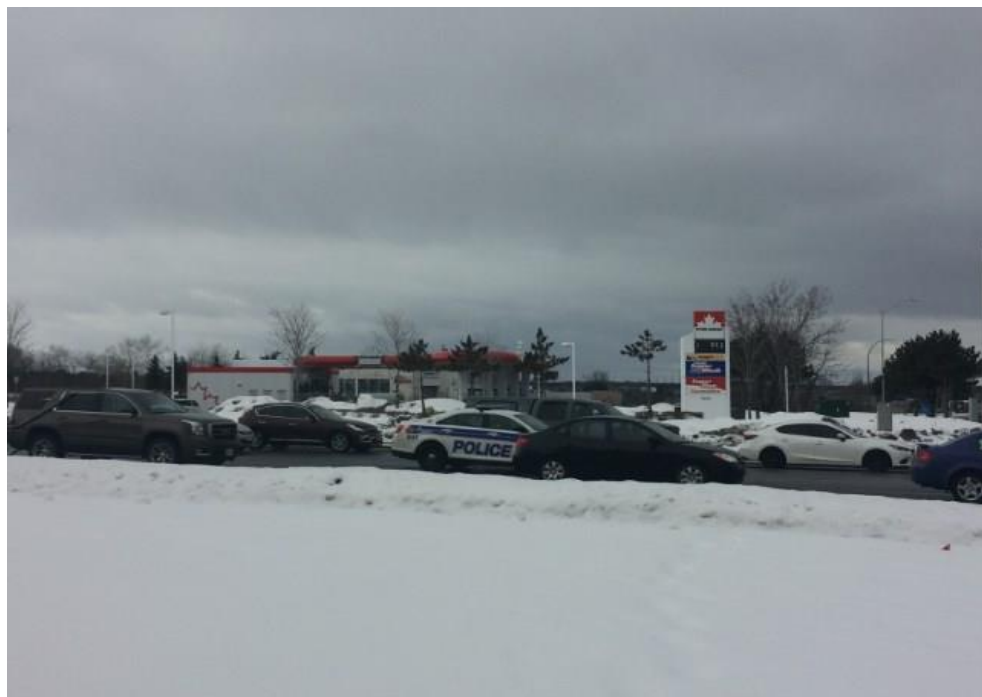
Photo 8: Looking west at the retail fuel outlet located on the surrounding lands south of the Site at the southeast corner of Hunt Club Road and Riverside Drive.

It was noted during the site visit that a retail fuel outlet was located on the surrounding lands south of the Site at 4000 Riverside Drive; approximately 70 m south of the Site. The presence of this retail fuel outlet is considered to be an off-Site PCA. As previously discussed, construction debris is present in the fill material located on the Site and fill material of unknown original and quality has been placed on the Site since the most recent Phase Two ESA investigation in 2001. As such, the current presence of this fill material on the Site is an on-Site PCA.
