# **Phase One Environmental Site Assessment**

2040 Arrowsmith Drive, Ottawa, Ontario

January 7, 2022

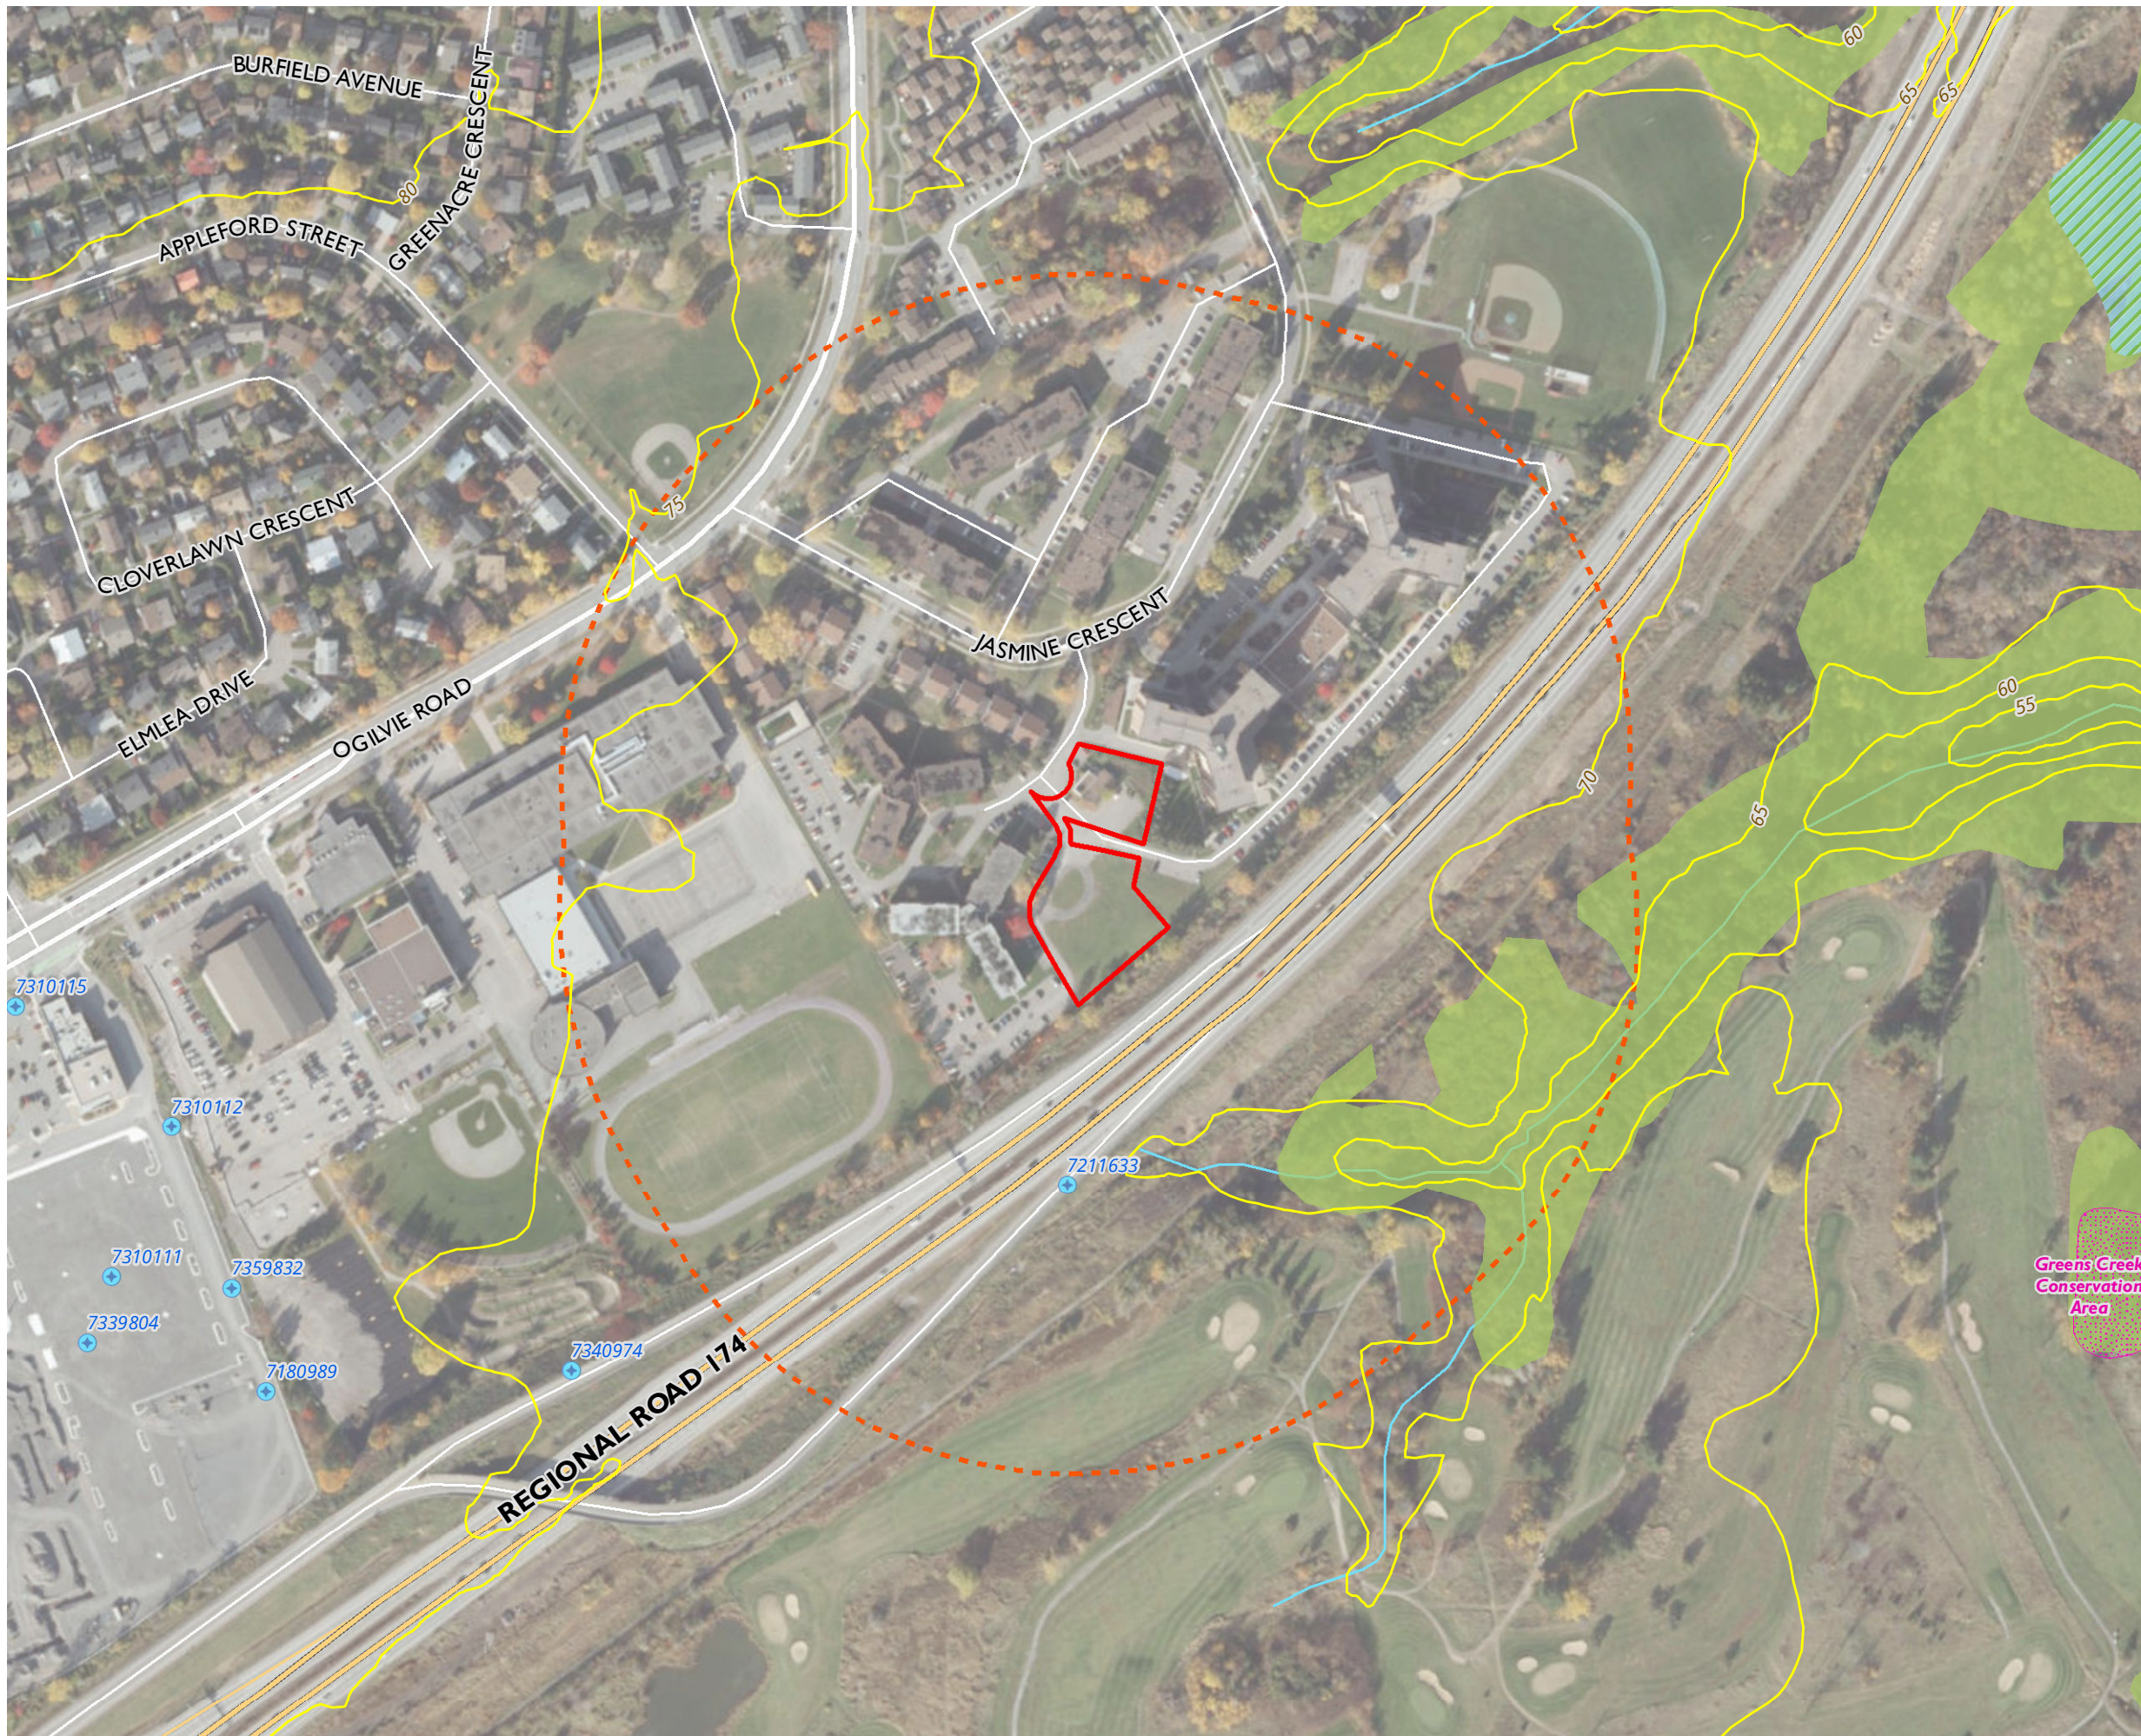
Off-Site PCAs	
PCA #	PCA Description
1	PCA Other - Spills
2	#46 - Rail Yards, Track, and Spurs
3	PCA Other - Potential leaks from fuel lines

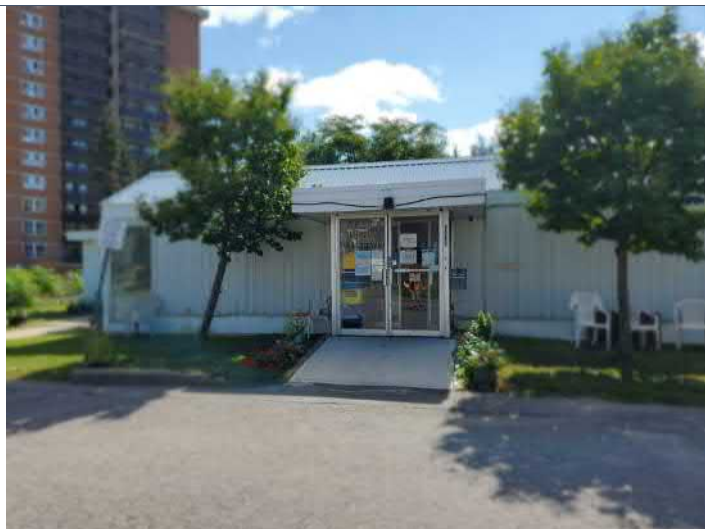
Picture 1 – Site building on RSC Property (facing south)

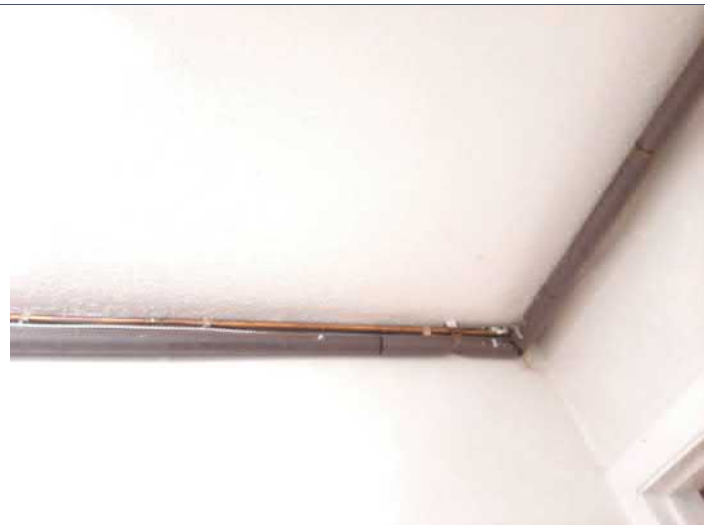
Picture 3 – Piping inside site building

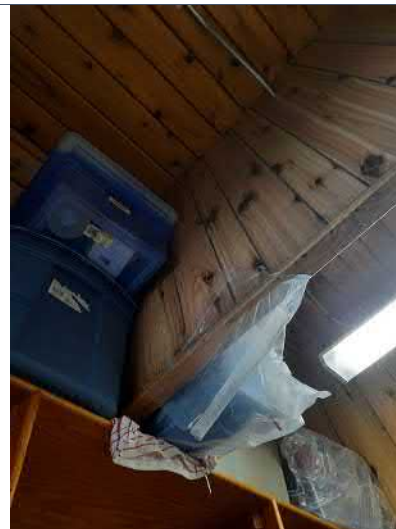
Picture 4 – Patched portion of ceiling in site building that has been reported by staff to have leaks in the past

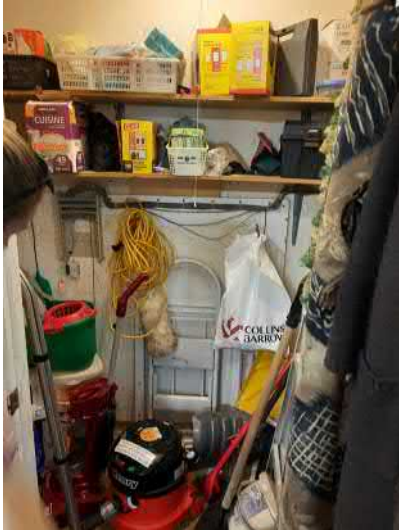
Chemicals stored at the RSC property include household cleaners including bleach. No spills or staining were observed within the vicinity of the chemicals. It is noted that cleaning products were being stored in a small storage closet with carpet flooring and no floor drains.

Picture 5 – Contents of storage closet/closet containing water heater

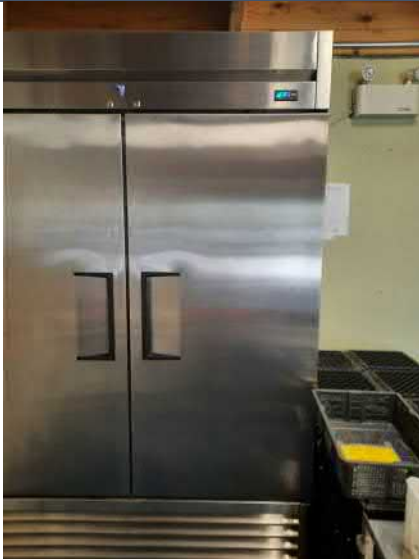
Potential ODS-containing equipment observed at the RSC Property includes residential type refrigerators and freezers. ODS equipment is not expected to result in impacts to soil or groundwater at the RSC Property.

Picture 7 – Industrial sized refrigerator in site building

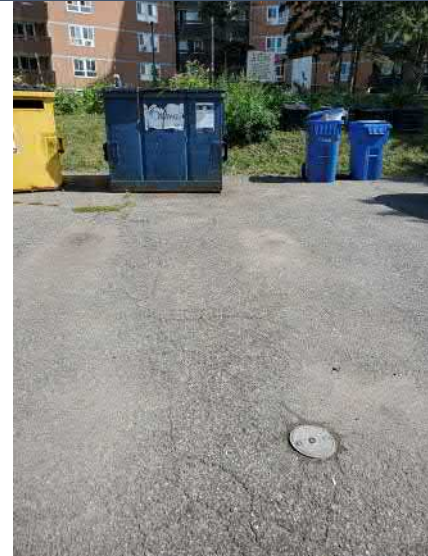
- Asphalt-paved access roadways and parking areas surrounding the building. Catch basins were observed in these areas.
- An asphalt-paved parking lot is located to the southeast of the building. One flushed-mount style monitoring well is located here, which was installed as part of Dillon's 2013 Phase Two ESA (confirmed by referencing the Site Plan from the report). Waste bins are situated at the north east edge of the parking lot.

Picture 10 – Monitoring well (facing east) in parking area, waste bins.

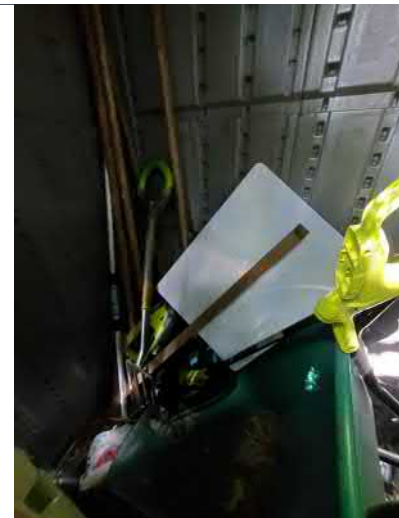
- Additional structures on the RSC Property include a storage shed and several locker stalls (located adjacent to the south wall of the building). The storage shed contains lawn maintenance equipment. It was noted that the City has since taken over the maintenance of the RSC Property and these items are no longer needed or used. Storage lockers are designated for volunteers of the GEFC and typically contain personal items used to tend to community gardens (gloves, small tools, etc.). No chemicals or fertilizers are stored on the property.

Picture 12 – Contents of small storage shed located on south side of site building

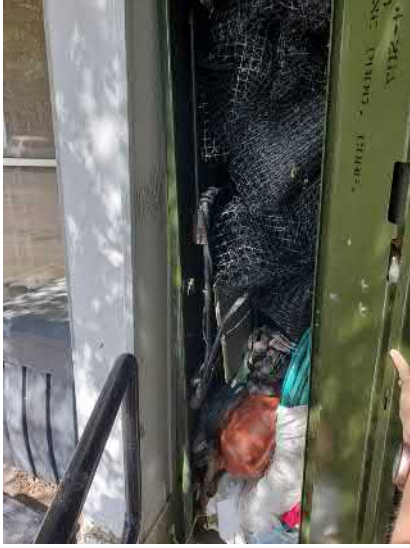
Picture 13 – Contents of storage locker located on south side of site building

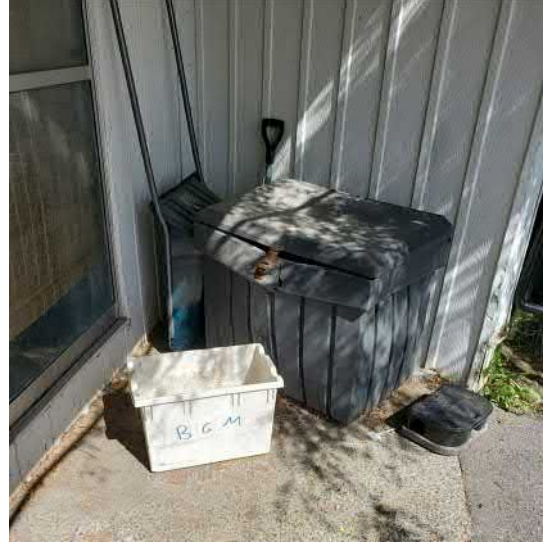
Picture 14 – Salt storage bin located at south entrance of site building

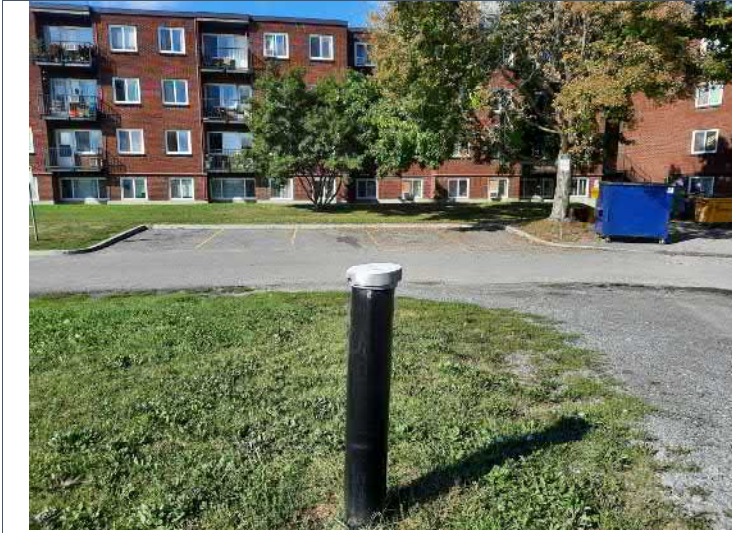
Picture 17 – Monitoring well on eastern portion of property

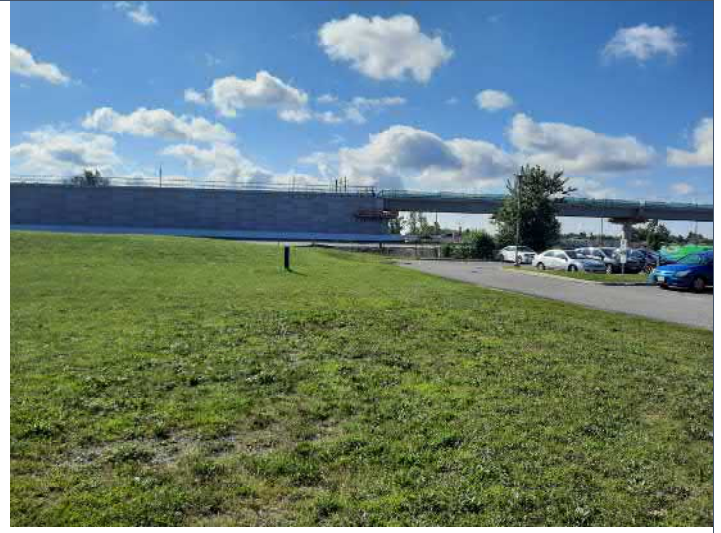
Picture 18 – Site view from landscaped portion of property (facing south) capturing berm and monitoring well

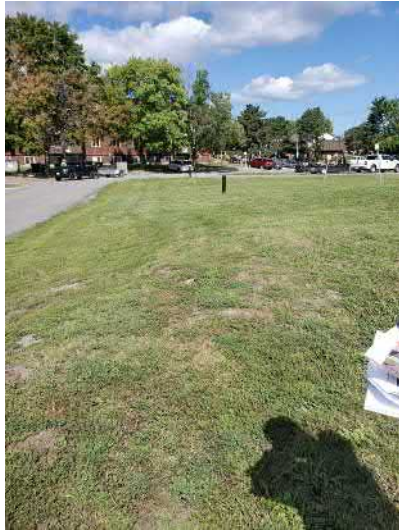
pathway. The southern-most portion of the grassed area slopes upward at a higher elevation than the rest of the grassed area and borders a chained-link fence. Two monument style monitoring wells were observed along the west portion of the grassed area, which were installed as part of Dillon's 2013 Phase Two ESA (confirmed by referencing the Site Plan from the report).

Picture 19 – Site view from landscaped portion of property (facing north) capturing two monitoring wells
