**RE: 1086 Antochi Lane Residential Development
Environmental Impact Statement and Tree Conservation Report**

**1086 ANTOCHI LANE
ENVIRONMENTAL IMPACT STATEMENT and TREE CONSERVATION REPORT**

**1086 Antochi Lane
Manotick, City of Ottawa**

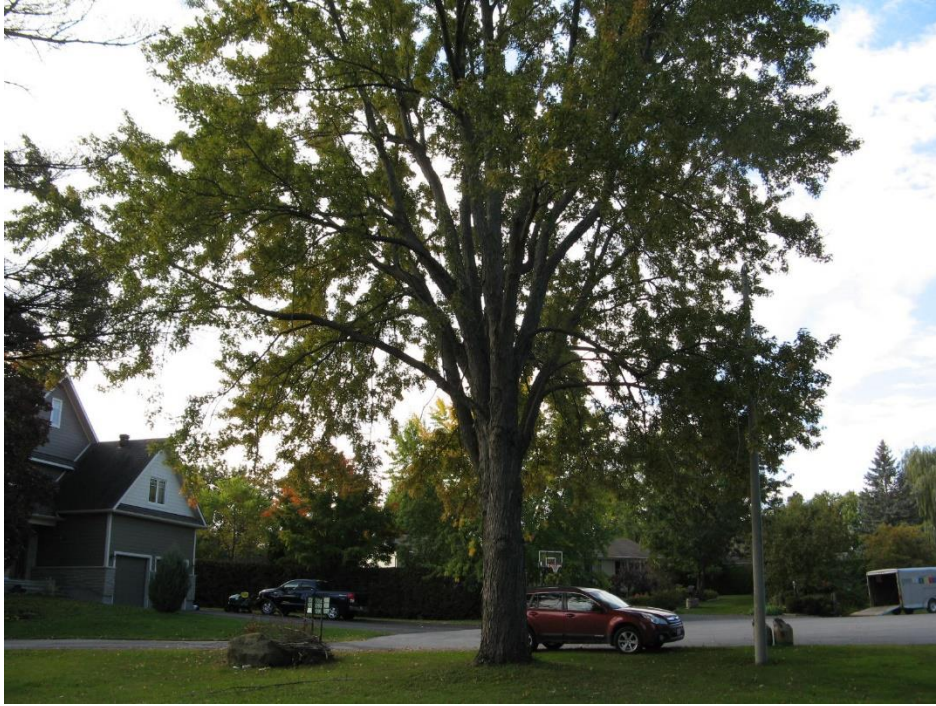
One city co-owned tree is present adjacent to the Antochi Lane cul-de-sac. This mature silver maple in apparently good condition (Photo 1) is described in Table 1 as Tree # 1. In terms of adjacent trees, Tree group number 2, dominated by Norway maples up to 30cm dbh, is along the property line shared with 1101 Antochi Lane (Photo 2). A 55cm dbh Norway maple is approximately 4.5 metres southwest of the existing private road in the front lawn of 1100 Antochi Lane (Tree # 24, Photo # 8). Tree group numbers 13, 14, and 16 are along and to the south of the south property line. These include a 60cm dbh red oak two metres south of the property line in the rear yard of 1091 Orchard Hollow Drive (Photo 6) and many white spruce in the 30cm dbh range and smaller apple and Manitoba maple along the shared property line with 1099 Orchard Hollow Drive and to the south. The latter is identified as a mixed hedgerow on Map 1.

*Photo 1 – Mature silver maple near property line adjacent to cul-de-sac (Tree # 1).
View looking west*

No impacts are anticipated on the co-owned silver maple (Tree # 1) adjacent to the cul-de-sac as the proposed access will be in the same general location as the existing access and the closest portion of the new road or new residence will be about twelve metres from the tree trunk.

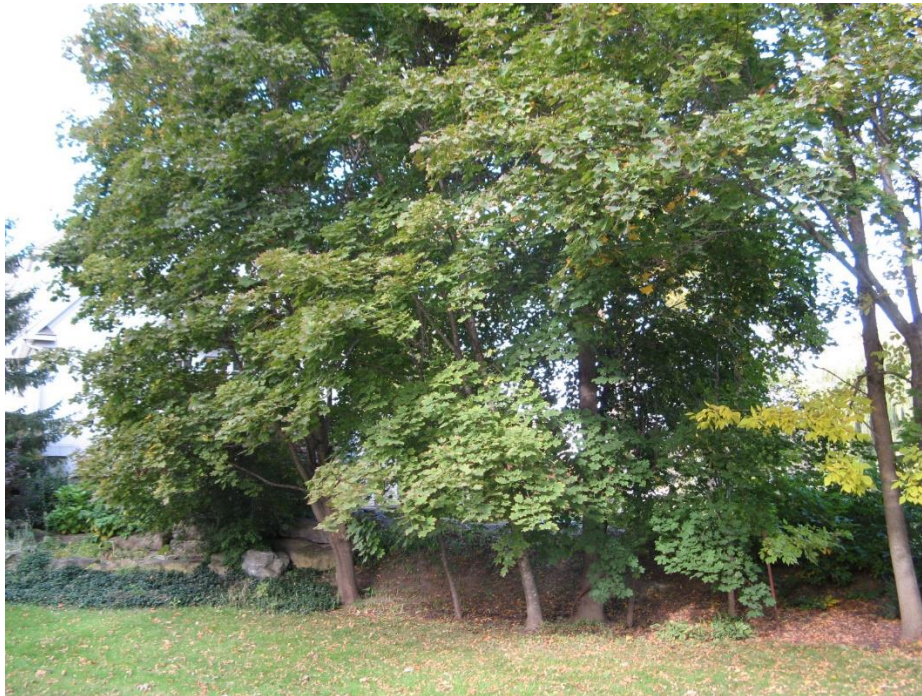
*Photo 2 – Norway maples along north property line in the northeast corner of the site
(Tree group # 2). View looking northwest*

The critical root zones of trees along the west portion of the north property line (Tree group # 2) will extend up to three metres onto the site. No impacts are anticipated on the critical root zone of these Norway maples and ash trees as the closest potential disturbance to their root systems will be greater than twenty metres from the tree trunks.

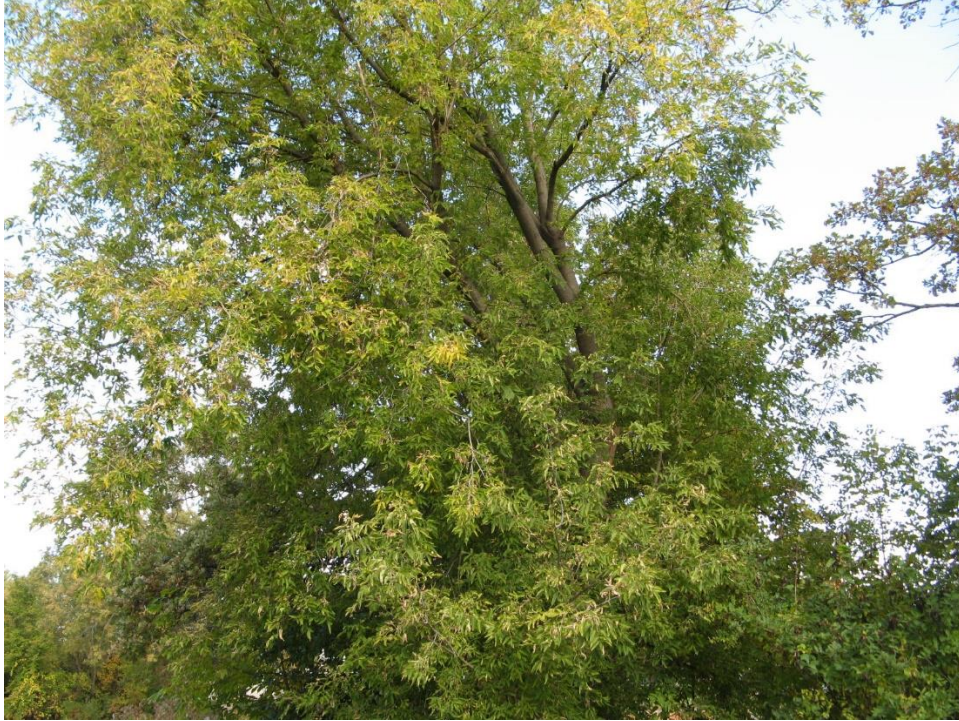
Most of the on-site trees are along the perimeter, including the Rideau River shoreline, shown as deciduous hedgerows on Map 1. Several mature bur oaks are present (Photos 3 and 4), along with smaller green ash, Colorado spruce, white cedar, and basswood. The shoreline trees are described in Table 1 below as tree groups 5 - 11. The largest bur oaks are up to 50cm dbh. Regenerating stems of Manitoba maple, white cedar, European mountain ash, white spruce, and green ash are among the shoreline trees, along with common buckthorn and glossy buckthorn, shrubs. Other than the ash and associated impacts of the emerald ash borer, most of the shoreline trees appear to be in generally good condition.

Photo 3 – Mature bur oak (Tree # 7) along Rideau River shoreline in the northeast portion of the site. View looking northeast.

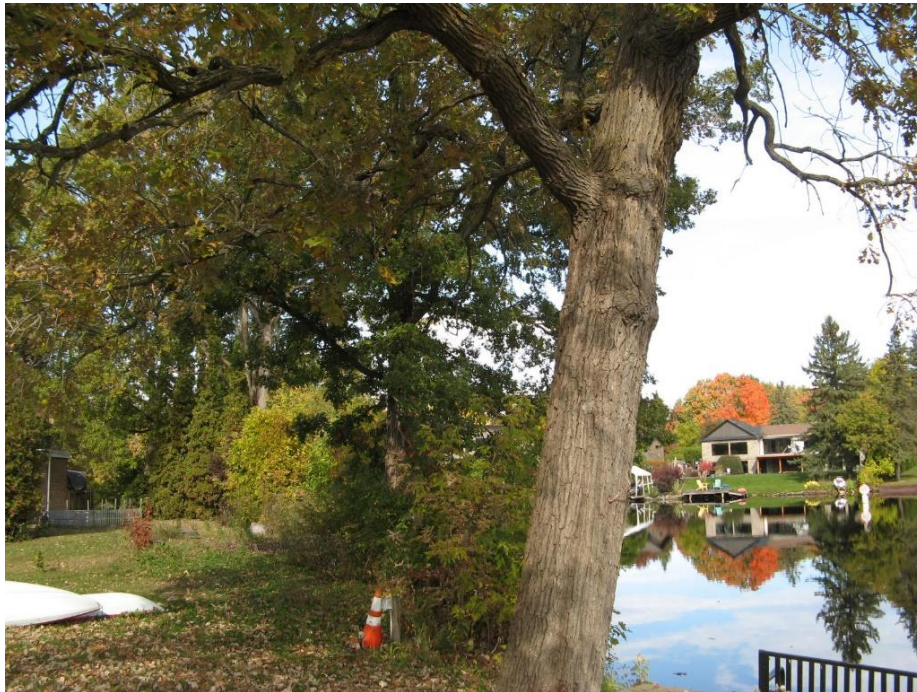
Photo 4 – More bur oak along the Rideau River shoreline (Tree group # 11). This example is on the east edge of the site with view looking northwest

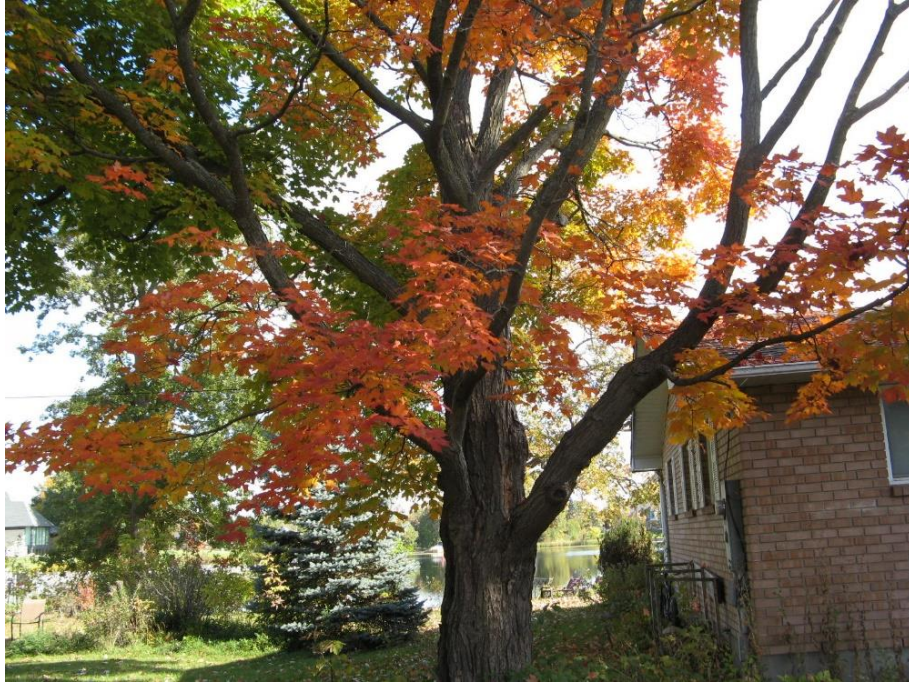
The larger trees in the interior of the site are a 60cm dbh Norway maple in the west portion to the east of the cul-de-sac (Tree # 3), a 56cm dbh red maple (Photo 5) and white spruce 40cm dbh in the southeast portion of the site (Trees # 12 and 17), and a 75cm dbh silver maple in the northeast portion (Tree # 19).

*Photo 5 – Red maple (Tree # 12) adjacent to residence in the southeast corner of the site.
View looking east*

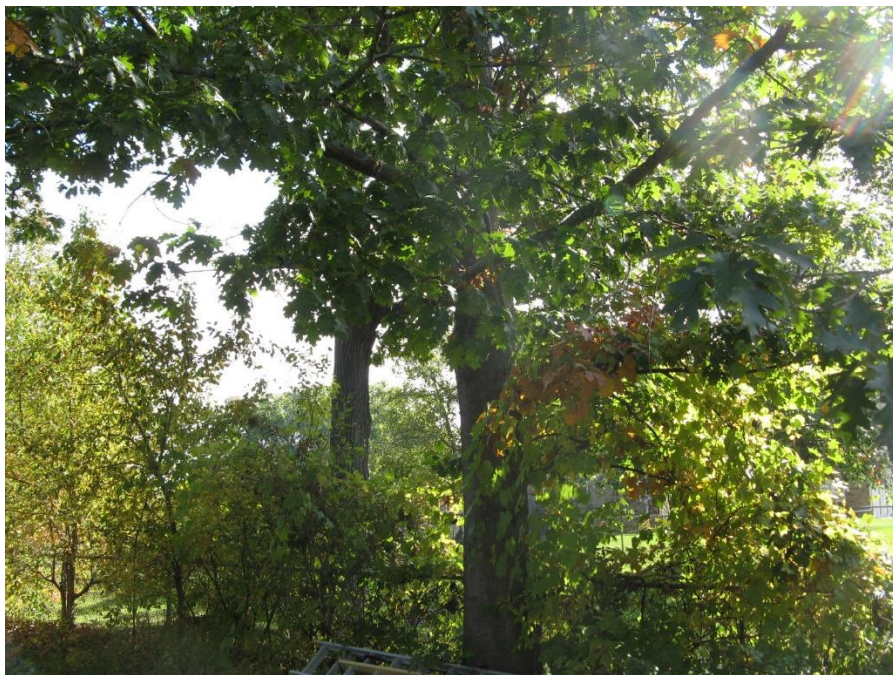
*Photo 6 – Red oak (Tree # 13) and adjacent red oak to the south the southeast corner of the site.
View looking southeast*

Along the east portion of the south site boundary no impacts are anticipated on the 60cm dbh red oak (adjacent to Tree group # 13) approximately two metres to the south of the site as this area is at the outer edge of the thirty metre river setback. Further west, the critical root zones of the white spruce and other trees (Tree group # 14) adjacent to the south property line will extend onto the site up to 1.5 metres and will likely be impacted by construction of the propose retaining wall. Discussions are required with the adjacent landowner at 1099 Orchard Hollow Drive regarding potential removal of the trees followed by plantings of native tree species in locations acceptable to the adjacent landowner.

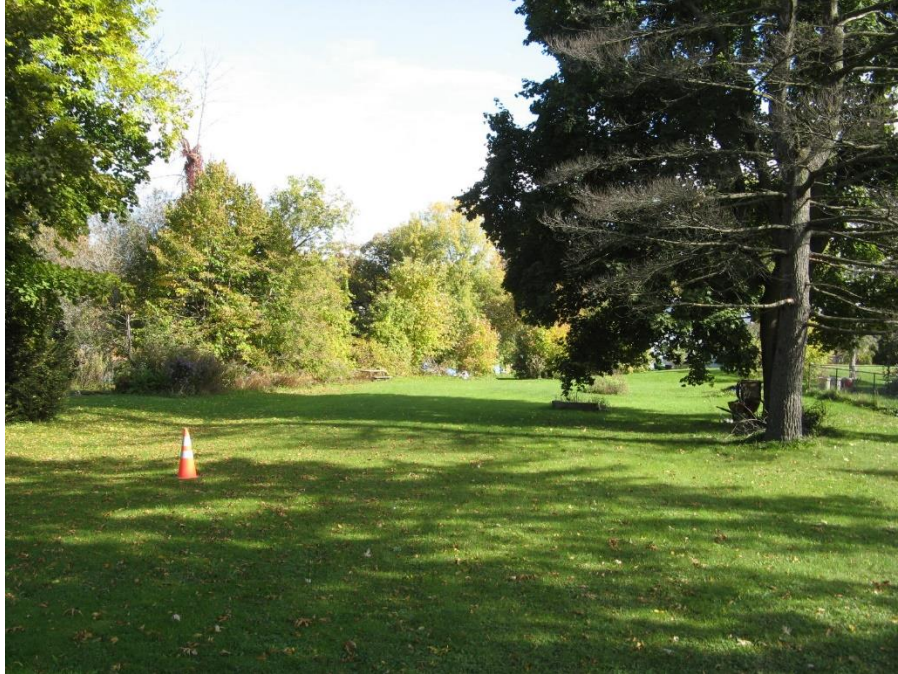
In addition to the dominant blue grass (Photo 7), scattered ground flora in the mowed areas include field sow-thistle, bird's-foot trefoil, red clover, yellow wood sorrel, ground ivy, Canada thistle, and common dandelion. Portions of the shoreline are not mowed and in these areas

Photo 7 – Typical site conditions with mowed lawns and scattered intermediate-aged and mature trees. Colorado spruce is on the right (Tree # 4), with mature bur oak along the Rideau River shoreline in the background. View looking east

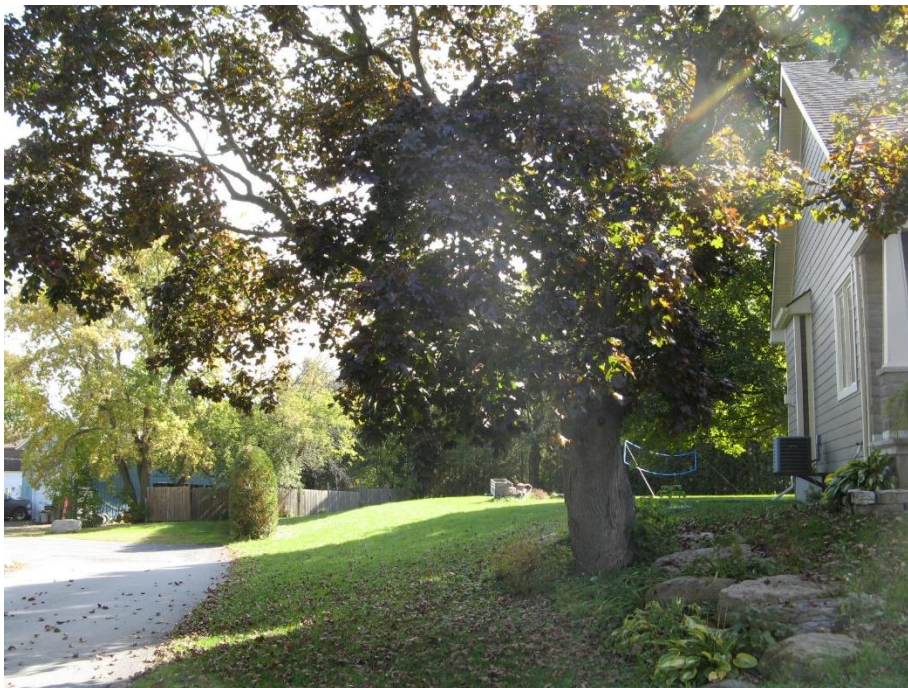
Photo 8 – Off-site Norway maple (Tree # 24) adjacent to the existing private road accessing the site off Antochi Lane. View looking southeast

Approximately one metre of the critical root zone of the 55cm Norway maple (Tree # 24) in the front lawn at 1100 Antochi Lane will extend onto the site. This tree is not anticipated to be impacted due to the relatively low sensitivity of Norway maple and that the tree is located at a higher elevation than the site. In addition, this portion of the site is already disturbed due the existing asphalt private road off Antochi Lane, although a retaining wall will be required along the property line in this area.

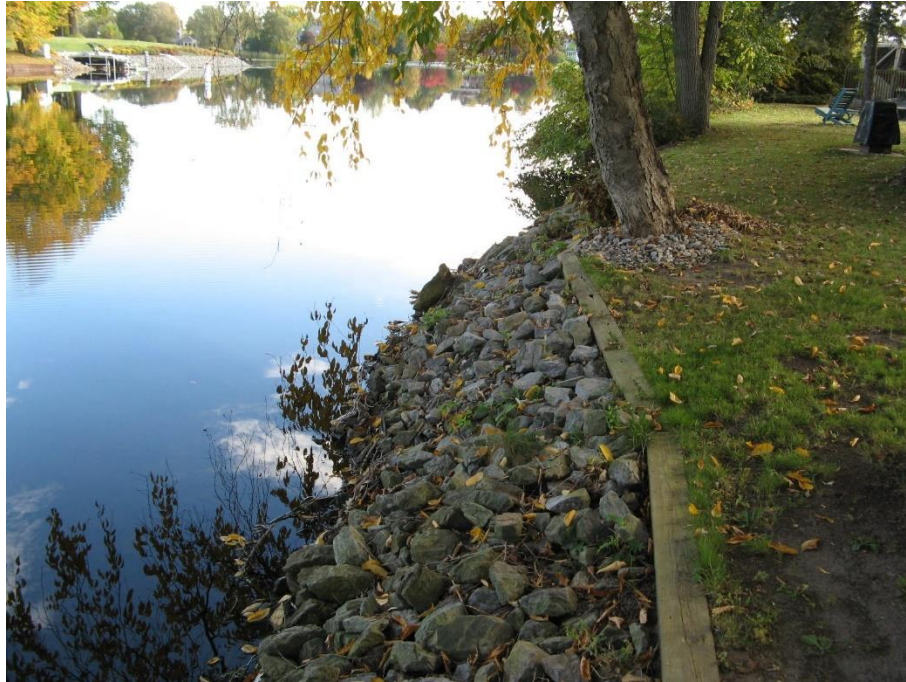
Photo 9 – Typical hardened shoreline conditions with rock protection, good tree cover, and mowed landscape. View looking east along north edge of site

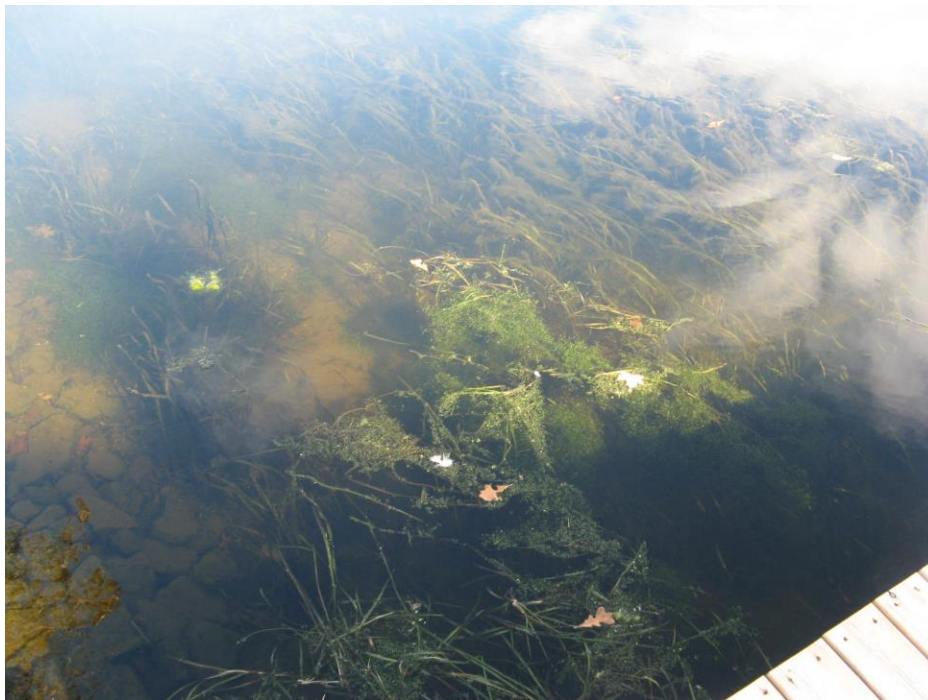
Photo 10 – Submersed and floating vegetation and cobbles in littoral zone adjacent to the southeast site edge. View looking northeast

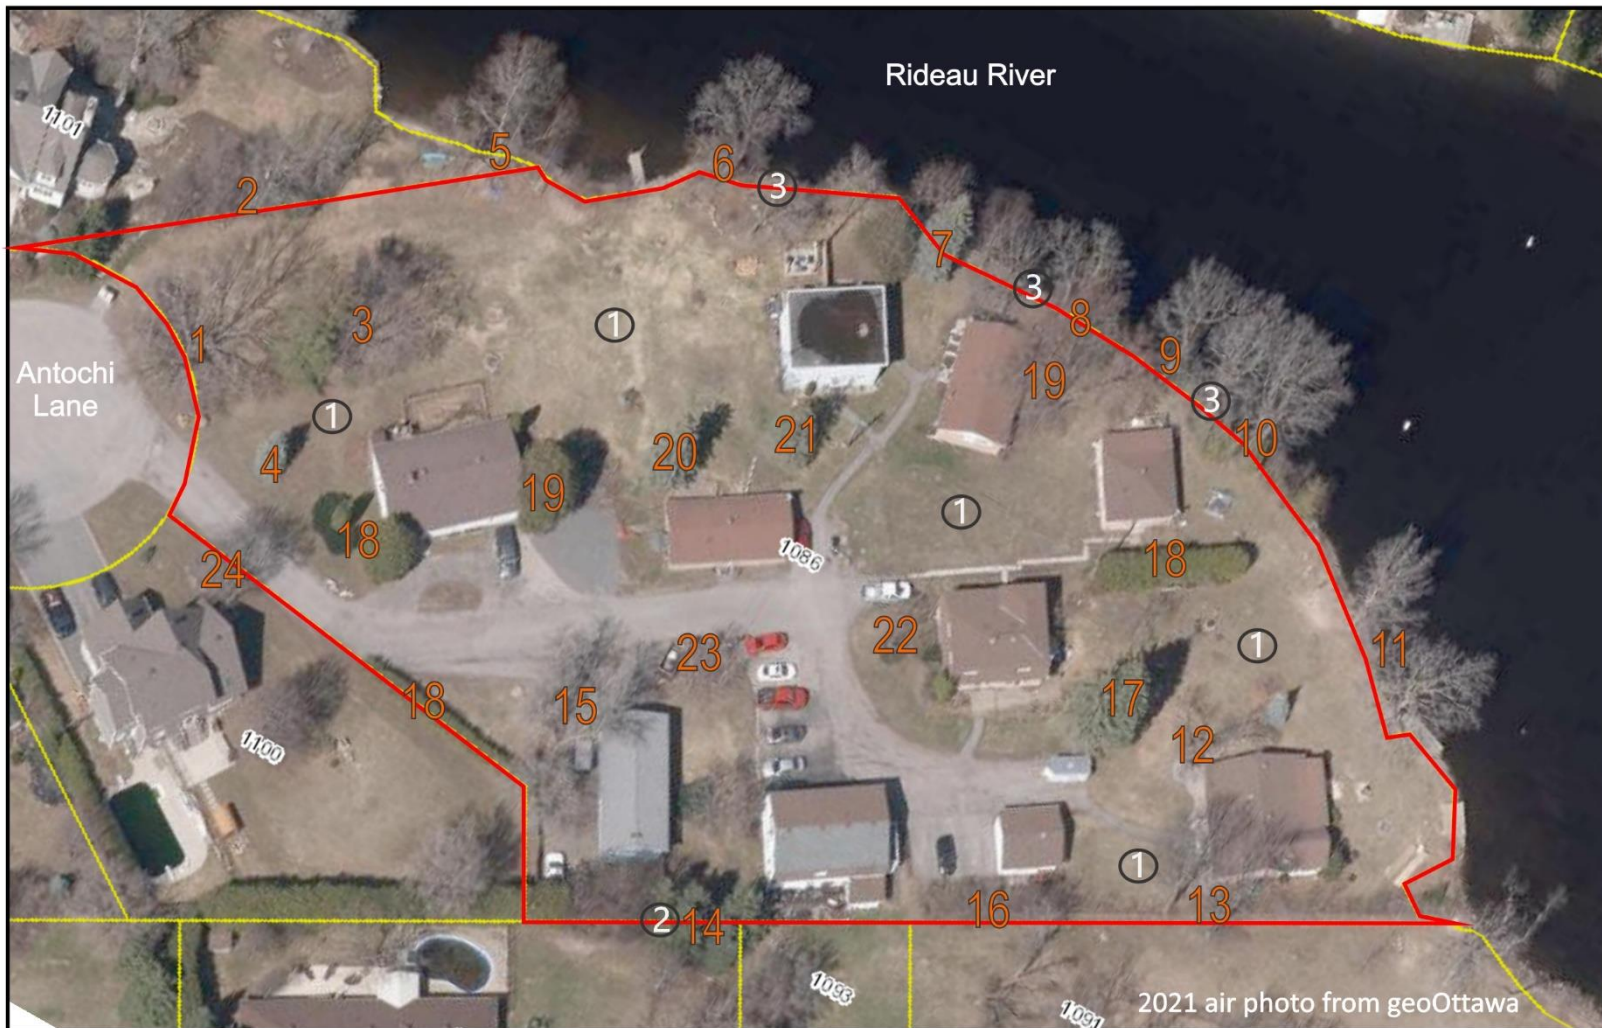
Map 1

The scattered trees throughout the site are described in the following table, with the associated numbers shown on Map 1.

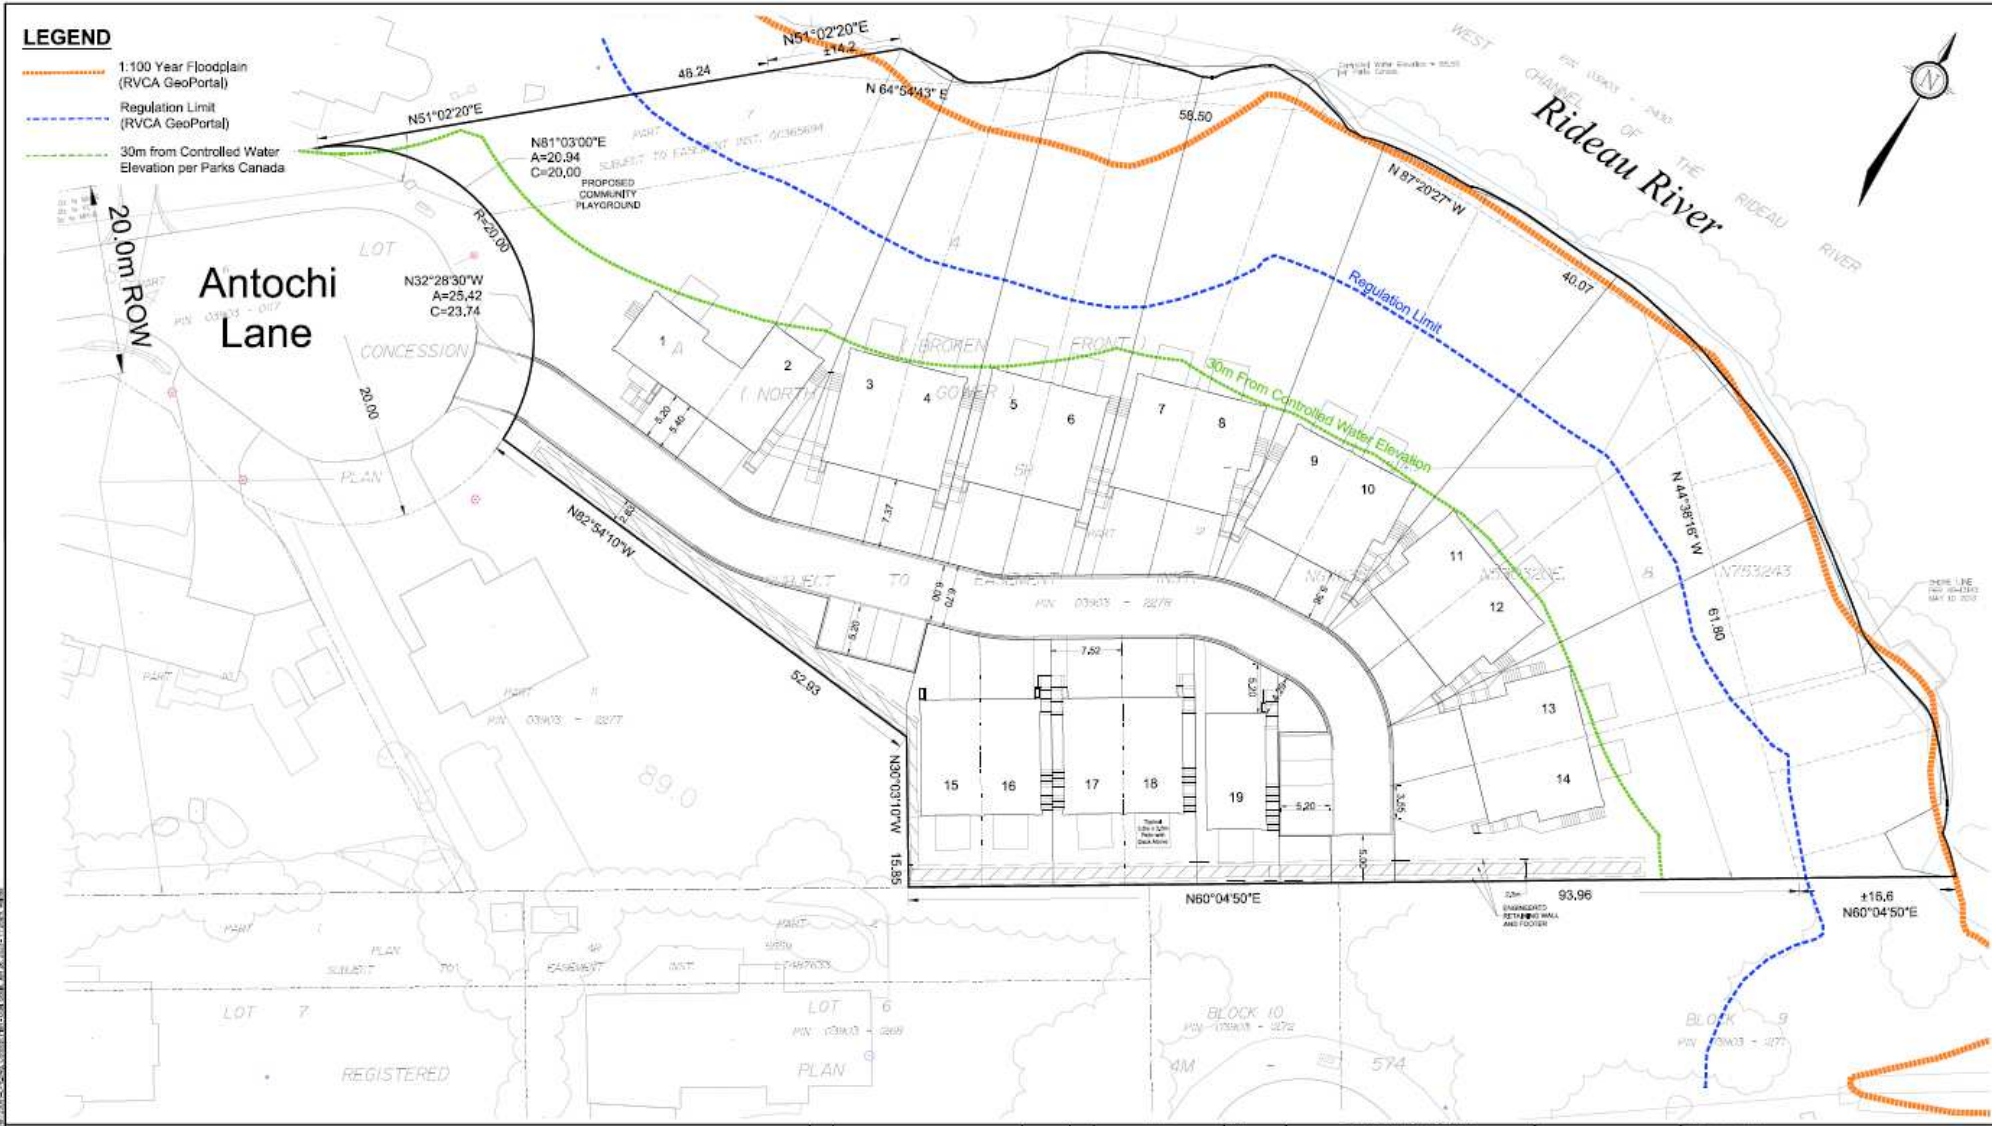
MAP 2 – CONCEPT PLAN

The Rideau River is immediately to the north and east of the site. The floodplain (see orange line on Map 2) is generally within a metre or two of the shoreline, extending onto the site by up to 12 metres for a width of approximately 25 metres in the north portion of the site. At the site, the west channel of the Rideau leaves the main channel. The west channel to the north of the site varies between approximately 40 and 60 metres in width, with the main channel to the east in the range of 120 to 140 metres wide. The variety of morphological features in the area of the site is less than other portions of the Rideau River corridor, with a lack of side channels and riffle features. However, the overhanging branches of the mature bur oaks and other woody vegetation along the shoreline provide soil stability, and important shade and food inputs for the littoral zone, which appears to extend up to ten metres from the shoreline. Submergent and floating aquatic vegetation adds to the quality and quantity of available spawning, nursery and feeding habitat (Photo 10), although emergent vegetation is generally lacking in the littoral zones adjacent to the site. Areas of small rock protection are along the shoreline and wetland habitat does not extend onto the site from the adjacent shoreline (Photo 9). Cobbles are common in areas (Photo 10), with fines the dominant substrate in the balance of the littoral zone adjacent to the site.

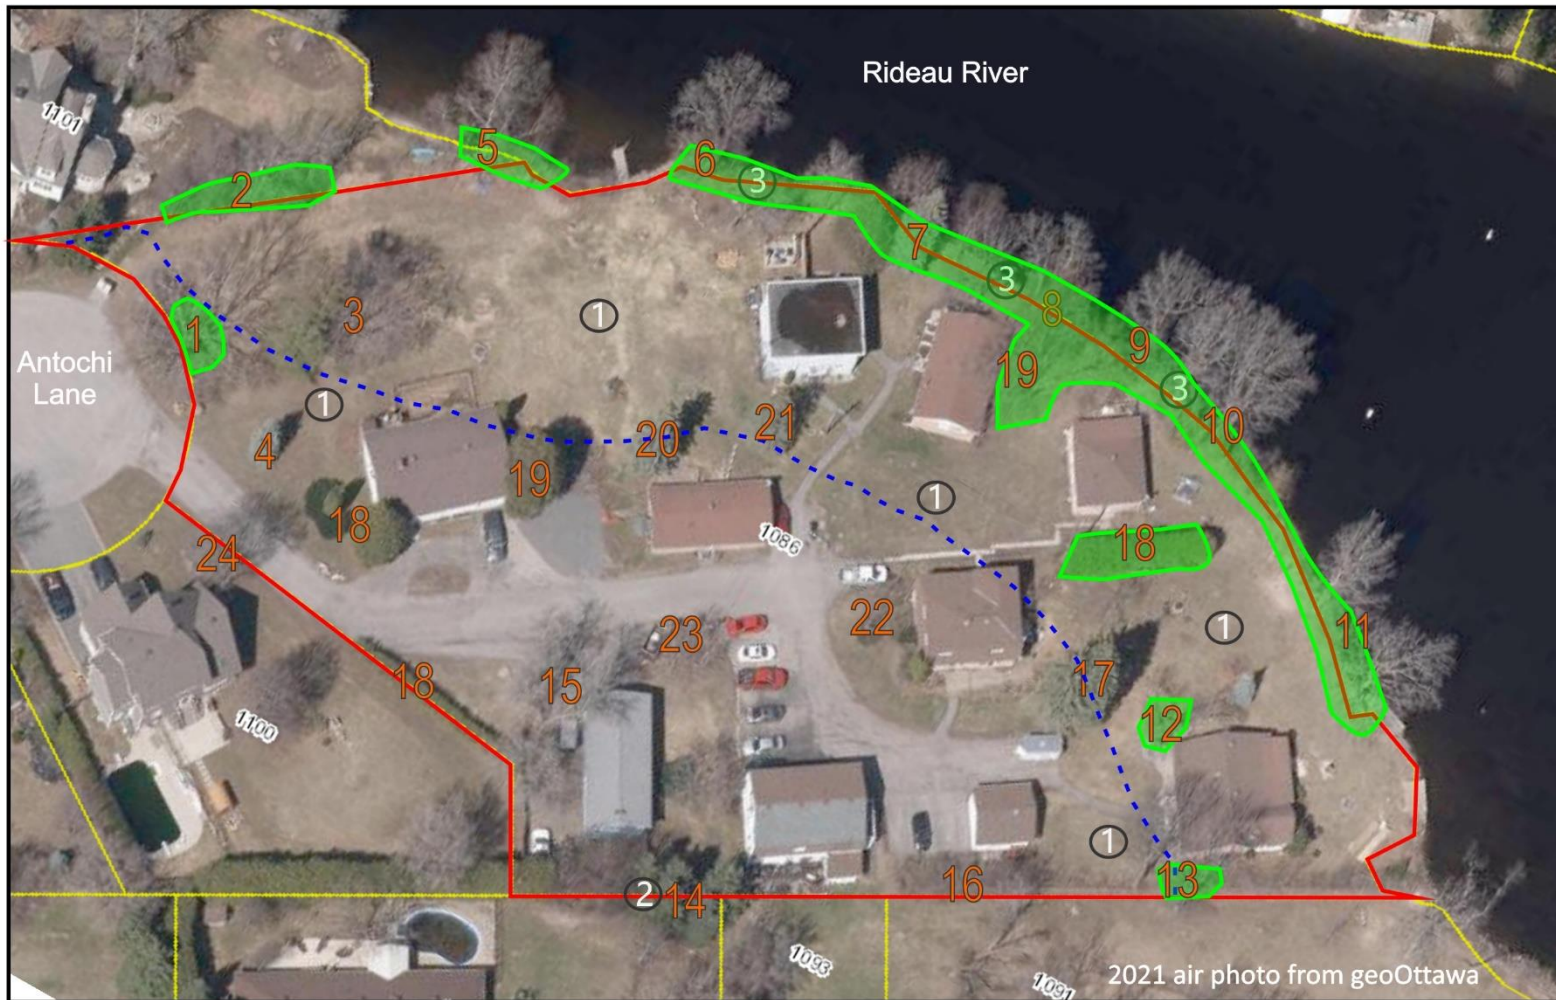
PROPOSED CONSERVED VEGETATION

Due to the proposed density of the development footprint and associated servicing, tree retention is not anticipated to be feasible for the interior of the site greater than thirty metres from the Rideau River shoreline. Proposed retaining walls will reduce the extent of tree retention along the southwest and south property lines south of the private road and in the rear yard of the new residences. As shown on Map 3 and indicated in Table 1, many clusters of trees along the Rideau River shoreline and in the thirty metre setback will be retained. Trees to be retained include most of the intermediate-sized and larger examples of the more desirable tree species including red maple, silver maple, white spruce, and bur oak.
