**Geotechnical Investigation
Proposed Residential Development
1086 Antochi Lane
Ottawa, Ontario**

1910753 Ontario Inc.
6900 Sunset Boulevard
Ottawa, Ontario
K4P 1C5

February 7, 2023
Project: 100152.004

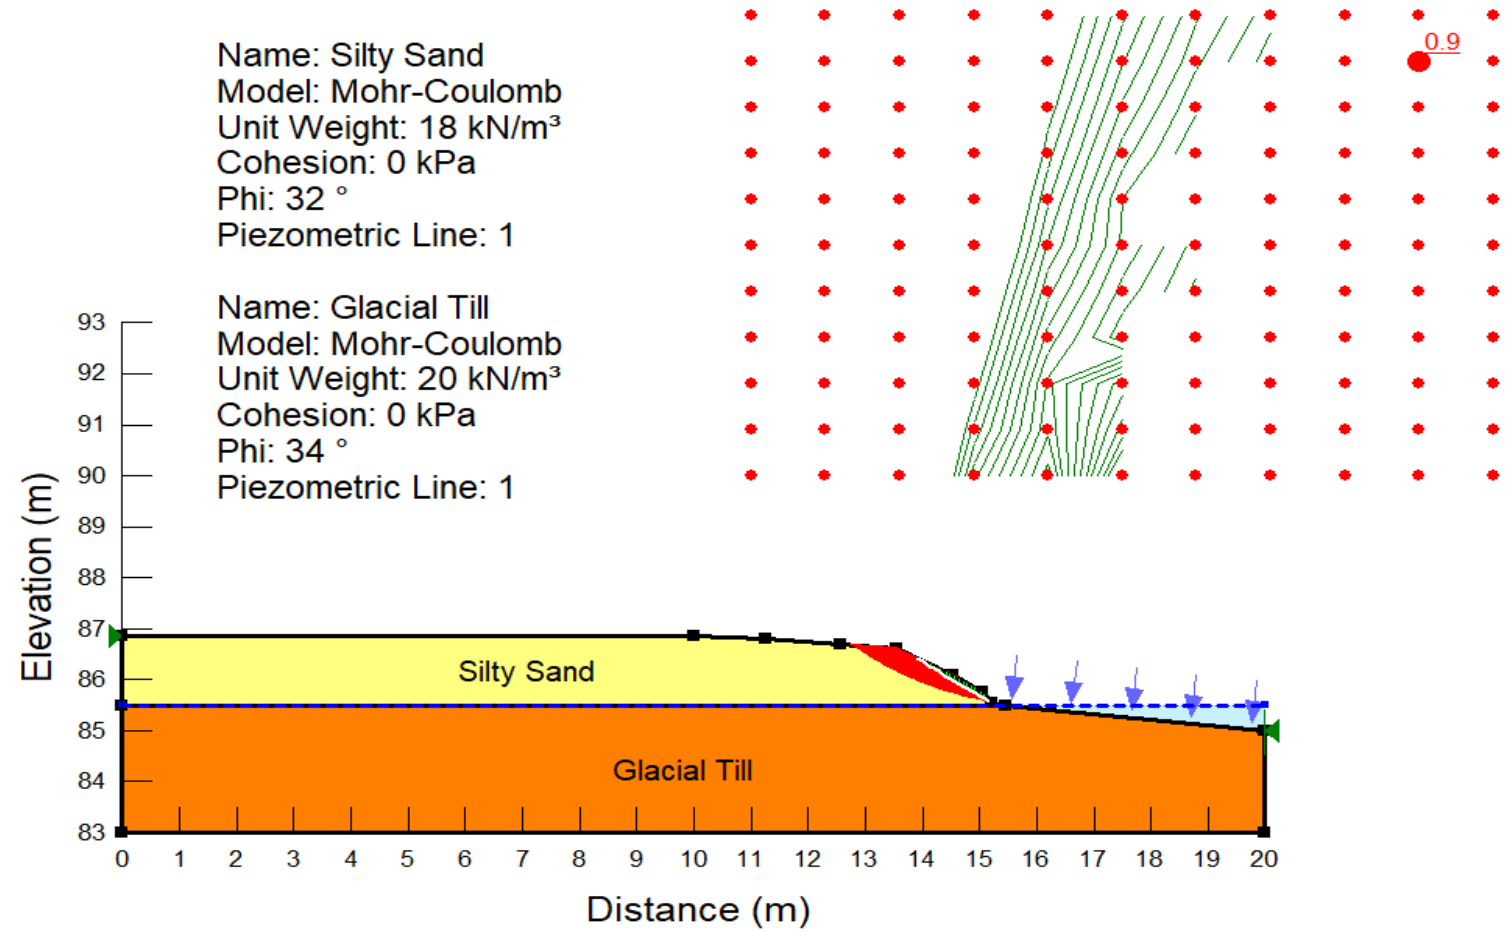
Slope Cross Section B-B
 1086 Antochi Lane
 Ottawa, Ontario

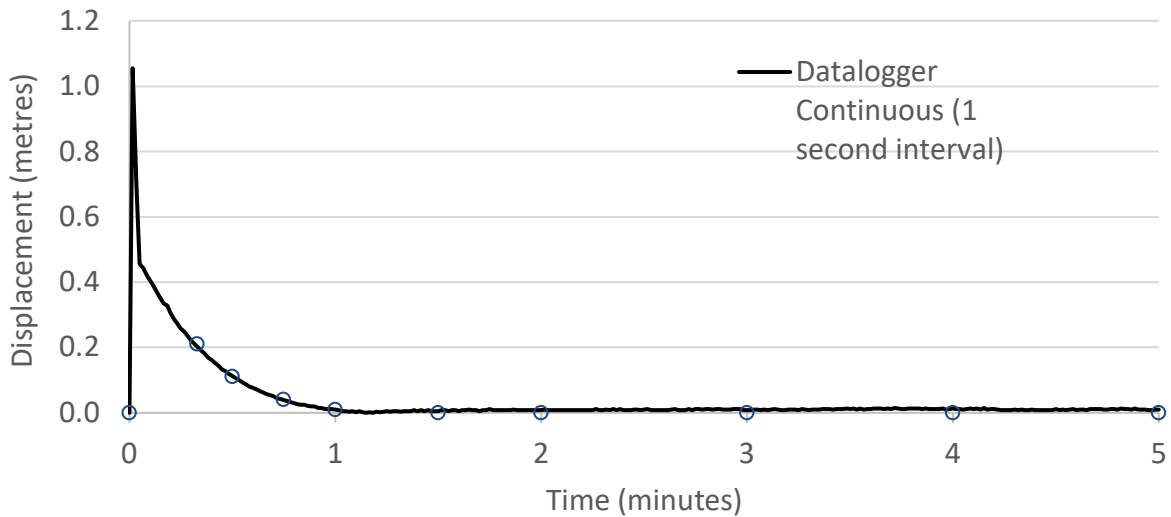
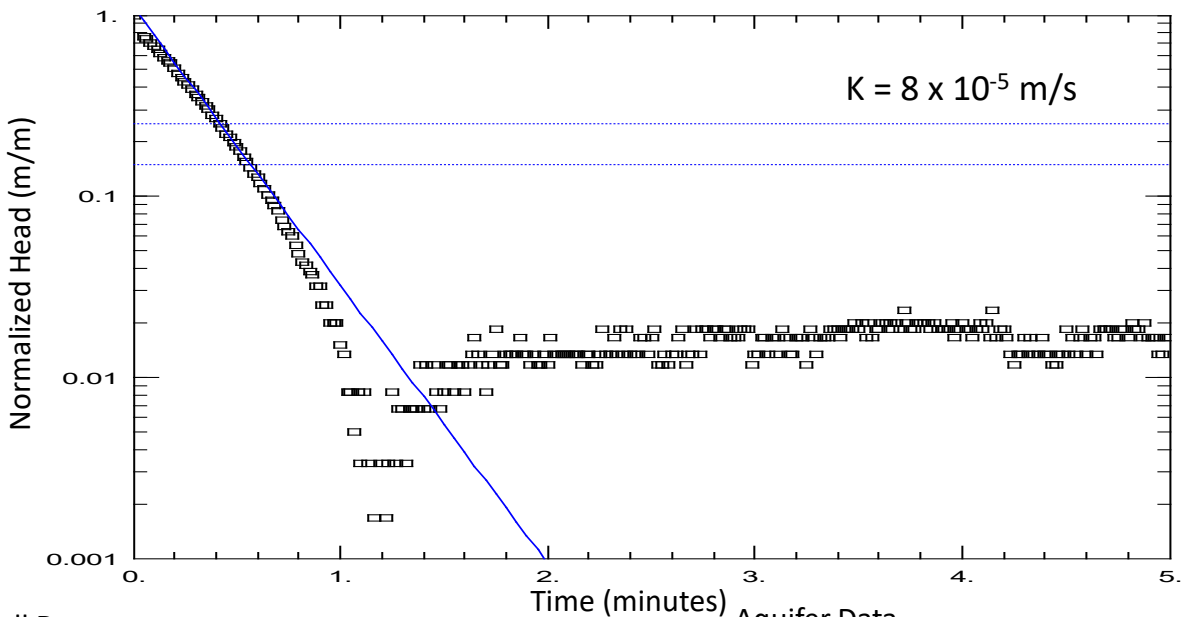
FIGURE E1

Borehole 21-01 Falling Head (FH) Test

Borehole 21-01 FH: Hvorslev Analysis

Well Data:

Displacement observed (slug size): 1.05 metres (0.60 m)
Well Depth: 3.83 metres
Screen Length: 1.5 metres
Well Radius: 0.0255 metres
