Phase I Environmental Site Assessment

Vacant Property
575 Dealership Drive
Ottawa, Ontario

April 5, 2022

Report: PE5660-1

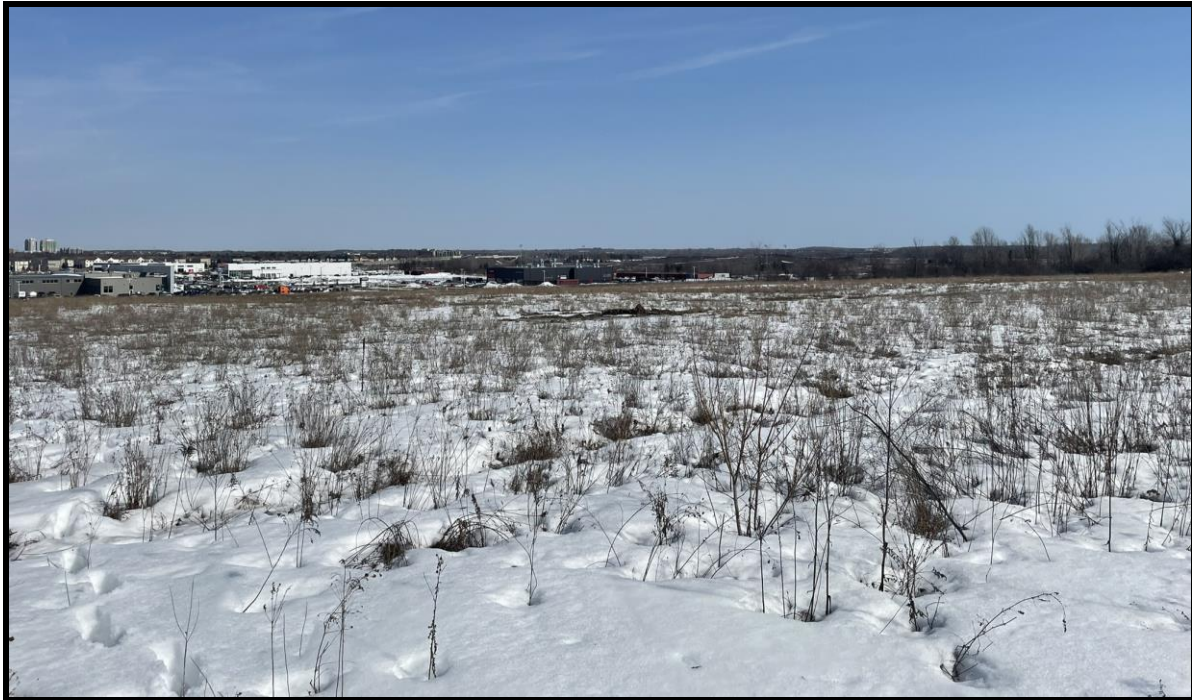
Photograph 1: View of the southeast portion of the subject site, taken from the northwest corner of the site, at the property line.

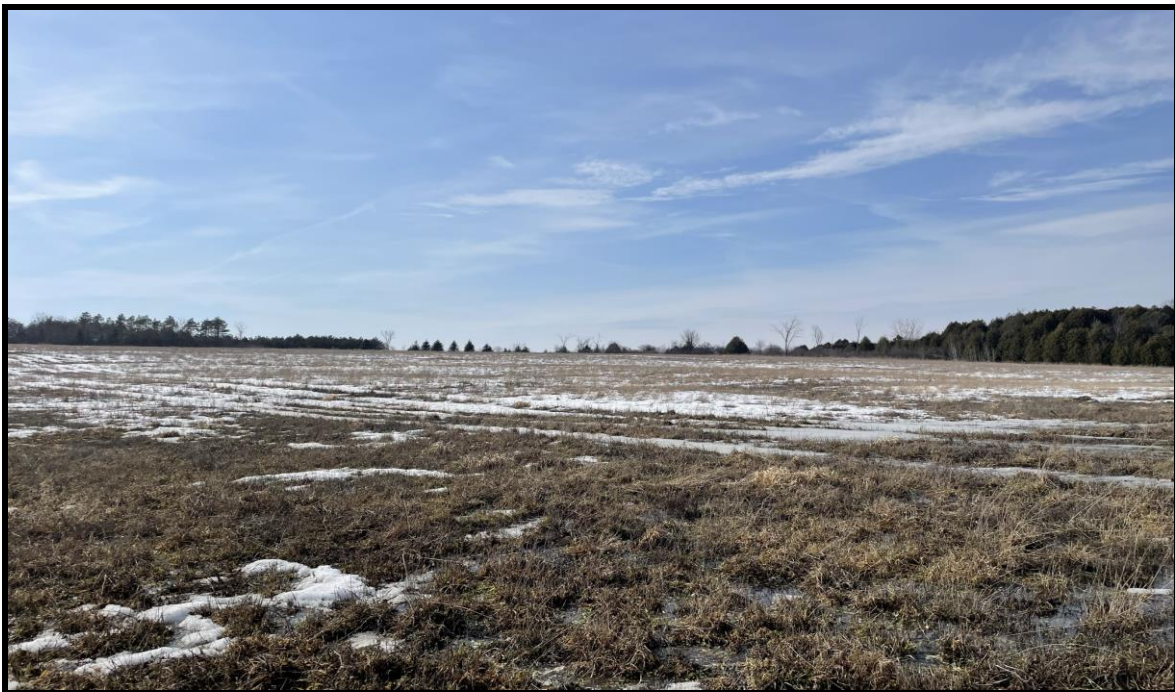
Photograph 2: View of the northwestern portion of the subject site, taken from the southeast corner of the site, at the property line.
