# Phase One Environmental Site Assessment

265 Centrum Boulevard, Orléans, ON K1E 3X7

**Bayview Orleans Inc.**  
Final Report

March 2023  
02300762.000

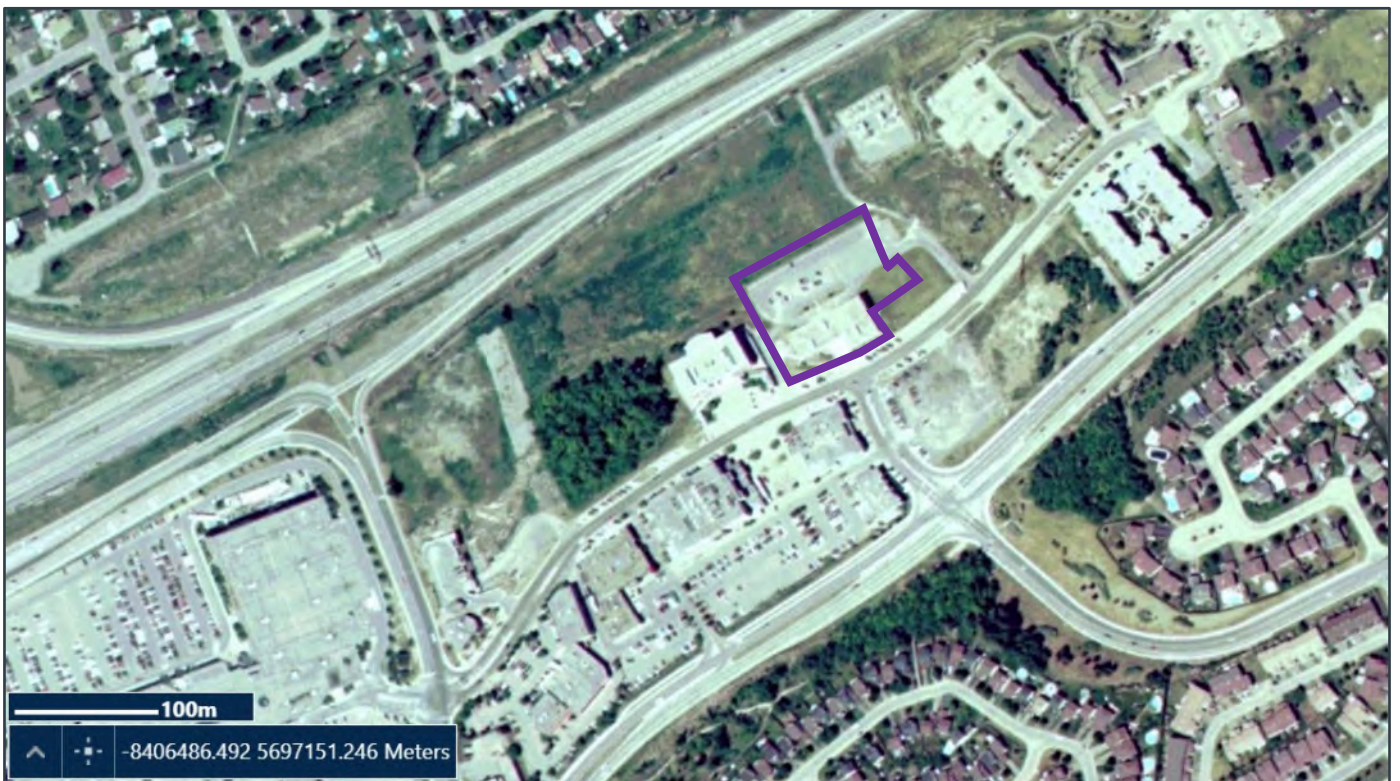
1999	Developed with a parking lot, driveway lane, and building that appears to be for commercial use.	North: Similar to 1991 photograph. South: Similar to 1991 photograph. East: Similar to 1991 photograph. West: Similar to 1991 photograph.
2002	Similar to 1999 photograph.	North: Electronic substation appears decommissioned with the access roads/pathways beginning to appear overgrown with vegetation/not maintained as well as previously observed. South: Similar to 1999 photograph. East: Additional development east with a building that appears to be for residential use. West: Similar to 1999 photograph.
2008	Similar to 2002 photograph.	North: Electronic substation appears fully removed and the area to be under construction. South: Similar to 2002 photograph. East: Similar to 2002 photograph. West: Development of what appears to be a commercial building at 245 Centrum Boulevard.
2011	A new addition to the building on Site is visible on the eastern side of the property.	North: Area previously observed to be under construction now appears complete. A new surface water feature, presumably a stormwater pond is visible north of the Site. South: Similar to 2008 photograph. East: Similar to 2008 photograph. West: Similar to 2008 photograph.

A2 - Aerial Photograph 1999 (GeoOttawa).

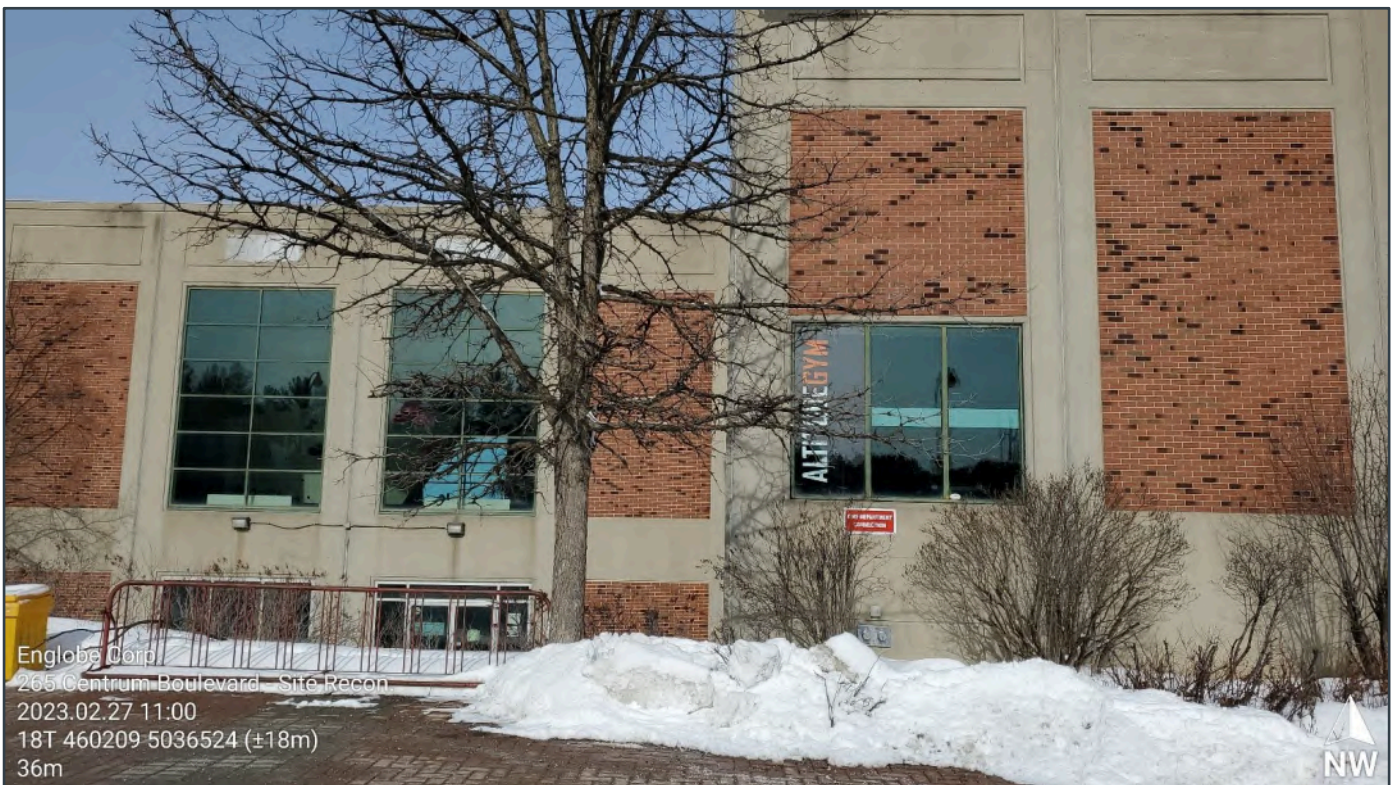
One two-storey building, and one small one-storey shed with vinyl siding was observed at the Phase One Property at the time of Englobe's Site Reconnaissance. The original building footprint consists of a brick and mortar exterior, meanwhile the exterior of the new addition mainly consisted of metal siding.

Site Photograph 2: Overview of the Site building (original build).

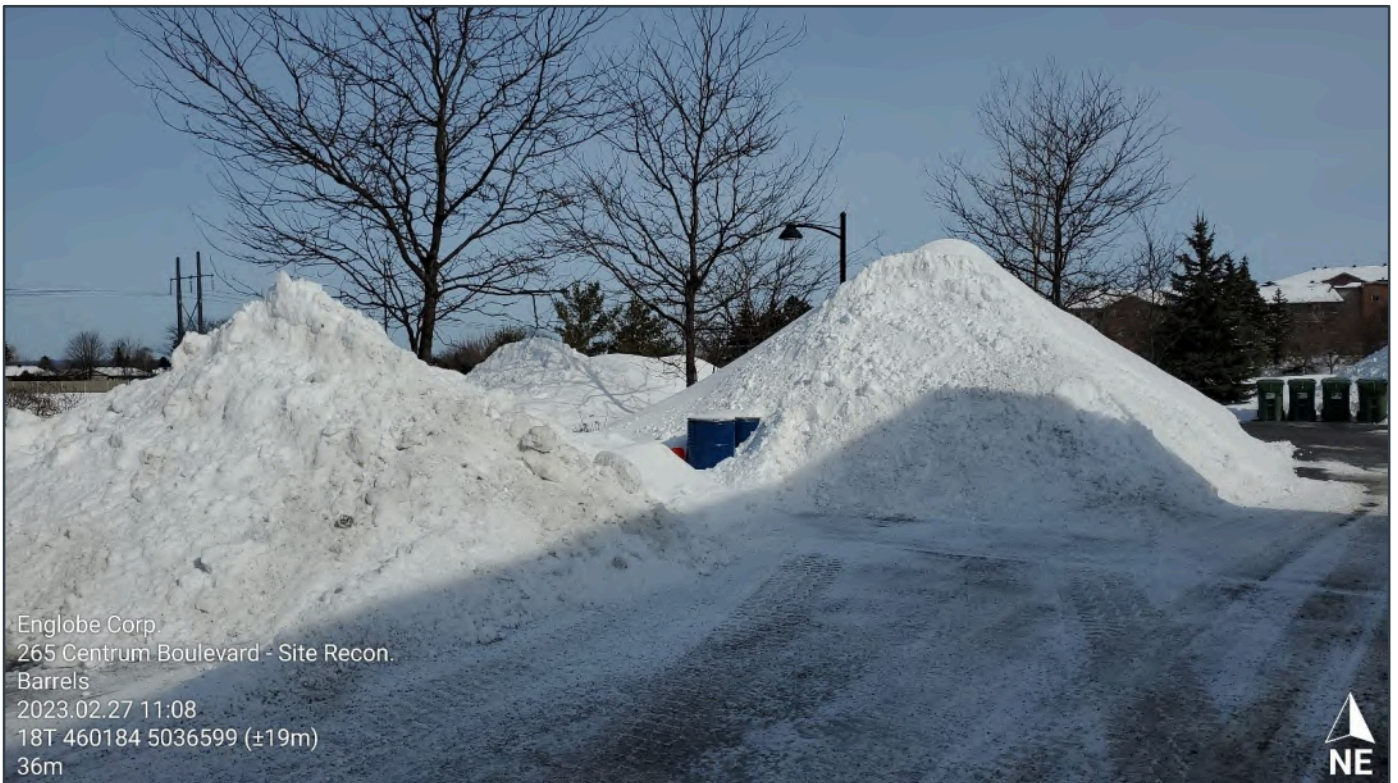
No fuel storage tanks were observed at the Phase One Property at the time of Englobe's Site Reconnaissance. Two steel 250-L drums were noted along northern property boundary, presumably containing the soil cuttings from Yuri Mendez Engineering subsurface investigation in May 2022. De-icing salt storage containers were noted along the exterior of the Phase One Property, in the vicinity of walk path and driving/parking areas.

**Site Photograph 4: Two steel 250-L drums noted along northern property boundary, presumably containing the soil cuttings from Yuri Mendez Engineering subsurface investigation in May 2022.**

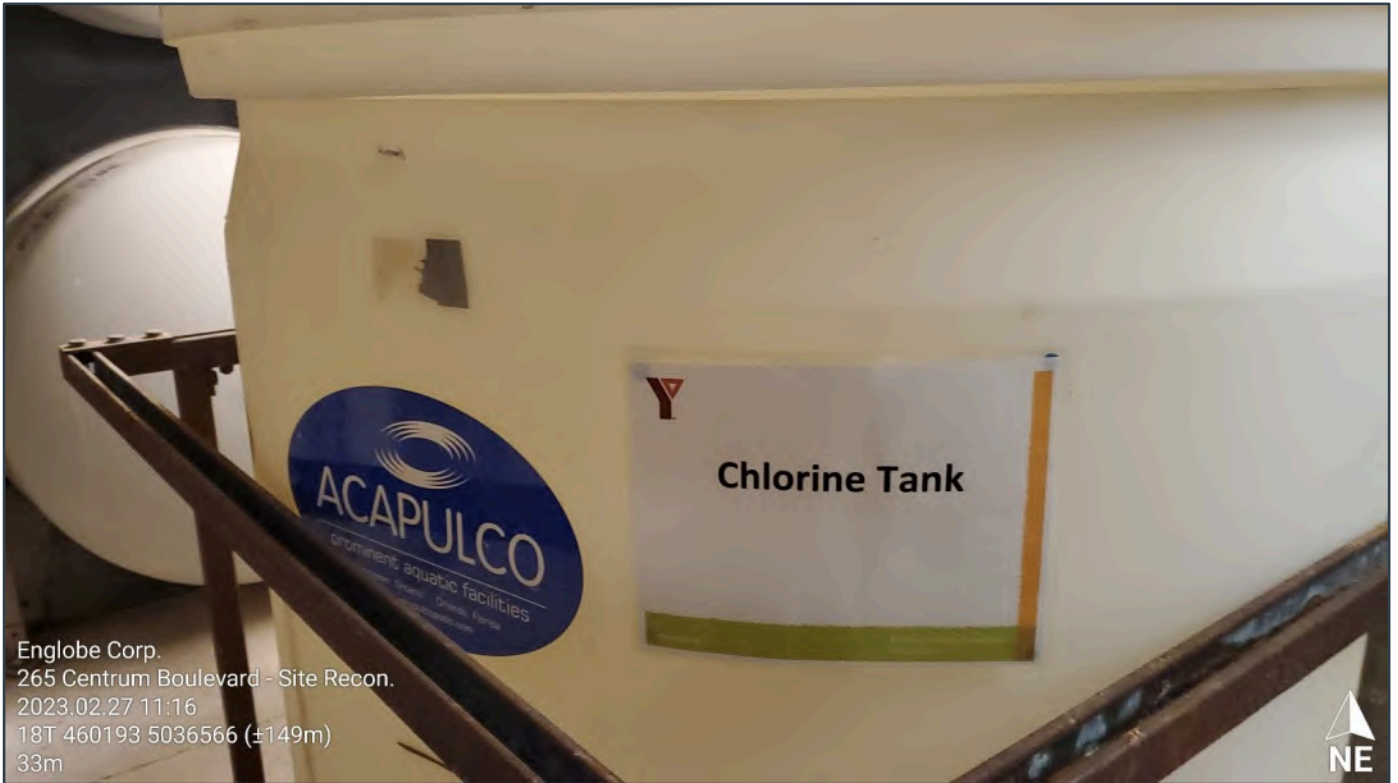
Site Photograph 7: Overview of the plastic chlorine tank (empty) in the pool valve room (basement).
